Asbestos Report

YARRIAMBIACK SHIRE COUNCIL

PROPERTY ADDRESS:
LB82 AERODROME
78 HOPETOUN AERODROME ROAD
HOPETOUN VIC 3396

INSPECTION DATE: 27 JANUARY 2021
REFERENCE NUMBER: 62062

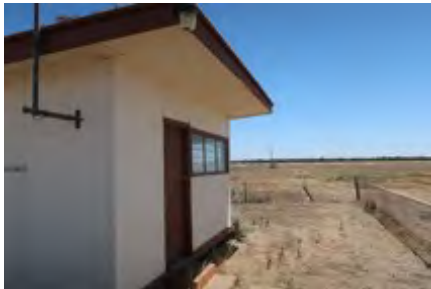
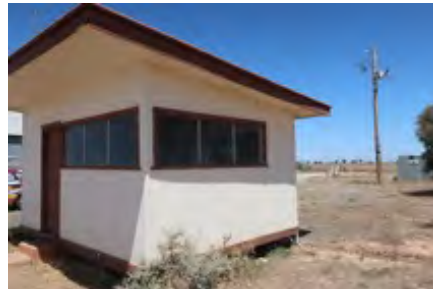
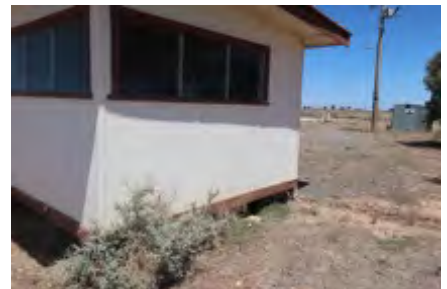
Area 5

LB82 Aerodrome: entire perimeter of building. The Walls (F C Sheeting) has Asbestos Containing Material (ACM) present.

RISK ASSESSMENT					
Type of Asbestos or Hazardous Material	No sample taken - Visual ID	Condition	GOOD	Likelihood of Damage	L (Low) – possible
		Activity	Moderate		
		Sealed	Yes	Friability	Bonded (non-friable)
		Labelled	Y	Exposure Risk	Low - Negligible or low risk
		Quantity

Maintain paint or sealant

Priority	MEDIUM	Label Required	Yes	Re- Audit Date	27 Jan 2022
Action	No remedial action required, unless disturbed				
Recommendation	Maintain paint or sealant to ACM surfaces. Particular attention should be given to side edges, ensure paint/sealant covers ALL exposed ACM surfaces.				
Legislative Requirements Victorian Regulation 2007	Warning labels should be affixed. Avoid mechanical damage and abrasion. Remove if refurbishment, structural alteration or demolition is to be carried out in this area. Re-inspect every 12 months or earlier if disturbed or removed in accordance with the Victorian Regulation 2007. All remedial/removal repairs require a Clearance Inspection & Certificate to be recorded by an approved and competent assessor.

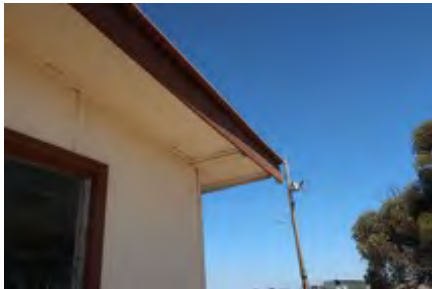
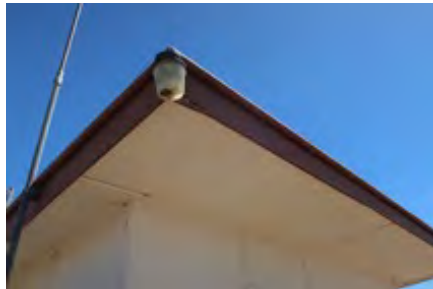
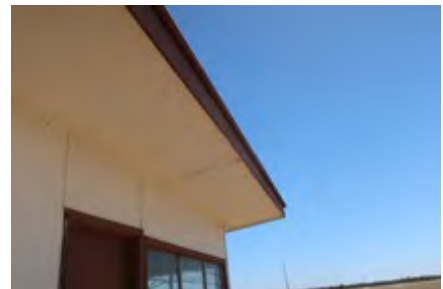
LB82 Aerodrome: entire perimeter of building. The Soffit (F C Sheeting) has Asbestos Containing Material (ACM) present.

RISK ASSESSMENT					
Type of Asbestos or Hazardous Material	No sample taken - Visual ID	Condition	GOOD	Likelihood of Damage	L (Low) – possible
		Activity	Moderate		
		Sealed	Yes	Friability	Bonded (non-friable)
		Labelled	Y	Exposure Risk	Low - Negligible or low risk
		Quantity

Maintain paint or sealant

RISK CONTROL					
Priority	MEDIUM	Label Required	Yes	Re- Audit Date	27 Jan 2022
Action	No remedial action required, unless disturbed				
Recommendation	Maintain paint or sealant to ACM surfaces. Particular attention should be given to side edges, ensure paint/sealant covers ALL exposed ACM surfaces.				
Legislative Requirements Victorian Regulation 2007	Warning labels should be affixed. Avoid mechanical damage and abrasion. Remove if refurbishment, structural alteration or demolition is to be carried out in this area. Re-inspect every 12 months or earlier if disturbed or removed in accordance with the Victorian Regulation 2007. All remedial/removal repairs require a Clearance Inspection & Certificate to be recorded by an approved and competent assessor.

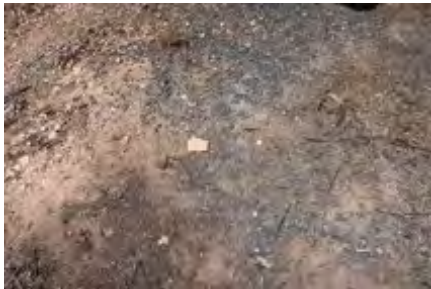
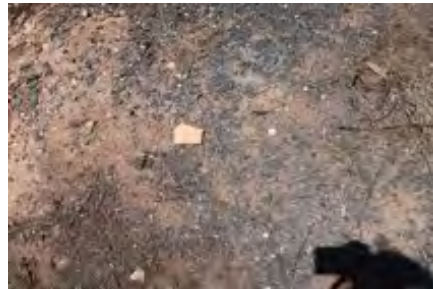
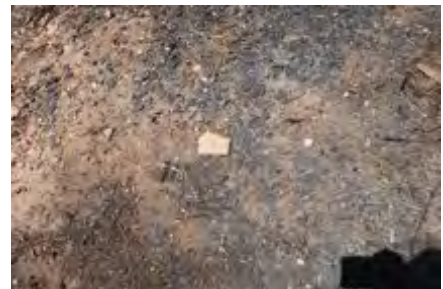
LB82 Aerodrome: rear of building. The Debris - Broken (Debris) has Asbestos Containing Material (ACM) present.

RISK ASSESSMENT					
Type of Asbestos or Hazardous Material	No sample taken - Visual ID	Condition	POOR	Likelihood of Damage	H (High) - almost certain
		Activity	Moderate		
		Sealed	No	Friability	Exposed Fibres
		Labelled	No	Exposure Risk	High - Short term exposure risk
		Quantity

Debris on Surface

RISK CONTROL					
Priority	IMMEDIATE	Label Required	Yes	Re- Audit Date	27 Jan 2022
Action	Restrict access and target for imminent removal				
Recommendation	Debris on Surface - The Debris requires immediate cleanup and disposal with specialised equipment and with licensed removalist to safely remove the asbestos debris.				
Legislative Requirements Victorian Regulation 2007	ACM debris visible. Recommend cleanup by licensed Asbestos Removalist. Warning labels should be affixed. Avoid mechanical damage and abrasion. Remove if refurbishment, structural alteration or demolition is to be carried out in this area. Re-inspect every 12 months or earlier if disturbed or removed in accordance with the Victorian Regulation 2007. All remedial/removal repairs require a Clearance Inspection & Certificate to be recorded by an approved and competent assessor.

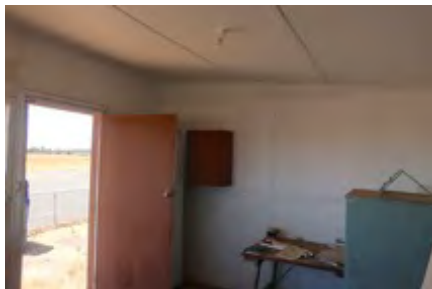
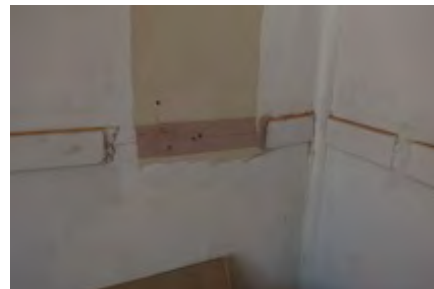
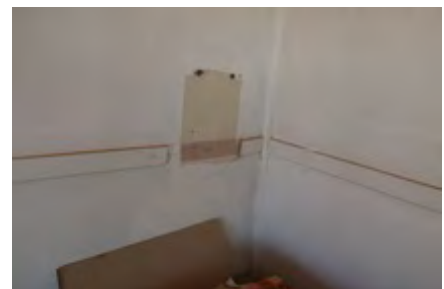
Area 3**LB82 Aerodrome: Office 1. The Walls and Ceiling (F C Sheeting) has Asbestos Containing Material (ACM) present.****RISK ASSESSMENT**

Type of Asbestos or Hazardous Material	No sample taken - Visual ID	Condition	AVERAGE	Likelihood of Damage	L (Low) – possible
		Activity	Moderate		
		Sealed	No	Friability	Bonded (non-friable)
		Labelled	Y	Exposure Risk	Medium - Moderate risk
		Quantity

Raw Material

Priority	HIGH	Label Required	Yes	Re- Audit Date	27 Jan 2022
Action	Remedial repairs required - seal raw material / edges				
Recommendation	Raw material sheeting - The area requires immediate remedial repairs. It is recommended the asbestos material be sealed with an approved membrane.				
Legislative Requirements Victorian Regulation 2007	<p>Damaged ACM visible in area. Requires IMMEDIATE ATTENTION. WARNING labels should be affixed. Avoid mechanical damage and abrasion. Remove if refurbishment, structural alteration or demolition is to be carried out in this area. Re-inspect every 12 months or earlier if disturbed or removed in accordance with the Victorian Regulation 2007.</p> <p>All remedial/removal repairs require a Clearance Inspection & Certificate to be recorded by an approved and competent assessor.</p>

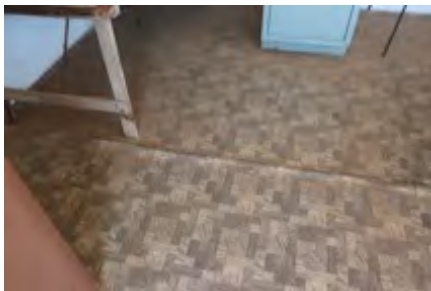
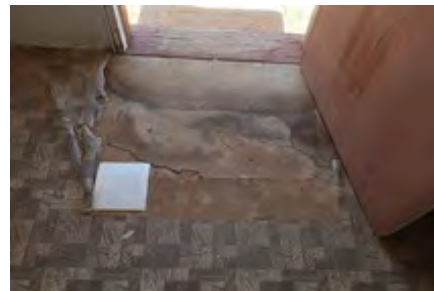
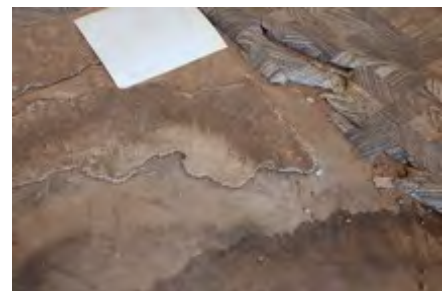
LB82 Aerodrome: Office 1. The Floor (Linoleum) has Asbestos Containing Material (ACM) present.

RISK ASSESSMENT					
Type of Asbestos or Hazardous Material	Chrysotile	Condition	POOR	Likelihood of Damage	L (Low) – possible
	Sample taken 62062-001	Activity	Moderate		
		Sealed	Yes	Friability	Friable
		Labelled	Y	Exposure Risk	High - Short term exposure risk
		Quantity

Damaged material

Priority	IMMEDIATE	Label Required	Yes	Re- Audit Date	27 Jan 2022
Action	Remedial repairs required - seal exposed edges or replace or laminate over damaged material				
Recommendation	Damaged material - The damaged area requires immediate remedial repairs. It is recommended the asbestos sheeting be replaced.				
Legislative Requirements Victorian Regulation 2007	Damaged ACM visible in area. Requires IMMEDIATE ATTENTION. WARNING labels should be affixed. Avoid mechanical damage and abrasion. Remove if refurbishment, structural alteration or demolition is to be carried out in this area. Re-inspect every 12 months or earlier if disturbed or removed in accordance with the Victorian Regulation 2007. All remedial/removal repairs require a Clearance Inspection & Certificate to be recorded by an approved and competent assessor.
