# Asbestos Report

YARRIAMBIACK SHIRE COUNCIL

PROPERTY ADDRESS:  
LB58B BOWLING CLUB  
4 AUSTIN STREET AND 54 EVELYN STREET  
HOPETOUN VIC 3396

INSPECTION DATE: 27 JANUARY 2021  
REFERENCE NUMBER: 62063

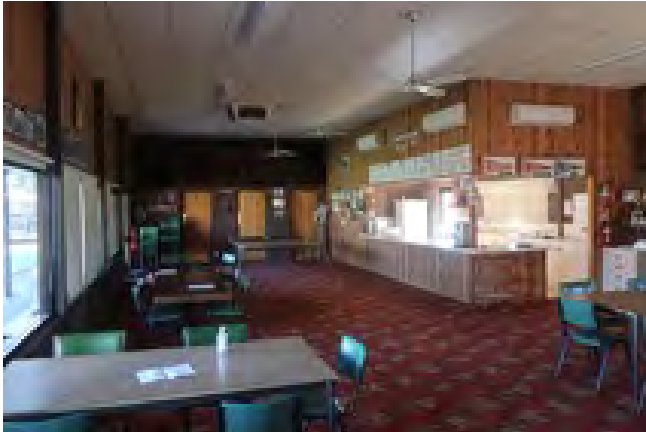
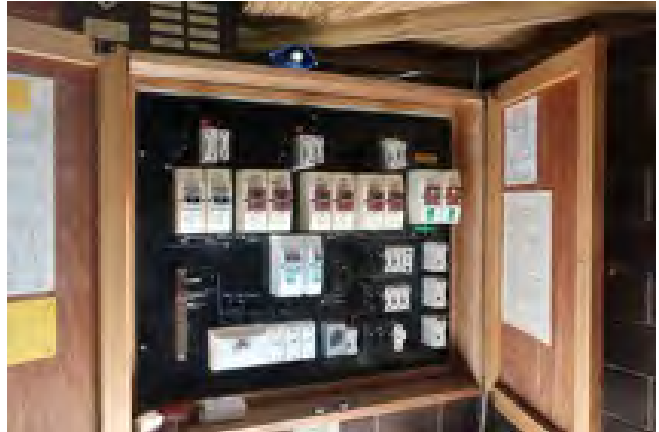
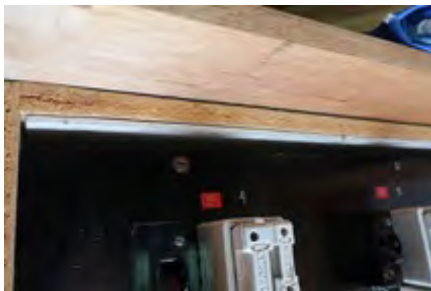
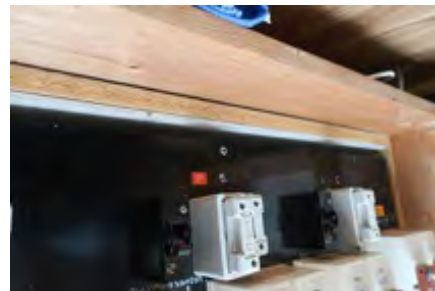
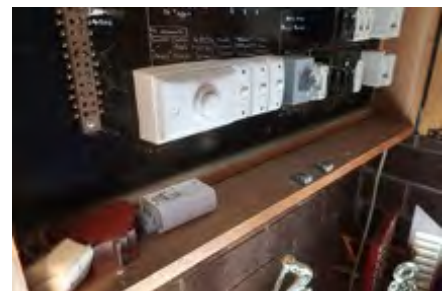
**Area 2**

**Main building LB58B Bowling Club: Main room 1. The Electrical Cabinet - lining (F C Sheeting) has Asbestos Containing Material (ACM) present.**

RISK ASSESSMENT					
Type of Asbestos or Hazardous Material	No sample taken - Visual ID	Condition	AVERAGE	Likelihood of Damage	L (Low) – possible
		Activity	Moderate		
		Sealed	No	Friability	Bonded (non-friable)
		Labelled	Y	Exposure Risk	Medium - Moderate risk
		Quantity

RISK CONTROL					
Priority	HIGH	Label Required	Yes	Re- Audit Date	27 Jan 2022
Action	Remedial repairs required - seal raw material / edges				
Recommendation	Raw material sheeting - The area requires immediate remedial repairs. It is recommended the asbestos material be sealed with an approved membrane.				
Legislative Requirements Victorian Regulation 2007	Damaged ACM visible in area. Requires IMMEDIATE ATTENTION. WARNING labels should be affixed. Avoid mechanical damage and abrasion. Remove if refurbishment, structural alteration or demolition is to be carried out in this area. Re-inspect every 12 months or earlier if disturbed or removed in accordance with the Victorian OH&S Regulation 2017. All remedial/removal repairs require a Clearance Inspection & Certificate to be recorded by an approved and competent assessor.

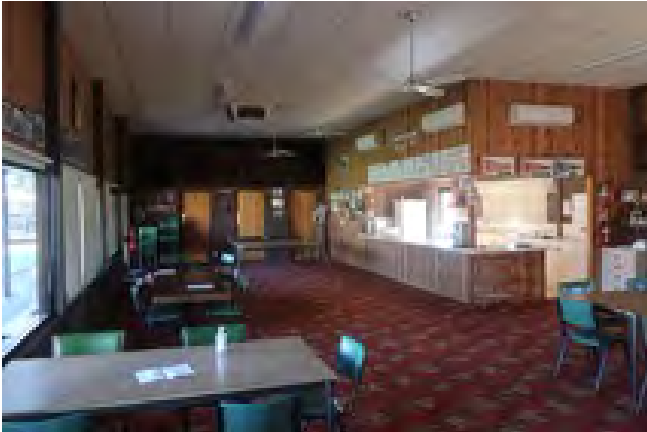
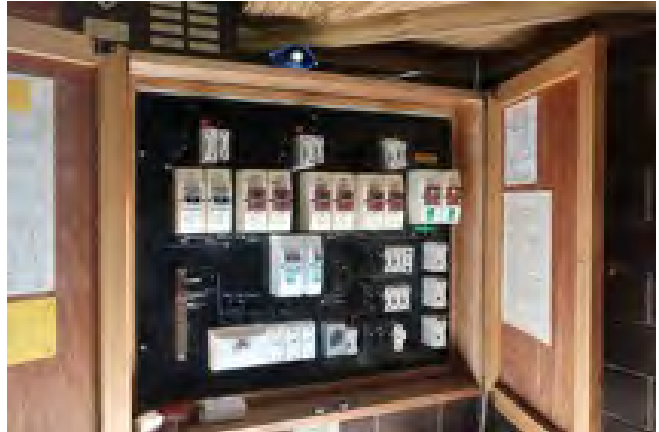
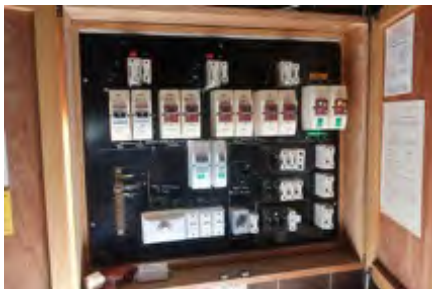
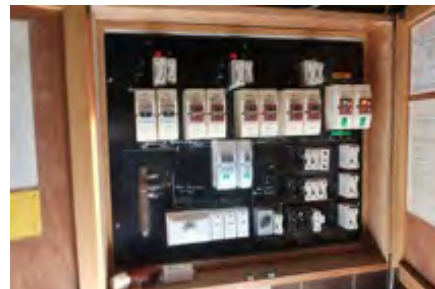
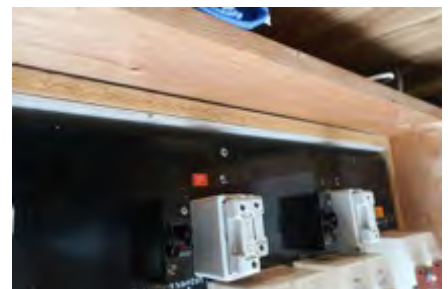
**Main building LB58B Bowling Club: Main room 1. The A: Electrical board; B: Ceramic Fuses (A: Zelemite; B: Cloth Inserts) has Asbestos Containing Material (ACM) present.**

RISK ASSESSMENT					
Type of Asbestos or Hazardous Material	No sample taken - Visual ID	Condition	GOOD	Likelihood of Damage	L (Low) – possible
		Activity	Moderate		
		Sealed	Yes	Friability	Bonded (non-friable)
		Labelled	Y	Exposure Risk	Low - Negligible or low risk
		Quantity

RISK CONTROL					
Priority	MEDIUM	Label Required	Yes	Re- Audit Date	27 Jan 2022
Action	No remedial action required, unless disturbed				
Recommendation	Maintain paint or sealant to ACM surfaces. Particular attention should be given to side edges, ensure paint/sealant covers ALL exposed ACM surfaces.				
Legislative Requirements Victorian Regulation 2007	Warning labels should be affixed. Avoid mechanical damage and abrasion. Remove if refurbishment, structural alteration or demolition is to be carried out in this area. Re-inspect every 12 months or earlier if disturbed or removed in accordance with the Victorian OH&S Regulation 2017. All remedial/removal repairs require a Clearance Inspection & Certificate to be recorded by an approved and competent assessor.

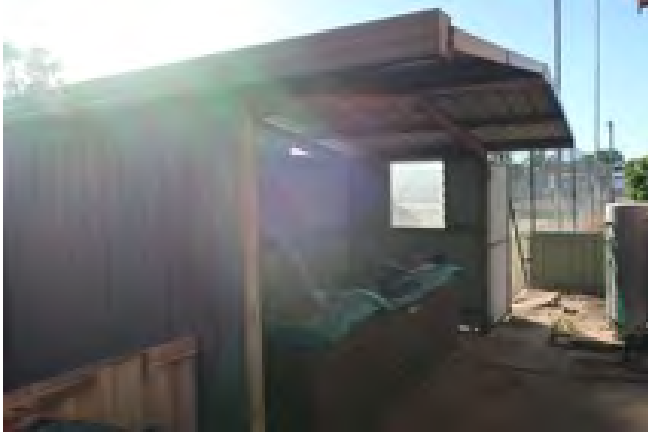
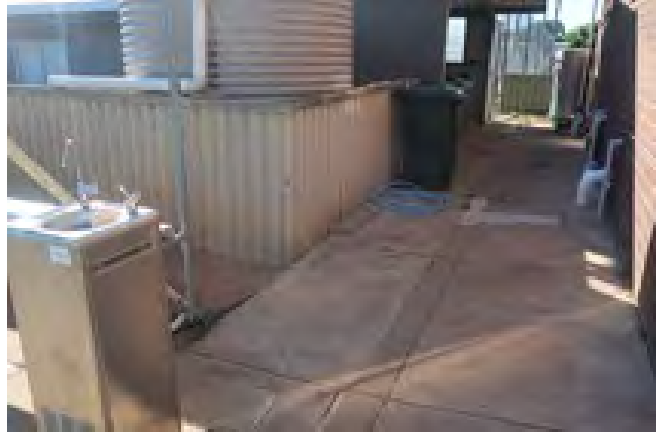
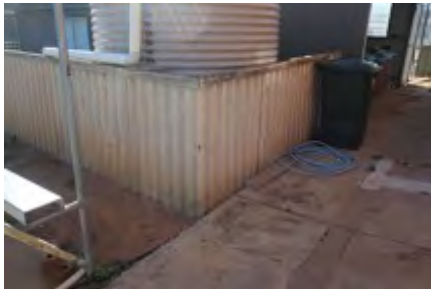
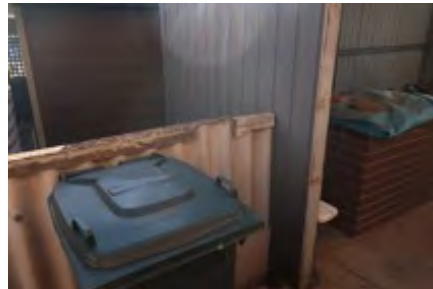
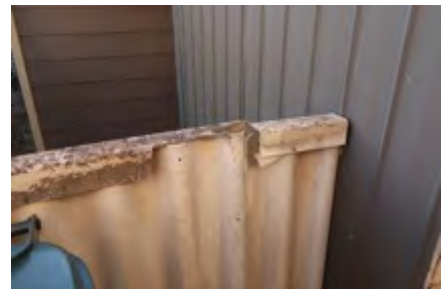
**Area 4**

**Shed 1: left side of building. The Fence (Fibrous Cement Product) has Asbestos Containing Material (ACM) present.**

RISK ASSESSMENT					
Type of Asbestos or Hazardous Material	No sample taken - Visual ID	Condition	AVERAGE	Likelihood of Damage	L (Low) – possible
		Activity	Moderate		
		Sealed	No	Friability	Bonded (non-friable)
		Labelled	Y	Exposure Risk	Medium - Moderate risk
		Quantity

RISK CONTROL					
Priority	HIGH	Label Required	Yes	Re- Audit Date	27 Jan 2022
Action	Remedial repairs required - seal raw material / edges				
Recommendation	Raw material sheeting - The area requires immediate remedial repairs. It is recommended the asbestos material be sealed with an approved membrane.				
Legislative Requirements Victorian Regulation 2007	Damaged ACM visible in area. Requires IMMEDIATE ATTENTION. WARNING labels should be affixed. Avoid mechanical damage and abrasion. Remove if refurbishment, structural alteration or demolition is to be carried out in this area. Re-inspect every 12 months or earlier if disturbed or removed in accordance with the Victorian OH&S Regulation 2017. All remedial/removal repairs require a Clearance Inspection & Certificate to be recorded by an approved and competent assessor.

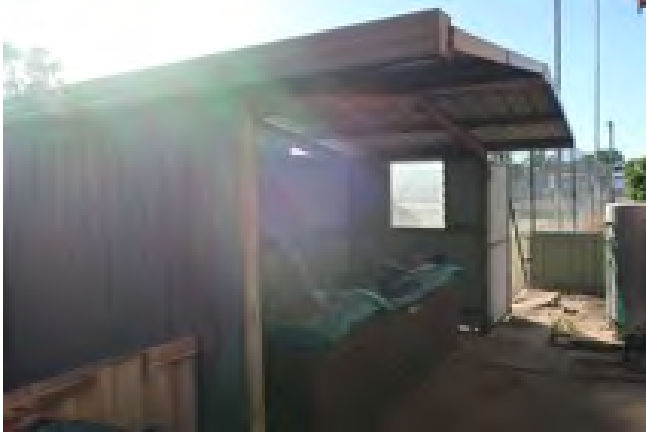
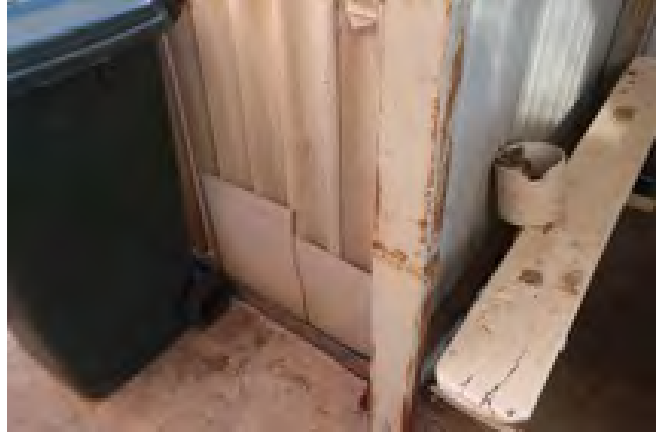
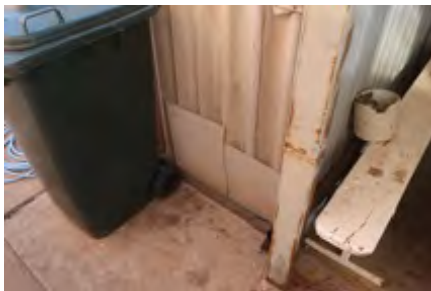
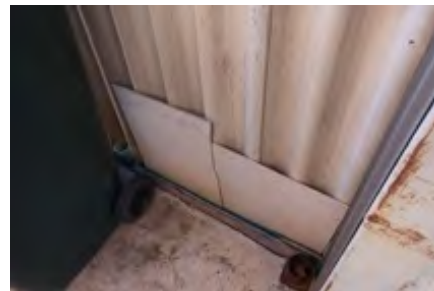
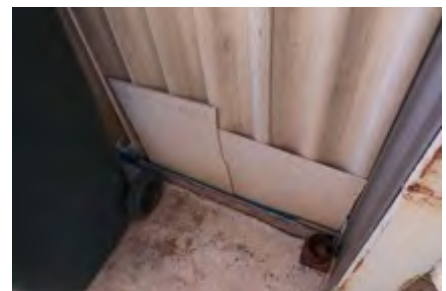
**Area 3****Shed 1: left side of building. The Fence - flat sheeting (F C Sheet) has Asbestos Containing Material (ACM) present.****RISK ASSESSMENT**

<b>Type of Asbestos or Hazardous Material</b>	No sample taken - Visual ID	<b>Condition</b>	POOR	<b>Likelihood of Damage</b>	L (Low) – possible
		<b>Activity</b>	Moderate		
		<b>Sealed</b>	No	<b>Friability</b>	Exposed Fibres
		<b>Labelled</b>	Y	<b>Exposure Risk</b>	Medium - Moderate risk
		<b>Quantity</b>

<b>Priority</b>	HIGH	<b>Label Required</b>	Yes	<b>Re- Audit Date</b>	27 Jan 2022
<b>Action</b>	Remedial repairs required - seal raw material / edges				
<b>Recommendation</b>	Debris on Surface - The Debris requires immediate cleanup and disposal with specialised equipment and with licensed removalist to safely remove the asbestos debris.				
<b>Legislative Requirements Victorian Regulation 2007</b>	ACM debris visible. Recommend cleanup by licensed Asbestos Removalist. Warning labels should be affixed. Avoid mechanical damage and abrasion. Remove if refurbishment, structural alteration or demolition is to be carried out in this area. Re-inspect every 12 months or earlier if disturbed or removed in accordance with the Victorian OH&S Regulation 2017. All remedial/removal repairs require a Clearance Inspection & Certificate to be recorded by an approved and competent assessor.

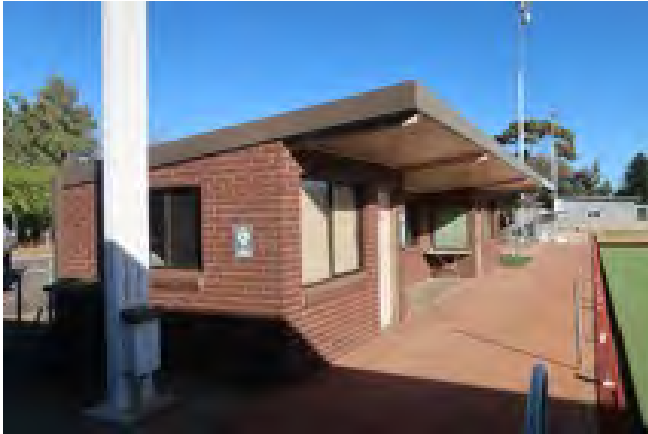
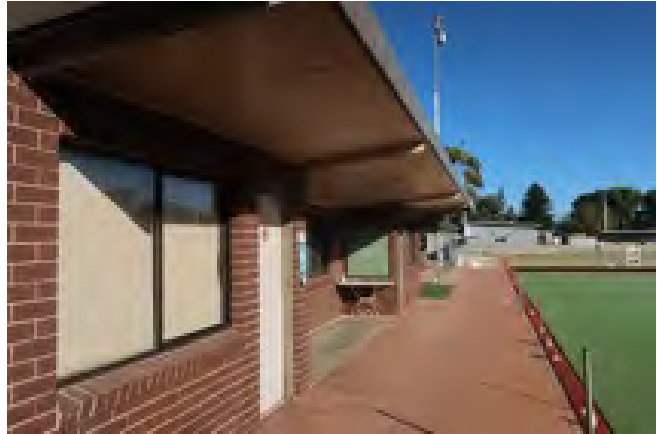
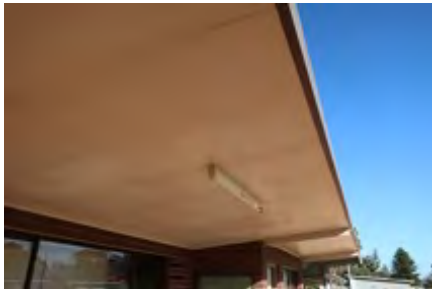
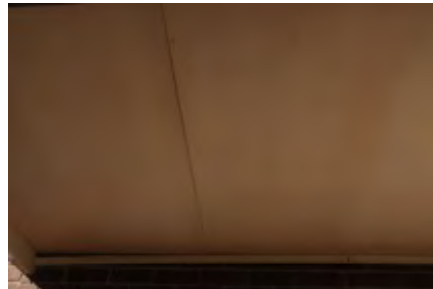
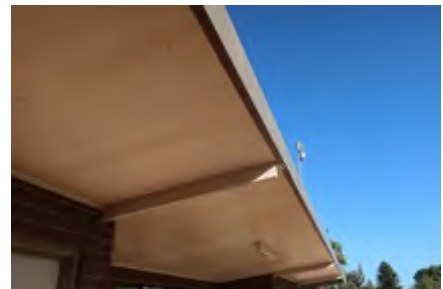
**Area 6**

**Old club house: front of building. The Ceiling (F C Sheeting) has Asbestos Containing Material (ACM) present.**

RISK ASSESSMENT					
Type of Asbestos or Hazardous Material	No sample taken - Visual ID	Condition	GOOD	Likelihood of Damage	L (Low) – possible
		Activity	Moderate		
		Sealed	Yes	Friability	Bonded (non-friable)
		Labelled	Y	Exposure Risk	Low - Negligible or low risk
		Quantity

RISK CONTROL					
Priority	MEDIUM	Label Required	Yes	Re- Audit Date	27 Jan 2022
Action	No remedial action required, unless disturbed				
Recommendation	Maintain paint or sealant to ACM surfaces. Particular attention should be given to side edges, ensure paint/sealant covers ALL exposed ACM surfaces.				
Legislative Requirements Victorian Regulation 2007	Warning labels should be affixed. Avoid mechanical damage and abrasion. Remove if refurbishment, structural alteration or demolition is to be carried out in this area. Re-inspect every 12 months or earlier if disturbed or removed in accordance with the Victorian OH&S Regulation 2017. All remedial/removal repairs require a Clearance Inspection & Certificate to be recorded by an approved and competent assessor.

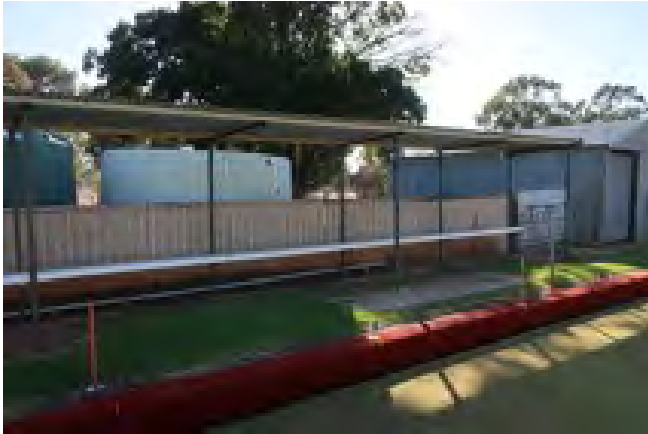
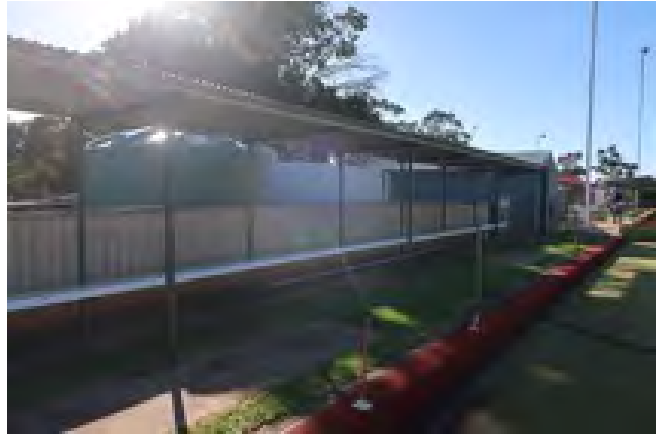
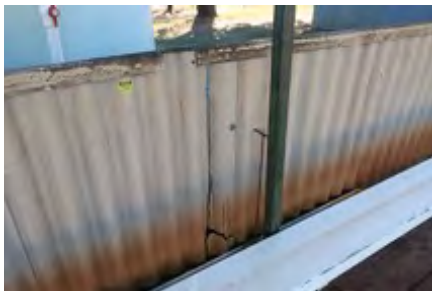
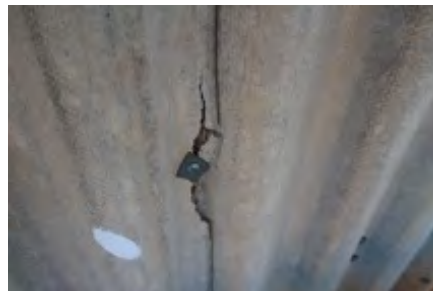
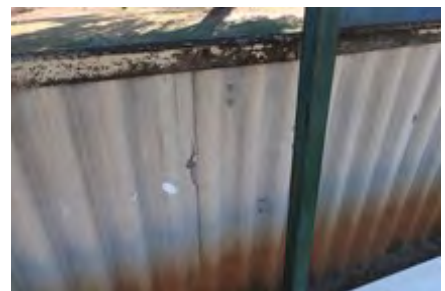
**Area 1**

**Grounds: Various fencing. The Fence (Fibrous Cement Product) has Asbestos Containing Material (ACM) present.**

RISK ASSESSMENT					
Type of Asbestos or Hazardous Material	No sample taken - Visual ID	Condition	POOR	Likelihood of Damage	L (Low) – possible
		Activity	Moderate		
		Sealed	No	Friability	Exposed Fibres
		Labelled	Y	Exposure Risk	Low - Negligible or low risk
		Quantity

Priority	HIGH	Label Required	Yes	Re- Audit Date	27 Jan 2022
Action	Remedial repairs required - seal raw material / edges				
Recommendation	Damaged material - The damaged area requires immediate remedial repairs. It is recommended the asbestos sheeting be replaced.				
Legislative Requirements Victorian Regulation 2007	The ACM identified is in a raw unsealed or uncoated state and therefore constitutes a risk of exposure. The area should be either removed (as preference) or sealed with an appropriate sealant. Particular attention should be given to any exposed edges. Re-inspect every 12 months or earlier if disturbed or removed in accordance with the Victorian OH&S Regulation 2017. All remedial/removal repairs require a Clearance Inspection & Certificate to be recorded by an approved and competent assessor.
