Asbestos Report

YARRIAMBIACK SHIRE COUNCIL

PROPERTY ADDRESS:
LR33 CARAVAN PARK
6194 HENTY HIGHWAY
HOPETOUN VIC 3396

INSPECTION DATE: 27 JANUARY 2021
REFERENCE NUMBER: 62064

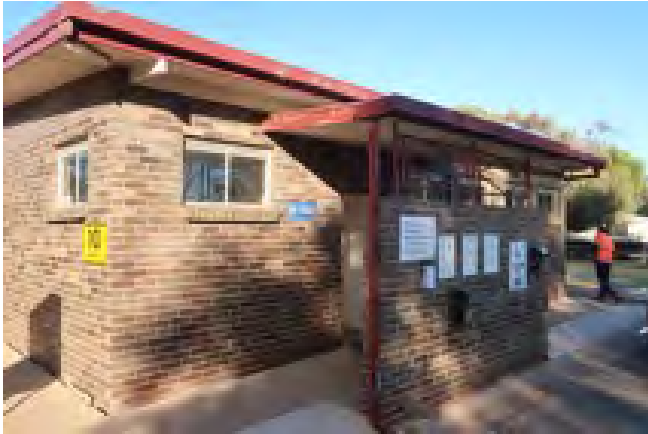
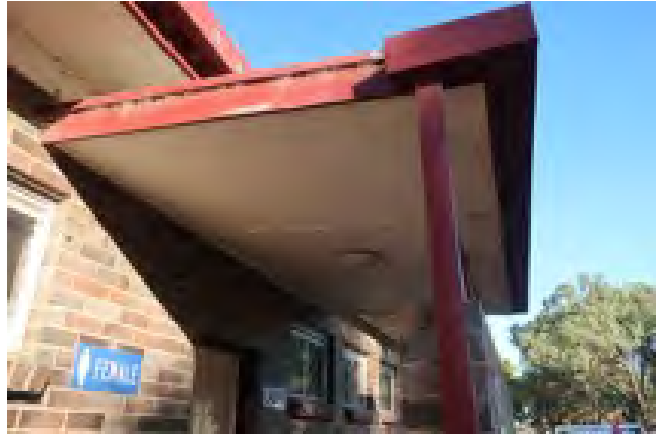
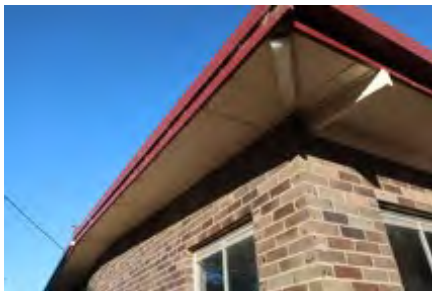
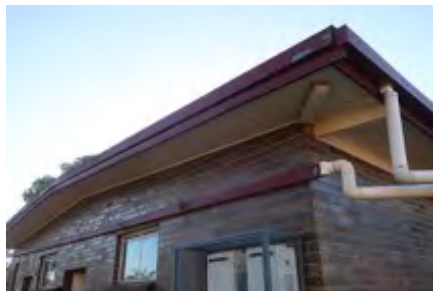
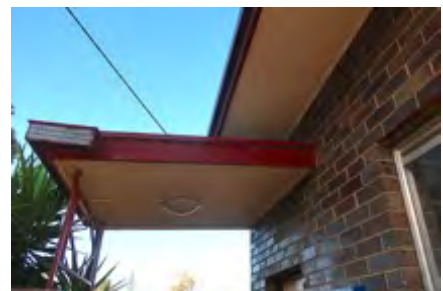
Area 2

Amenities Building LR33 Caravan Park: entire perimeter of building. The soffits & Ceilings (F C Sheeting) has Asbestos Containing Material (ACM) present.

RISK ASSESSMENT					
Type of Asbestos or Hazardous Material	Chrysotile	Condition	GOOD	Likelihood of Damage	L (Low) – possible
	Same as Sample - 62064 -002	Activity	Moderate		
		Sealed	Yes	Friability	Bonded (non-friable)
		Labelled	Y	Exposure Risk	Low - Negligible or low risk
		Quantity

Priority	MEDIUM	Label Required	Yes	Re- Audit Date	27 Jan 2022
Action	No remedial action required, unless disturbed				
Recommendation	Maintain paint or sealant to ACM surfaces. Particular attention should be given to side edges, ensure paint/sealant covers ALL exposed ACM surfaces.				
Legislative Requirements Victorian Regulation 2007	Warning labels should be affixed. Avoid mechanical damage and abrasion. Remove if refurbishment, structural alteration or demolition is to be carried out in this area. Re-inspect every 12 months or earlier if disturbed or removed in accordance with the Victorian OH&S Regulation 2017. All remedial/removal repairs require a Clearance Inspection & Certificate to be recorded by an approved and competent assessor.

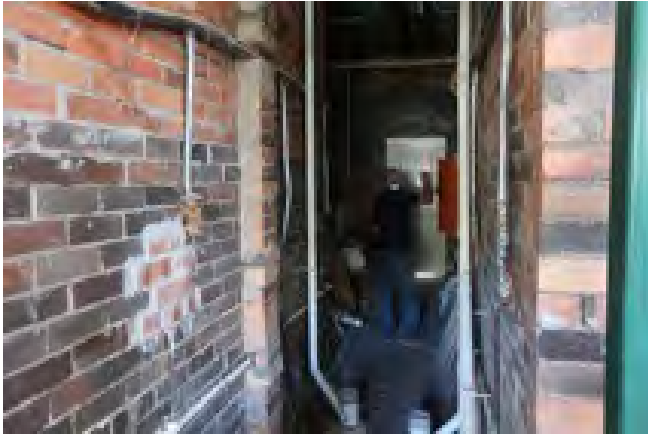
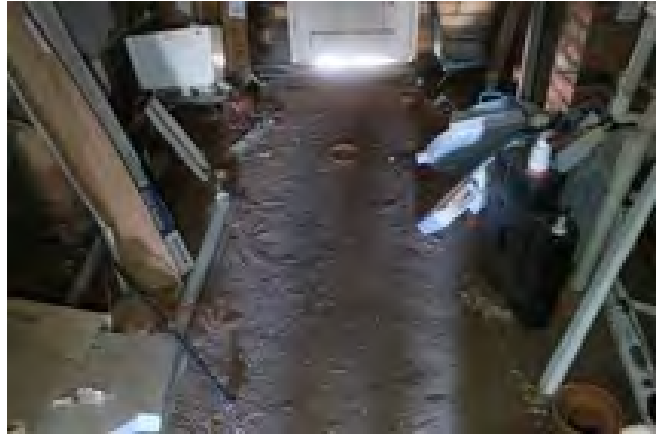
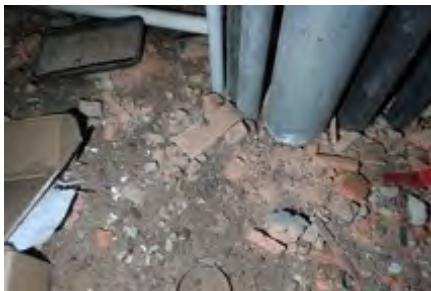
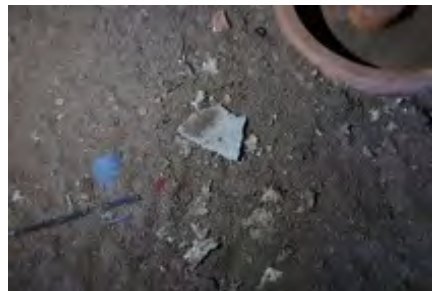
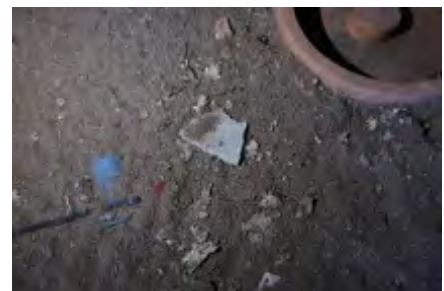
Amenities Building LR33 Caravan Park: Service alley 1.1. The Debris - Broken (Debris) has Asbestos Containing Material (ACM) present.

RISK ASSESSMENT					
Type of Asbestos or Hazardous Material	Chrysotile	Condition	POOR	Likelihood of Damage	H (High) - almost certain
	Sample taken 62064-001	Activity	Moderate		
		Sealed	No	Friability	Exposed Fibres
		Labelled	No	Exposure Risk	High - Short term exposure risk
		Quantity

Debris on Ground

Priority	IMMEDIATE	Label Required	Yes	Re- Audit Date	27 Jan 2022
Action	Restrict access and target for imminent removal				
Recommendation	Debris on Surface - The Debris requires immediate cleanup and disposal with specialised equipment and with licensed removalist to safely remove the asbestos debris.				
Legislative Requirements Victorian Regulation 2007	ACM debris visible. Recommend cleanup by licensed Asbestos Removalist. Warning labels should be affixed. Avoid mechanical damage and abrasion. Remove if refurbishment, structural alteration or demolition is to be carried out in this area. Re-inspect every 12 months or earlier if disturbed or removed in accordance with the Victorian OH&S Regulation 2017. All remedial/removal repairs require a Clearance Inspection & Certificate to be recorded by an approved and competent assessor.

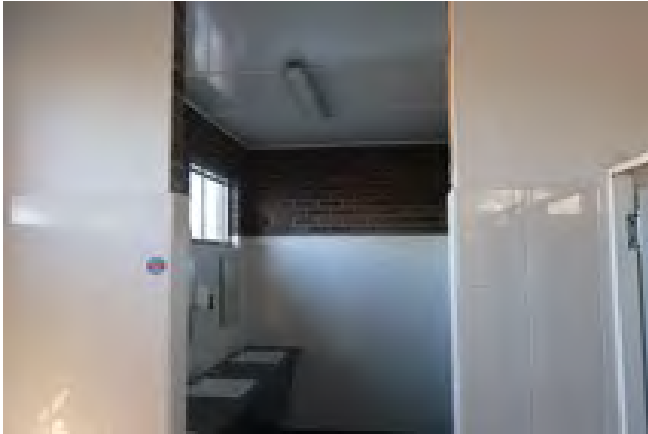
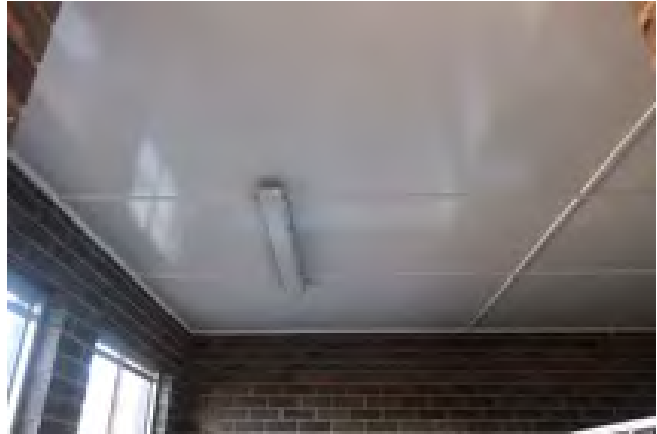
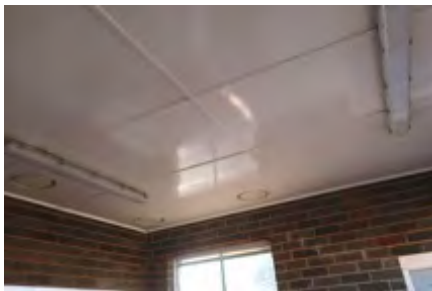
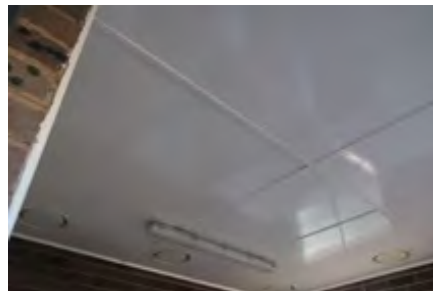
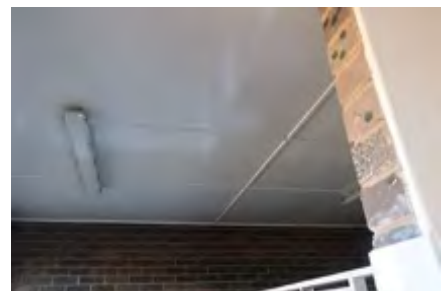
Amenities Building LR33 Caravan Park: Male bathroom 2. The Ceiling (F C Sheeting) has Asbestos Containing Material (ACM) present.

RISK ASSESSMENT					
Type of Asbestos or Hazardous Material	Chrysotile	Condition	GOOD	Likelihood of Damage	L (Low) – possible
	Sample taken 62064-002	Activity	Moderate		
		Sealed	Yes	Friability	Bonded (non-friable)
		Labelled	Y	Exposure Risk	Low - Negligible or low risk
		Quantity

RISK CONTROL					
Priority	MEDIUM	Label Required	Yes	Re- Audit Date	27 Jan 2022
Action	No remedial action required, unless disturbed				
Recommendation	Maintain paint or sealant to ACM surfaces. Particular attention should be given to side edges, ensure paint/sealant covers ALL exposed ACM surfaces.				
Legislative Requirements Victorian Regulation 2007	Warning labels should be affixed. Avoid mechanical damage and abrasion. Remove if refurbishment, structural alteration or demolition is to be carried out in this area. Re-inspect every 12 months or earlier if disturbed or removed in accordance with the Victorian OH&S Regulation 2017. All remedial/removal repairs require a Clearance Inspection & Certificate to be recorded by an approved and competent assessor.
