Asbestos Report

YARRIAMBIACK SHIRE COUNCIL

PROPERTY ADDRESS:
LB86 CORRONG HOMESTEAD
EVELYN STREET
HOPETOUN VIC 3396

INSPECTION DATE: 27 JANUARY 2021
REFERENCE NUMBER: 62065

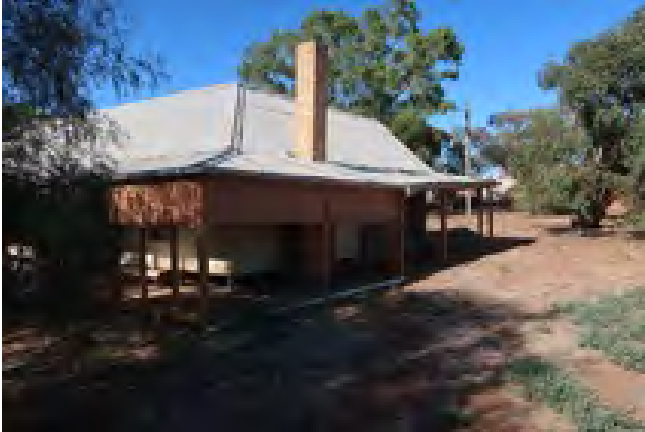
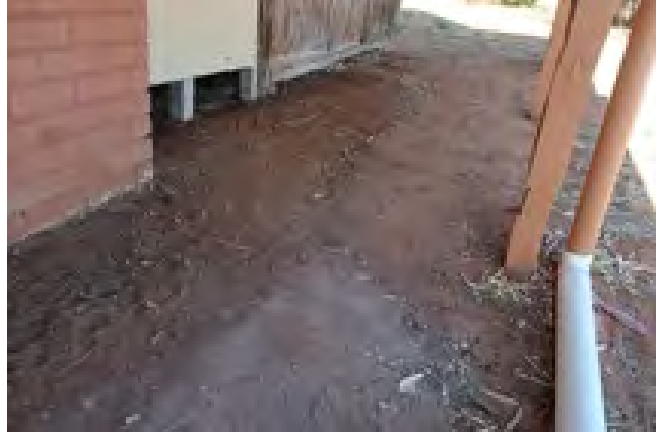
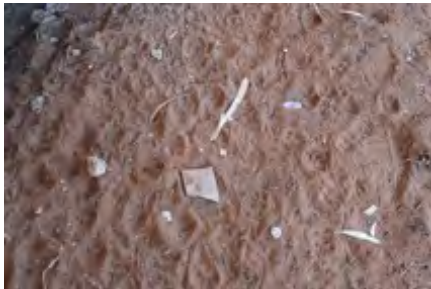
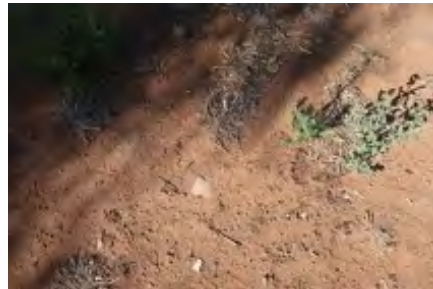
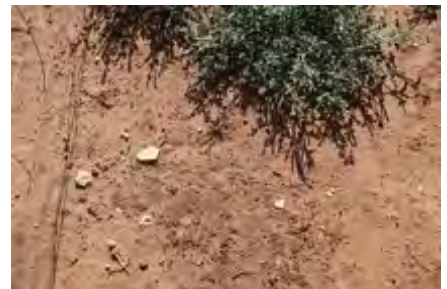
Area 1**LB86 Corrong Homestead: left side of building. The Debris - Broken (Debris) has Asbestos Containing Material (ACM) present.****RISK ASSESSMENT**

Type of Asbestos or Hazardous Material	Chrysotile Amosite Crocidolite Sample taken 62065-001	Condition	POOR	Likelihood of Damage	H (High) - almost certain
		Activity	Moderate		
		Sealed	No	Friability	Exposed Fibres
		Labelled	No	Exposure Risk	Medium - Moderate risk
		Quantity

Debris on Ground

Priority	IMMEDIATE	Label Required	Yes	Re- Audit Date	27 Jan 2022
Action	Restrict access and target for imminent removal				
Recommendation	Debris on Ground - The Debris requires immediate cleanup and disposal with specialized equipment and with licenced removalist to safely remove the asbestos debris.				
Legislative Requirements Victorian Regulation 2007	ACM debris visible. Recommend cleanup by licensed Asbestos Removalist. Warning labels should be affixed. Avoid mechanical damage and abrasion. Remove if refurbishment, structural alteration or demolition is to be carried out in this area. Re-inspect every 12 months or earlier if disturbed or removed in accordance with the Victorian OH&S Regulation 2017. All remedial/removal repairs require a Clearance Inspection & Certificate to be recorded by an approved and competent assessor.

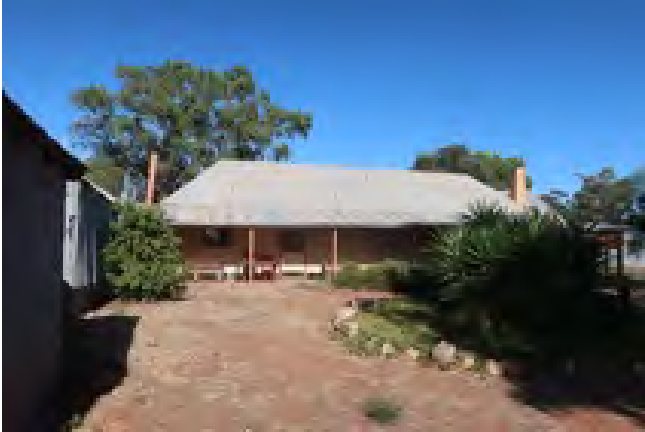
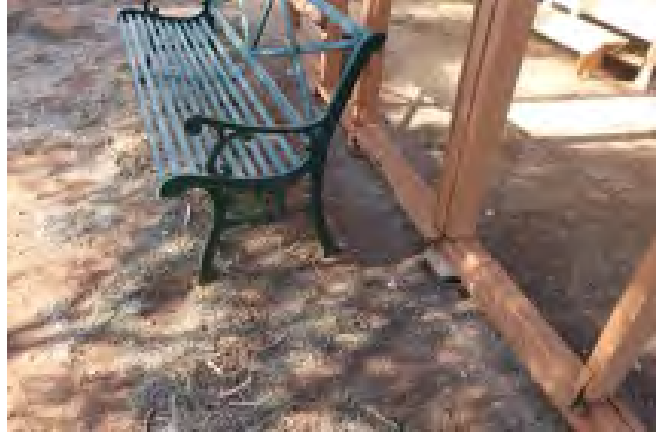
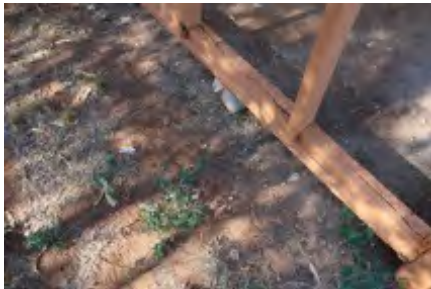
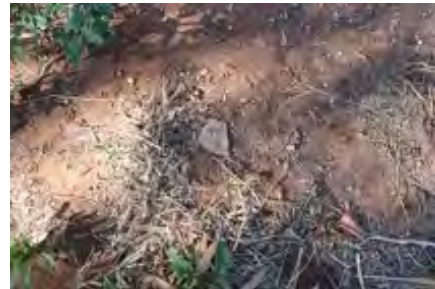
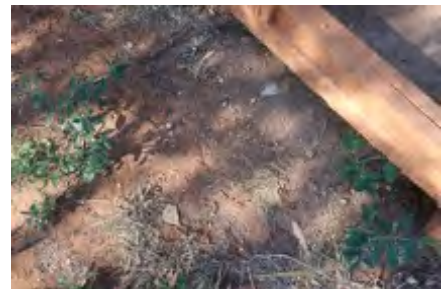
Area 2**LB86 Corrong Homestead: rear of building. The Debris - Broken (Debris) has Asbestos Containing Material (ACM) present.****RISK ASSESSMENT**

Type of Asbestos or Hazardous Material	Chrysotile	Condition	POOR	Likelihood of Damage	H (High) - almost certain
	Amosite	Activity	Moderate		
	Crocidolite	Sealed	No	Friability	Exposed Fibres
	Same as Sample - 62065-001	Labelled	No	Exposure Risk	Medium - Moderate risk
		Quantity

Debris on Ground

Priority	IMMEDIATE	Label Required	Yes	Re- Audit Date	27 Jan 2022
Action	Restrict access and target for imminent removal				
Recommendation	Debris on Ground - The Debris requires immediate cleanup and disposal with specialized equipment and with licenced removalist to safely remove the asbestos debris.				
Legislative Requirements Victorian Regulation 2007	ACM debris visible. Recommend cleanup by licensed Asbestos Removalist. Warning labels should be affixed. Avoid mechanical damage and abrasion. Remove if refurbishment, structural alteration or demolition is to be carried out in this area. Re-inspect every 12 months or earlier if disturbed or removed in accordance with the Victorian OH&S Regulation 2017. All remedial/removal repairs require a Clearance Inspection & Certificate to be recorded by an approved and competent assessor.

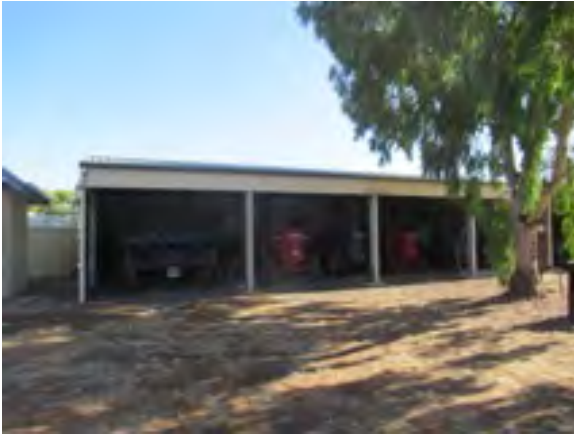
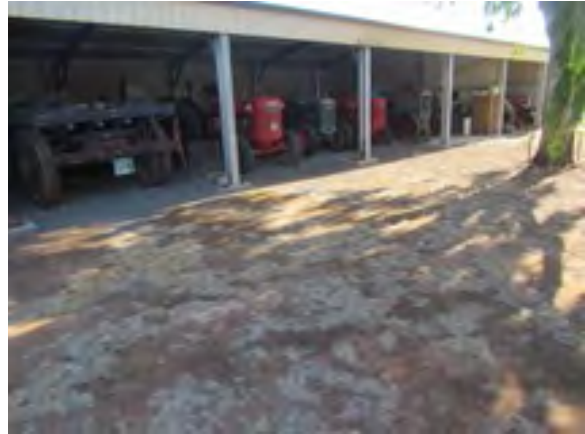
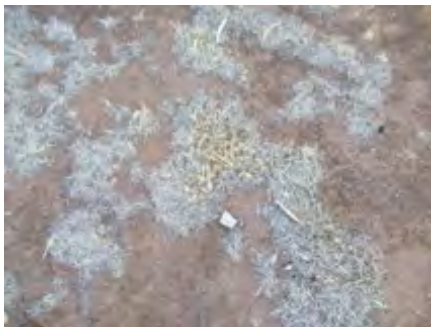
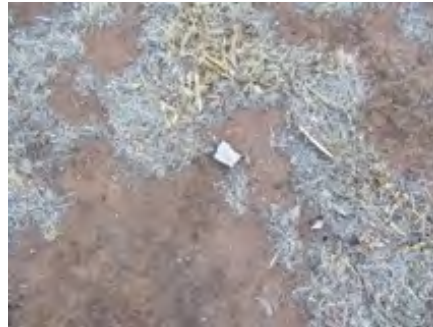
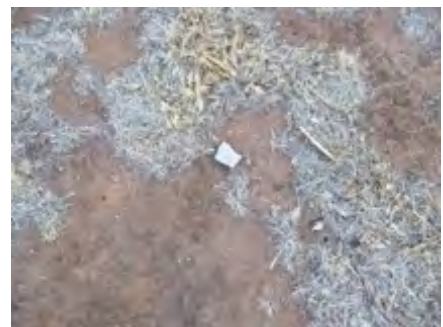
Area 3

Tractor shed: front of building. The Debris - Broken (Debris) has Asbestos Containing Material (ACM) present.

RISK ASSESSMENT					
Type of Asbestos or Hazardous Material	No sample taken - Visual ID	Condition	POOR	Likelihood of Damage	H (High) - almost certain
		Activity	Moderate		
		Sealed	No	Friability	Exposed Fibres
		Labelled	No	Exposure Risk	Medium - Moderate risk
		Quantity

Debri on Ground

Priority	IMMEDIATE	Label Required	Yes	Re- Audit Date	27 Jan 2022
Action	Restrict access and target for imminent removal				
Recommendation	Debri on Ground - The Debris requires immediate cleanup and disposal with specialized equipment and with licenced removalist to safely remove the asbestos debri.				
Legislative Requirements Victorian Regulation 2007	ACM debri visible. Recommend cleanup by licensed Asbestos Removalist. Warning labels should be affixed. Avoid mechanical damage and abrasion. Remove if refurbishment, structural alteration or demolition is to be carried out in this area. Re-inspect every 12 months or earlier if disturbed or removed in accordance with the Victorian OH&S Regulation 2017. All remedial/removal repairs require a Clearance Inspection & Certificate to be recorded by an approved and competent assessor.

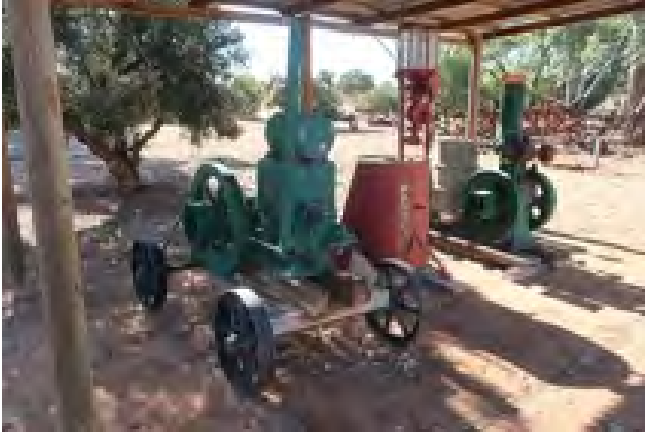
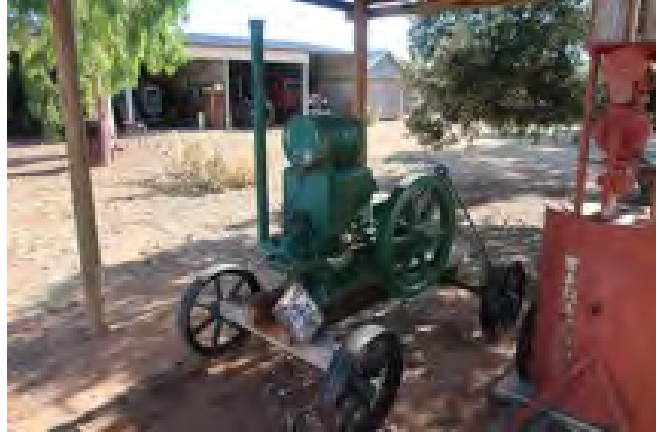
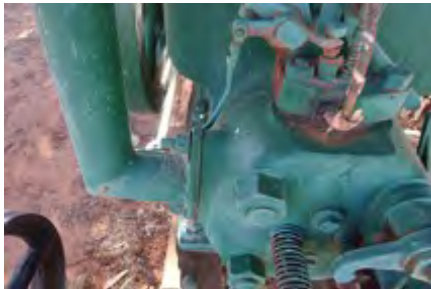
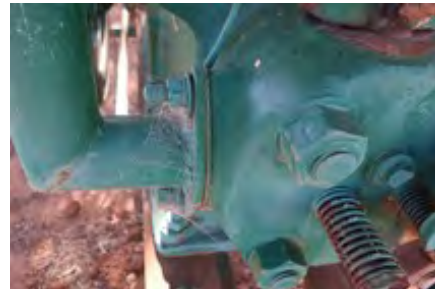
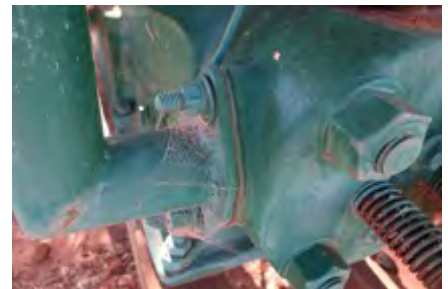
Area 5**Shelter: - Imperial engine 1. The Exhaust Gasket (Compound Material) has Asbestos Containing Material (ACM) present.****RISK ASSESSMENT**

Type of Asbestos or Hazardous Material	Chrysotile	Condition	AVERAGE	Likelihood of Damage	L (Low) – possible
	Sample taken 62065-002	Activity	Moderate		
		Sealed	No	Friability	Exposed Fibres
		Labelled	Y	Exposure Risk	Low - Negligible or low risk
		Quantity

Maintain paint or sealant

Priority	HIGH	Label Required	Yes	Re- Audit Date	27 Jan 2022
Action	Remedial repairs required - seal raw material / edges				
Recommendation	Raw material - The area requires immediate remedial repairs. It is recommended the asbestos material be sealed with an approved membrane.				
Legislative Requirements Victorian Regulation 2007	Warning labels should be affixed. Avoid mechanical damage and abrasion. Remove if refurbishment, structural alteration or demolition is to be carried out in this area. Re-inspect every 12 months or earlier if disturbed or removed in accordance with the Victorian OH&S Regulation 2017. All remedial/removal repairs require a Clearance Inspection & Certificate to be recorded by an approved and competent assessor.

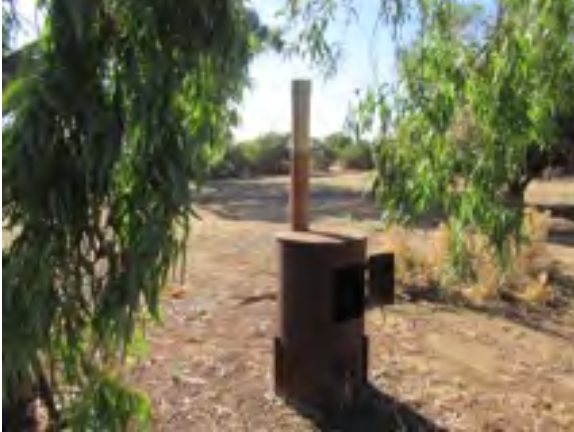
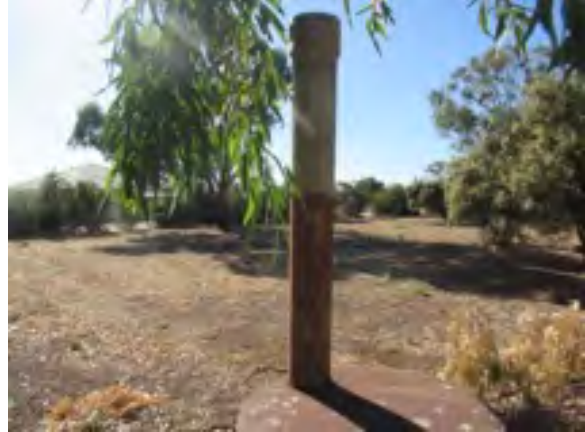
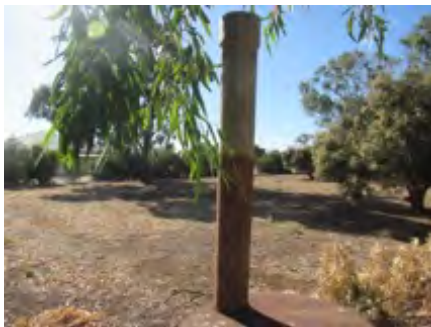
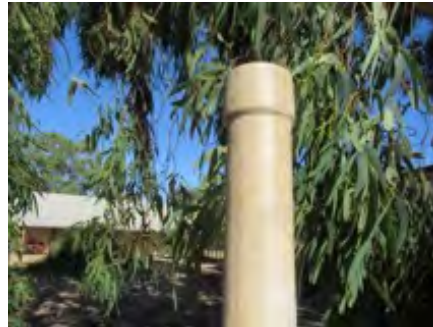
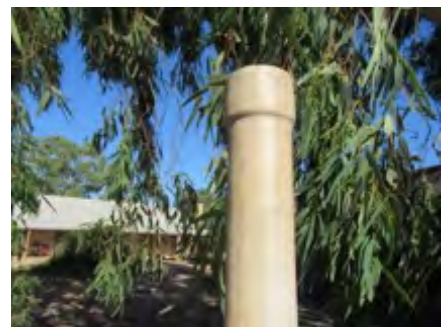
Area 4**Grounds: Fire stove. The Flue (Fibrous Cement Product) has Asbestos Containing Material (ACM) present.****RISK ASSESSMENT**

Type of Asbestos or Hazardous Material	Chrysotile Amosite Crocidolite Sample taken 62065-008	Condition	AVERAGE	Likelihood of Damage	L (Low) – possible
		Activity	Moderate		
		Sealed	No	Friability	Bonded (non-friable)
		Labelled	Y	Exposure Risk	Medium - Moderate risk
		Quantity

Raw Material

Priority	HIGH	Label Required	Yes	Re- Audit Date	27 Jan 2022
Action	Remedial repairs required - seal raw material / edges				
Recommendation	Raw material sheeting - The area requires immediate remedial repairs. It is recommended the asbestos material be sealed with an approved membrane.				
Legislative Requirements Victorian Regulation 2007	<p>Damaged ACM visible in area. Requires IMMEDIATE ATTENTION. WARNING labels should be affixed. Avoid mechanical damage and abrasion. Remove if refurbishment, structural alteration or demolition is to be carried out in this area. Re-inspect every 12 months or earlier if disturbed or removed in accordance with the Victorian OH&S Regulation 2017.</p> <p>All remedial/removal repairs require a Clearance Inspection & Certificate to be recorded by an approved and competent assessor.</p>
