**Global
Asbestos
Audits**

Asbestos Report

YARRIAMBIACK SHIRE COUNCIL

PROPERTY ADDRESS:
LB72 DEPOT
92 CUMMING STREET
HOPETOUN VIC 3396

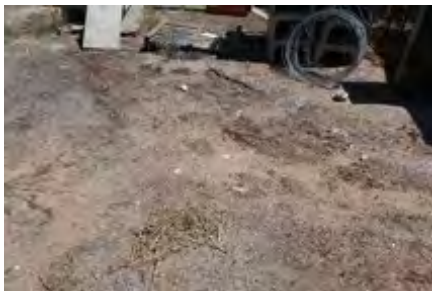
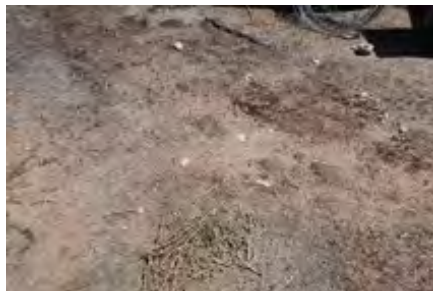
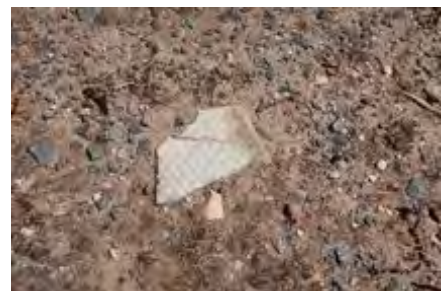
Area 1

LB72 Depot: rear of building. The Debris - Broken (Debris) has Asbestos Containing Material (ACM) present.

RISK ASSESSMENT					
Type of Asbestos or Hazardous Material	No sample taken - Visual ID	Condition	POOR	Likelihood of Damage	H (High) - almost certain
		Activity	Moderate		
		Sealed	No	Friability	Exposed Fibres
		Labelled	No	Exposure Risk	Medium - Moderate risk
		Quantity

Debris on Ground

Debris on Surface

RISK CONTROL					
Priority	IMMEDIATE	Label Required	Yes	Re- Audit Date	27 Jan 2022
Action	Restrict access and target for imminent removal				
Recommendation	Debris on Surface - The Debris requires immediate cleanup and disposal with specialised equipment and with licensed removalist to safely remove the asbestos debris.				
Legislative Requirements Victorian Regulation 2007	ACM debris visible. Recommend cleanup by licensed Asbestos Removalist. Warning labels should be affixed. Avoid mechanical damage and abrasion. Remove if refurbishment, structural alteration or demolition is to be carried out in this area. Re-inspect every 12 months or earlier if disturbed or removed in accordance with the Victorian OH&S Regulation 2017. All remedial/removal repairs require a Clearance Inspection & Certificate to be recorded by an approved and competent assessor.

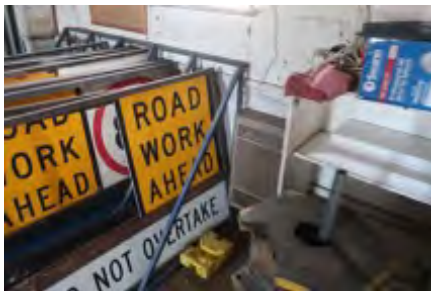
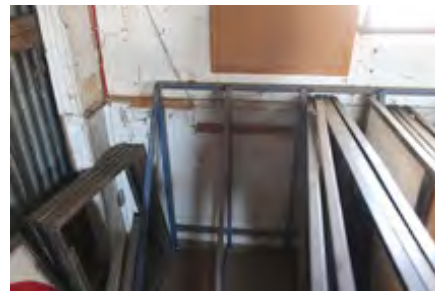
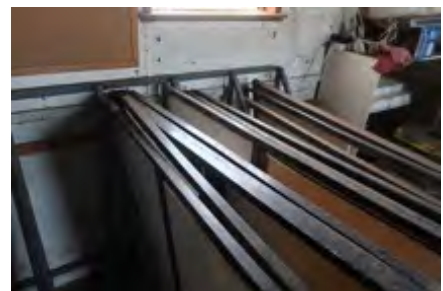
Area 3**LB72 Depot: Sign room 3. The Wall - Lower Panel (F C Sheeting) has Asbestos Containing Material (ACM) present.****RISK ASSESSMENT**

Type of Asbestos or Hazardous Material	Chrysotile	Condition	GOOD	Likelihood of Damage	L (Low) – possible
	Sample taken 62066-002	Activity	Moderate		
		Sealed	Yes	Friability	Bonded (non-friable)
		Labelled	Y	Exposure Risk	Low - Negligible or low risk
		Quantity

Maintain paint or sealant

Priority	MEDIUM	Label Required	Yes	Re- Audit Date	27 Jan 2022
Action	No remedial action required, unless disturbed				
Recommendation	Maintain paint or sealant to ACM surfaces. Particular attention should be given to side edges, ensure paint/sealant covers ALL exposed ACM surfaces.				
Legislative Requirements Victorian Regulation 2007	Warning labels should be affixed. Avoid mechanical damage and abrasion. Remove if refurbishment, structural alteration or demolition is to be carried out in this area. Re-inspect every 12 months or earlier if disturbed or removed in accordance with the Victorian OH&S Regulation 2017. All remedial/removal repairs require a Clearance Inspection & Certificate to be recorded by an approved and competent assessor.

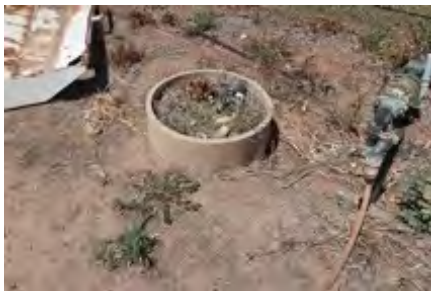
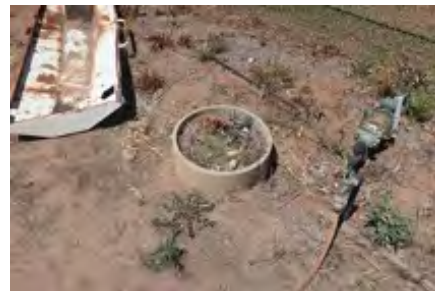
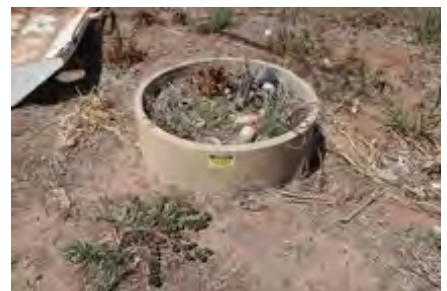
Area 2**Yard: Yard. The Pipe(s) (Garden beds (unusable)) has Asbestos Containing Material (ACM) present.****RISK ASSESSMENT**

Type of Asbestos or Hazardous Material	Chrysotile	Condition	POOR	Likelihood of Damage	VH (Very High) – most likely
	Amosite	Activity	Low		
	Sample taken 62066-005	Sealed	No	Friability	Exposed Fibres
		Labelled	Y	Exposure Risk	Medium - Moderate risk
		Quantity

Garden beds (unusable)

The pipes are being used as garden beds, the likelihood of damage and soil contamination is very high - recommend to remove.

Priority	HIGH	Label Required	Yes	Re- Audit Date	27 Jan 2022
Action	Remove during normal maintenance or refurbishment				
Recommendation	The pipes are being used as garden beds, the likelihood of damage and soil contamination is very high - recommend to remove. Debris on Surface - The Debris requires immediate cleanup and disposal with specialised equipment and with licensed removalist to safely remove the asbestos debris.				
Legislative Requirements Victorian Regulation 2007	ACM debris visible. Recommend cleanup by licensed Asbestos Removalist. Warning labels should be affixed. Avoid mechanical damage and abrasion. Remove if refurbishment, structural alteration or demolition is to be carried out in this area. Re-inspect every 12 months or earlier if disturbed or removed in accordance with the Victorian OH&S Regulation 2017. All remedial/removal repairs require a Clearance Inspection & Certificate to be recorded by an approved and competent assessor.
