# Asbestos Report

**YARRIAMBIACK SHIRE COUNCIL**

**PROPERTY ADDRESS:  
HOPETOUN CFA SHED  
62 LASCELLES STREET  
HOPETOUN VIC 3396**

**INSPECTION DATE: 27 JANUARY 2021  
REFERENCE NUMBER: 62069**

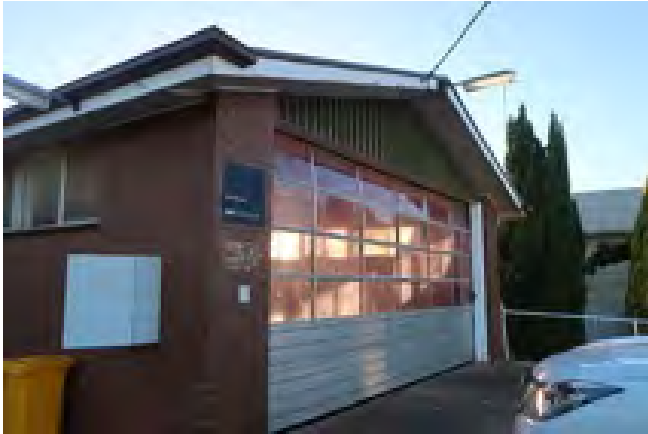
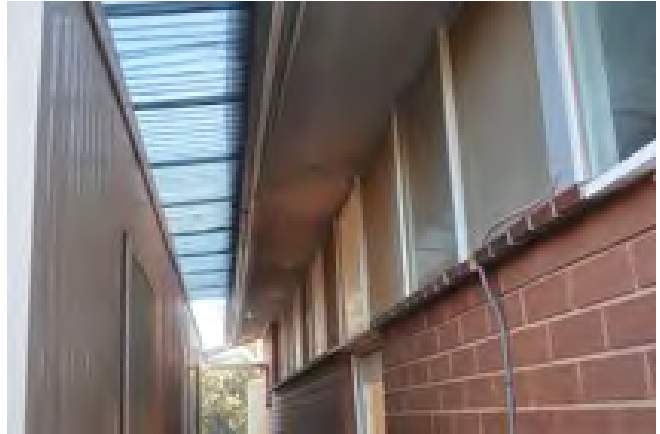
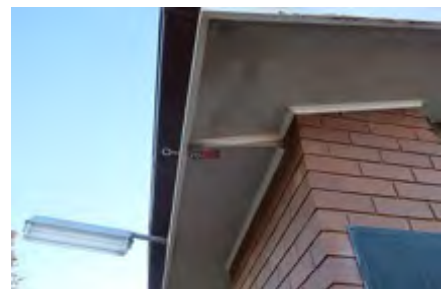
**Area 6**

**Hopetoun CFA Shed: entire perimeter of building. The Soffit (F C Sheeting) has Asbestos Containing Material (ACM) present.**

RISK ASSESSMENT					
Type of Asbestos or Hazardous Material	Chrysotile	Condition	AVERAGE	Likelihood of Damage	L (Low) – possible
	Sample taken 62069-001	Activity	Moderate		
		Sealed	No	Friability	Bonded (non-friable)
		Labelled	Y	Exposure Risk	Medium - Moderate risk
		Quantity

Raw Material

Raw material sheeting - The area requires immediate remedial repairs. It is recommended the asbestos material be sealed with an approved membrane.

Priority	HIGH	Label Required	Yes	Re- Audit Date	27 Jan 2022
Action	Remedial repairs required - seal raw material / edges				
Recommendation	Raw material sheeting - The area requires immediate remedial repairs. It is recommended the asbestos material be sealed with an approved membrane.				
Legislative Requirements Victorian Regulation 2007	Damaged ACM visible in area. Requires IMMEDIATE ATTENTION. WARNING labels should be affixed. Avoid mechanical damage and abrasion. Remove if refurbishment, structural alteration or demolition is to be carried out in this area. Re-inspect every 12 months or earlier if disturbed or removed in accordance with the Victorian OH&S Regulation 2017. <b>All remedial/removal repairs require a Clearance Inspection &amp; Certificate to be recorded by an approved and competent assessor.</b>

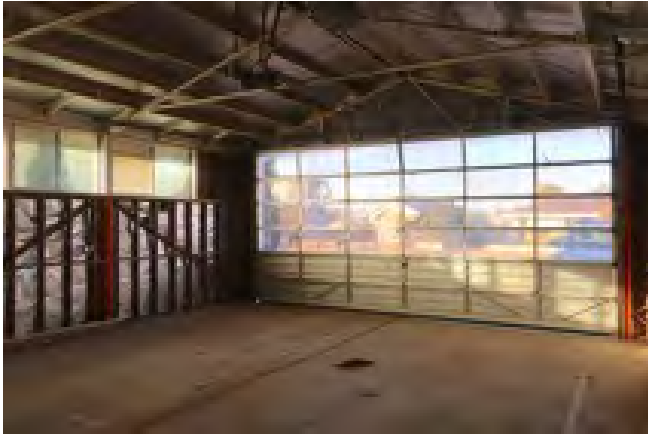
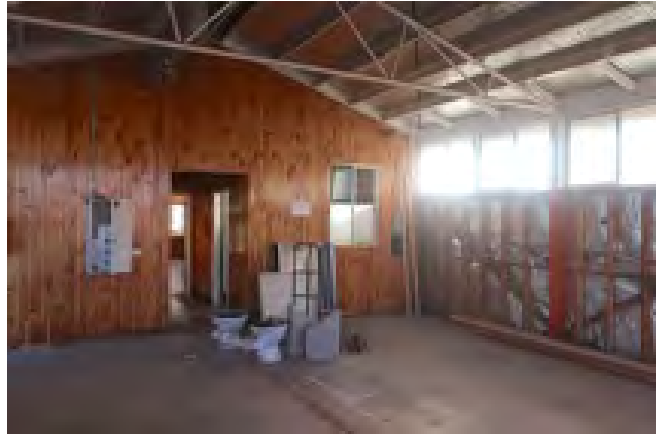
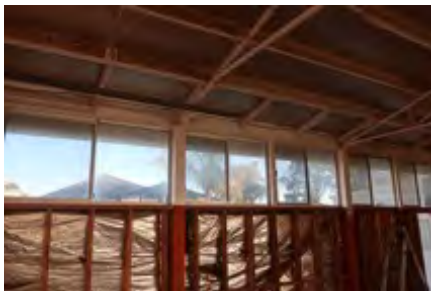
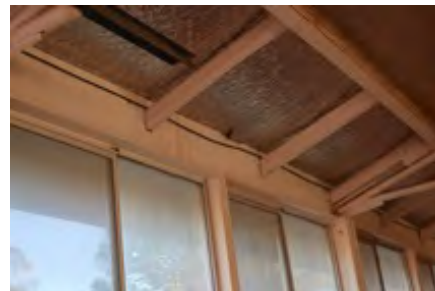
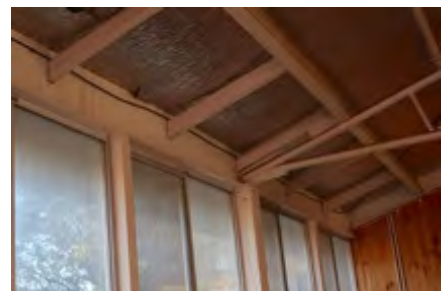
**Hopetoun CFA Shed: Garage 1. The Infill panel/s above windows (F C Sheeting) has Asbestos Containing Material (ACM) present.**

RISK ASSESSMENT					
Type of Asbestos or Hazardous Material	Chrysotile	Condition	GOOD	Likelihood of Damage	L (Low) – possible
	Sample taken 62069-002	Activity	Moderate		
		Sealed	Yes	Friability	Bonded (non-friable)
		Labelled	No	Exposure Risk	Low - Negligible or low risk
		Quantity

Priority	MEDIUM	Label Required	Yes	Re- Audit Date	27 Jan 2022
Action	No remedial action required, unless disturbed				
Recommendation	Maintain paint or sealant to ACM surfaces. Particular attention should be given to side edges, ensure paint/sealant covers ALL exposed ACM surfaces.				
Legislative Requirements Victorian Regulation 2007	Warning labels should be affixed. Avoid mechanical damage and abrasion. Remove if refurbishment, structural alteration or demolition is to be carried out in this area. Re-inspect every 12 months or earlier if disturbed or removed in accordance with the Victorian OH&S Regulation 2017. <b>All remedial/removal repairs require a Clearance Inspection &amp; Certificate to be recorded by an approved and competent assessor.</b>

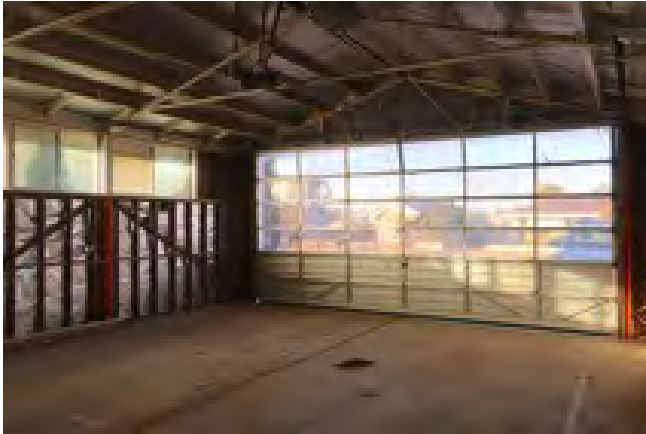
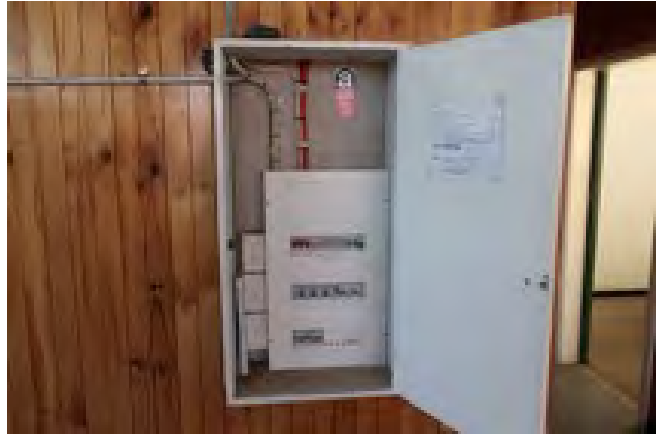
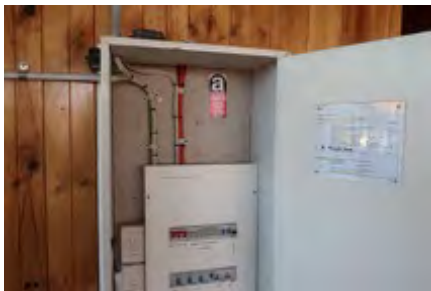
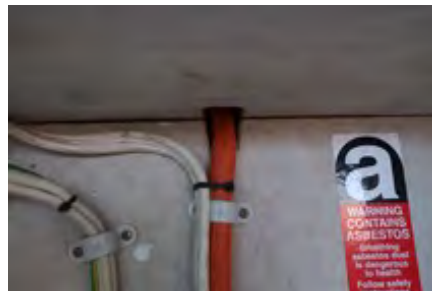
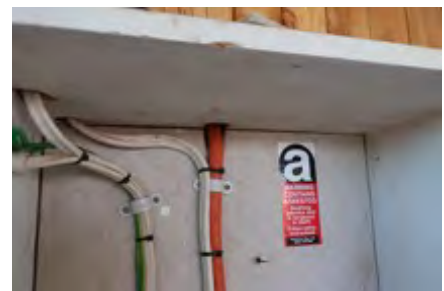
**Hopetoun CFA Shed: Garage 1. The Electrical Cabinet - backing panel (F C Sheeting) has Asbestos Containing Material (ACM) present.**

RISK ASSESSMENT					
Type of Asbestos or Hazardous Material	Chrysotile	Condition	AVERAGE	Likelihood of Damage	L (Low) – possible
	Sample taken 62069-003	Activity	Moderate		
		Sealed	No	Friability	Bonded (non-friable)
		Labelled	Y	Exposure Risk	Medium - Moderate risk
		Quantity

Raw Material

Priority	HIGH	Label Required	Yes	Re- Audit Date	27 Jan 2022
Action	Remedial repairs required - seal raw material / edges				
Recommendation	Raw material sheeting - The area requires immediate remedial repairs. It is recommended the asbestos material be sealed with an approved membrane.				
Legislative Requirements Victorian Regulation 2007	Damaged ACM visible in area. Requires IMMEDIATE ATTENTION. WARNING labels should be affixed. Avoid mechanical damage and abrasion. Remove if refurbishment, structural alteration or demolition is to be carried out in this area. Re-inspect every 12 months or earlier if disturbed or removed in accordance with the Victorian OH&S Regulation 2017. <b>All remedial/removal repairs require a Clearance Inspection &amp; Certificate to be recorded by an approved and competent assessor.</b>

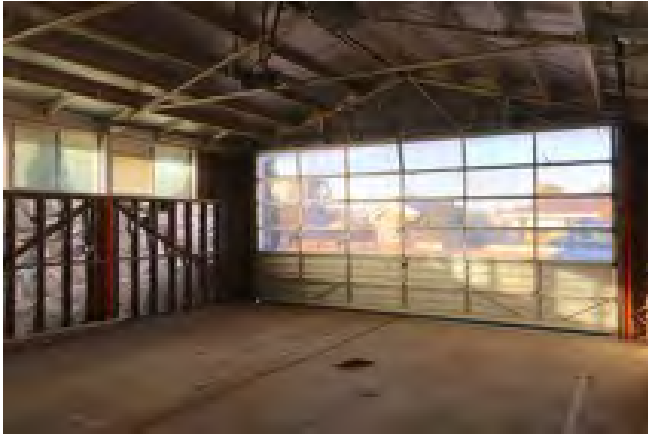
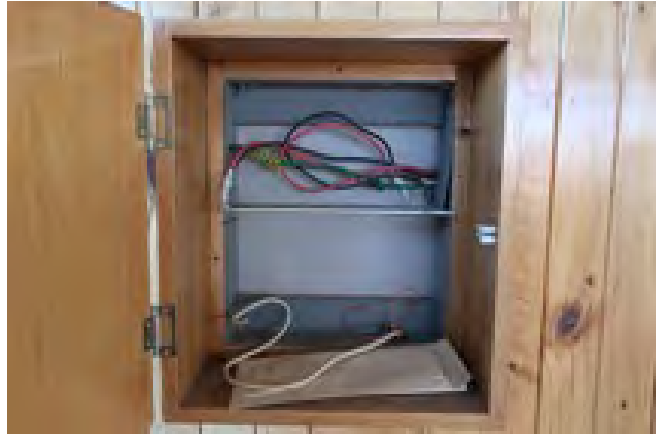
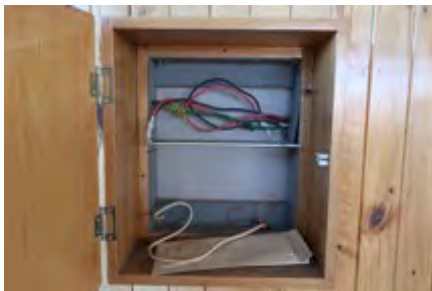
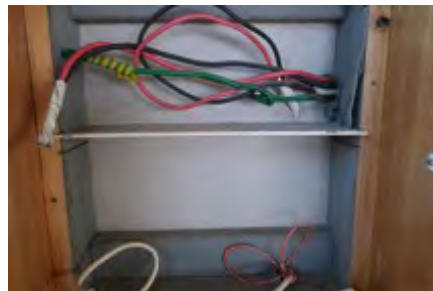
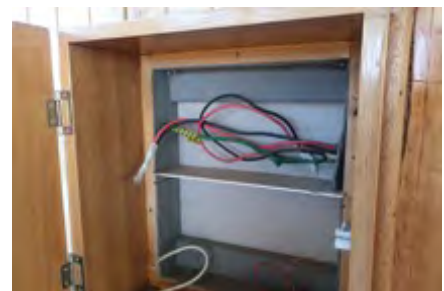
**Hopetoun CFA Shed: Garage 1. The Siren Cabinet - backing panel (F C Sheeting) has Asbestos Containing Material (ACM) present.**

RISK ASSESSMENT					
Type of Asbestos or Hazardous Material	Chrysotile	Condition	AVERAGE	Likelihood of Damage	L (Low) – possible
	Same as Sample - 62069-003	Activity	Moderate		
		Sealed	No	Friability	Bonded (non-friable)
		Labelled	Y	Exposure Risk	Medium - Moderate risk
		Quantity

Raw Material

RISK CONTROL					
Priority	HIGH	Label Required	Yes	Re- Audit Date	27 Jan 2022
Action	Remedial repairs required - seal raw material / edges				
Recommendation	Raw material sheeting - The area requires immediate remedial repairs. It is recommended the asbestos material be sealed with an approved membrane.				
Legislative Requirements Victorian Regulation 2007	Damaged ACM visible in area. Requires IMMEDIATE ATTENTION. WARNING labels should be affixed. Avoid mechanical damage and abrasion. Remove if refurbishment, structural alteration or demolition is to be carried out in this area. Re-inspect every 12 months or earlier if disturbed or removed in accordance with the Victorian OH&S Regulation 2017. <b>All remedial/removal repairs require a Clearance Inspection &amp; Certificate to be recorded by an approved and competent assessor.</b>

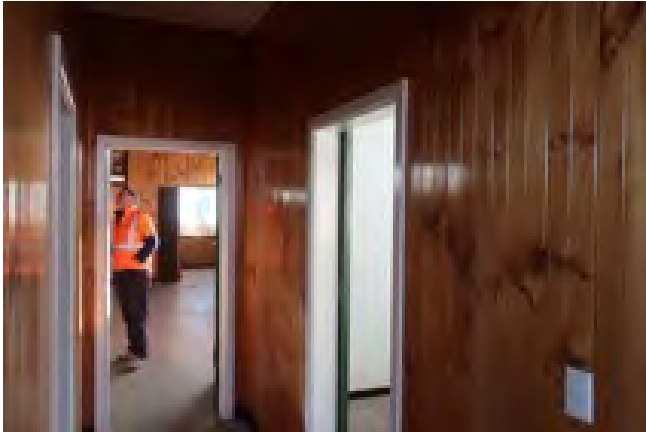
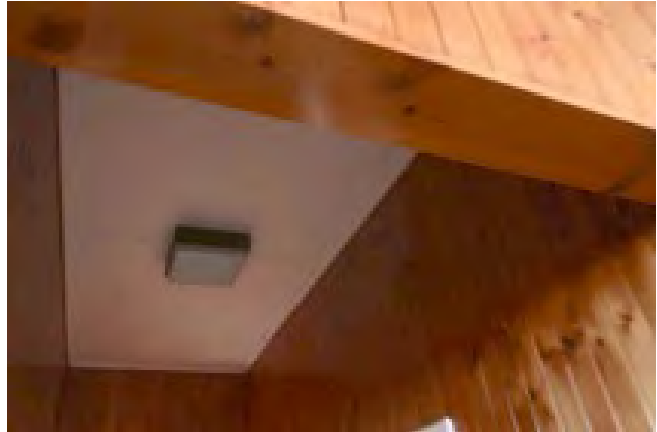
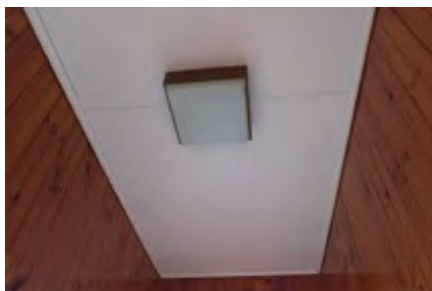
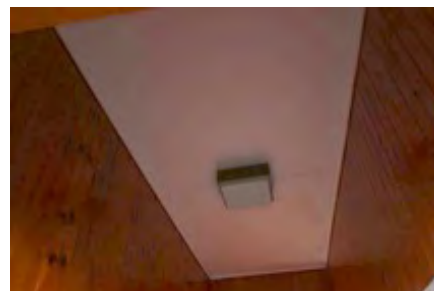
**Area 13****Hopetoun CFA Shed: Hallway 2. The Ceiling (F C Sheeting) has Asbestos Containing Material (ACM) present.****RISK ASSESSMENT**

<b>Type of Asbestos or Hazardous Material</b>	Chrysotile	<b>Condition</b>	GOOD	<b>Likelihood of Damage</b>	L (Low) – possible
	Same as Sample - 62069 -005	<b>Activity</b>	Moderate		
		<b>Sealed</b>	Yes	<b>Friability</b>	Bonded (non-friable)
		<b>Labelled</b>	Y	<b>Exposure Risk</b>	Low - Negligible or low risk
		<b>Quantity</b>

<b>Priority</b>	MEDIUM	<b>Label Required</b>	Yes	<b>Re- Audit Date</b>	27 Jan 2022
<b>Action</b>	No remedial action required, unless disturbed				
<b>Recommendation</b>	Maintain paint or sealant to ACM surfaces. Particular attention should be given to side edges, ensure paint/sealant covers ALL exposed ACM surfaces.				
<b>Legislative Requirements Victorian Regulation 2007</b>	Warning labels should be affixed. Avoid mechanical damage and abrasion. Remove if refurbishment, structural alteration or demolition is to be carried out in this area. Re-inspect every 12 months or earlier if disturbed or removed in accordance with the Victorian OH&S Regulation 2017. <b>All remedial/removal repairs require a Clearance Inspection &amp; Certificate to be recorded by an approved and competent assessor.</b>

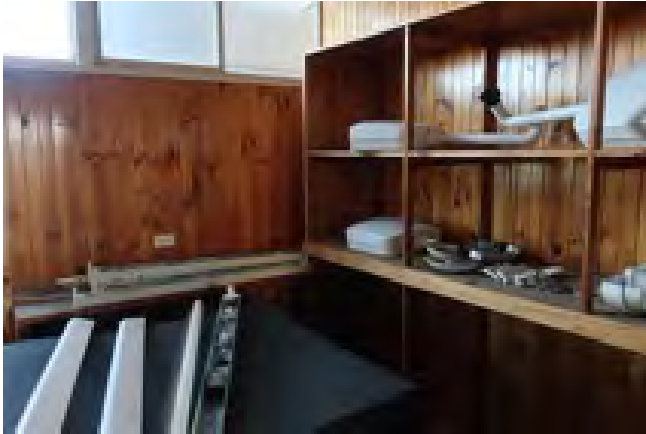
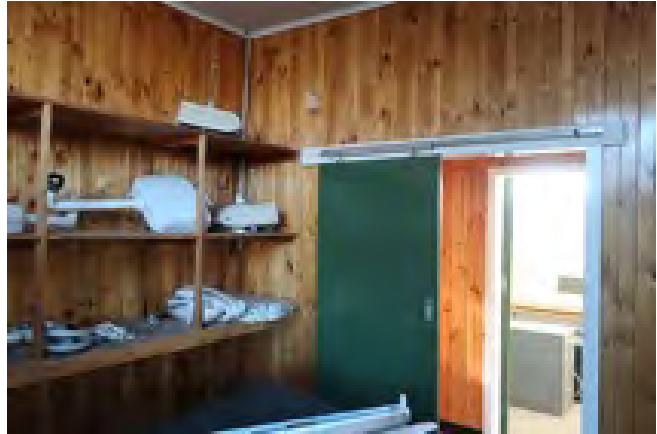
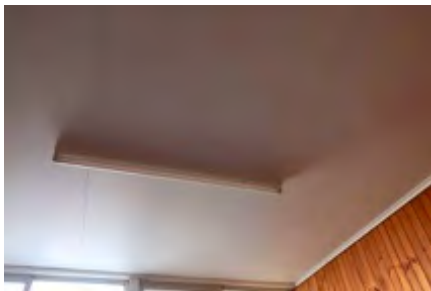
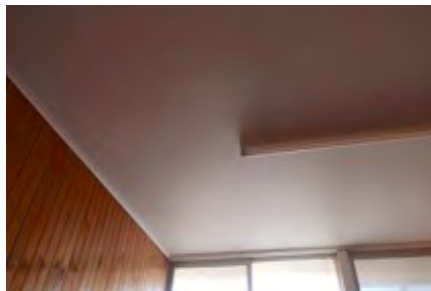
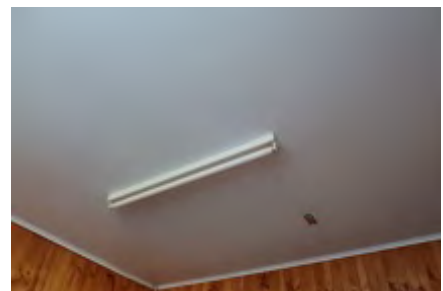
**Hopetoun CFA Shed: Workshop 3. The Ceiling (F C Sheeting) has Asbestos Containing Material (ACM) present.**

RISK ASSESSMENT					
Type of Asbestos or Hazardous Material	Chrysotile	Condition	GOOD	Likelihood of Damage	L (Low) – possible
	Same as Sample - 62069 -005	Activity	Moderate		
		Sealed	Yes	Friability	Bonded (non-friable)
		Labelled	Y	Exposure Risk	Low - Negligible or low risk
		Quantity

Priority	MEDIUM	Label Required	Yes	Re- Audit Date	27 Jan 2022
Action	No remedial action required, unless disturbed				
Recommendation	Maintain paint or sealant to ACM surfaces. Particular attention should be given to side edges, ensure paint/sealant covers ALL exposed ACM surfaces.				
Legislative Requirements Victorian Regulation 2007	Warning labels should be affixed. Avoid mechanical damage and abrasion. Remove if refurbishment, structural alteration or demolition is to be carried out in this area. Re-inspect every 12 months or earlier if disturbed or removed in accordance with the Victorian OH&S Regulation 2017. <b>All remedial/removal repairs require a Clearance Inspection &amp; Certificate to be recorded by an approved and competent assessor.</b>

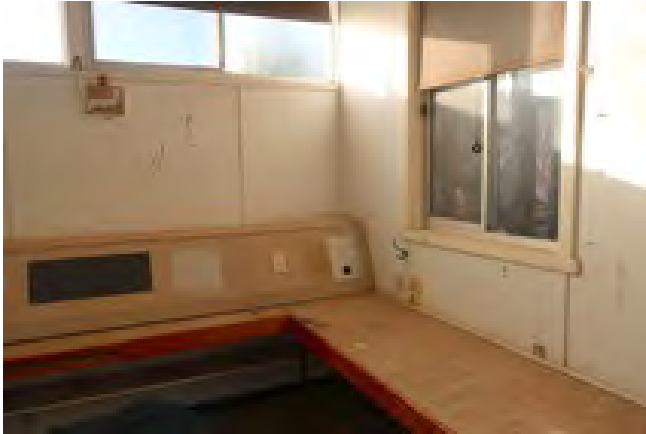
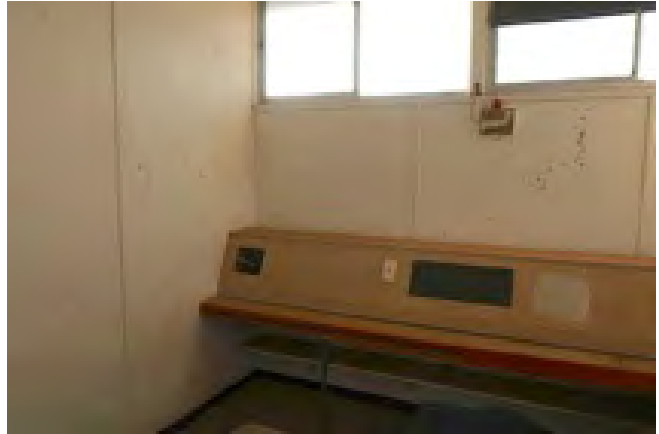
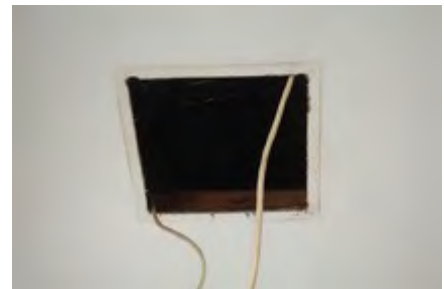
**Hopetoun CFA Shed: Control room 4. The Ceiling (F C Sheeting) has Asbestos Containing Material (ACM) present.**

RISK ASSESSMENT					
Type of Asbestos or Hazardous Material	Chrysotile	Condition	GOOD	Likelihood of Damage	L (Low) – possible
	Sample taken 62069-005	Activity	Moderate		
		Sealed	Yes	Friability	Bonded (non-friable)
		Labelled	Y	Exposure Risk	Low - Negligible or low risk
		Quantity

Priority	MEDIUM	Label Required	Yes	Re- Audit Date	27 Jan 2022
Action	No remedial action required, unless disturbed				
Recommendation	Maintain paint or sealant to ACM surfaces. Particular attention should be given to side edges, ensure paint/sealant covers ALL exposed ACM surfaces.				
Legislative Requirements Victorian Regulation 2007	Warning labels should be affixed. Avoid mechanical damage and abrasion. Remove if refurbishment, structural alteration or demolition is to be carried out in this area. Re-inspect every 12 months or earlier if disturbed or removed in accordance with the Victorian OH&S Regulation 2017. <b>All remedial/removal repairs require a Clearance Inspection &amp; Certificate to be recorded by an approved and competent assessor.</b>

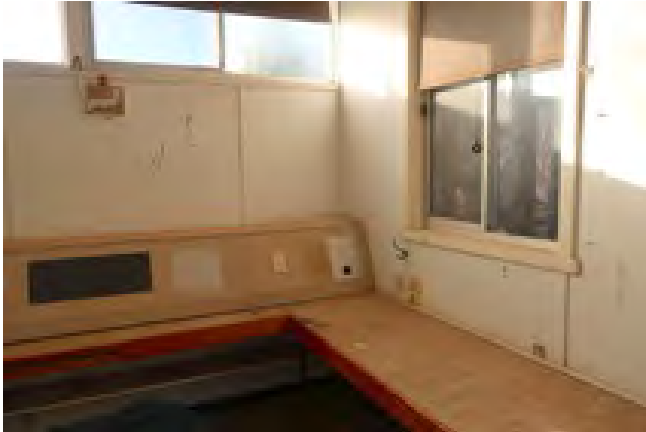
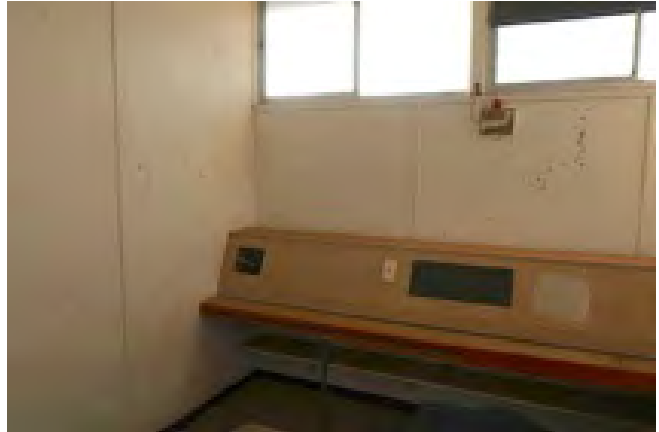
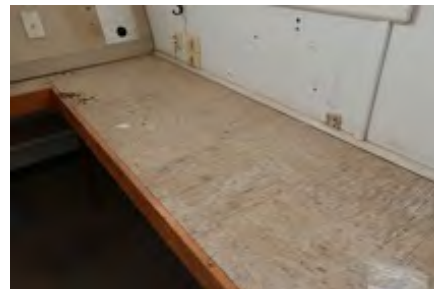
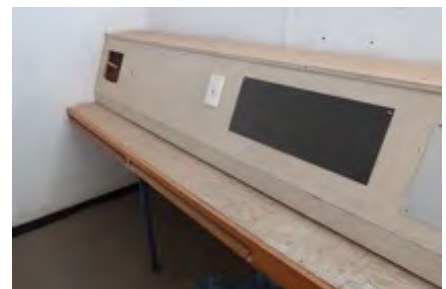
**Area 10****Hopetoun CFA Shed: Control room 4. The Bench top (Vinyl Tiles) has Asbestos Containing Material (ACM) present.****RISK ASSESSMENT**

<b>Type of Asbestos or Hazardous Material</b>	Chrysotile	<b>Condition</b>	GOOD	<b>Likelihood of Damage</b>	L (Low) – possible
	Sample taken 62069-006	<b>Activity</b>	Moderate		
		<b>Sealed</b>	Yes	<b>Friability</b>	Bonded (non-friable)
		<b>Labelled</b>	Y	<b>Exposure Risk</b>	Medium - Moderate risk
		<b>Quantity</b>

<b>Priority</b>	MEDIUM	<b>Label Required</b>	Yes	<b>Re- Audit Date</b>	27 Jan 2022
<b>Action</b>	No remedial action required, unless disturbed				
<b>Recommendation</b>	Maintain paint or sealant to ACM surfaces. Particular attention should be given to side edges, ensure paint/sealant covers ALL exposed ACM surfaces.				
<b>Legislative Requirements Victorian Regulation 2007</b>	Warning labels should be affixed. Avoid mechanical damage and abrasion. Remove if refurbishment, structural alteration or demolition is to be carried out in this area. Re-inspect every 12 months or earlier if disturbed or removed in accordance with the Victorian OH&S Regulation 2017. <b>All remedial/removal repairs require a Clearance Inspection &amp; Certificate to be recorded by an approved and competent assessor.</b>

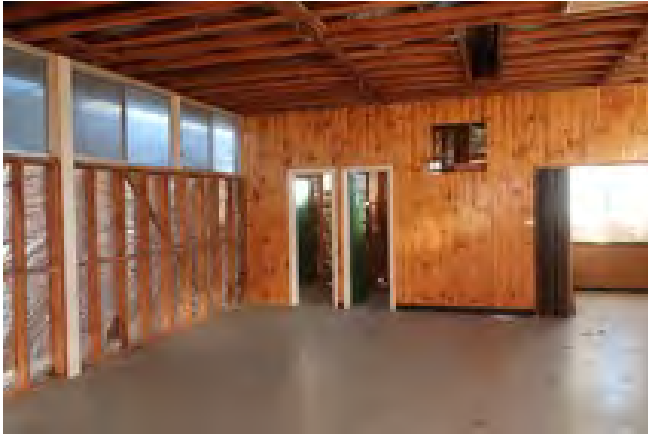
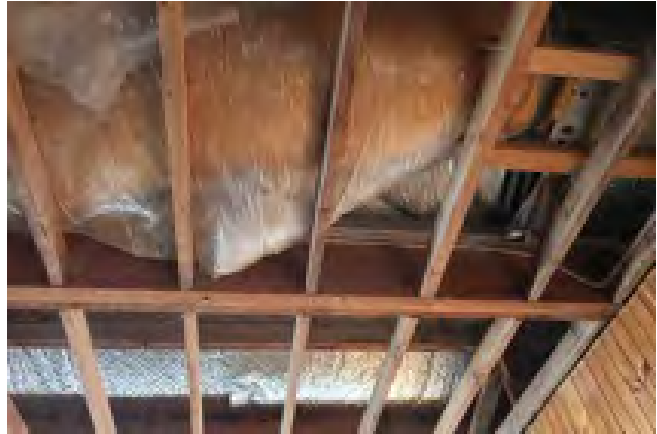
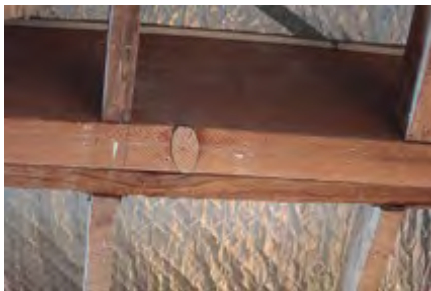
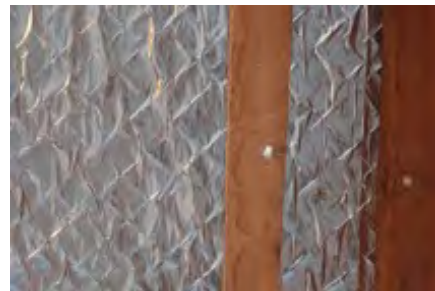
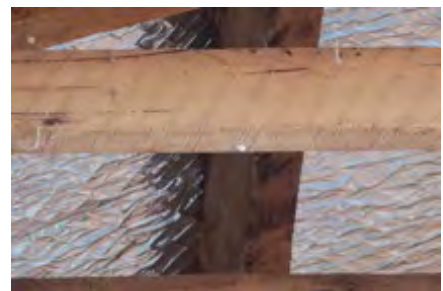
**Hopetoun CFA Shed: Main room 5. The Walls & Ceiling joist (Debris) has Asbestos Containing Material (ACM) present.**

RISK ASSESSMENT					
Type of Asbestos or Hazardous Material	Chrysotile	Condition	POOR	Likelihood of Damage	H (High) - almost certain
	Same as Sample - 62069 -008	Activity	Moderate		
		Sealed	No	Friability	Exposed Fibres
		Labelled	No	Exposure Risk	High - Short term exposure risk
		Quantity

Removal Residue

- 4 Hopetoun CFA Shed: Main room 5. The Walls & Ceiling joist (Debris) has Asbestos Containing Material (ACM) present.**
- Areas require decontamination and barricading. Debris on Surface - The Debris requires immediate cleanup and disposal with specialised equipment and with licensed removalist to safely remove the asbestos debris.  
Debris residue from incomplete or improper asbestos removal. Recommend to refer to removal Control Plan; Review & correct procedures.

RISK CONTROL					
Priority	IMMEDIATE	Label Required	Yes	Re- Audit Date	27 Jan 2022
Action	Restrict access and target for imminent removal				
Recommendation	Areas require decontamination and barricading. Debris on Surface - The Debris requires immediate cleanup and disposal with specialised equipment and with licensed removalist to safely remove the asbestos debris. Debris residue from incomplete or improper asbestos removal. Recommend to refer to removal Control Plan: Review & correct procedures.				
Legislative Requirements Victorian Regulation 2007	ACM debris visible. Do not enter without PPE, site is currently an uncontrolled asbestos removal site. Recommend cleanup by licensed Asbestos Removalist. Warning labels should be affixed. Avoid mechanical damage and abrasion. Re-inspect before occupation and clearance provided in accordance with the Victorian OH&S Regulation 2017. <b>All remedial/removal repairs require a Clearance Inspection &amp; Certificate to be recorded by an approved and competent assessor.</b>

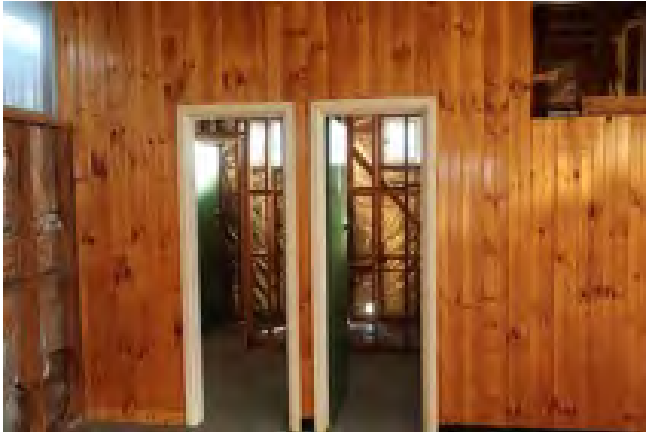
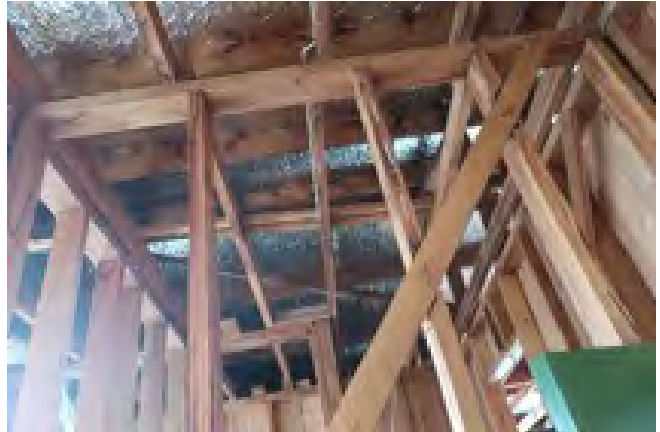
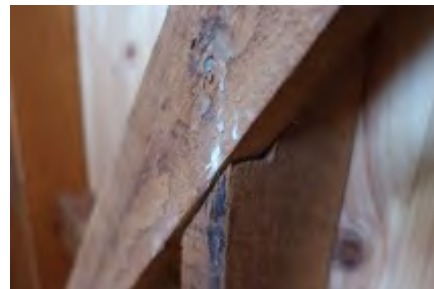
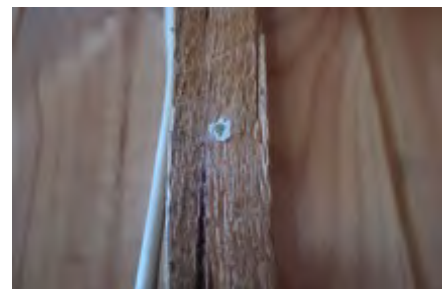
**Hopetoun CFA Shed: Bathrooms x2: Rooms 6 & 7. The Walls & Ceiling joist (Debris) has Asbestos Containing Material (ACM) present.**

RISK ASSESSMENT					
Type of Asbestos or Hazardous Material	Chrysotile	Condition	POOR	Likelihood of Damage	H (High) - almost certain
	Same as Sample - 62069 -008	Activity	Moderate		
		Sealed		Friability	Exposed Fibres
		Labelled	No	Exposure Risk	High - Short term exposure risk
		Quantity

Removal Residue

- 3 Hopetoun CFA Shed: Bathrooms x2: Rooms 6 & 7. The Walls & Ceiling joist (Debris) has Asbestos Containing Material (ACM) present.**
- Areas require decontamination and barricading. Debris on Surface - The Debris requires immediate cleanup and disposal with specialised equipment and with licensed removalist to safely remove the asbestos debris.  
Debris residue from incomplete or improper asbestos removal. Recommend to refer to removal Control Plan; Review & correct procedures.

RISK CONTROL					
Priority	IMMEDIATE	Label Required	Yes	Re- Audit Date	27 Jan 2022
Action	Restrict access and target for imminent removal				
Recommendation	Areas require decontamination and barricading. Debris on Surface - The Debris requires immediate cleanup and disposal with specialised equipment and with licensed removalist to safely remove the asbestos debris. Debris residue from incomplete or improper asbestos removal. Recommend to refer to removal Control Plan: Review & correct procedures.				
Legislative Requirements Victorian Regulation 2007	ACM debris visible. Do not enter without PPE, site is currently an uncontrolled asbestos removal site. Recommend cleanup by licensed Asbestos Removalist. Warning labels should be affixed. Avoid mechanical damage and abrasion. Re-inspect before occupation and clearance provided in accordance with the Victorian OH&S Regulation 2017. <b>All remedial/removal repairs require a Clearance Inspection &amp; Certificate to be recorded by an approved and competent assessor.</b>

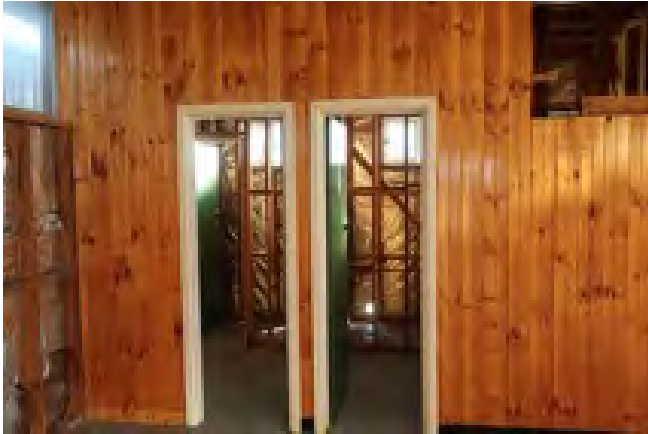
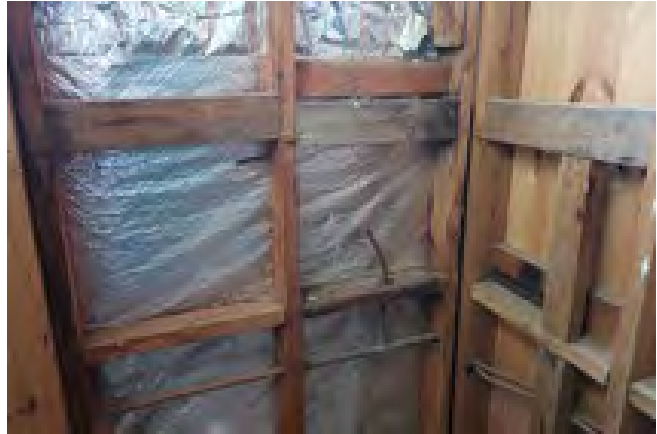
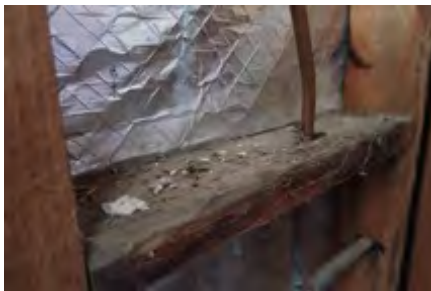
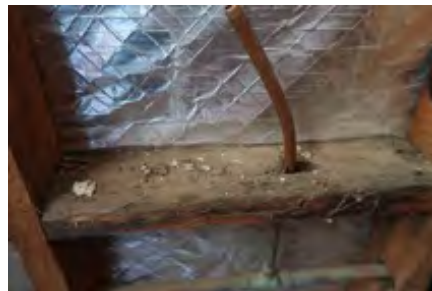
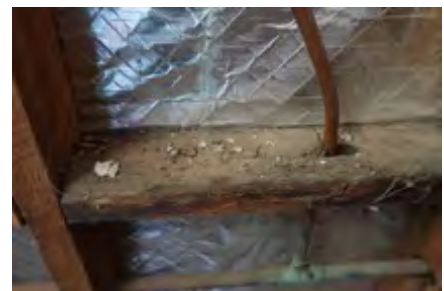
**Hopetoun CFA Shed: Bathrooms x2: Rooms 6 & 7. The Wall (Debris) has Asbestos Containing Material (ACM) present.**

RISK ASSESSMENT					
Type of Asbestos or Hazardous Material	Chrysotile	Condition	POOR	Likelihood of Damage	L (Low) – possible
	Sample taken 62069-008	Activity	Moderate		
		Sealed	No	Friability	Exposed Fibres
		Labelled	No	Exposure Risk	High - Short term exposure risk
		Quantity

Debris on Framing

- 2 Hopetoun CFA Shed: Bathrooms x2: Rooms 6 & 7. The Wall (Debris) has Asbestos Containing Material (ACM) present.**
- Areas require decontamination and barricading. Debris on Surface - The Debris requires immediate cleanup and disposal with specialised equipment and with licensed removalist to safely remove the asbestos debris.  
Debris residue from incomplete or improper asbestos removal. Recommend to refer to removal Control Plan; Review & correct procedures.

Priority	IMMEDIATE	Label Required	Yes	Re- Audit Date	27 Jan 2022
Action	Restrict access and target for imminent removal				
Recommendation	Areas require decontamination and barricading. Debris on Surface - The Debris requires immediate cleanup and disposal with specialised equipment and with licensed removalist to safely remove the asbestos debris. Debris residue from incomplete or improper asbestos removal. Recommend to refer to removal Control Plan: Review & correct procedures.				
Legislative Requirements Victorian Regulation 2007	ACM debris visible. Do not enter without PPE, site is currently an uncontrolled asbestos removal site. Recommend cleanup by licensed Asbestos Removalist. Warning labels should be affixed. Avoid mechanical damage and abrasion. Re-inspect before occupation and clearance provided in accordance with the Victorian OH&S Regulation 2017. <b>All remedial/removal repairs require a Clearance Inspection &amp; Certificate to be recorded by an approved and competent assessor.</b>

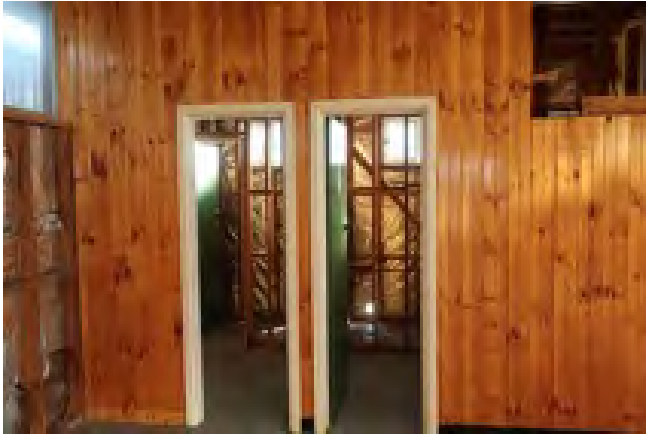
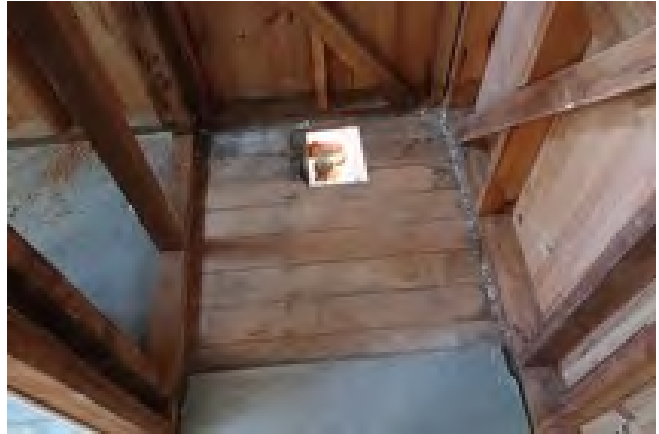
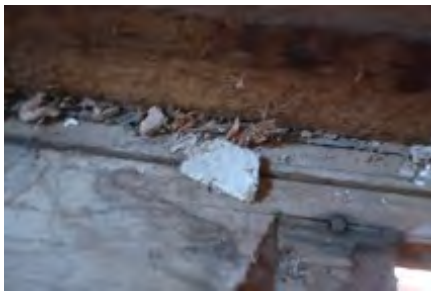
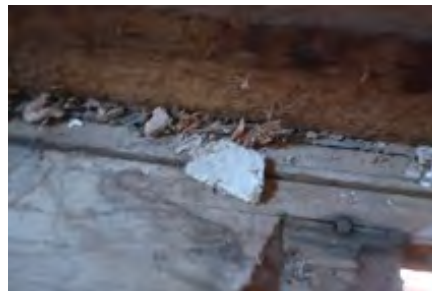
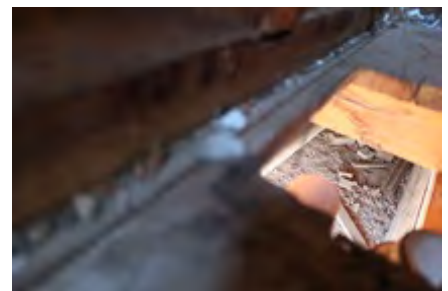
**Hopetoun CFA Shed: Bathrooms x2: Rooms 6 & 7. The Debris - Broken (Debris) has Asbestos Containing Material (ACM) present.**

RISK ASSESSMENT					
Type of Asbestos or Hazardous Material	Chrysotile	Condition	POOR	Likelihood of Damage	H (High) - almost certain
	Same as Sample - 62069 -008	Activity	Moderate		
		Sealed	No	Friability	Exposed Fibres
		Labelled	No	Exposure Risk	High - Short term exposure risk
		Quantity

Debris on Floor

- 1 **Hopetoun CFA Shed: Bathrooms x2: Rooms 6 & 7. The Debris - Broken (Debris) has Asbestos Containing Material (ACM) present.**

Debris residue from incomplete or improper asbestos removal. Recommend to refer to removal Control Plan; Review & correct procedures.

Priority	IMMEDIATE	Label Required	Yes	Re- Audit Date	27 Jan 2022
Action	Restrict access and target for imminent removal				
Recommendation	Areas require decontamination and barricading. Debris on Surface - The Debris requires immediate cleanup and disposal with specialised equipment and with licensed removalist to safely remove the asbestos debris. Debris residue from incomplete or improper asbestos removal. Recommend to refer to removal Control Plan: Review & correct procedures.				
Legislative Requirements Victorian Regulation 2007	ACM debris visible. Do not enter without PPE, site is currently an uncontrolled asbestos removal site. Recommend cleanup by licensed Asbestos Removalist. Warning labels should be affixed. Avoid mechanical damage and abrasion. Re-inspect before occupation and clearance provided in accordance with the Victorian OH&S Regulation 2017. <b>All remedial/removal repairs require a Clearance Inspection &amp; Certificate to be recorded by an approved and competent assessor.</b>

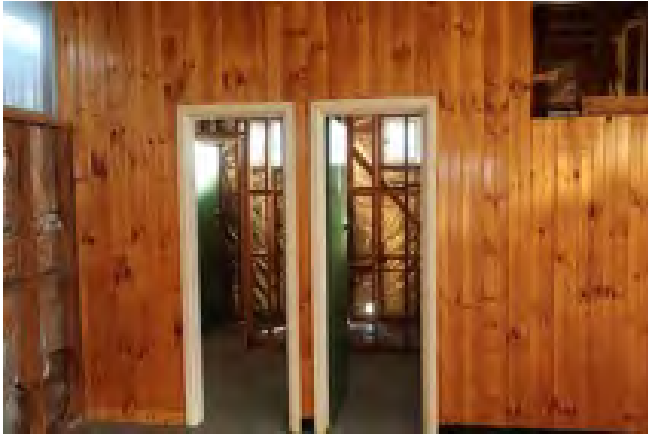
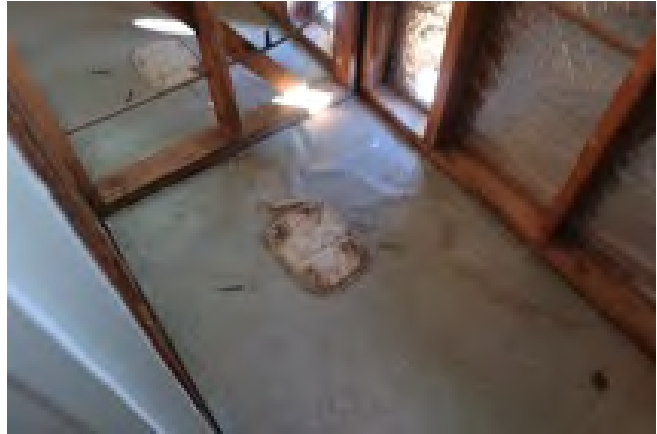
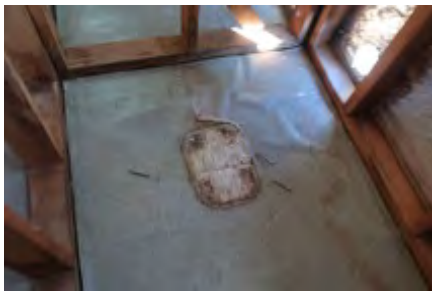
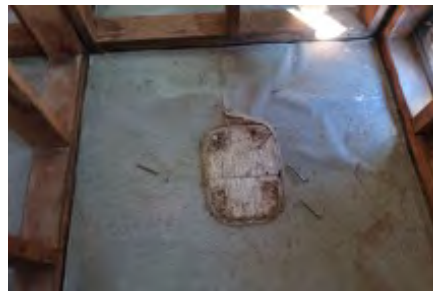
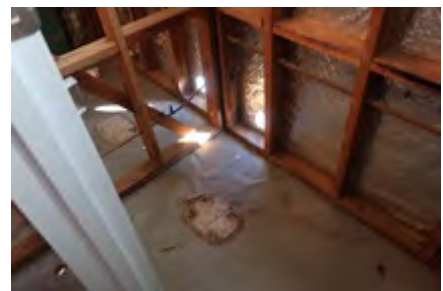
**Hopetoun CFA Shed: Bathrooms x2: Rooms 6 & 7. The Floor (Vinyl Tiles) has Asbestos Containing Material (ACM) present.**

RISK ASSESSMENT					
Type of Asbestos or Hazardous Material	Chrysotile	Condition	GOOD	Likelihood of Damage	L (Low) – possible
	Sample taken 62069-009	Activity	Moderate		
		Sealed	Yes	Friability	Bonded (non-friable)
		Labelled	Y	Exposure Risk	Low - Negligible or low risk
		Quantity

Priority	MEDIUM	Label Required	Yes	Re- Audit Date	27 Jan 2022
Action	No remedial action required, unless disturbed				
Recommendation	Maintain paint or sealant to ACM surfaces. Particular attention should be given to side edges, ensure paint/sealant covers ALL exposed ACM surfaces.				
Legislative Requirements Victorian Regulation 2007	Warning labels should be affixed. Avoid mechanical damage and abrasion. Remove if refurbishment, structural alteration or demolition is to be carried out in this area. Re-inspect every 12 months or earlier if disturbed or removed in accordance with the Victorian OH&S Regulation 2017. <b>All remedial/removal repairs require a Clearance Inspection &amp; Certificate to be recorded by an approved and competent assessor.</b>

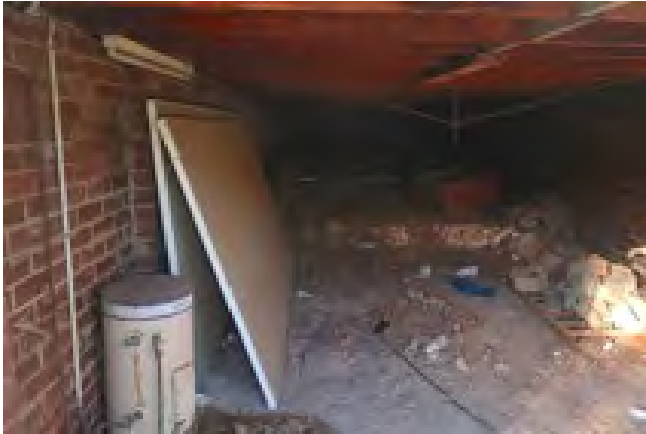
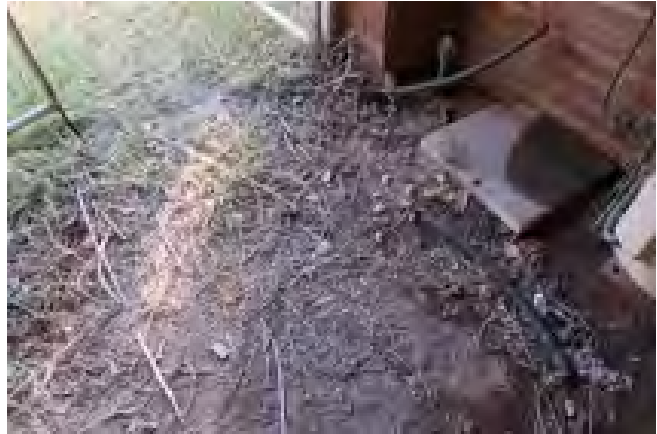
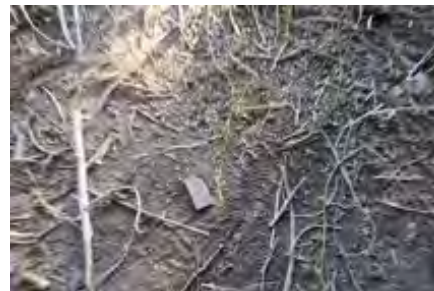
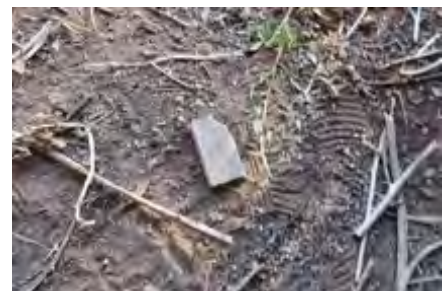
**Hopetoun CFA Shed: Sub floor 1 - beneath bathroom. The Debris - Broken (Debris) has Asbestos Containing Material (ACM) present.**

RISK ASSESSMENT					
Type of Asbestos or Hazardous Material	No sample taken - Visual ID	Condition	POOR	Likelihood of Damage	H (High) - almost certain
		Activity	Moderate		
		Sealed	No	Friability	Exposed Fibres
		Labelled	Y	Exposure Risk	High - Short term exposure risk
		Quantity

Debris on Surface

- 5 Hopetoun CFA Shed: Sub floor 1 - beneath bathroom. The Debris - Broken (Debris) has Asbestos Containing Material (ACM) present.**
- Debris on Surface - The Debris requires immediate cleanup and disposal with specialised equipment and with licensed removalist to safely remove the asbestos debris.

RISK CONTROL					
Priority	IMMEDIATE	Label Required	Yes	Re- Audit Date	27 Jan 2022
Action	Restrict access and target for imminent removal				
Recommendation	Debris on Surface - The Debris requires immediate cleanup and disposal with specialised equipment and with licensed removalist to safely remove the asbestos debris.				
Legislative Requirements Victorian Regulation 2007	ACM debris visible. Recommend cleanup by licensed Asbestos Removalist. Warning labels should be affixed. Avoid mechanical damage and abrasion. Remove if refurbishment, structural alteration or demolition is to be carried out in this area. Re-inspect every 12 months or earlier if disturbed or removed in accordance with the Victorian OH&S Regulation 2017. <b>All remedial/removal repairs require a Clearance Inspection &amp; Certificate to be recorded by an approved and competent assessor.</b>
