# Asbestos Report

YARRIAMBIACK SHIRE COUNCIL

PROPERTY ADDRESS:  
LB77 MEMORIAL HALL  
13 AUSTIN STREET  
HOPETOUN VIC 3396

INSPECTION DATE: 27 JANUARY 2021  
REFERENCE NUMBER: 62071

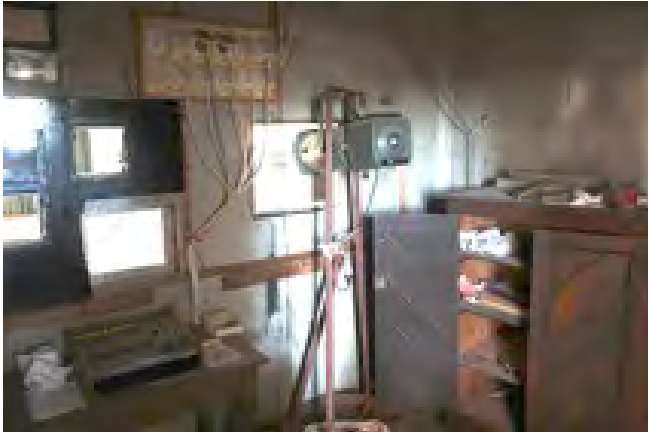
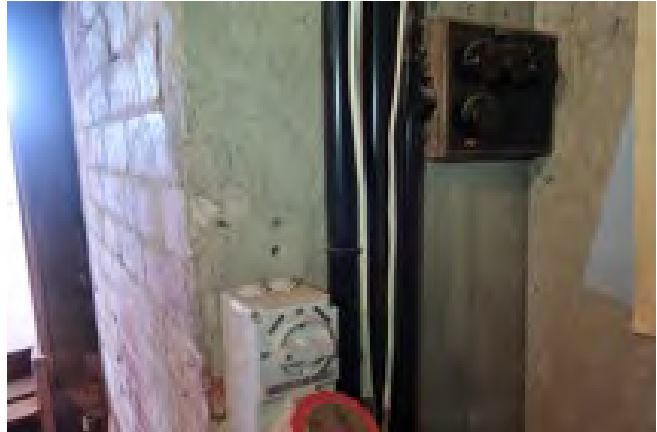
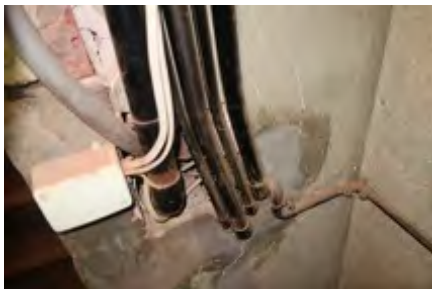
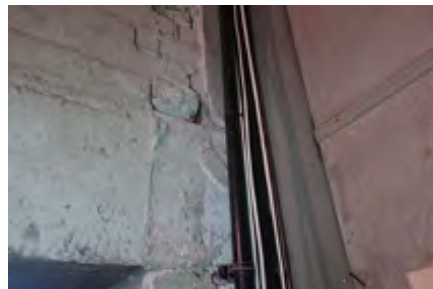
**Area 20**

**LB77 Memorial Hall: Level 1 Projector room 11. The Electrical conduit (black) (Electrical cable (concealed)) has Asbestos Containing Material (ACM) present.**

RISK ASSESSMENT					
Type of Asbestos or Hazardous Material	No sample taken - Visual ID	Condition	GOOD	Likelihood of Damage	VL (Very Low)- unlikely or rare
		Activity	Low		
		Sealed	Yes	Friability	Bonded (non-friable)
		Labelled	Y	Exposure Risk	Low - Negligible or low risk
		Quantity

RISK CONTROL					
Priority	MEDIUM	Label Required	Yes	Re- Audit Date	27 Jan 2022
Action	No remedial action required, unless disturbed				
Recommendation	Maintain paint or sealant to ACM surfaces. Particular attention should be given to side edges, ensure paint/sealant covers ALL exposed ACM surfaces.				
Legislative Requirements Victorian Regulation 2007	Warning labels should be affixed. Avoid mechanical damage and abrasion. Remove if refurbishment, structural alteration or demolition is to be carried out in this area. Re-inspect every 12 months or earlier if disturbed or removed in accordance with the Victorian OH&S Regulation 2017. All remedial/removal repairs require a Clearance Inspection & Certificate to be recorded by an approved and competent assessor.
