# Asbestos Report

YARRIAMBIACK SHIRE COUNCIL

PROPERTY ADDRESS:  
LB74A PRESCHOOL  
87-89 MANDEVILLE STREET  
HOPETOUN VIC 3396

INSPECTION DATE: 27 JANUARY 2021  
REFERENCE NUMBER: 62072

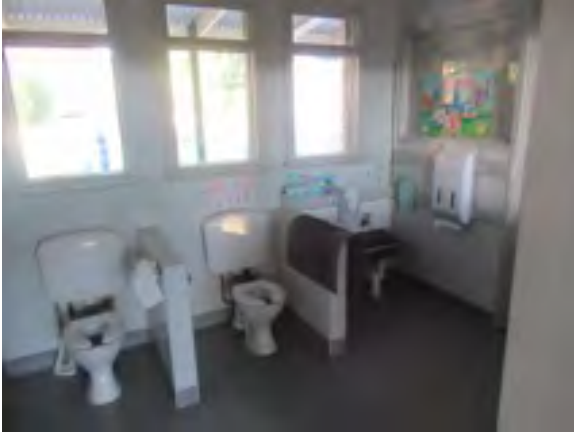
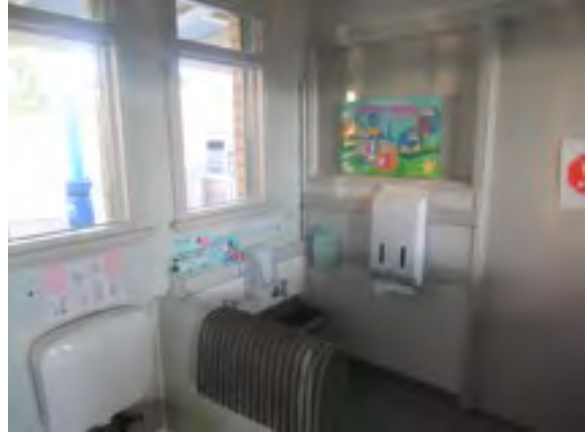
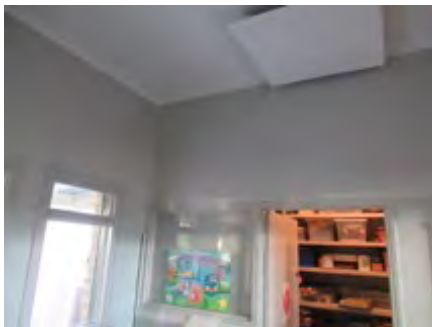
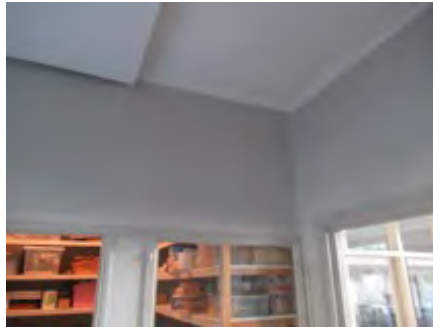
**Area 1**

**LB74A Preschool: Bathroom 11. The Walls - Upper wall above door (F C Sheeting) has Asbestos Containing Material (ACM) present.**

RISK ASSESSMENT					
Type of Asbestos or Hazardous Material	Chrysotile	Condition	GOOD	Likelihood of Damage	L (Low) – possible
	Sample taken 62072-002	Activity	Moderate		
		Sealed	Yes	Friability	Bonded (non-friable)
		Labelled	Y	Exposure Risk	Low - Negligible or low risk
		Quantity

Priority	MEDIUM	Label Required	Yes	Re- Audit Date	27 Jan 2022
Action	No remedial action required, unless disturbed				
Recommendation	Maintain paint or sealant to ACM surfaces. Particular attention should be given to side edges, ensure paint/sealant covers ALL exposed ACM surfaces.				
Legislative Requirements Victorian Regulation 2007	Warning labels should be affixed. Avoid mechanical damage and abrasion. Remove if refurbishment, structural alteration or demolition is to be carried out in this area. Re-inspect every 12 months or earlier if disturbed or removed in accordance with the Victorian OH&S Regulation 2017. All remedial/removal repairs require a Clearance Inspection & Certificate to be recorded by an approved and competent assessor.

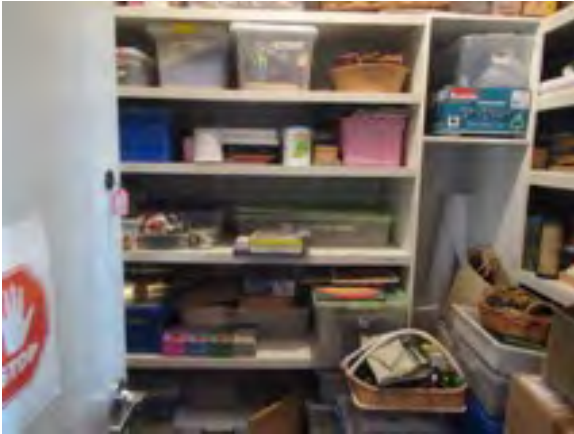
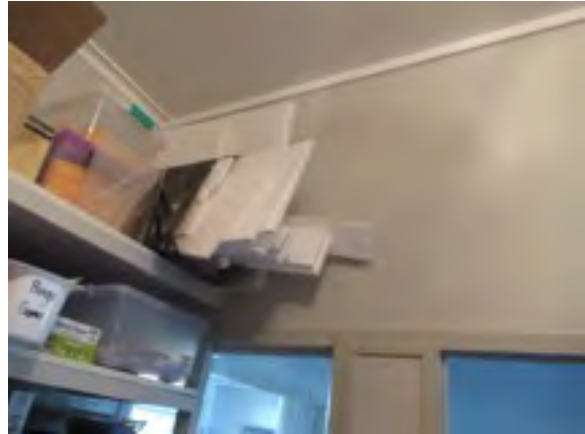
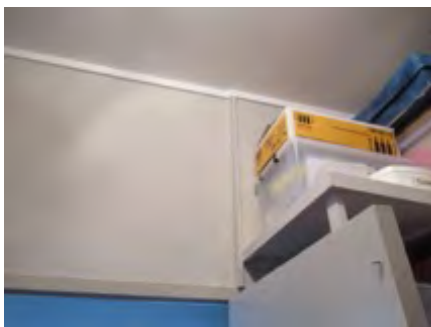
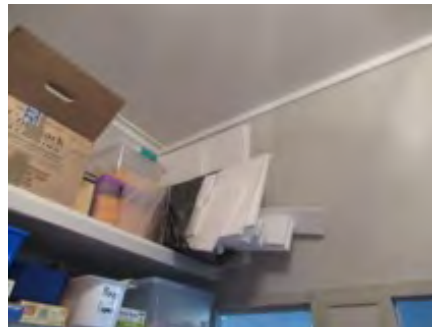
**LB74A Preschool: Storeroom 11.1. The Walls - above door (F C Sheeting) has Asbestos Containing Material (ACM) present.**

RISK ASSESSMENT					
Type of Asbestos or Hazardous Material	Chrysotile	Condition	GOOD	Likelihood of Damage	L (Low) – possible
	Sample taken 62072-003	Activity	Low		
		Sealed	Yes	Friability	Bonded (non-friable)
		Labelled	Y	Exposure Risk	Low - Negligible or low risk
		Quantity

Priority	MEDIUM	Label Required	Yes	Re- Audit Date	27 Jan 2022
Action	No remedial action required, unless disturbed				
Recommendation	Maintain paint or sealant to ACM surfaces. Particular attention should be given to side edges, ensure paint/sealant covers ALL exposed ACM surfaces.				
Legislative Requirements Victorian Regulation 2007	Warning labels should be affixed. Avoid mechanical damage and abrasion. Remove if refurbishment, structural alteration or demolition is to be carried out in this area. Re-inspect every 12 months or earlier if disturbed or removed in accordance with the Victorian OH&S Regulation 2017. All remedial/removal repairs require a Clearance Inspection & Certificate to be recorded by an approved and competent assessor.

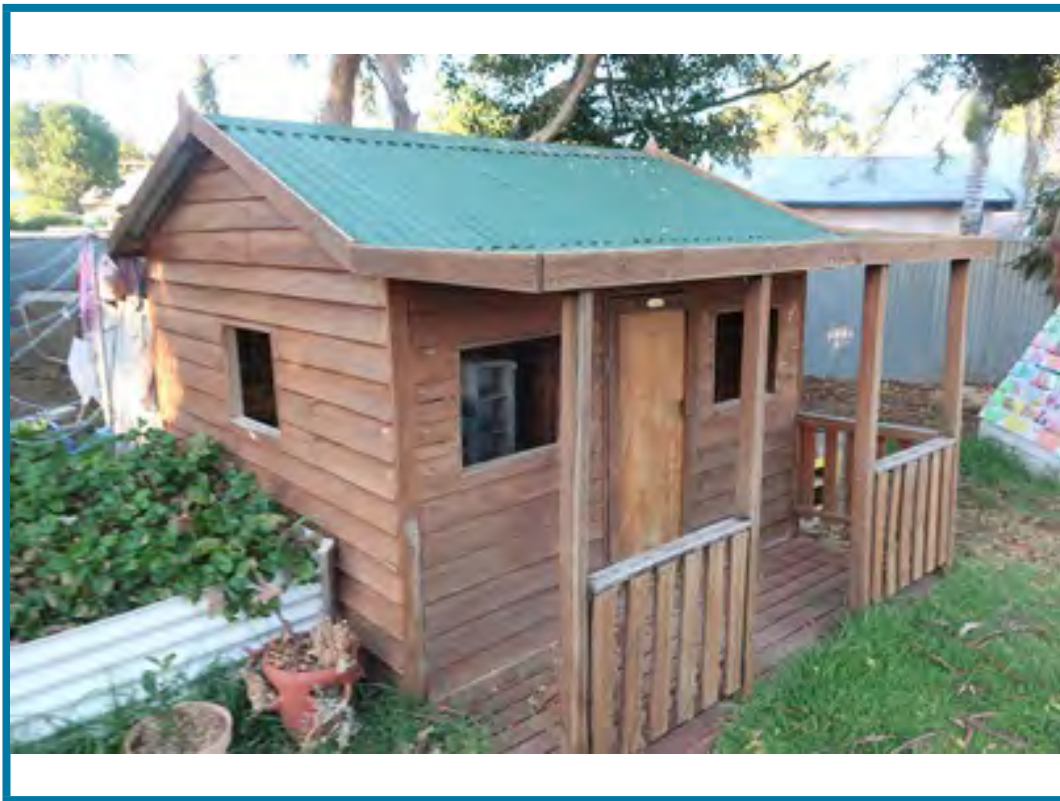
# Playhouse

Location	Area	Component Materials	ACM Identified	Type Asbestos Assessment	Condition	Priority	Signage Required
Playhouse - entire perimeter of building.		No Asbestos Materials	No	No sample taken - Visual ID

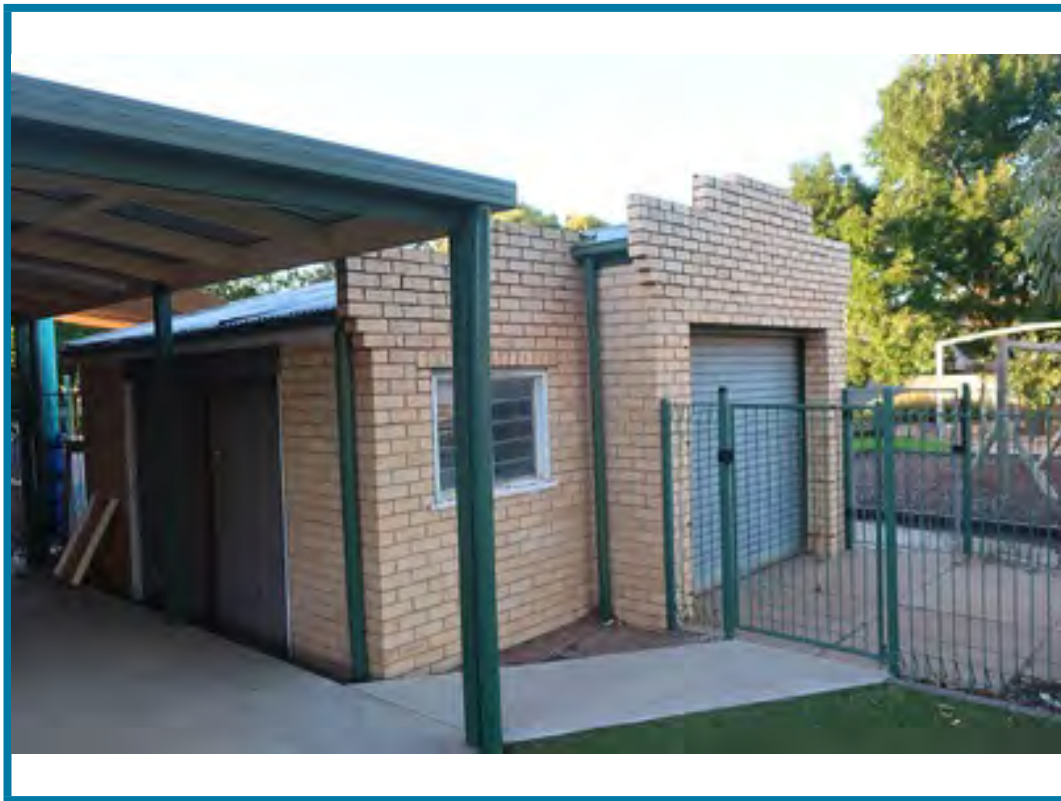
# Shed

Location	Area	Component Materials	ACM Identified	Type Asbestos Assessment	Condition	Priority	Signage Required
Shed - entire perimeter of building.		No Asbestos Materials	No	No sample taken - Visual ID

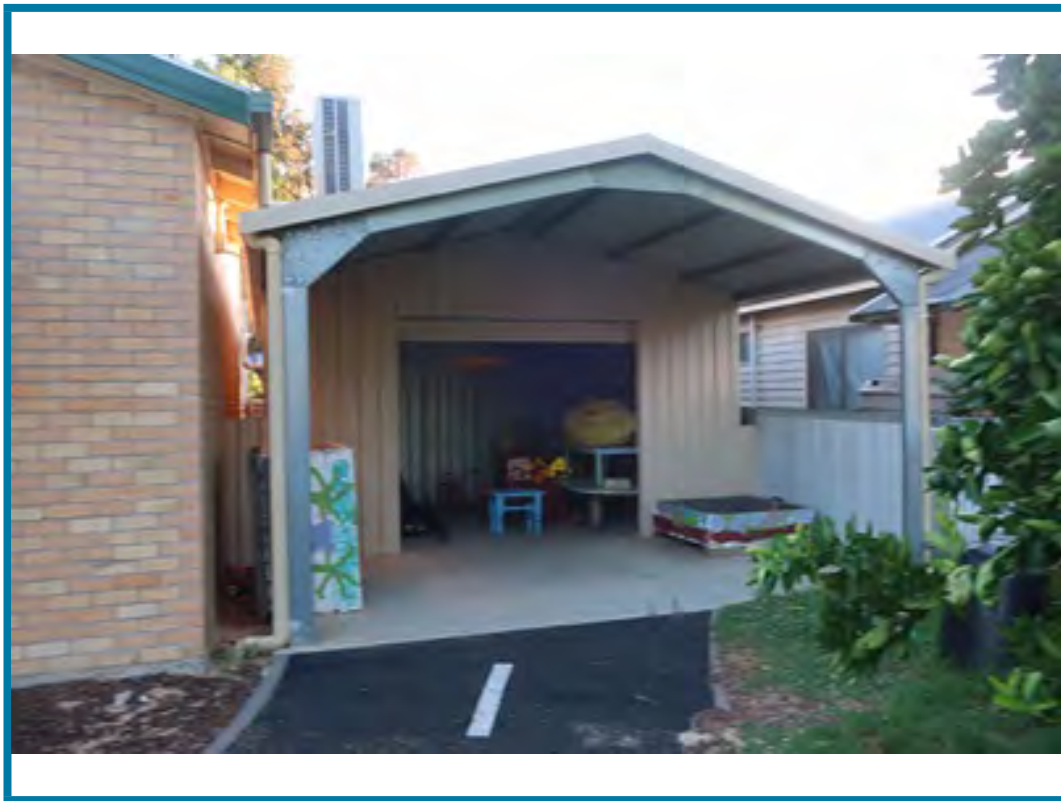
# Shed 2

Location	Area	Component Materials	ACM Identified	Type Asbestos Assessment	Condition	Priority	Signage Required
Shed 2 - entire perimeter of building.		No Asbestos Materials	No	No sample taken - Visual ID
