# Asbestos Report

YARRIAMBIACK SHIRE COUNCIL

PROPERTY ADDRESS:  
LB58D SCOUT HALL  
54 EVELYN STREET  
HOPETOUN VIC 3396

INSPECTION DATE: 27 JANUARY 2021  
REFERENCE NUMBER: 62075

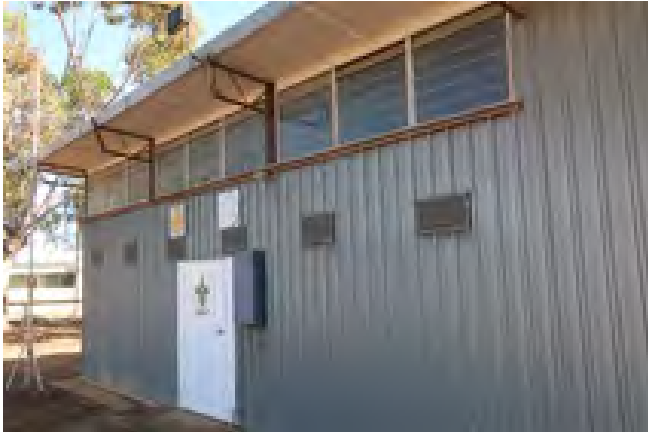
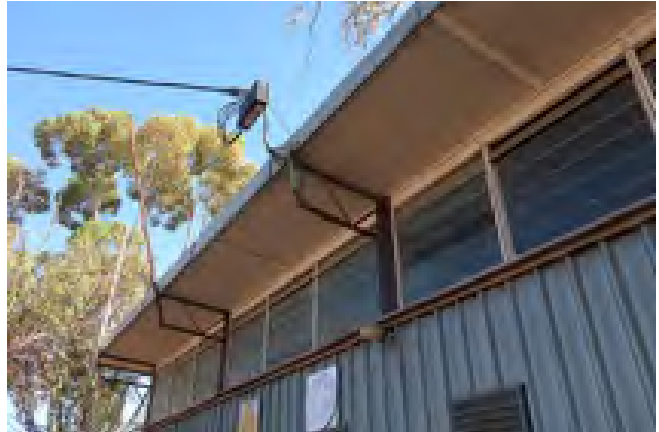
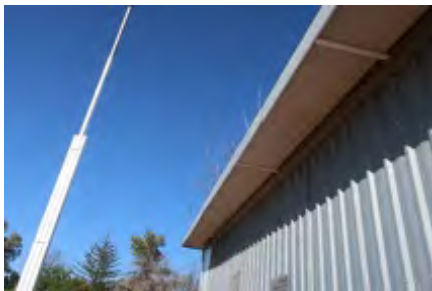
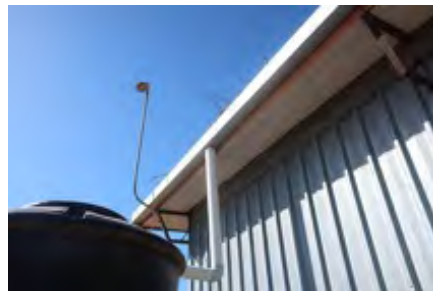
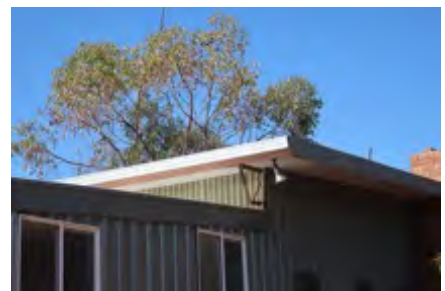
**Area 2**

**LB58D Scout Hall: entire perimeter of building. The Soffit (F C Sheeting) has Asbestos Containing Material (ACM) present.**

RISK ASSESSMENT					
Type of Asbestos or Hazardous Material	No sample taken - Visual ID	Condition	AVERAGE	Likelihood of Damage	L (Low) – possible
		Activity	Moderate		
		Sealed	No	Friability	Bonded (non-friable)
		Labelled	Y	Exposure Risk	Medium - Moderate risk
		Quantity

Priority	HIGH	Label Required	Yes	Re- Audit Date	27 Jan 2022
Action	Remedial repairs required - seal raw material / edges				
Recommendation	Raw material sheeting - The area requires immediate remedial repairs. It is recommended the asbestos material be sealed with an approved membrane.				
Legislative Requirements Victorian Regulation 2007	Damaged ACM visible in area. Requires IMMEDIATE ATTENTION. WARNING labels should be affixed. Avoid mechanical damage and abrasion. Remove if refurbishment, structural alteration or demolition is to be carried out in this area. Re-inspect every 12 months or earlier if disturbed or removed in accordance with the Victorian OH&S Regulation 2017. All remedial/removal repairs require a Clearance Inspection & Certificate to be recorded by an approved and competent assessor.

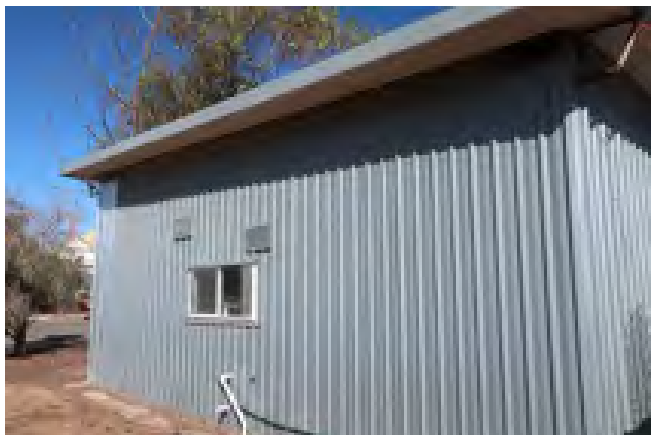
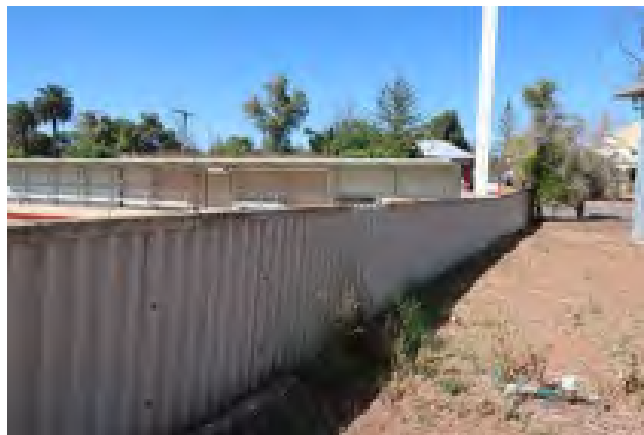
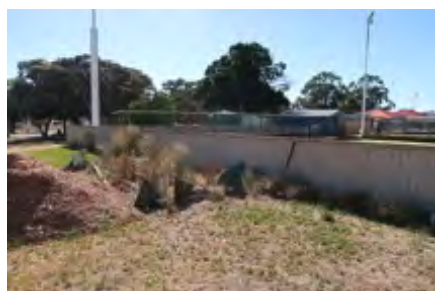
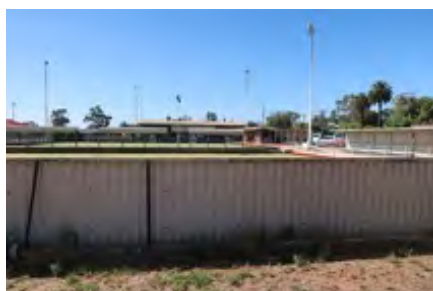
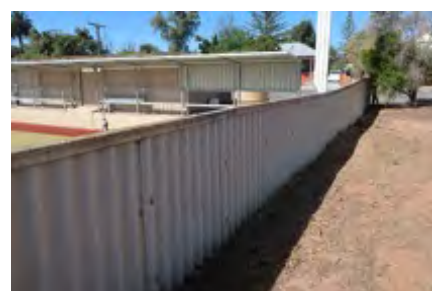
**LB58D Scout Hall: right side of building. The Fence (F C Sheeting) has Asbestos Containing Material (ACM) present.**

RISK ASSESSMENT					
Type of Asbestos or Hazardous Material	No sample taken - Visual ID	Condition	AVERAGE	Likelihood of Damage	L (Low) – possible
		Activity	Moderate		
		Sealed	No	Friability	Bonded (non-friable)
		Labelled	Y	Exposure Risk	Medium - Moderate risk
		Quantity

RISK CONTROL					
Priority	HIGH	Label Required	Yes	Re- Audit Date	27 Jan 2022
Action	Remedial repairs required - seal raw material / edges				
Recommendation	Raw material sheeting - The area requires immediate remedial repairs. It is recommended the asbestos material be sealed with an approved membrane.				
Legislative Requirements Victorian Regulation 2007	Damaged ACM visible in area. Requires IMMEDIATE ATTENTION. WARNING labels should be affixed. Avoid mechanical damage and abrasion. Remove if refurbishment, structural alteration or demolition is to be carried out in this area. Re-inspect every 12 months or earlier if disturbed or removed in accordance with the Victorian OH&S Regulation 2017. All remedial/removal repairs require a Clearance Inspection & Certificate to be recorded by an approved and competent assessor.

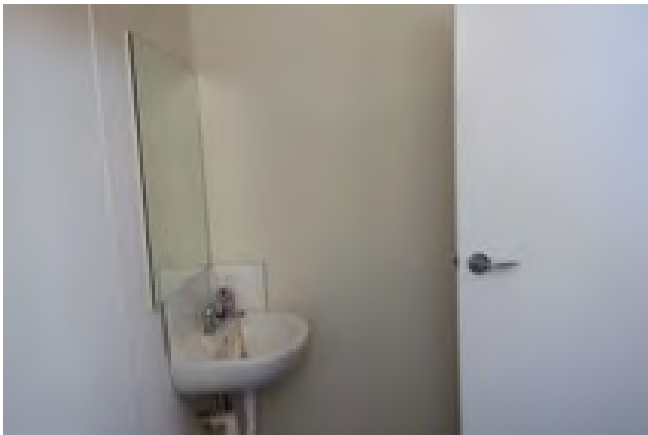
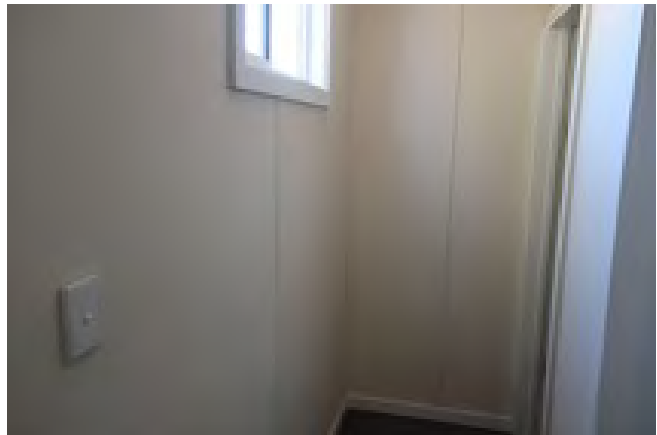
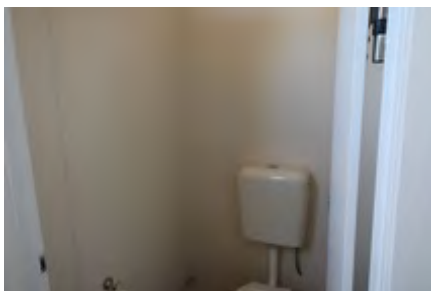
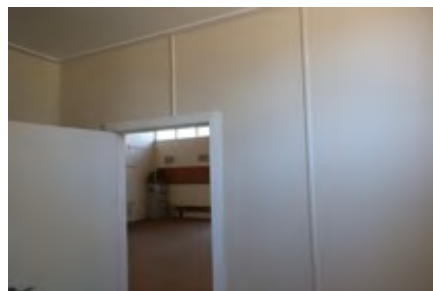
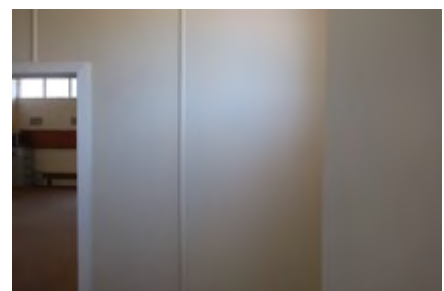
**LB58D Scout Hall: Female bathroom 2. The Walls (F C Sheeting) has Asbestos Containing Material (ACM) present.**

RISK ASSESSMENT					
Type of Asbestos or Hazardous Material	Chrysotile	Condition	GOOD	Likelihood of Damage	L (Low) – possible
	Sample taken 62075-003	Activity	Moderate		
		Sealed	Yes	Friability	Bonded (non-friable)
		Labelled	Y	Exposure Risk	Low - Negligible or low risk
		Quantity

RISK CONTROL					
Priority	MEDIUM	Label Required	Yes	Re- Audit Date	27 Jan 2022
Action	No remedial action required, unless disturbed				
Recommendation	Maintain paint or sealant to ACM surfaces. Particular attention should be given to side edges, ensure paint/sealant covers ALL exposed ACM surfaces.				
Legislative Requirements Victorian Regulation 2007	Warning labels should be affixed. Avoid mechanical damage and abrasion. Remove if refurbishment, structural alteration or demolition is to be carried out in this area. Re-inspect every 12 months or earlier if disturbed or removed in accordance with the Victorian OH&S Regulation 2017. All remedial/removal repairs require a Clearance Inspection & Certificate to be recorded by an approved and competent assessor.

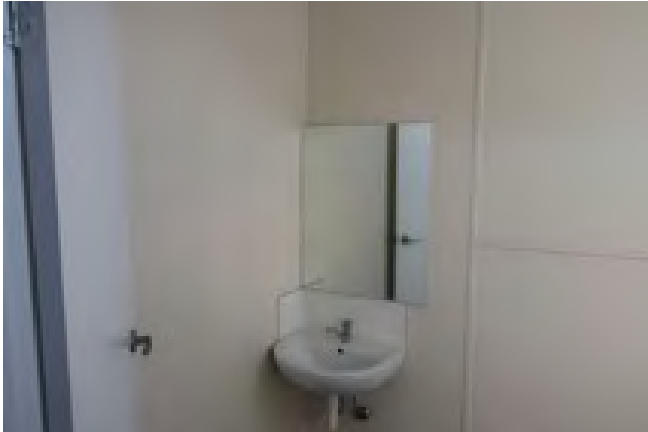
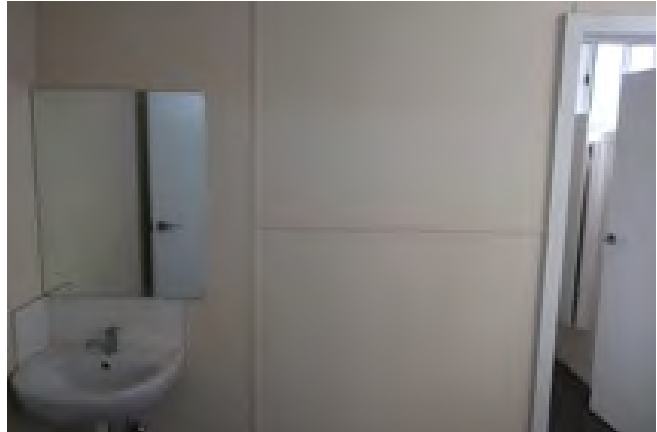
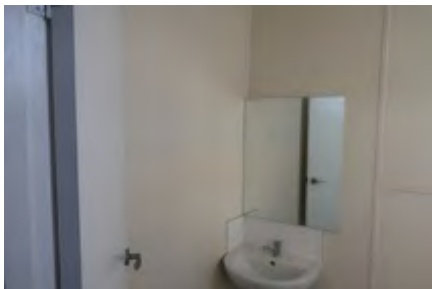
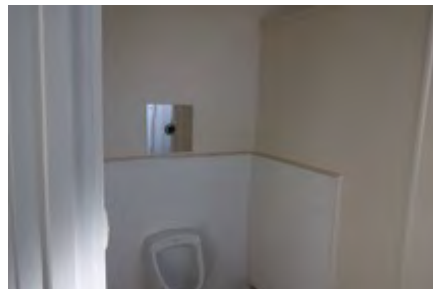
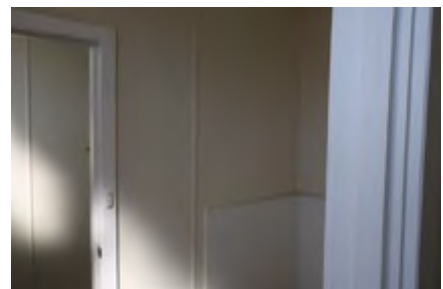
**LB58D Scout Hall: Male bathroom 3. The Walls (F C Sheeting) has Asbestos Containing Material (ACM) present.**

RISK ASSESSMENT					
Type of Asbestos or Hazardous Material	Chrysotile	Condition	GOOD	Likelihood of Damage	L (Low) – possible
	Same as Sample - 62075 -003	Activity	Moderate		
		Sealed	Yes	Friability	Bonded (non-friable)
		Labelled	Y	Exposure Risk	Low - Negligible or low risk
		Quantity

RISK CONTROL					
Priority	MEDIUM	Label Required	Yes	Re- Audit Date	27 Jan 2022
Action	No remedial action required, unless disturbed				
Recommendation	Maintain paint or sealant to ACM surfaces. Particular attention should be given to side edges, ensure paint/sealant covers ALL exposed ACM surfaces.				
Legislative Requirements Victorian Regulation 2007	Warning labels should be affixed. Avoid mechanical damage and abrasion. Remove if refurbishment, structural alteration or demolition is to be carried out in this area. Re-inspect every 12 months or earlier if disturbed or removed in accordance with the Victorian OH&S Regulation 2017. All remedial/removal repairs require a Clearance Inspection & Certificate to be recorded by an approved and competent assessor.

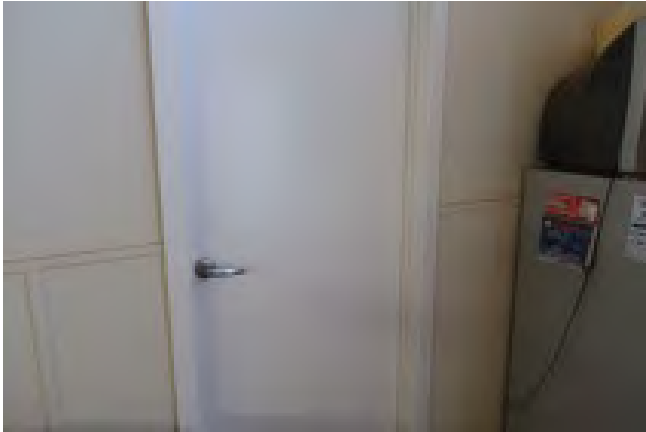
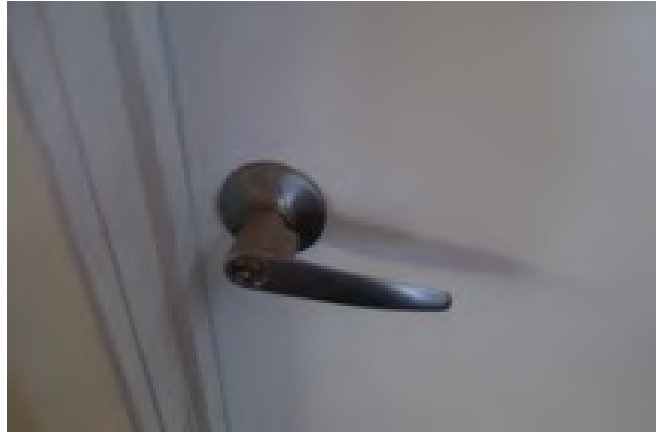
**Area 1****LB58D Scout Hall: 5. Until the area is inspected, it should be managed as if it Asbestos Containing Material (ACM) is present.****RISK ASSESSMENT**

<b>Type of Asbestos or Hazardous Material</b>	No sample taken - No Access	<b>Condition</b>		<b>Likelihood of Damage</b>	
		<b>Activity</b>			
		<b>Sealed</b>		<b>Friability</b>	
		<b>Labelled</b>	No	<b>Exposure Risk</b>	
		<b>Quantity</b>

<b>Priority</b>	HIGH	<b>Label Required</b>	Yes	<b>Re- Audit Date</b>	27 Jan 2022
<b>Action</b>					
<b>Recommendation</b>					
<b>Legislative Requirements Victorian Regulation 2007</b>	Unable to Gain Access. Assume asbestos in area and provide monitoring if work undertaken in these areas. If access is made available, contact Global Asbestos Audits for re-inspection
