Asbestos Report

YARRIAMBIACK SHIRE COUNCIL

PROPERTY ADDRESS:
LB90 SENIOR CITIZENS
20 Dennys Street
HOPETOUN VIC 3396

Inspection Date: 27 January 2021
Reference Number: 62076

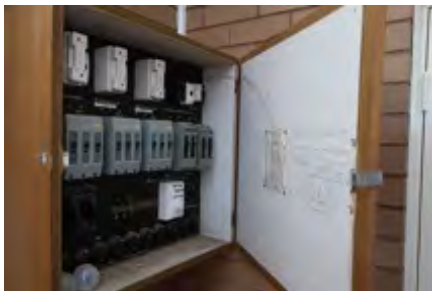
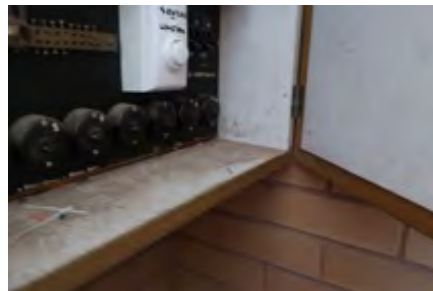
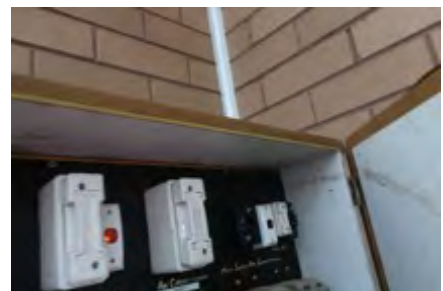
LB90 Senior Citizens: Entry/ walkway 1. The Electrical Cabinet - lining (F C Sheeting) has Asbestos Containing Material (ACM) present.

RISK ASSESSMENT					
Type of Asbestos or Hazardous Material	No sample taken - Visual ID	Condition	AVERAGE	Likelihood of Damage	L (Low) – possible
		Activity	Moderate		
		Sealed	No	Friability	Bonded (non-friable)
		Labelled	Y	Exposure Risk	Medium - Moderate risk
		Quantity

Raw Material

RISK CONTROL					
Priority	HIGH	Label Required	Yes	Re- Audit Date	27 Jan 2022
Action	Remedial repairs required - seal raw material / edges				
Recommendation	Raw material sheeting - The area requires immediate remedial repairs. It is recommended the asbestos material be sealed with an approved membrane.				
Legislative Requirements Victorian Regulation 2007	Damaged ACM visible in area. Requires IMMEDIATE ATTENTION. WARNING labels should be affixed. Avoid mechanical damage and abrasion. Remove if refurbishment, structural alteration or demolition is to be carried out in this area. Re-inspect every 12 months or earlier if disturbed or removed in accordance with the Victorian OH&S Regulation 2017. All remedial/removal repairs require a Clearance Inspection & Certificate to be recorded by an approved and competent assessor.

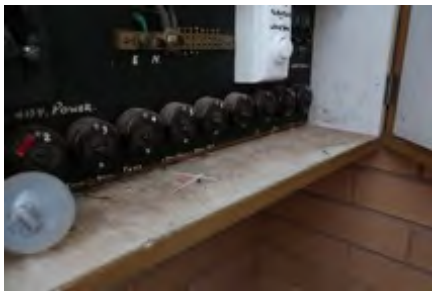
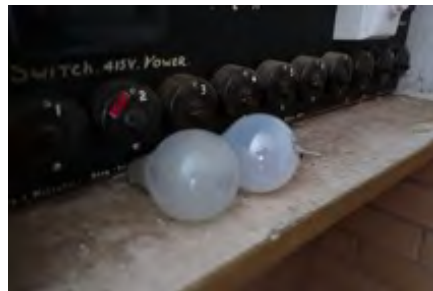
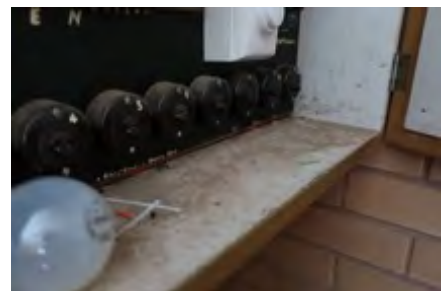
LB90 Senior Citizens: Entry/ walkway 1. The Electrical Cabinet (Debris) has Asbestos Containing Material (ACM) present.

RISK ASSESSMENT					
Type of Asbestos or Hazardous Material	Chrysotile	Condition	POOR	Likelihood of Damage	H (High) - almost certain
	Sample taken 62076-001	Activity	Low		
		Sealed	No	Friability	Exposed Fibres
		Labelled	Y	Exposure Risk	High - Short term exposure risk
		Quantity

Debris on Surface

Priority	IMMEDIATE	Label Required	Yes	Re- Audit Date	27 Jan 2022
Action	Restrict access and target for imminent removal				
Recommendation	Airmonitoring is required. Debris on Surface - The Debris requires immediate cleanup and disposal with specialised equipment and with licensed removalist to safely remove the asbestos debris.				
Legislative Requirements Victorian Regulation 2007	ACM debris visible. Recommend cleanup by licensed Asbestos Removalist. Warning labels should be affixed. Avoid mechanical damage and abrasion. Remove if refurbishment, structural alteration or demolition is to be carried out in this area. Re-inspect every 12 months or earlier if disturbed or removed in accordance with the Victorian OH&S Regulation 2017. All remedial/removal repairs require a Clearance Inspection & Certificate to be recorded by an approved and competent assessor.

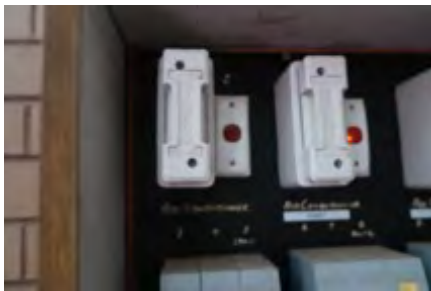
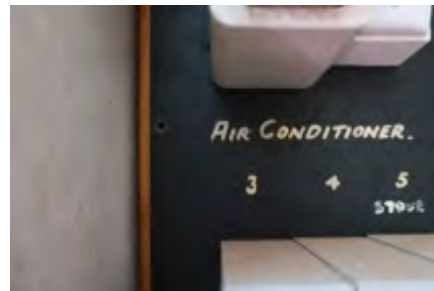
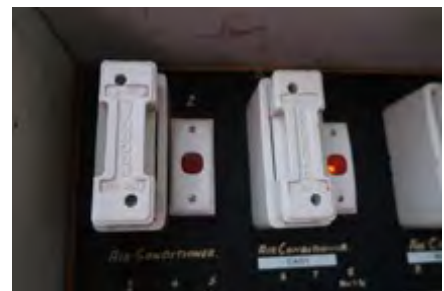
LB90 Senior Citizens: Entry/ walkway 1. The A: Electrical board; B: Ceramic Fuses (A: Zelemite; B: Cloth Inserts) has Asbestos Containing Material (ACM) present.

RISK ASSESSMENT					
Type of Asbestos or Hazardous Material	Chrysotile	Condition	AVERAGE	Likelihood of Damage	L (Low) – possible
	Sample taken 62076-002 (Zelemite)	Activity	Moderate	Friability	Exposed Fibres
		Sealed	Yes	Exposure Risk	Medium - Moderate risk
		Labelled	Y		
		Quantity

Penetration Holes

Priority	HIGH	Label Required	Yes	Re- Audit Date	27 Jan 2022
Action	Remedial repairs required - seal raw material / edges				
Recommendation	Penetration Holes - The exposed edges require approved sealant. It is further recommended the gaps be filled with sealant. Do not remove the fuses without asbestos controls - test for cloth inserts				
Legislative Requirements Victorian Regulation 2007	Damaged ACM visible in area. Requires IMMEDIATE ATTENTION. WARNING labels should be affixed. Avoid mechanical damage and abrasion. Remove if refurbishment, structural alteration or demolition is to be carried out in this area. Re-inspect every 12 months or earlier if disturbed or removed in accordance with the Victorian OH&S Regulation 2017. All remedial/removal repairs require a Clearance Inspection & Certificate to be recorded by an approved and competent assessor.

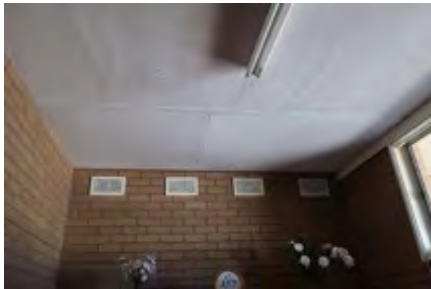
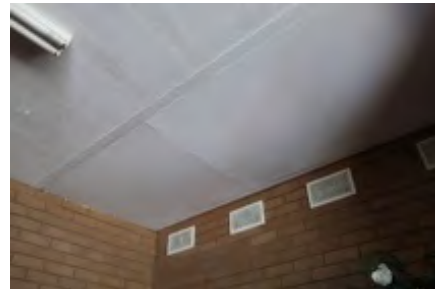
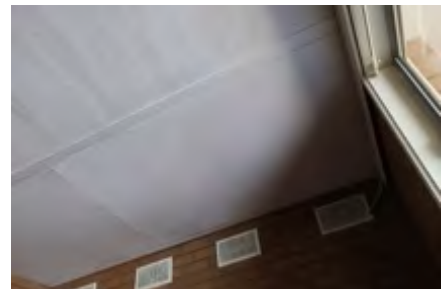
Area 4**LB90 Senior Citizens: Entry/ walkway 1. The Ceiling panels (F C Sheeting) has Asbestos Containing Material (ACM) present.****RISK ASSESSMENT**

Type of Asbestos or Hazardous Material	No sample taken - Visual ID	Condition	GOOD	Likelihood of Damage	L (Low) – possible
		Activity	Moderate		
		Sealed	Yes	Friability	Bonded (non-friable)
		Labelled	Y	Exposure Risk	Low - Negligible or low risk
		Quantity

Priority	MEDIUM	Label Required	Yes	Re- Audit Date	27 Jan 2022
Action	No remedial action required, unless disturbed				
Recommendation	Maintain paint or sealant to ACM surfaces. Particular attention should be given to side edges, ensure paint/sealant covers ALL exposed ACM surfaces.				
Legislative Requirements Victorian Regulation 2007	Warning labels should be affixed. Avoid mechanical damage and abrasion. Remove if refurbishment, structural alteration or demolition is to be carried out in this area. Re-inspect every 12 months or earlier if disturbed or removed in accordance with the Victorian OH&S Regulation 2017. All remedial/removal repairs require a Clearance Inspection & Certificate to be recorded by an approved and competent assessor.
