# Asbestos Report

YARRIAMBIACK SHIRE COUNCIL

PROPERTY ADDRESS:  
LB82 SHIRE DEPOT  
68 HOPETOUN AERODROME ROAD  
HOPETOUN VIC 3396

INSPECTION DATE: 27 JANUARY 2021  
REFERENCE NUMBER: 62077

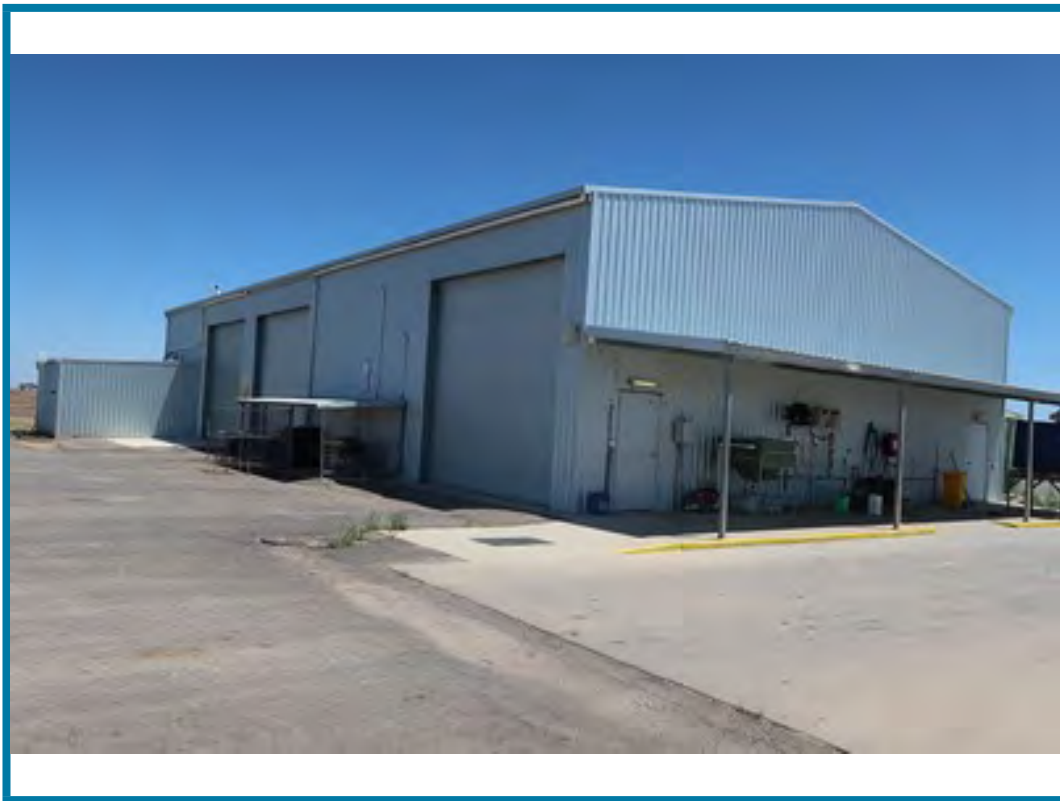
# 1 - Workshop

Location	Area	Component Materials	ACM Identified	Type Asbestos Assessment	ConditionPriority	Signage Required
1 - Workshop - entire perimeter of building.		No Asbestos Materials	No	No sample taken - Visual ID

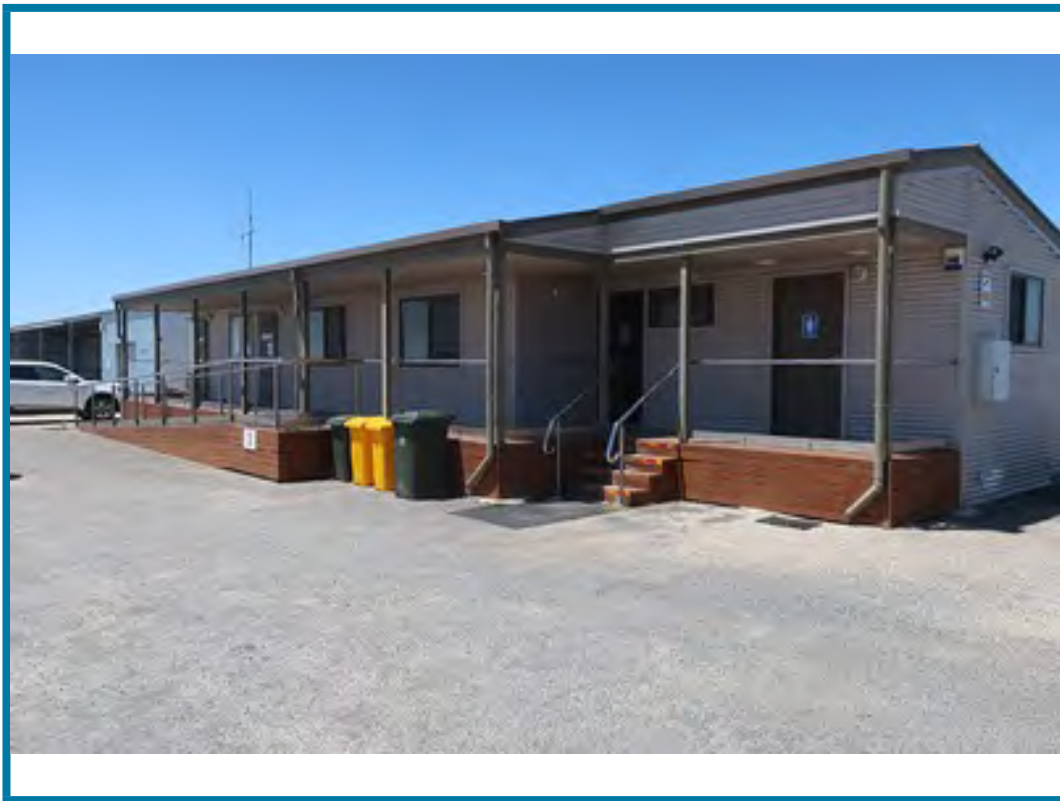
## 3 - Office Block

Location	Area	Component Materials	ACM Identified	Type Asbestos Assessment	ConditionPriority	Signage Required
3 - Office Block - entire perimeter of building.		No Asbestos Materials	No	No sample taken - Visual ID

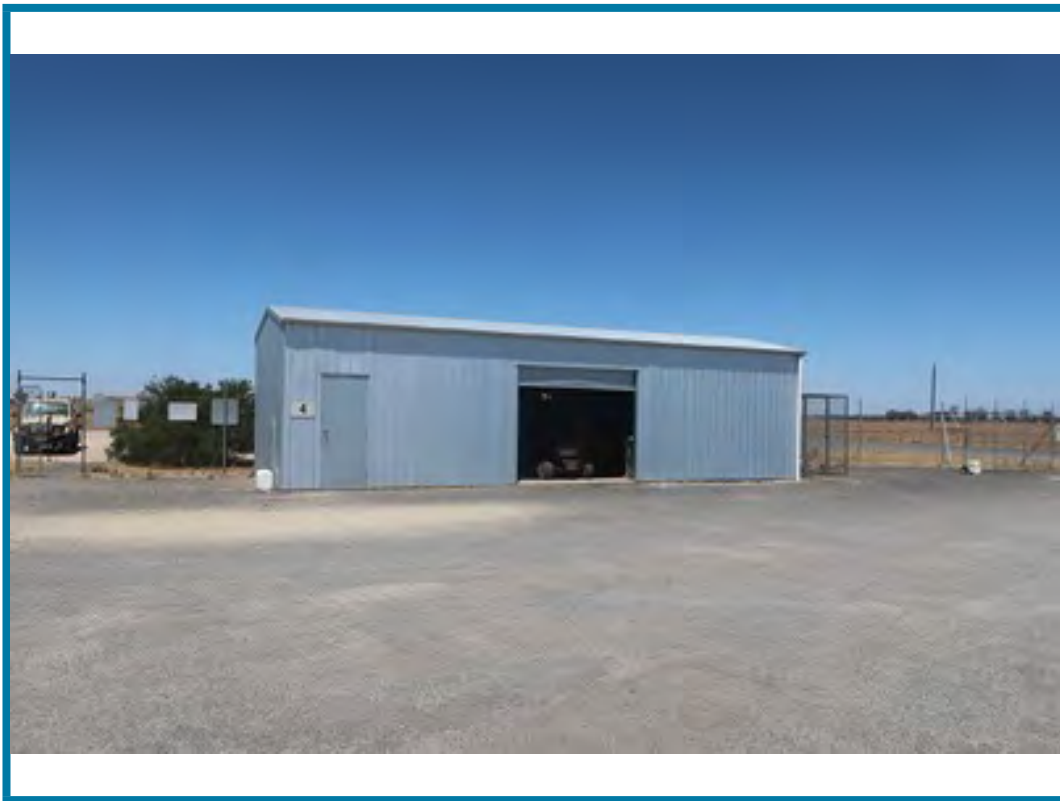
## 4 - Shed

Location	Area	Component Materials	ACM Identified	Type Asbestos Assessment	ConditionPriority	Signage Required
4 - Shed - entire perimeter of building.		No Asbestos Materials	No	No sample taken - Visual ID

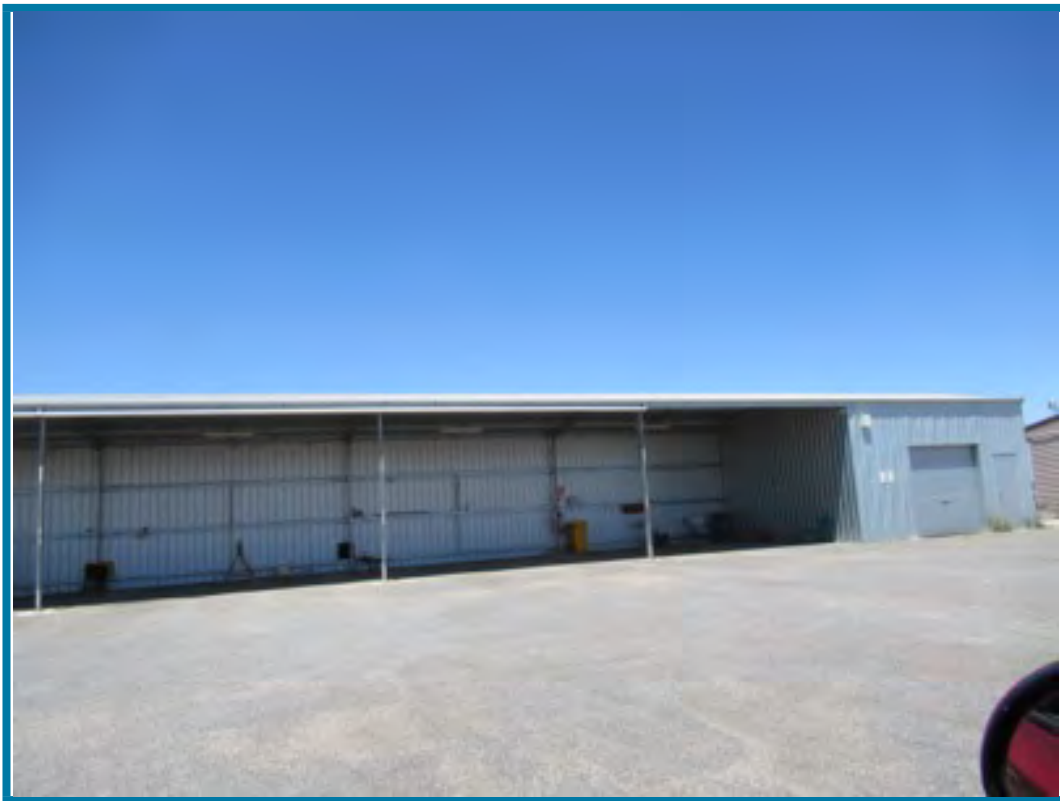
# Car Shed

Location	Area	Component Materials	ACM Identified	Type Asbestos Assessment	ConditionPriority	Signage Required
Car Shed - entire perimeter of building.		No Asbestos Materials	No	No sample taken - Visual ID

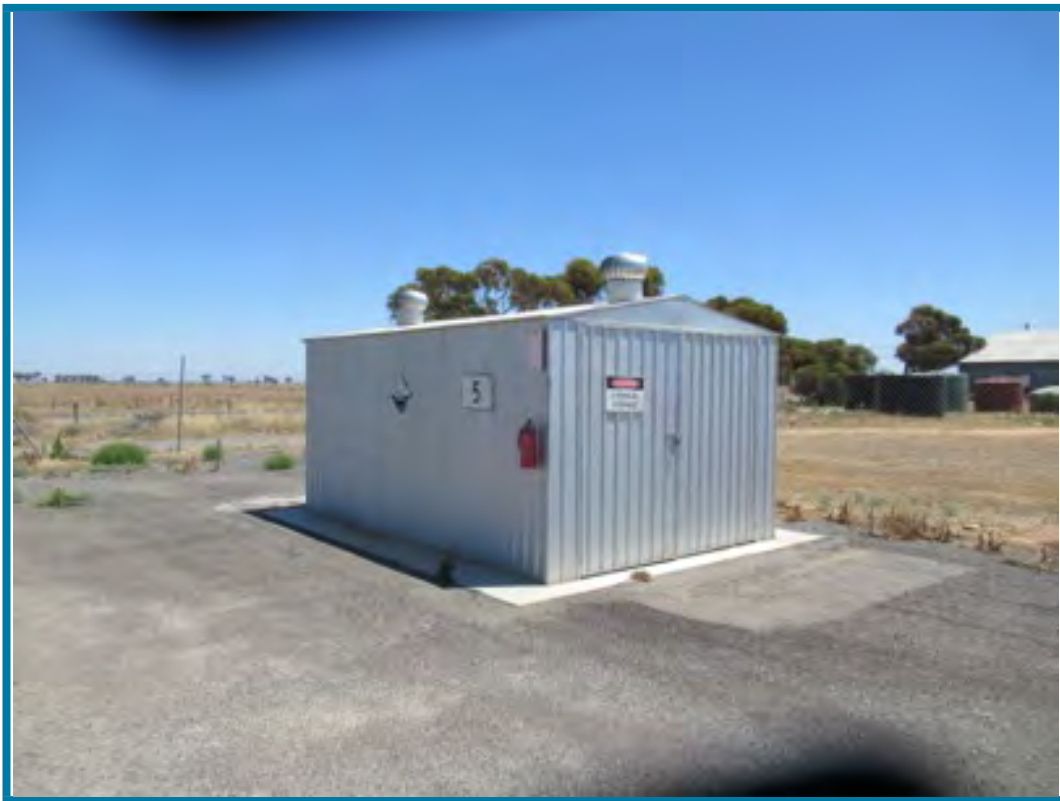
# Chemical store shed

Location	Area	Component Materials	ACM Identified	Type Asbestos Assessment	ConditionPriority	Signage Required
Chemical store shed - entire perimeter of building.		No Asbestos Materials	No	No sample taken - Visual ID

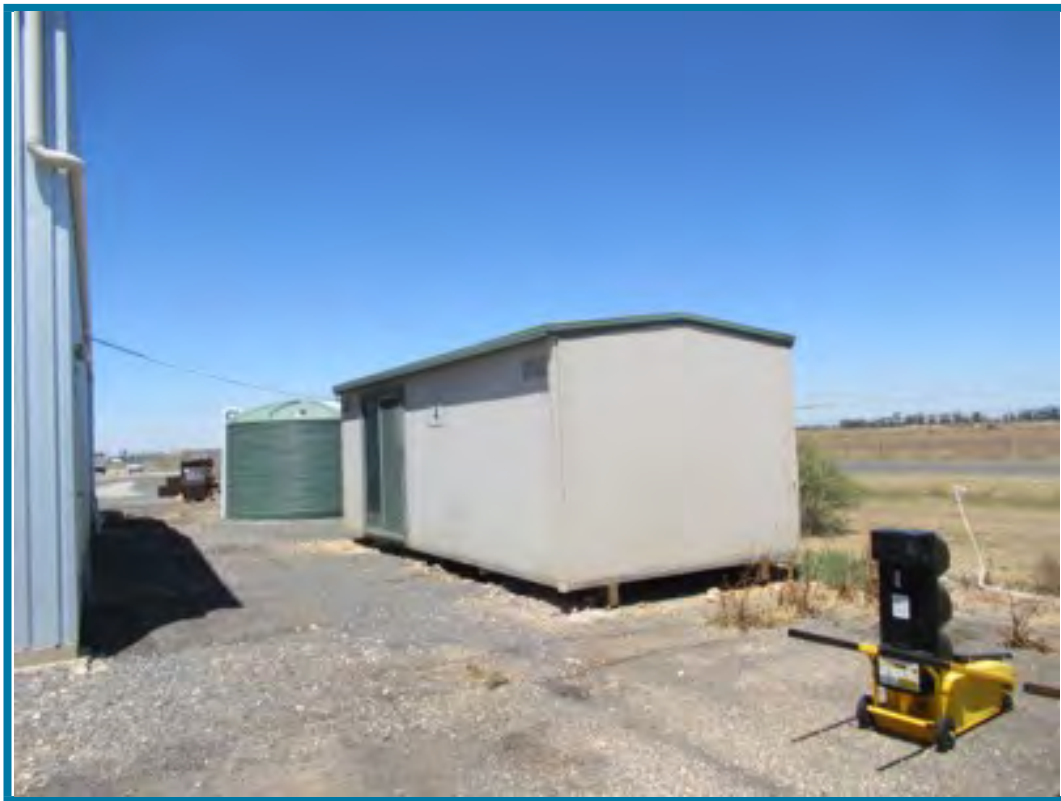
# Demountable office

Location	Area	Component Materials	ACM Identified	Type Asbestos Assessment	ConditionPriority	Signage Required
Demountable office - entire perimeter of building.		No Asbestos Materials	No	No sample taken - Visual ID

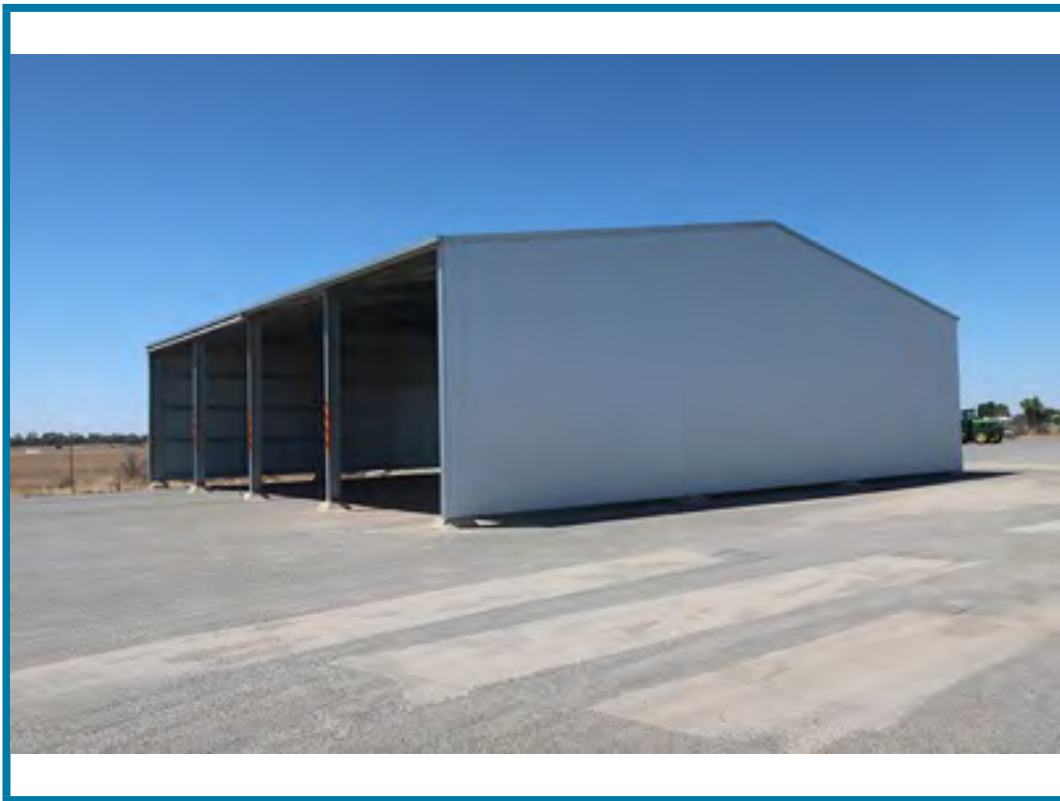
# Shed

Location	Area	Component Materials	ACM Identified	Type Asbestos Assessment	ConditionPriority	Signage Required
Shed - entire perimeter of building.		No Asbestos Materials	No	No sample taken - Visual ID
