Asbestos Report

YARRIAMBIACK SHIRE COUNCIL

**PROPERTY ADDRESS:
LB58A SWIMMING POOL
4 AUSTIN STREET AND 54 EVELYN STREET
HOPETOUN VIC 3396**

**INSPECTION DATE: 27 JANUARY 2021
REFERENCE NUMBER: 62080**

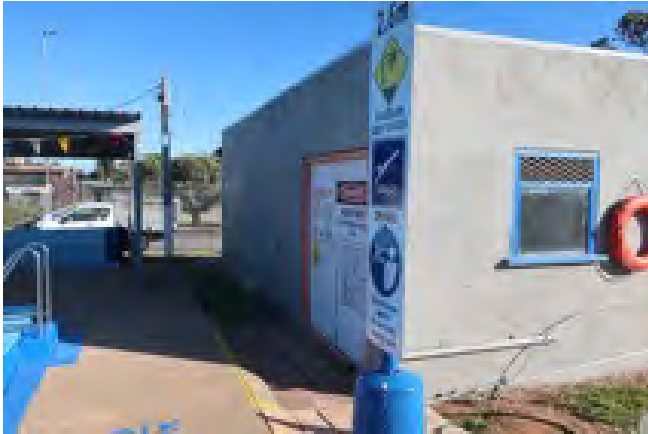
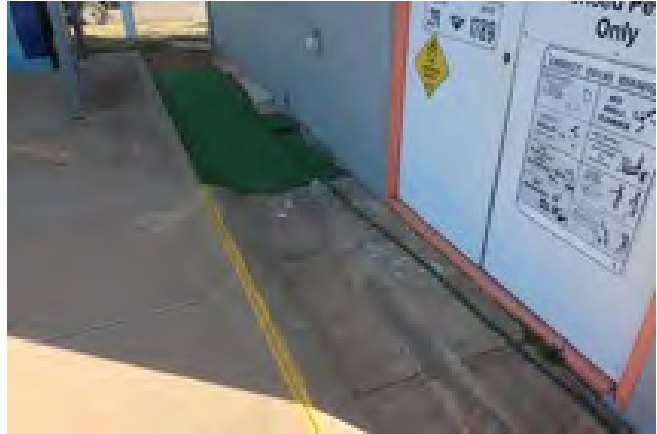
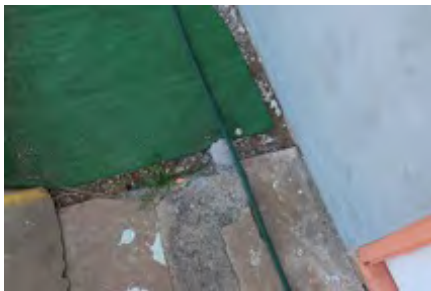
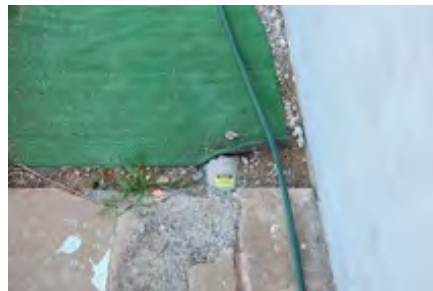
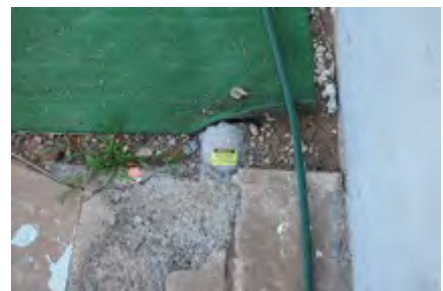
Area 1

Pump house: right side of building. The Pipe(s) (F C Sheeting) has Asbestos Containing Material (ACM) present.

RISK ASSESSMENT					
Type of Asbestos or Hazardous Material	Chrysotile Amosite Crocidolite Sample taken 62080-004	Condition	AVERAGE	Likelihood of Damage	L (Low) – possible
		Activity	Low		
		Sealed	No	Friability	Bonded (non-friable)
		Labelled	Y	Exposure Risk	Medium - Moderate risk
		Quantity

Raw Material

Raw material sheeting - The area requires immediate remedial repairs. It is recommended the asbestos material be sealed with an approved membrane.

RISK CONTROL					
Priority	HIGH	Label Required	Yes	Re- Audit Date	27 Jan 2022
Action	Remedial repairs required - seal raw material / edges				
Recommendation	Raw material sheeting - The area requires immediate remedial repairs. It is recommended the asbestos material be sealed with an approved membrane.				
Legislative Requirements Victorian Regulation 2007	Damaged ACM visible in area. Requires IMMEDIATE ATTENTION. WARNING labels should be affixed. Avoid mechanical damage and abrasion. Remove if refurbishment, structural alteration or demolition is to be carried out in this area. Re-inspect every 12 months or earlier if disturbed or removed in accordance with the Victorian OH&S Regulation 2017. All remedial/removal repairs require a Clearance Inspection & Certificate to be recorded by an approved and competent assessor.

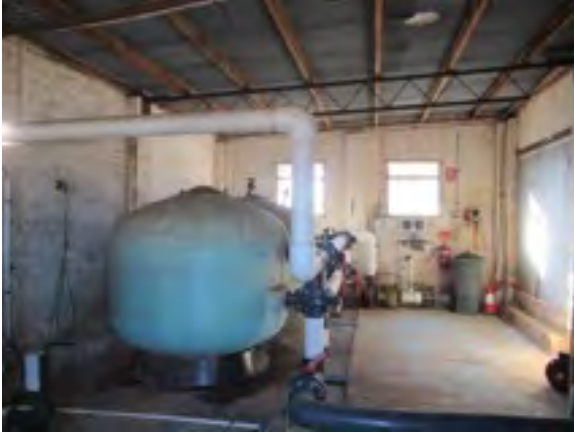
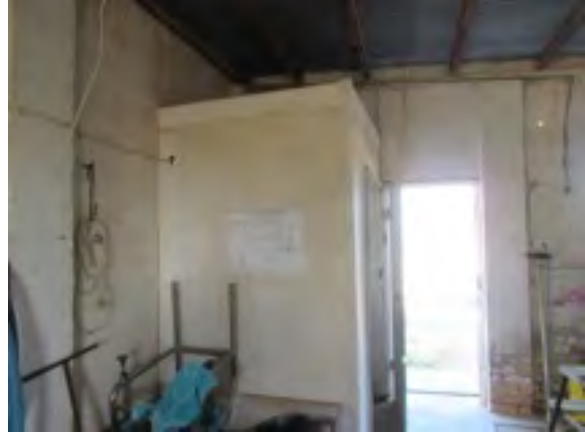
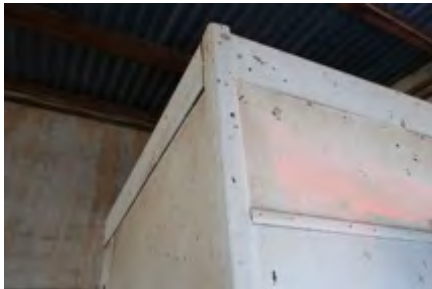
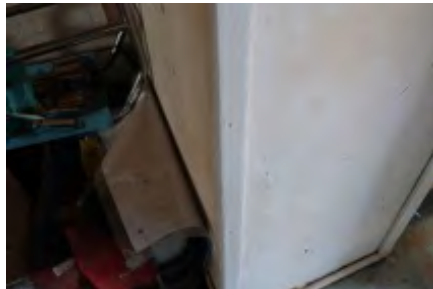
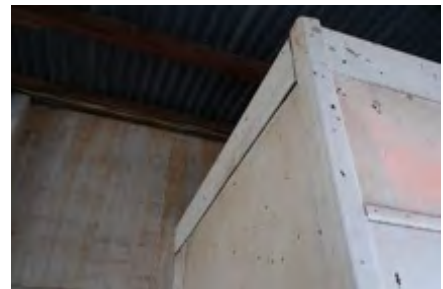
Pump house: Pump house. The Wall - Joiner strips & upper panels (Fibrous Cement Product) has Asbestos Containing Material (ACM) present.

RISK ASSESSMENT					
Type of Asbestos or Hazardous Material	No sample taken - Visual ID	Condition	GOOD	Likelihood of Damage	L (Low) – possible
		Activity	Moderate		
		Sealed	Yes	Friability	Bonded (non-friable)
		Labelled	Y	Exposure Risk	Low - Negligible or low risk
		Quantity

RISK CONTROL					
Priority	MEDIUM	Label Required	Yes	Re- Audit Date	27 Jan 2022
Action	No remedial action required, unless disturbed				
Recommendation	Maintain paint or sealant to ACM surfaces. Particular attention should be given to side edges, ensure paint/sealant covers ALL exposed ACM surfaces.				
Legislative Requirements Victorian Regulation 2007	Warning labels should be affixed. Avoid mechanical damage and abrasion. Remove if refurbishment, structural alteration or demolition is to be carried out in this area. Re-inspect every 12 months or earlier if disturbed or removed in accordance with the Victorian OH&S Regulation 2017. All remedial/removal repairs require a Clearance Inspection & Certificate to be recorded by an approved and competent assessor.

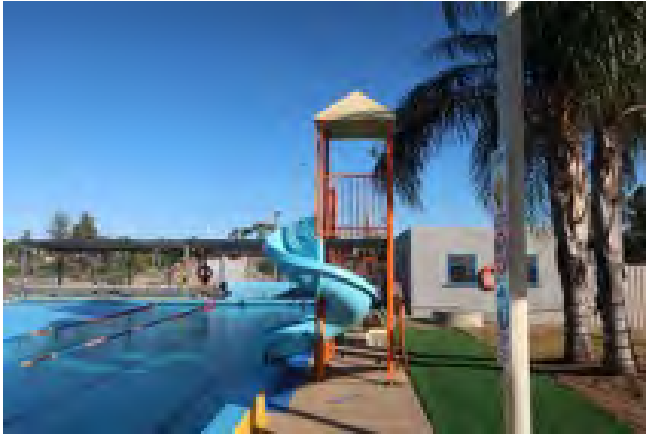
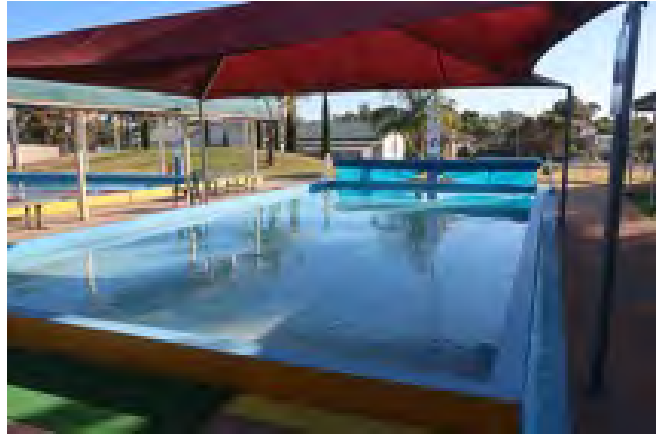
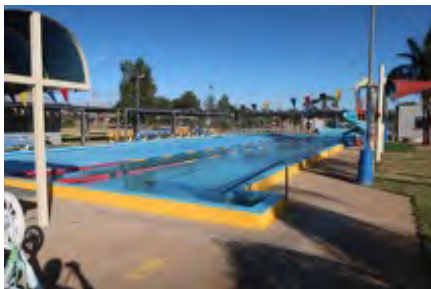
Area 4**Swimming pool slide: Swimming pool slide. The Membrane lining (Marble sheen) has Asbestos Containing Material (ACM) present.****RISK ASSESSMENT**

Type of Asbestos or Hazardous Material	No sample taken - Visual ID	Condition	GOOD	Likelihood of Damage	L (Low) – possible
		Activity	Moderate		
		Sealed	Yes	Friability	Bonded (non-friable)
		Labelled	No	Exposure Risk	Low - Negligible or low risk
		Quantity

Priority	MEDIUM	Label Required	No	Re- Audit Date	27 Jan 2022
Action	No remedial action required, unless disturbed				
Recommendation	Maintain paint or sealant to ACM surfaces. Particular attention should be given to side edges, ensure paint/sealant covers ALL exposed ACM surfaces. Test membrane - Marble sheen				
Legislative Requirements Victorian Regulation 2007	Warning labels should be affixed. Avoid mechanical damage and abrasion. Remove if refurbishment, structural alteration or demolition is to be carried out in this area. Re-inspect every 12 months or earlier if disturbed or removed in accordance with the Victorian OH&S Regulation 2017. All remedial/removal repairs require a Clearance Inspection & Certificate to be recorded by an approved and competent assessor.

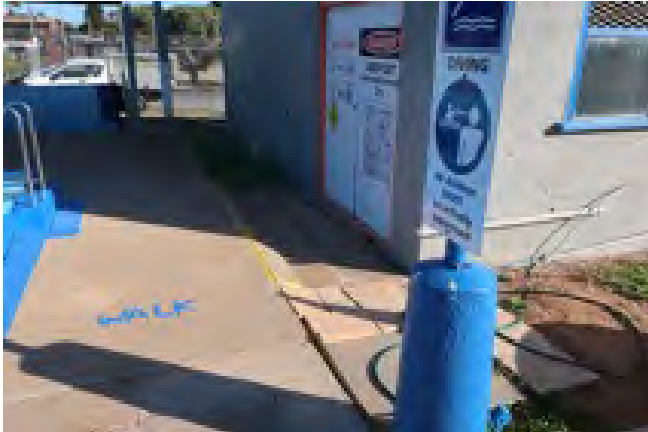
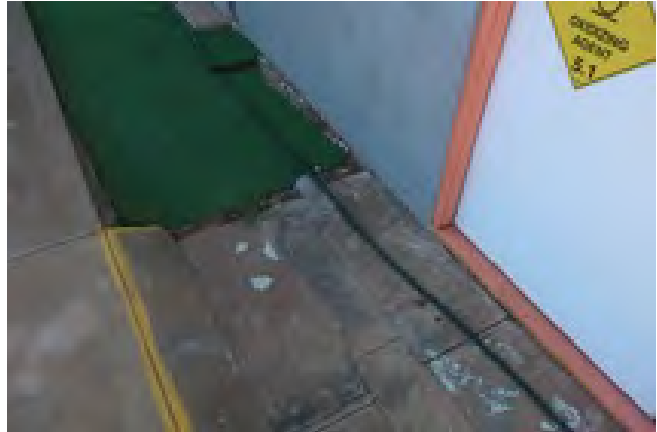
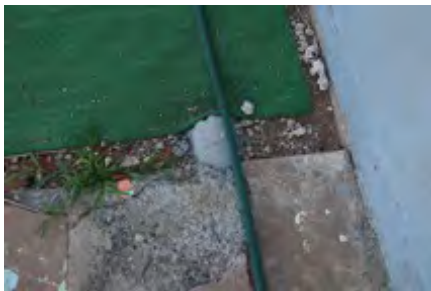
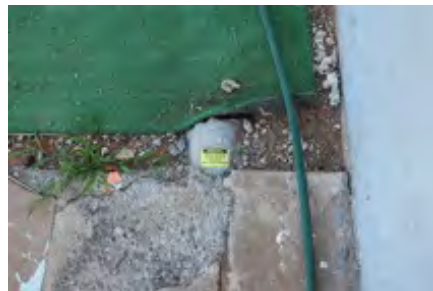
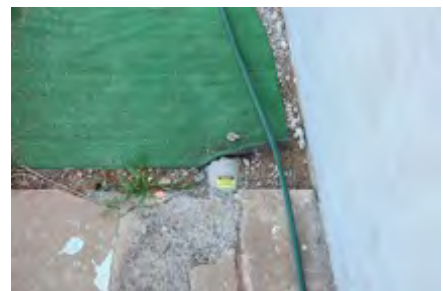
Area 2

General: Underground. The Pipe(s) (F C Sheeting) has Asbestos Containing Material (ACM) present.

RISK ASSESSMENT					
Type of Asbestos or Hazardous Material	Chrysotile Amosite Crocidolite Same as Sample - 62080 -004	Condition	GOOD	Likelihood of Damage	L (Low) – possible
		Activity	Low		
		Sealed	Yes	Friability	Bonded (non-friable)
		Labelled	Y	Exposure Risk	Low - Negligible or low risk
		Quantity

RISK CONTROL					
Priority	MEDIUM	Label Required	Yes	Re- Audit Date	27 Jan 2022
Action	No remedial action required, unless disturbed				
Recommendation	Maintain paint or sealant to ACM surfaces. Particular attention should be given to side edges, ensure paint/sealant covers ALL exposed ACM surfaces.				
Legislative Requirements Victorian Regulation 2007	Warning labels should be affixed. Avoid mechanical damage and abrasion. Remove if refurbishment, structural alteration or demolition is to be carried out in this area. Re-inspect every 12 months or earlier if disturbed or removed in accordance with the Victorian OH&S Regulation 2017. All remedial/removal repairs require a Clearance Inspection & Certificate to be recorded by an approved and competent assessor.
