Asbestos Report

YARRIAMBIACK SHIRE COUNCIL

PROPERTY ADDRESS:
LB58C TENNIS COURT CLUBROOMS
4 AUSTIN STREET
HOPETOUN VIC 3396

INSPECTION DATE: 27 JANUARY 2021
REFERENCE NUMBER: 62082

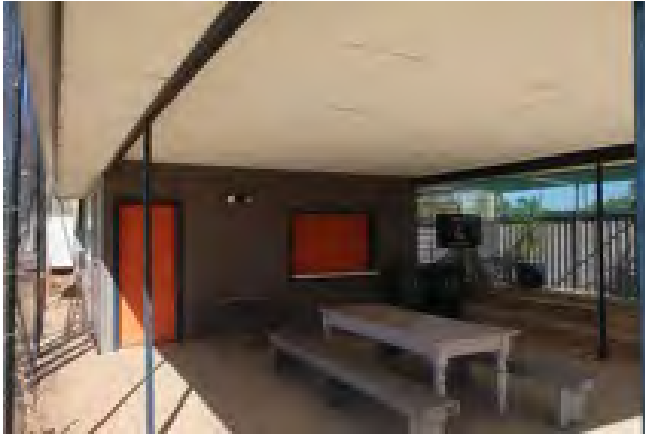
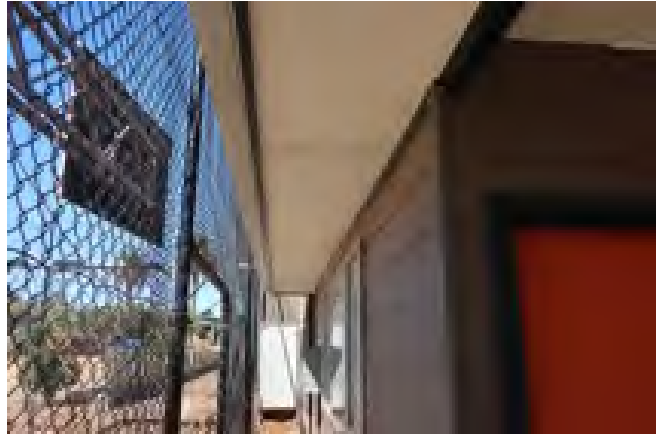
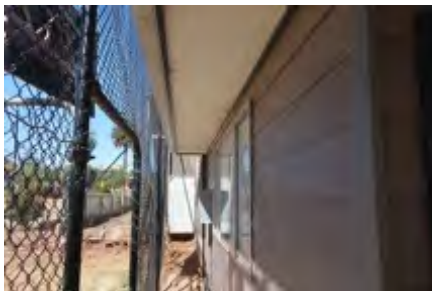
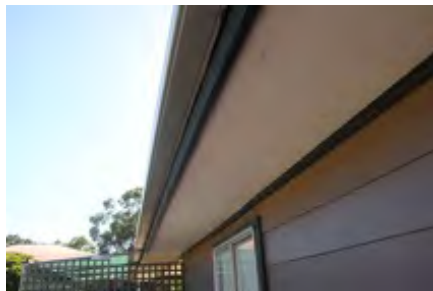
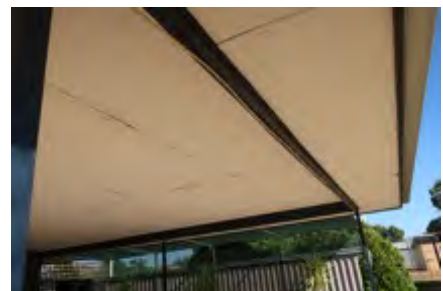
Area 4

Clubrooms LB58C Tennis Court Clubrooms: entire perimeter of building. The Soffit & Ceiling (F C Sheeting) has Asbestos Containing Material (ACM) present.

RISK ASSESSMENT					
Type of Asbestos or Hazardous Material	Chrysotile	Condition	GOOD	Likelihood of Damage	L (Low) – possible
	Sample taken 62082-001	Activity	Moderate		
		Sealed	Yes	Friability	Bonded (non-friable)
		Labelled	Y	Exposure Risk	Low - Negligible or low risk
		Quantity

Maintain paint or sealant

RISK CONTROL					
Priority	MEDIUM	Label Required	Yes	Re- Audit Date	27 Jan 2022
Action	No remedial action required, unless disturbed				
Recommendation	Maintain paint or sealant to ACM surfaces. Particular attention should be given to side edges, ensure paint/sealant covers ALL exposed ACM surfaces.				
Legislative Requirements Victorian Regulation 2007	Warning labels should be affixed. Avoid mechanical damage and abrasion. Remove if refurbishment, structural alteration or demolition is to be carried out in this area. Re-inspect every 12 months or earlier if disturbed or removed in accordance with the Victorian OH&S Regulation 2017. All remedial/removal repairs require a Clearance Inspection & Certificate to be recorded by an approved and competent assessor.

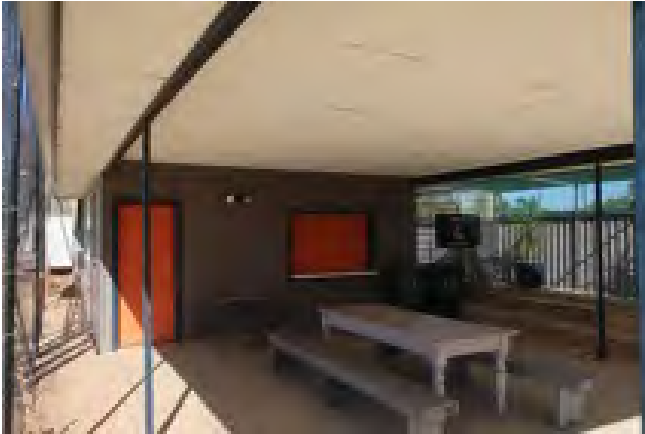
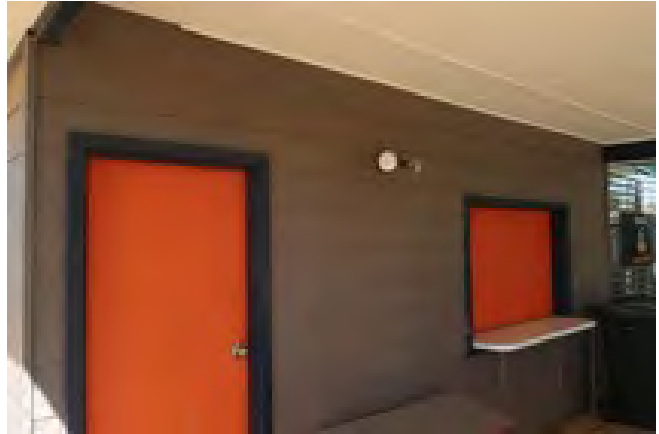
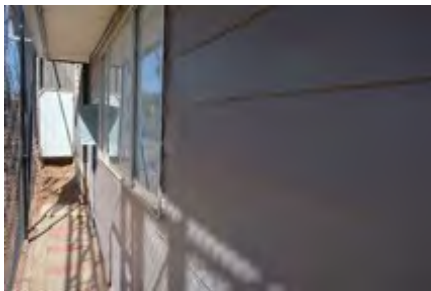
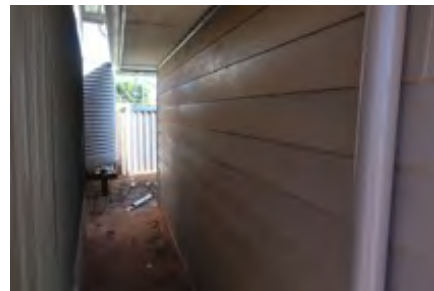
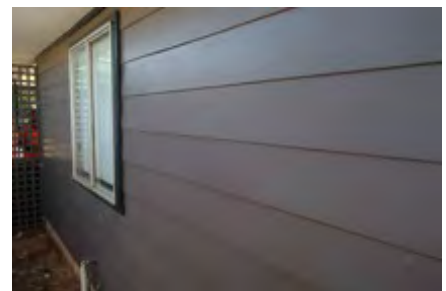
Clubrooms LB58C Tennis Court Clubrooms: entire perimeter of building. The Wall - planking (F C Sheeting) has Asbestos Containing Material (ACM) present.

RISK ASSESSMENT					
Type of Asbestos or Hazardous Material	Chrysotile	Condition	GOOD	Likelihood of Damage	L (Low) – possible
	Sample taken 62082-002	Activity	Moderate		
		Sealed	Yes	Friability	Bonded (non-friable)
		Labelled	No	Exposure Risk	Low - Negligible or low risk
		Quantity

Maintain paint or sealant

Priority	MEDIUM	Label Required	Yes	Re- Audit Date	27 Jan 2022
Action	No remedial action required, unless disturbed				
Recommendation	Maintain paint or sealant to ACM surfaces. Particular attention should be given to side edges, ensure paint/sealant covers ALL exposed ACM surfaces.				
Legislative Requirements Victorian Regulation 2007	Warning labels should be affixed. Avoid mechanical damage and abrasion. Remove if refurbishment, structural alteration or demolition is to be carried out in this area. Re-inspect every 12 months or earlier if disturbed or removed in accordance with the Victorian OH&S Regulation 2017. All remedial/removal repairs require a Clearance Inspection & Certificate to be recorded by an approved and competent assessor.

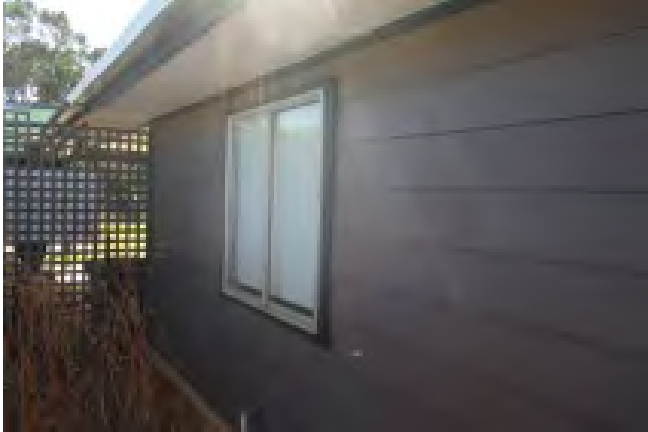
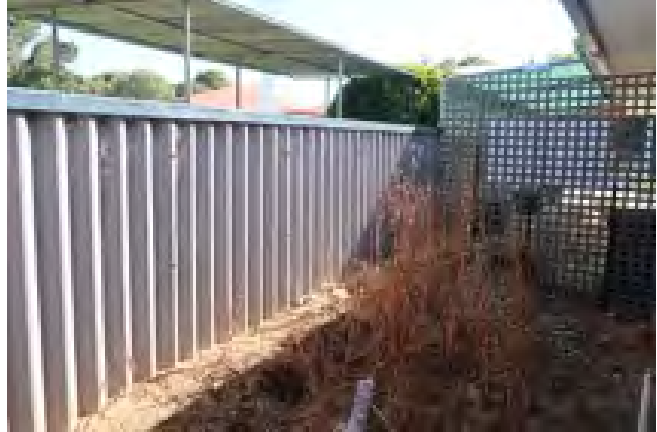
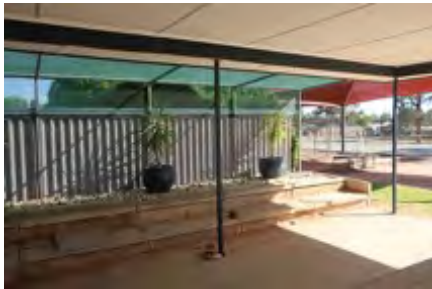
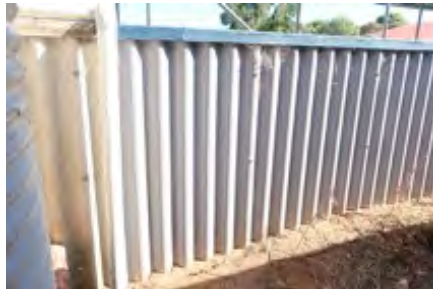
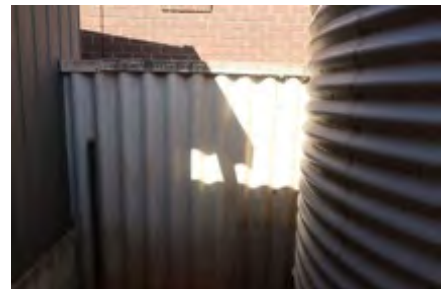
Clubrooms LB58C Tennis Court Clubrooms: right side of building. The Fence (Fibrous Cement Product) has Asbestos Containing Material (ACM) present.

RISK ASSESSMENT					
Type of Asbestos or Hazardous Material	No sample taken - Visual ID	Condition	AVERAGE	Likelihood of Damage	L (Low) – possible
		Activity	Moderate		
		Sealed	No	Friability	Bonded (non-friable)
		Labelled	Y	Exposure Risk	Medium - Moderate risk
		Quantity

Raw Material

RISK CONTROL					
Priority	HIGH	Label Required	Yes	Re- Audit Date	27 Jan 2022
Action	Remedial repairs required - seal raw material / edges				
Recommendation	Raw material sheeting - The area requires immediate remedial repairs. It is recommended the asbestos material be sealed with an approved membrane.				
Legislative Requirements Victorian Regulation 2007	Damaged ACM visible in area. Requires IMMEDIATE ATTENTION. WARNING labels should be affixed. Avoid mechanical damage and abrasion. Remove if refurbishment, structural alteration or demolition is to be carried out in this area. Re-inspect every 12 months or earlier if disturbed or removed in accordance with the Victorian OH&S Regulation 2017. All remedial/removal repairs require a Clearance Inspection & Certificate to be recorded by an approved and competent assessor.

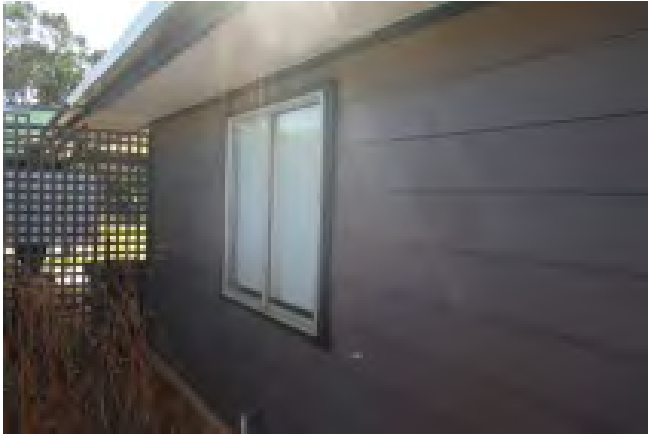
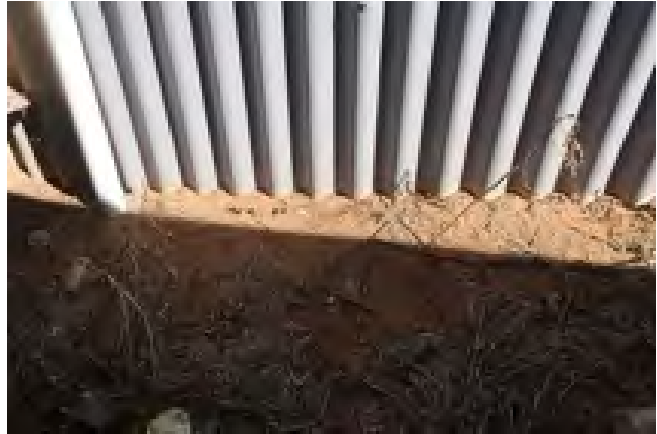
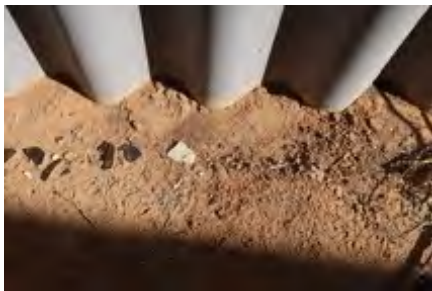
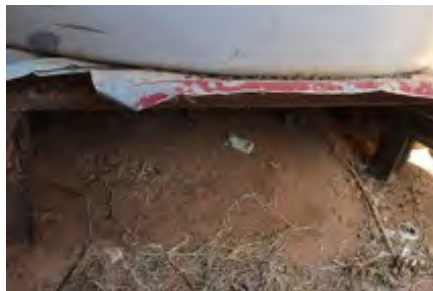
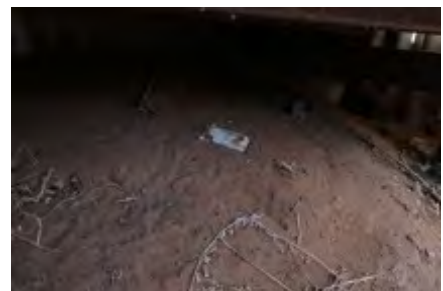
Clubrooms LB58C Tennis Court Clubrooms: right side of building. The Debris - Broken (Debris) has Asbestos Containing Material (ACM) present.

RISK ASSESSMENT					
Type of Asbestos or Hazardous Material	No sample taken - Visual ID	Condition	POOR	Likelihood of Damage	H (High) - almost certain
		Activity	Moderate		
		Sealed	No	Friability	Exposed Fibres
		Labelled	Y	Exposure Risk	High - Short term exposure risk
		Quantity

Debris on Ground

RISK CONTROL					
Priority	IMMEDIATE	Label Required	Yes	Re- Audit Date	27 Jan 2022
Action	Restrict access and target for imminent removal				
Recommendation	Debris on Surface - The Debris requires immediate cleanup and disposal with specialised equipment and with licensed removalist to safely remove the asbestos debris.				
Legislative Requirements Victorian Regulation 2007	ACM debris visible. Recommend cleanup by licensed Asbestos Removalist. Warning labels should be affixed. Avoid mechanical damage and abrasion. Remove if refurbishment, structural alteration or demolition is to be carried out in this area. Re-inspect every 12 months or earlier if disturbed or removed in accordance with the Victorian OH&S Regulation 2017. All remedial/removal repairs require a Clearance Inspection & Certificate to be recorded by an approved and competent assessor.

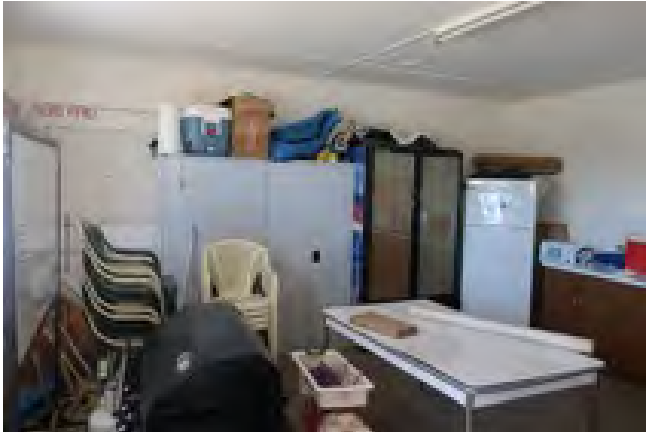
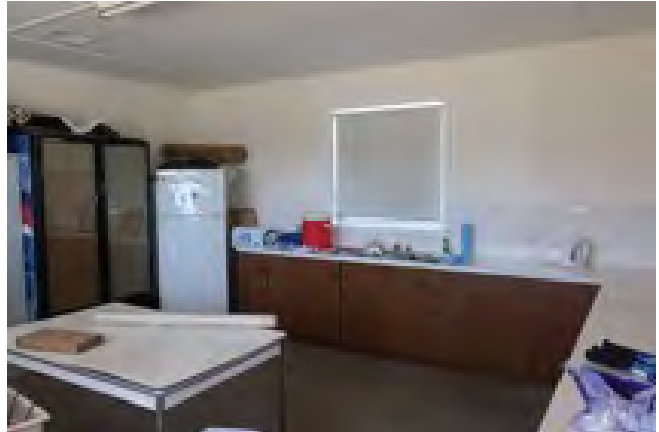
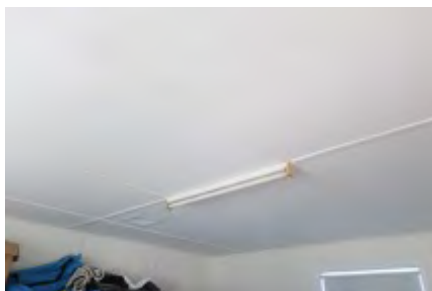
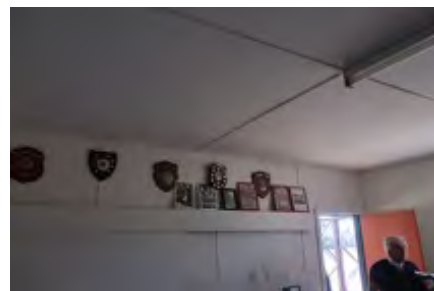
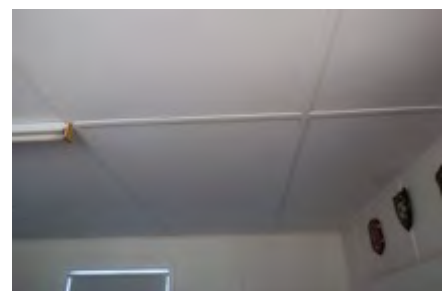
Area 3**Clubrooms LB58C Tennis Court Clubrooms: Clubroom 1. The Ceiling (F C Sheeting) has Asbestos Containing Material (ACM) present.****RISK ASSESSMENT**

Type of Asbestos or Hazardous Material	Chrysotile	Condition	GOOD	Likelihood of Damage	L (Low) – possible
	Same as Sample - 62082 -001	Activity	Moderate		
		Sealed	Yes	Friability	Bonded (non-friable)
		Labelled	Y	Exposure Risk	Low - Negligible or low risk
		Quantity

Maintain paint or sealant

Priority	MEDIUM	Label Required	Yes	Re- Audit Date	27 Jan 2022
Action	No remedial action required, unless disturbed				
Recommendation	Maintain paint or sealant to ACM surfaces. Particular attention should be given to side edges, ensure paint/sealant covers ALL exposed ACM surfaces.				
Legislative Requirements Victorian Regulation 2007	Warning labels should be affixed. Avoid mechanical damage and abrasion. Remove if refurbishment, structural alteration or demolition is to be carried out in this area. Re-inspect every 12 months or earlier if disturbed or removed in accordance with the Victorian OH&S Regulation 2017. All remedial/removal repairs require a Clearance Inspection & Certificate to be recorded by an approved and competent assessor.
