Asbestos Report

YARRIAMBIACK SHIRE COUNCIL

PROPERTY ADDRESS:
LB69 TIP HOPETOUN
8 TIP ROAD
HOPETOUN VIC 3396

INSPECTION DATE: 27 JANUARY 2021
REFERENCE NUMBER: 62083

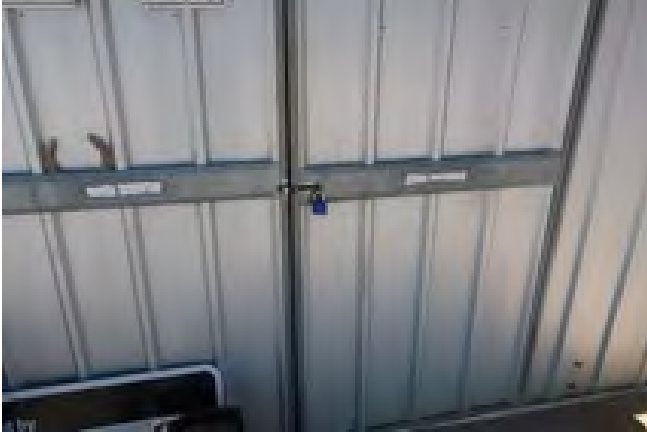
Area 5**Shed 1 LB69 Tip: . Until the area is inspected, it should be managed as if it Asbestos Containing Material (ACM) is present.****RISK ASSESSMENT**

Type of Asbestos or Hazardous Material	No sample taken - No Access	Condition		Likelihood of Damage	
		Activity			
		Sealed		Friability	
		Labelled	No	Exposure Risk	
		Quantity

Priority	HIGH	Label Required	Yes	Re- Audit Date	27 Jan 2022
Action					
Recommendation					
Legislative Requirements Victorian Regulation 2007	Unable to Gain Access. Assume asbestos in area and provide monitoring if work undertaken in these areas. If access is made available, contact Global Asbestos Audits for re-inspection

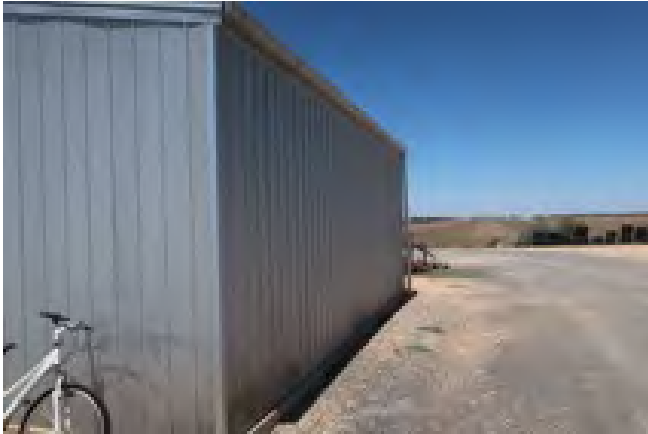
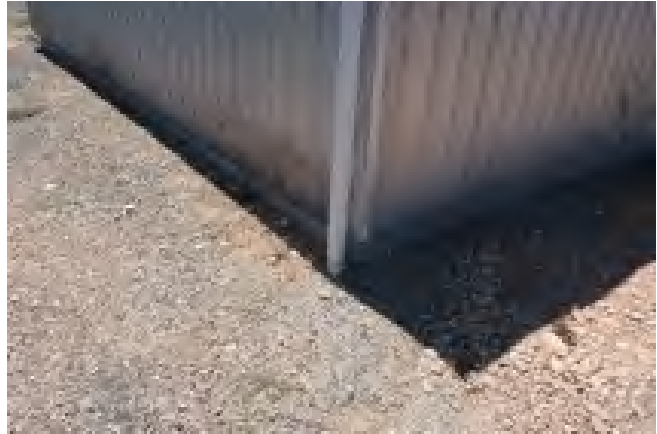
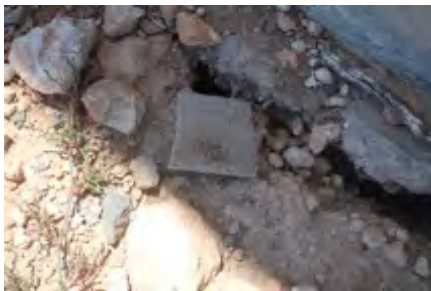
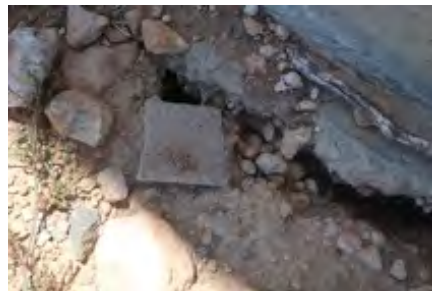
Area 4

Second chance - Shed 2: left side of building. The Debris - Broken (Debris) has Asbestos Containing Material (ACM) present.

RISK ASSESSMENT					
Type of Asbestos or Hazardous Material	Chrysotile	Condition	POOR	Likelihood of Damage	H (High) - almost certain
	Sample taken 62083-001	Activity	Moderate		
		Sealed	No	Friability	Exposed Fibres
		Labelled	No	Exposure Risk	High - Short term exposure risk
		Quantity

RISK CONTROL					
Priority	IMMEDIATE	Label Required	Yes	Re- Audit Date	27 Jan 2022
Action	Restrict access and target for imminent removal				
Recommendation	<p>Preliminary soil testing should be done to establish level of contamination & potential exposure. Debris on Surface - The Debris requires immediate cleanup and disposal with specialised equipment and with licensed removalist to safely remove the asbestos debris.</p> <p>In the meantime a wetting down program should be implemented and include minimal disturbance.</p>				
Legislative Requirements Victorian Regulation 2007	<p>ACM debris visible. Recommend cleanup by licensed Asbestos Removalist. Warning labels should be affixed. Avoid mechanical damage and abrasion. Re-inspect every 12 months or earlier if disturbed or removed in accordance with the Victorian OH&S Regulation 2017.</p> <p>All remedial/removal repairs require a Clearance Inspection & Certificate to be recorded by an approved and competent assessor.</p>

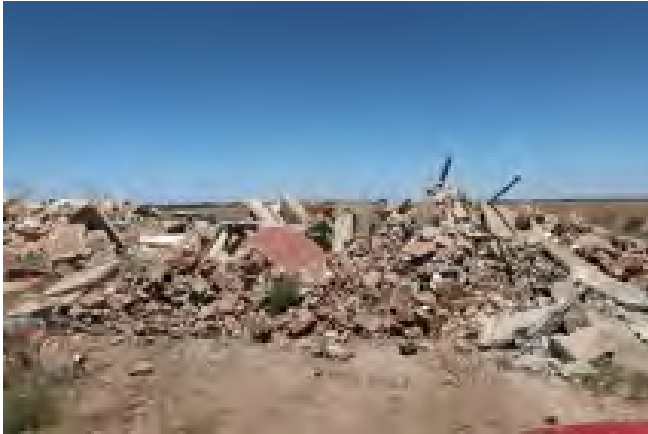
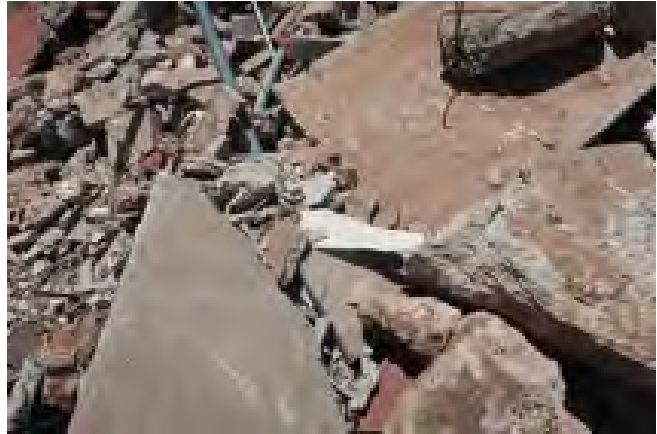
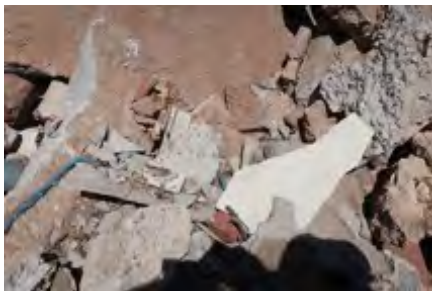
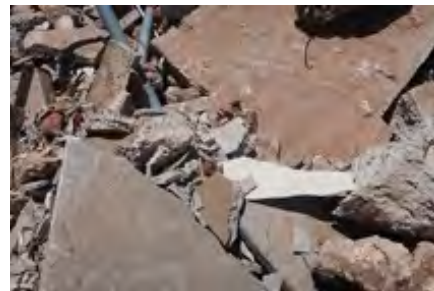
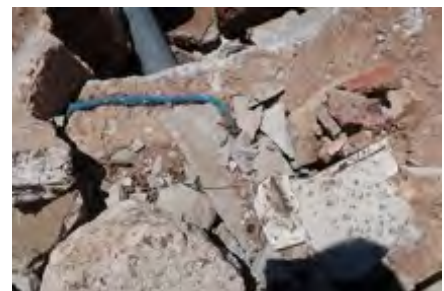
Area 2

Rubish Tip: Tip pile. The Debris - Broken (Debris) has Asbestos Containing Material (ACM) present.

RISK ASSESSMENT					
Type of Asbestos or Hazardous Material	Chrysotile	Condition	POOR	Likelihood of Damage	H (High) - almost certain
	Sample taken 62083-002	Activity	Moderate		
		Sealed	No	Friability	Friable
		Labelled	No	Exposure Risk	High - Short term exposure risk
		Quantity

RISK CONTROL					
Priority	IMMEDIATE	Label Required	Yes	Re- Audit Date	27 Jan 2022
Action	Restrict access and target for imminent removal				
Recommendation	<p>Preliminary soil testing should be done to establish level of contamination & potential exposure. Debris on Surface - The Debris requires immediate cleanup and disposal with specialised equipment and with licensed removalist to safely remove the asbestos debris.</p> <p>In the meantime a wetting down program should be implemented and include minimal disturbance.</p>				
Legislative Requirements Victorian Regulation 2007	<p>ACM debris visible. Recommend cleanup by licensed Asbestos Removalist. Warning labels should be affixed. Avoid mechanical damage and abrasion. Re-inspect every 12 months or earlier if disturbed or removed in accordance with the Victorian OH&S Regulation 2017.</p> <p>All remedial/removal repairs require a Clearance Inspection & Certificate to be recorded by an approved and competent assessor.</p>

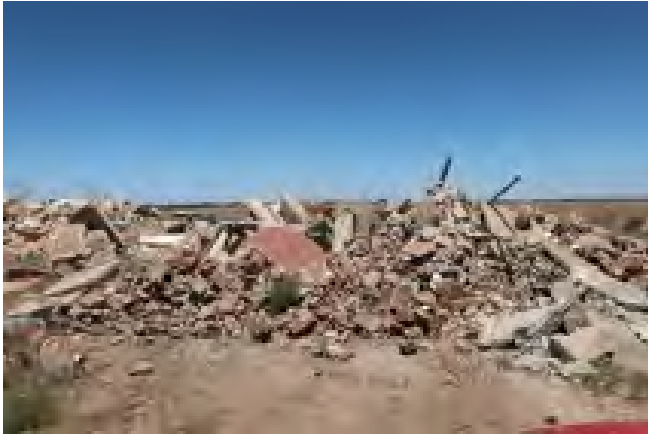
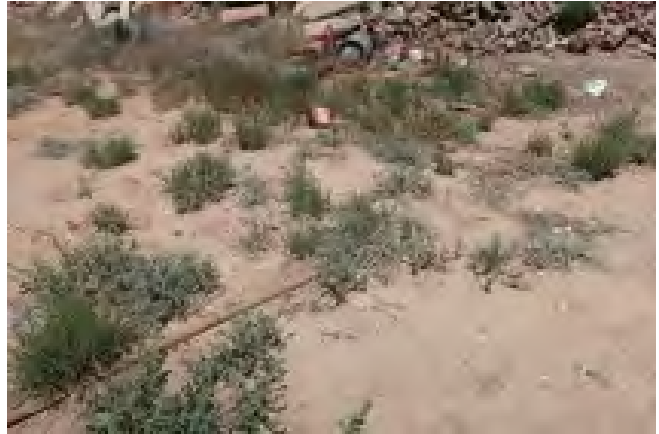
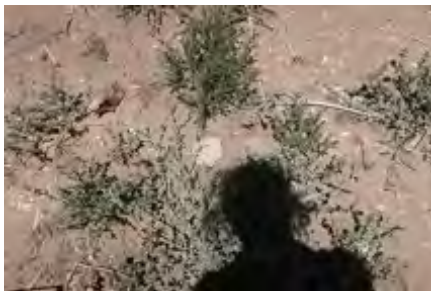
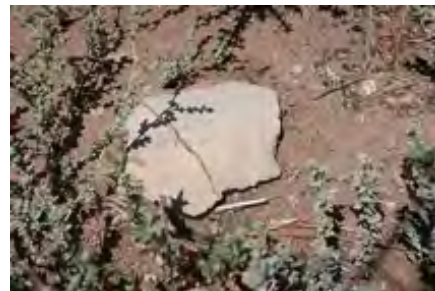
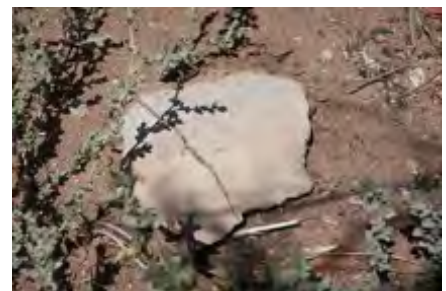
Rubish Tip: Tip pile. The Debris - Broken (Debris) has Asbestos Containing Material (ACM) present.

RISK ASSESSMENT					
Type of Asbestos or Hazardous Material	Chrysotile	Condition	POOR	Likelihood of Damage	H (High) - almost certain
	Same as Sample - 62083 -002	Activity	Moderate		
		Sealed	No	Friability	Friable
		Labelled	No	Exposure Risk	High - Short term exposure risk
		Quantity

RISK CONTROL					
Priority	IMMEDIATE	Label Required	Yes	Re- Audit Date	27 Jan 2022
Action	Restrict access and target for imminent removal				
Recommendation	<p>Preliminary soil testing should be done to establish level of contamination & potential exposure. Debris on Surface - The Debris requires immediate cleanup and disposal with specialised equipment and with licensed removalist to safely remove the asbestos debris.</p> <p>In the meantime a wetting down program should be implemented and include minimal disturbance.</p>				
Legislative Requirements Victorian Regulation 2007	<p>ACM debris visible. Recommend cleanup by licensed Asbestos Removalist. Warning labels should be affixed. Avoid mechanical damage and abrasion. Re-inspect every 12 months or earlier if disturbed or removed in accordance with the Victorian OH&S Regulation 2017.</p> <p>All remedial/removal repairs require a Clearance Inspection & Certificate to be recorded by an approved and competent assessor.</p>

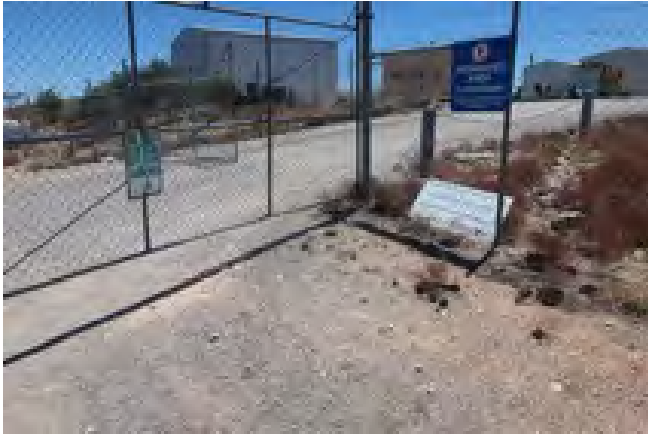
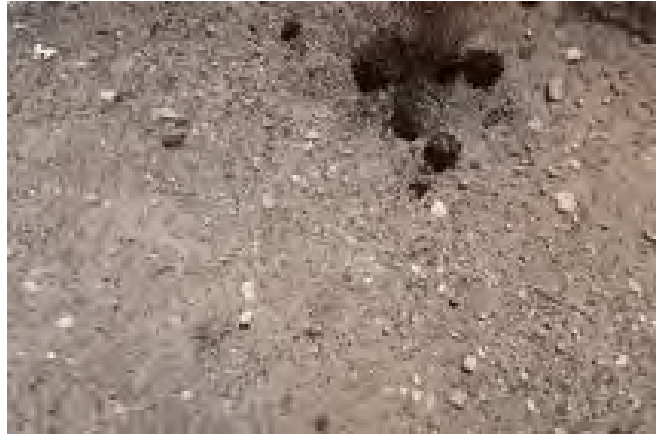
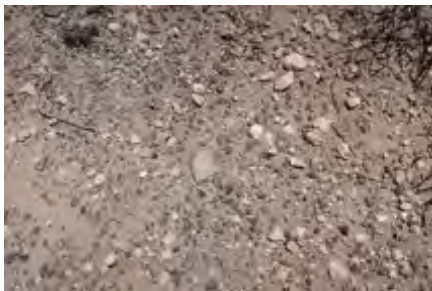
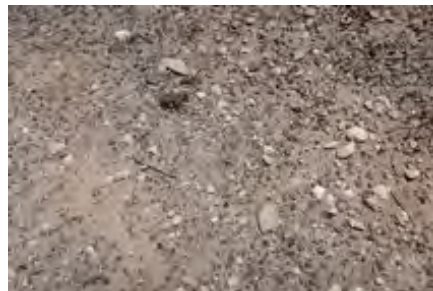
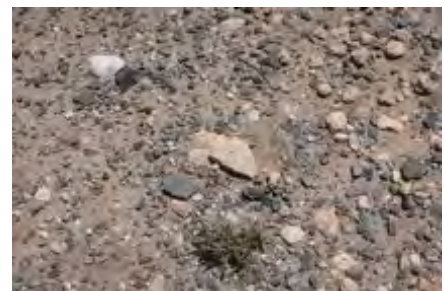
Area 1

Grounds: Front entrance. The Debris - Broken (Debris) has Asbestos Containing Material (ACM) present.

RISK ASSESSMENT					
Type of Asbestos or Hazardous Material	No sample taken - Visual ID	Condition	POOR	Likelihood of Damage	H (High) - almost certain
		Activity	High		
		Sealed	No	Friability	Exposed Fibres
		Labelled	No	Exposure Risk	High - Short term exposure risk
		Quantity

RISK CONTROL					
Priority	IMMEDIATE	Label Required	Yes	Re- Audit Date	27 Jan 2022
Action	Restrict access and target for imminent removal				
Recommendation	<p>Preliminary soil testing should be done to establish level of contamination & potential exposure. Debris on Surface - The Debris requires immediate cleanup and disposal with specialised equipment and with licensed removalist to safely remove the asbestos debris.</p> <p>In the meantime a wetting down program should be implemented and include minimal disturbance.</p>				
Legislative Requirements Victorian Regulation 2007	<p>ACM debris visible. Recommend cleanup by licensed Asbestos Removalist. Warning labels should be affixed. Avoid mechanical damage and abrasion. Re-inspect every 12 months or earlier if disturbed or removed in accordance with the Victorian OH&S Regulation 2017.</p> <p>All remedial/removal repairs require a Clearance Inspection & Certificate to be recorded by an approved and competent assessor.</p>
