Asbestos Report

YARRIAMBIACK SHIRE COUNCIL

PROPERTY ADDRESS:
LB83 SENIOR CITIZEN (OLD INFANT WELFARE
CENTRE)
71 PHILLIPS STREET
BEULAH VIC 3395

INSPECTION DATE: 8 FEBRUARY 2021
REFERENCE NUMBER: 62084

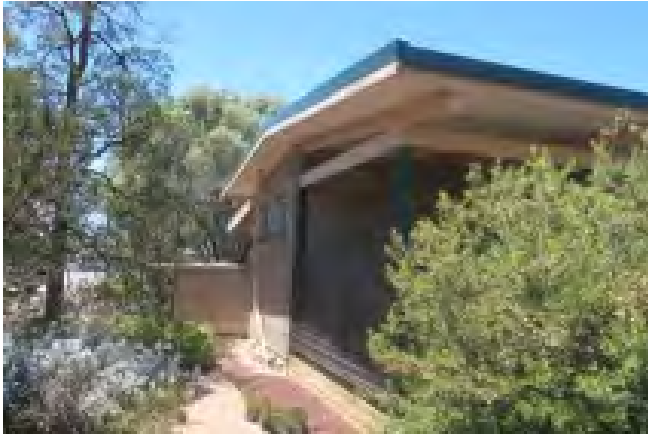
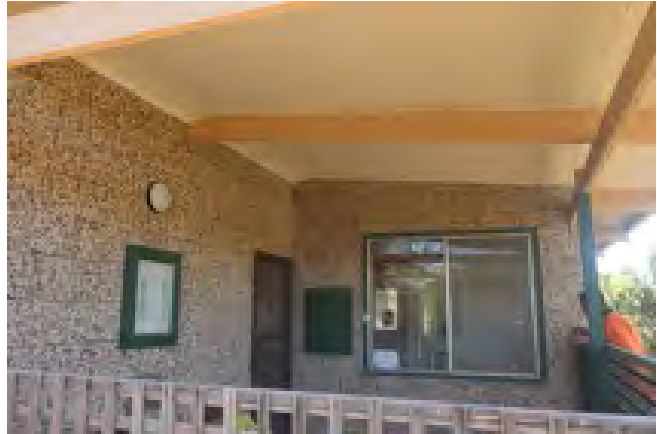
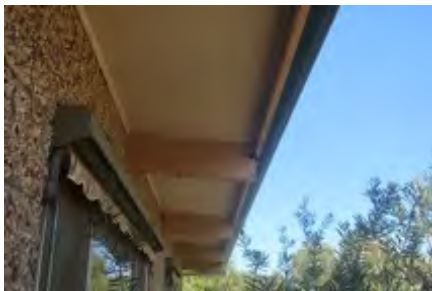
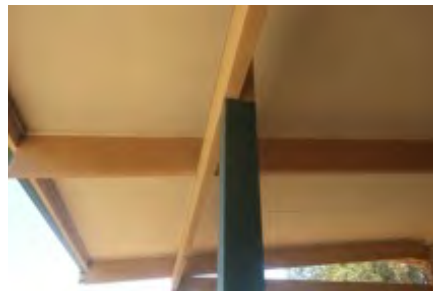
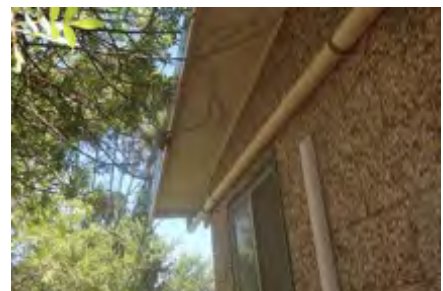
| RISK ASSESSMENT | | | | | |
|--|---|---|---|---|---|
| Type of Asbestos or Hazardous Material | No sample taken - Visual ID | Condition | GOOD | Likelihood of Damage | L (Low) – possible |
| | | Labelled | No | Exposure Risk | Low - Negligible or low risk |

Maintain paint or sealant

| RISK CONTROL | | | | | |
|--|---|---|---|---|---|
| Recommendation | Maintain paint or sealant to ACM surfaces. Particular attention should be given to side edges, ensure paint/sealant covers ALL exposed ACM surfaces. | | | | |

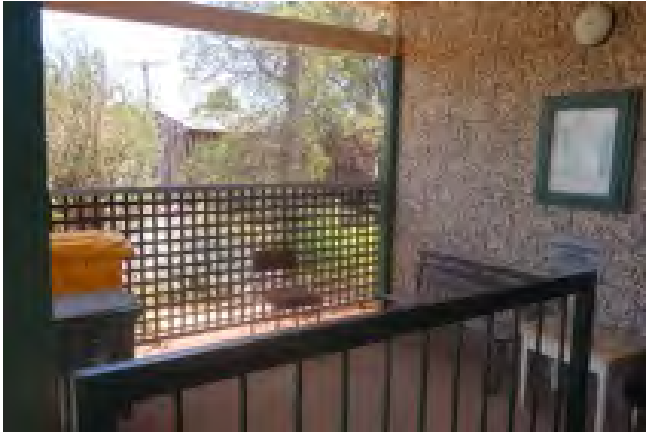
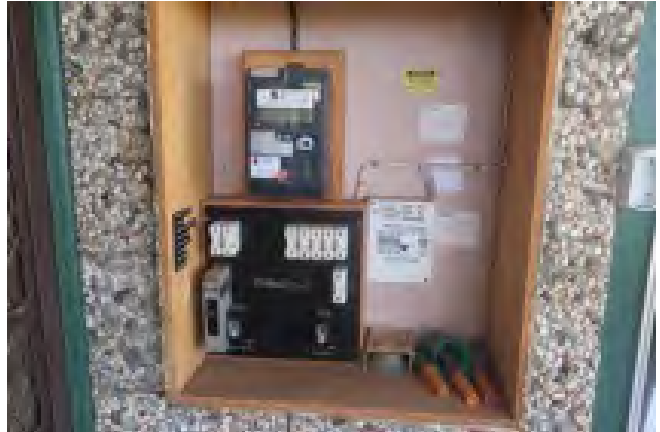
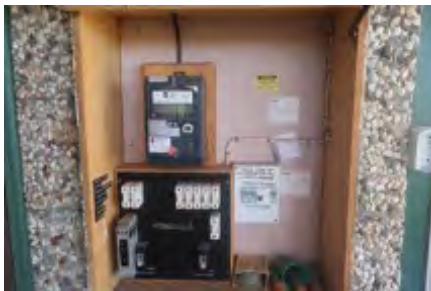
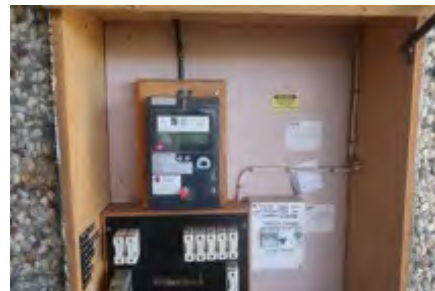
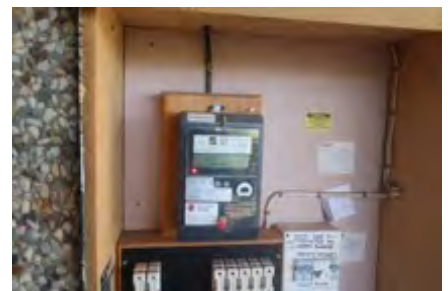
| RISK ASSESSMENT | | | | | |
|--|---|---|---|---|---|
| Type of Asbestos or Hazardous Material | No sample taken - Visual ID | Condition | AVERAGE | Likelihood of Damage | L (Low) – possible |
| | | Labelled | Y | Exposure Risk | Medium - Moderate risk |

Raw Material

| RISK CONTROL | | | | | |
|--|--|---|---|---|---|
| Action | Remedial repairs required - seal raw material / edges | | | | |
| Recommendation | Raw material sheeting - The area requires immediate remedial repairs. It is recommended the asbestos material be sealed with an approved membrane. | | | | |

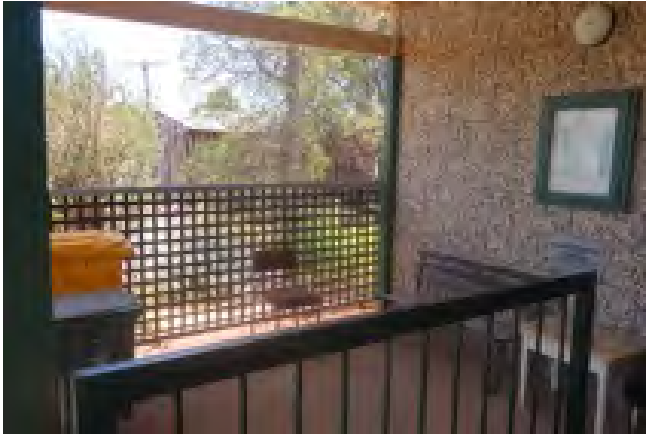
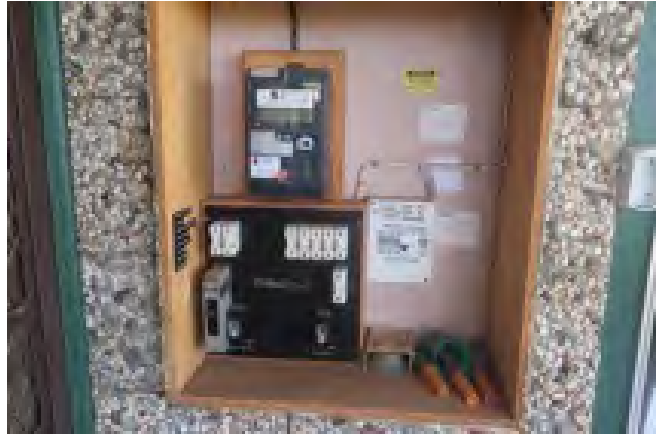
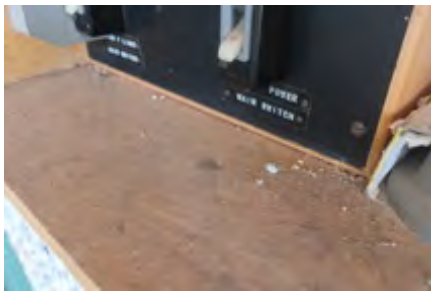
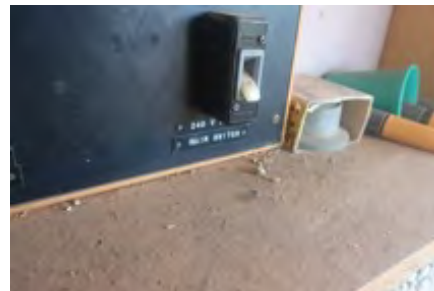
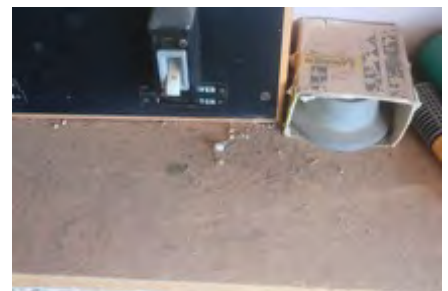
| RISK ASSESSMENT | | | | | |
|--|---|---|---|---|---|
| Type of Asbestos or Hazardous Material | No sample taken - Visual ID | Condition | POOR | Likelihood of Damage | H (High) - almost certain |
| | | Labelled | No | Exposure Risk | High - Short term exposure risk |

Debris on Surface

| RISK CONTROL | | | | | |
|--|--|---|---|---|---|
| Recommendation | Debris on Surface - The Debris requires immediate cleanup and disposal with specialised equipment and with licensed removalist to safely remove the asbestos debris. | | | | |

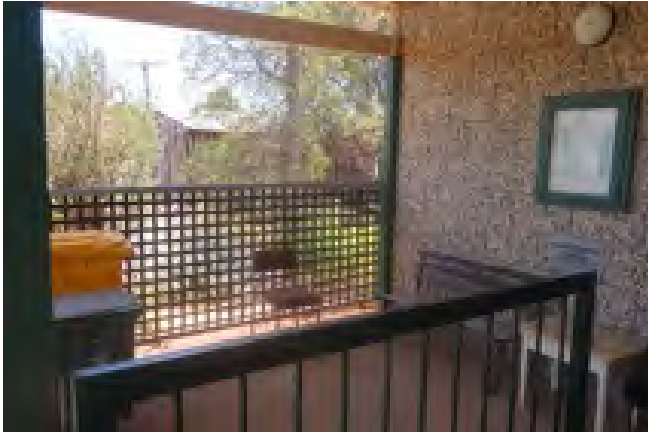
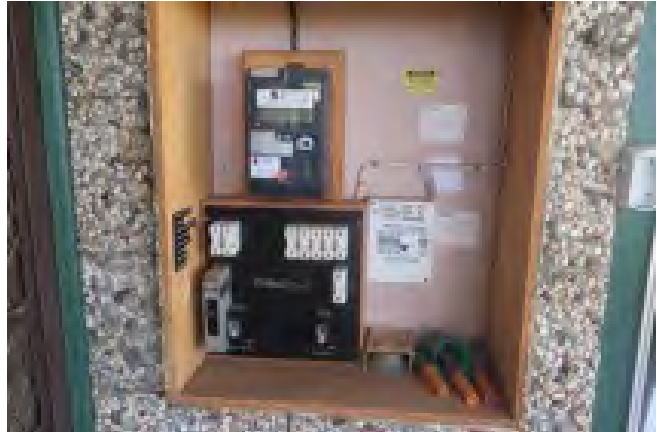
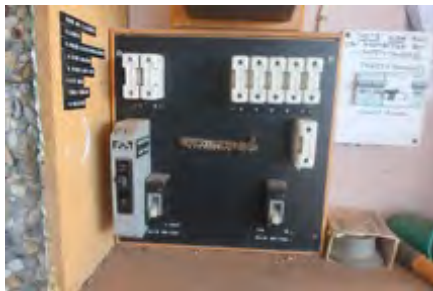
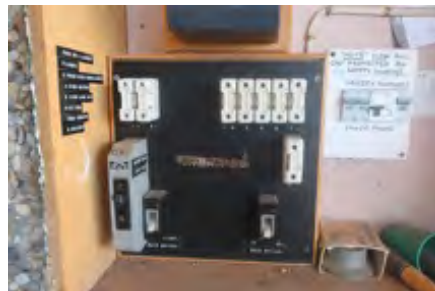
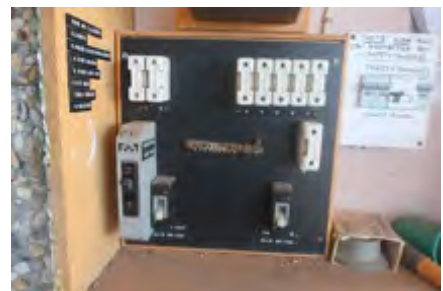
| RISK ASSESSMENT | | | | | |
|--|---|---|---|---|---|
| Type of Asbestos or Hazardous Material | No sample taken - Visual ID | Condition | GOOD | Likelihood of Damage | L (Low) – possible |
| | | Labelled | No | Exposure Risk | Low - Negligible or low risk |

Maintain paint or sealant

| Recommendation | Maintain paint or sealant to ACM surfaces. Particular attention should be given to side edges, ensure paint/sealant covers ALL exposed ACM surfaces. Do not remove the fuses without asbestos controls - test for cloth inserts | | | | |

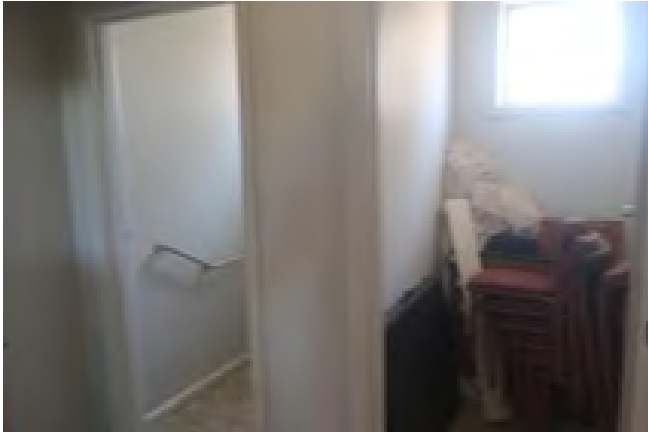
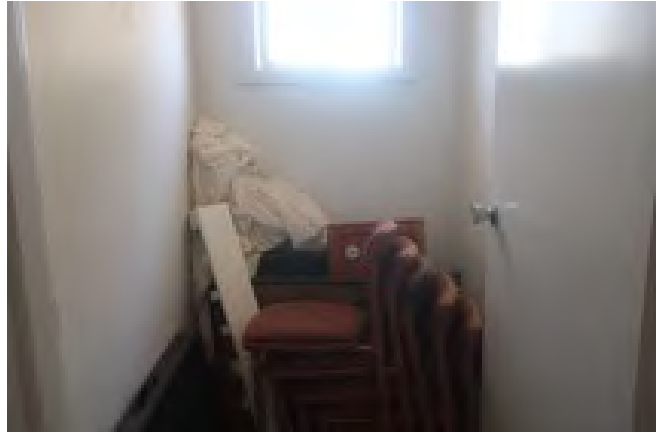
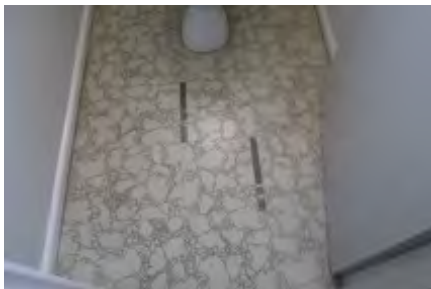
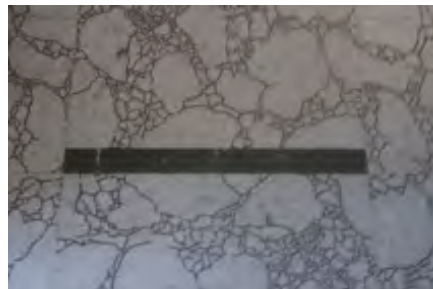
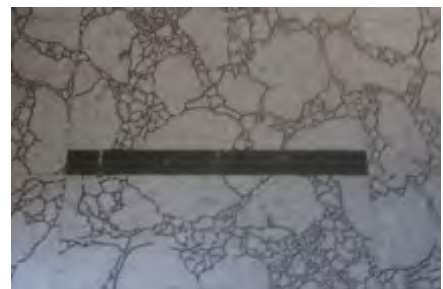
| RISK ASSESSMENT | | | | | |
|--|---|---|---|---|---|
| Type of Asbestos or Hazardous Material | Chrysotile | Condition | GOOD | Likelihood of Damage | L (Low) – possible |
| | | Labelled | No | Exposure Risk | Low - Negligible or low risk |

Maintain paint or sealant

| Recommendation | Maintain paint or sealant to ACM surfaces. Particular attention should be given to side edges, ensure paint/sealant covers ALL exposed ACM surfaces. | | | | |

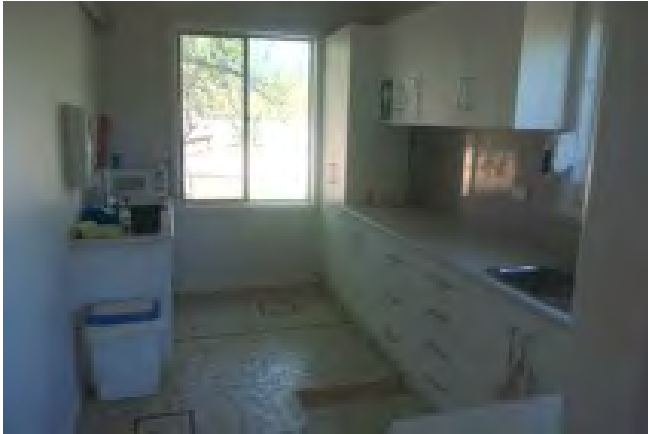
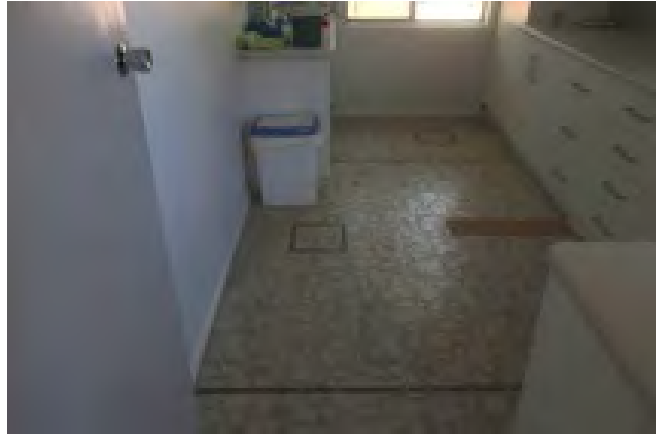
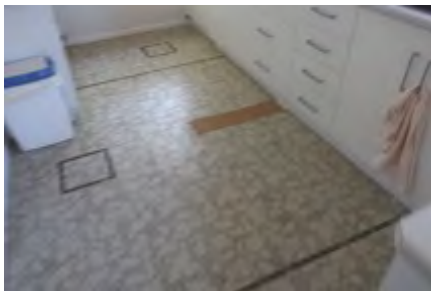
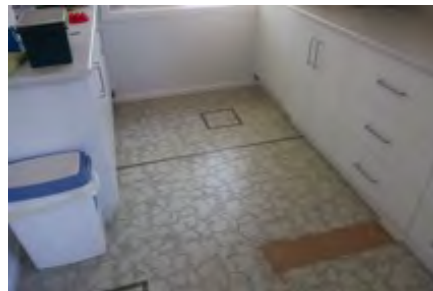
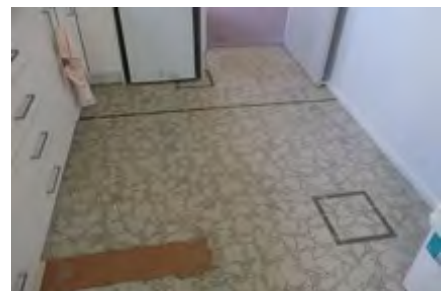
| RISK ASSESSMENT | | | | | |
|--|---|---|---|---|---|
| Type of Asbestos or Hazardous Material | Chrysotile | Condition | GOOD | Likelihood of Damage | L (Low) – possible |
| | | Labelled | No | Exposure Risk | Low - Negligible or low risk |

Maintain paint or sealant

| RISK CONTROL | | | | | |
|--|---|---|---|---|---|
| Recommendation | Maintain paint or sealant to ACM surfaces. Particular attention should be given to side edges, ensure paint/sealant covers ALL exposed ACM surfaces. | | | | |
