Asbestos Report

YARRIAMBIACK SHIRE COUNCIL

PROPERTY ADDRESS:
LB16 PUBLIC HALL
28B SWANN STREET
BRIM VIC 3391

INSPECTION DATE: 8 FEBRUARY 2021
REFERENCE NUMBER: 62088

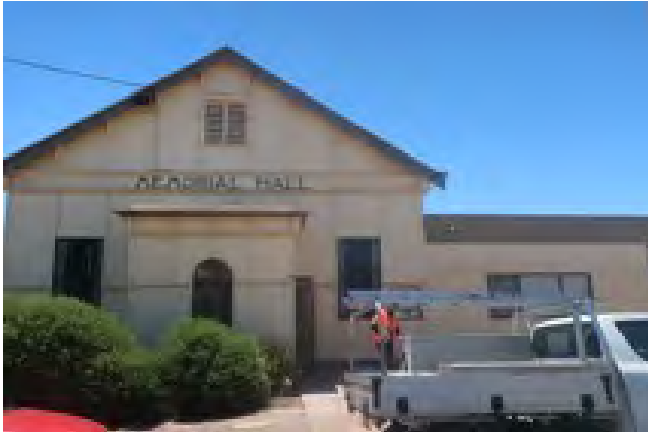
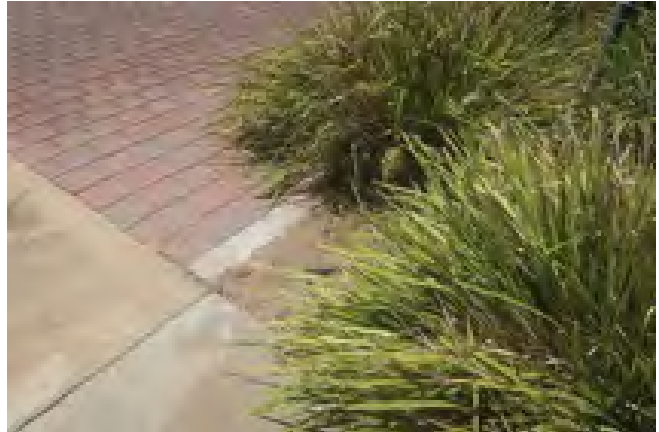
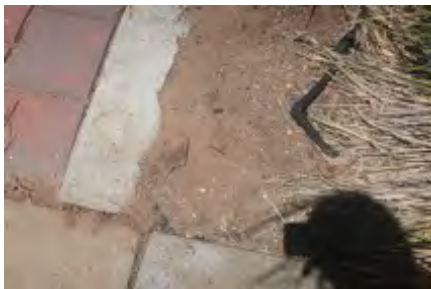
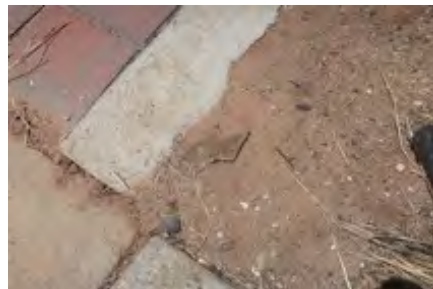
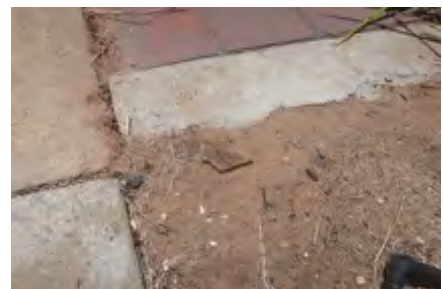
LB16 Public Hall: front of building. The Debris - Broken (Debris) has Asbestos Containing Material (ACM) present.

RISK ASSESSMENT					
Type of Asbestos or Hazardous Material	No sample taken - Visual ID	Condition	POOR	Likelihood of Damage	H (High) - almost certain
		Activity	Moderate		
		Sealed	No	Friability	Exposed Fibres
		Labelled	No	Exposure Risk	High - Short term exposure risk
		Quantity

RISK CONTROL					
Priority	IMMEDIATE	Label Required	Yes	Re- Audit Date	8 Feb 2022
Action	Restrict access and target for imminent removal				
Recommendation	Debris on Surface - The Debris requires immediate cleanup and disposal with specialised equipment and with licensed removalist to safely remove the asbestos debris.				
Legislative Requirements Victorian Regulation 2007	ACM debris visible. Recommend cleanup by licensed Asbestos Removalist. Warning labels should be affixed. Avoid mechanical damage and abrasion. Remove if refurbishment, structural alteration or demolition is to be carried out in this area. Re-inspect every 12 months or earlier if disturbed or removed in accordance with the Victorian OH&S Regulation 2017. All remedial/removal repairs require a Clearance Inspection & Certificate to be recorded by an approved and competent assessor.

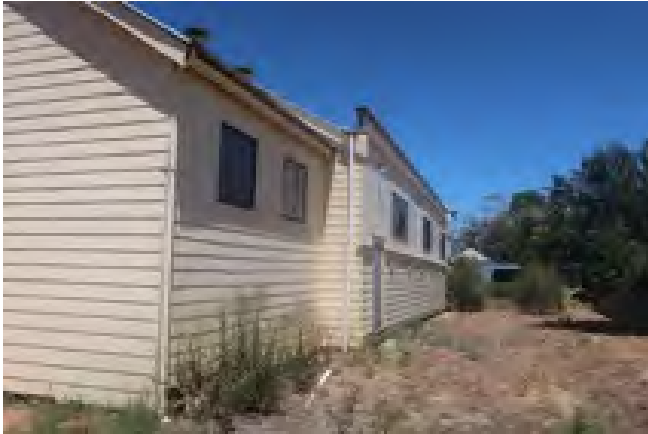
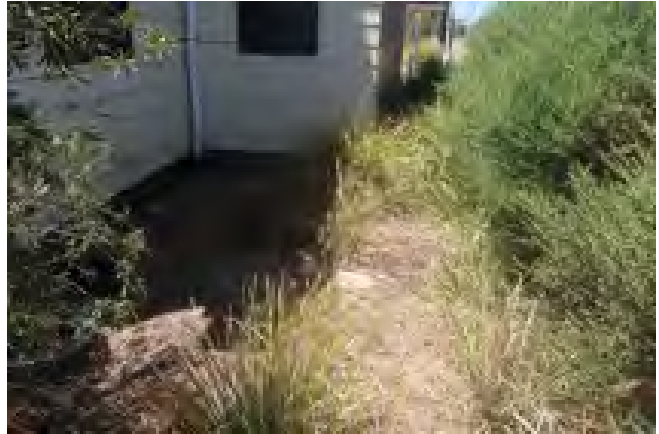
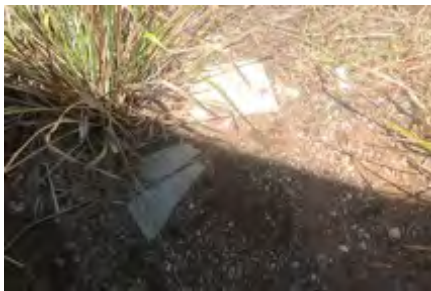
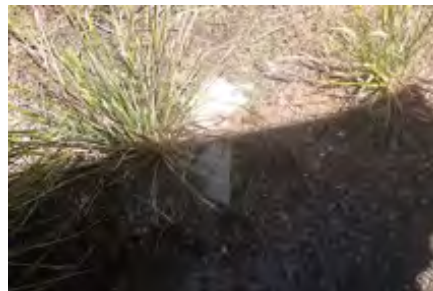
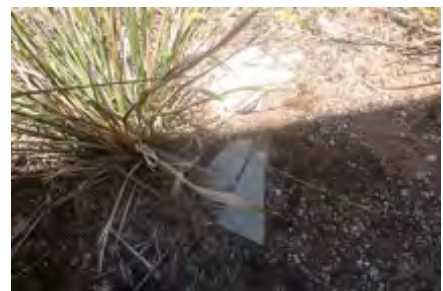
LB16 Public Hall: left side of building. The Debris - Broken (Debris) has Asbestos Containing Material (ACM) present.

RISK ASSESSMENT					
Type of Asbestos or Hazardous Material	No sample taken - Visual ID	Condition	POOR	Likelihood of Damage	H (High) - almost certain
		Activity	Moderate		
		Sealed	No	Friability	Exposed Fibres
		Labelled	No	Exposure Risk	High - Short term exposure risk
		Quantity

RISK CONTROL					
Priority	IMMEDIATE	Label Required	Yes	Re- Audit Date	8 Feb 2022
Action	Restrict access and target for imminent removal				
Recommendation	Debris on Surface - The Debris requires immediate cleanup and disposal with specialised equipment and with licensed removalist to safely remove the asbestos debris.				
Legislative Requirements Victorian Regulation 2007	ACM debris visible. Recommend cleanup by licensed Asbestos Removalist. Warning labels should be affixed. Avoid mechanical damage and abrasion. Remove if refurbishment, structural alteration or demolition is to be carried out in this area. Re-inspect every 12 months or earlier if disturbed or removed in accordance with the Victorian OH&S Regulation 2017. All remedial/removal repairs require a Clearance Inspection & Certificate to be recorded by an approved and competent assessor.

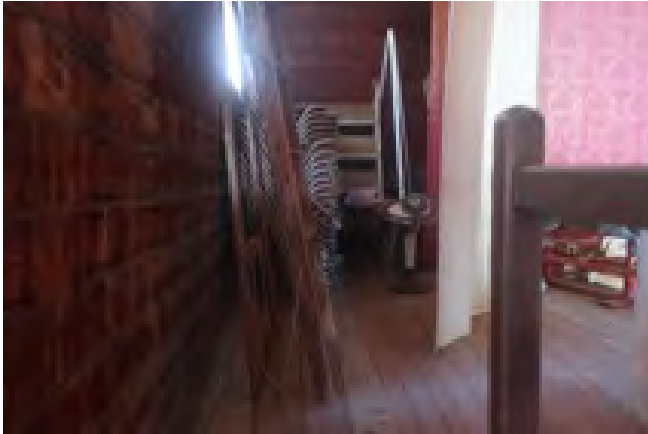
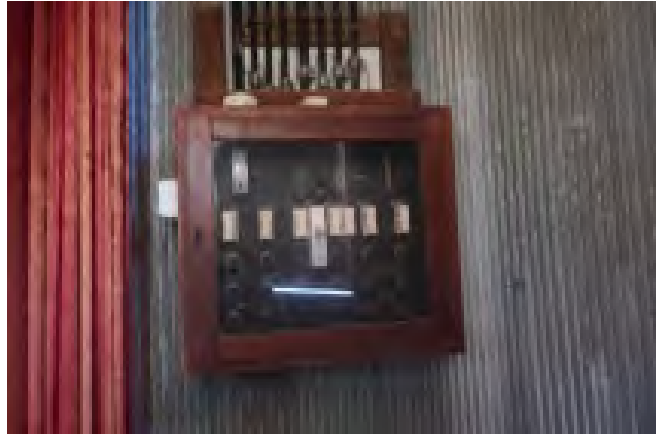
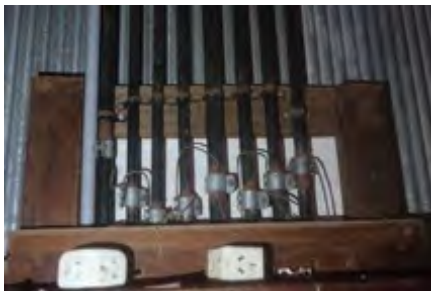
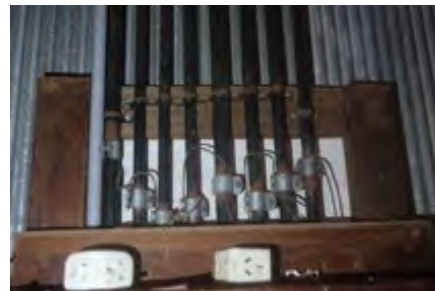
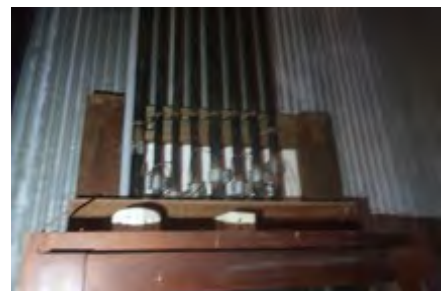
LB16 Public Hall: Stage. The Electrical Cabinet - backing (F C Sheet) has Asbestos Containing Material (ACM) present.

RISK ASSESSMENT					
Type of Asbestos or Hazardous Material	No sample taken - Visual ID	Condition	AVERAGE	Likelihood of Damage	L (Low) – possible
		Activity	Moderate		
		Sealed	No	Friability	Bonded (non-friable)
		Labelled	Y	Exposure Risk	Medium - Moderate risk
		Quantity

RISK CONTROL					
Priority	HIGH	Label Required	Yes	Re- Audit Date	8 Feb 2022
Action	Remedial repairs required - seal raw material / edges				
Recommendation	Raw material sheeting - The area requires immediate remedial repairs. It is recommended the asbestos material be sealed with an approved membrane.				
Legislative Requirements Victorian Regulation 2007	Damaged ACM visible in area. Requires IMMEDIATE ATTENTION. WARNING labels should be affixed. Avoid mechanical damage and abrasion. Remove if refurbishment, structural alteration or demolition is to be carried out in this area. Re-inspect every 12 months or earlier if disturbed or removed in accordance with the Victorian OH&S Regulation 2017. All remedial/removal repairs require a Clearance Inspection & Certificate to be recorded by an approved and competent assessor.

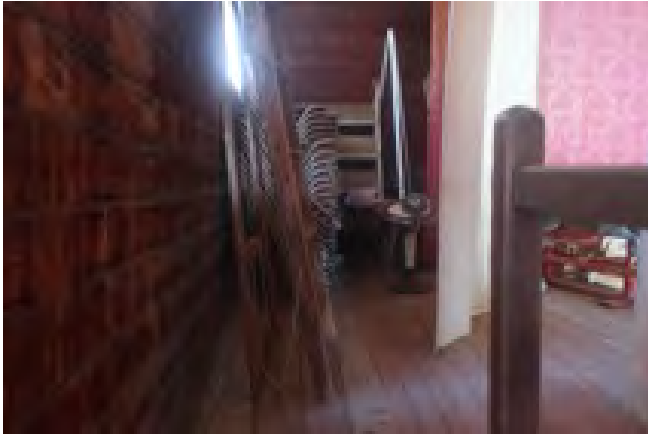
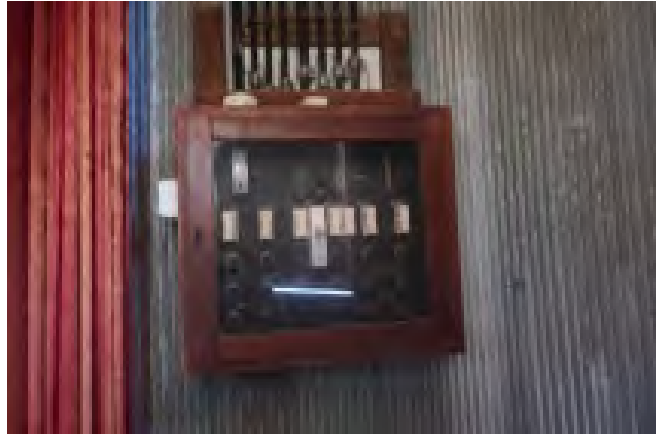
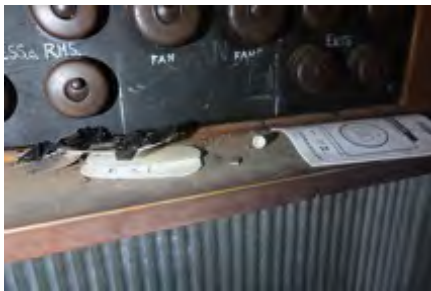
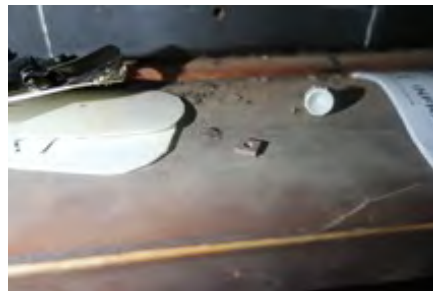
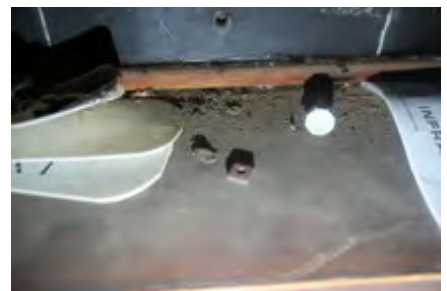
LB16 Public Hall: Stage. The Electrical Cabinet (Debris) has Asbestos Containing Material (ACM) present.

RISK ASSESSMENT					
Type of Asbestos or Hazardous Material	No sample taken - Visual ID	Condition	POOR	Likelihood of Damage	H (High) - almost certain
		Activity	Low		
		Sealed	No	Friability	Exposed Fibres
		Labelled	Y	Exposure Risk	High - Short term exposure risk
		Quantity

RISK CONTROL					
Priority	IMMEDIATE	Label Required	Yes	Re- Audit Date	8 Feb 2022
Action	Restrict access and target for imminent removal				
Recommendation	Debris on Surface - The Debris requires immediate cleanup and disposal with specialised equipment and with licensed removalist to safely remove the asbestos debris.				
Legislative Requirements Victorian Regulation 2007	ACM debris visible. Recommend cleanup by licensed Asbestos Removalist. Warning labels should be affixed. Avoid mechanical damage and abrasion. Remove if refurbishment, structural alteration or demolition is to be carried out in this area. Re-inspect every 12 months or earlier if disturbed or removed in accordance with the Victorian OH&S Regulation 2017. All remedial/removal repairs require a Clearance Inspection & Certificate to be recorded by an approved and competent assessor.

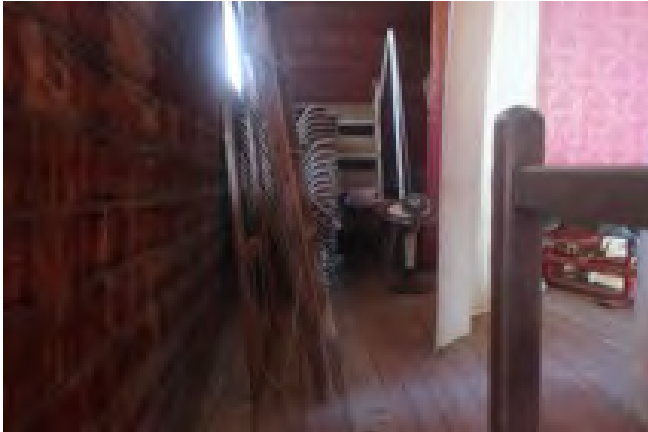
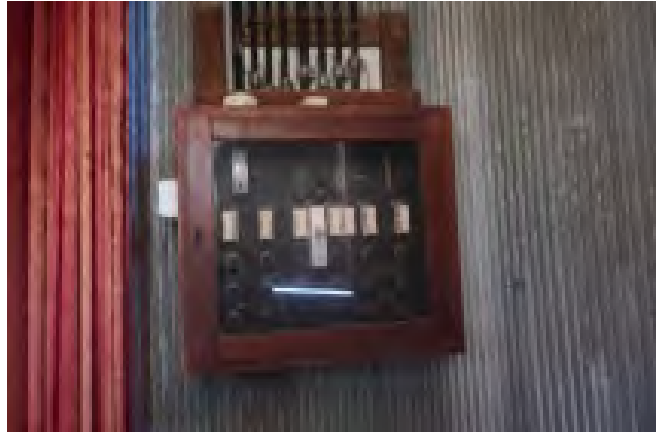
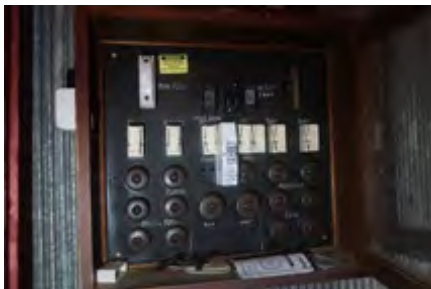
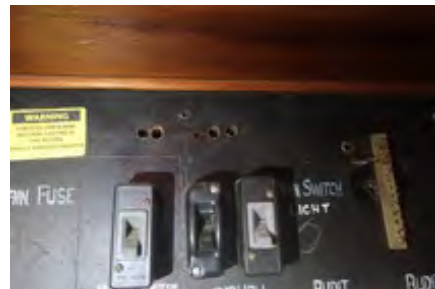
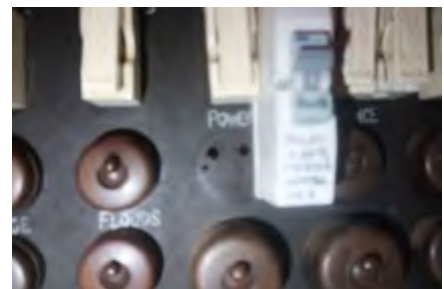
LB16 Public Hall: Stage. The A: Electrical board; B: Ceramic Fuses (A: Zelemite; B: Cloth Inserts) has Asbestos Containing Material (ACM) present.

RISK ASSESSMENT					
Type of Asbestos or Hazardous Material	No sample taken - Visual ID	Condition	AVERAGE	Likelihood of Damage	L (Low) – possible
		Activity	Moderate		
		Sealed	Yes	Friability	Exposed Fibres
		Labelled	Y	Exposure Risk	Medium - Moderate risk
		Quantity

Priority	HIGH	Label Required	Yes	Re- Audit Date	8 Feb 2022
Action	Remedial repairs required - seal raw material / edges				
Recommendation	Penetration Holes - The exposed edges require approved sealant. It is further recommended the gaps be filled with sealant. Do not remove the fuses without asbestos controls - test for cloth inserts				
Legislative Requirements Victorian Regulation 2007	Damaged ACM visible in area. Requires IMMEDIATE ATTENTION. WARNING labels should be affixed. Avoid mechanical damage and abrasion. Remove if refurbishment, structural alteration or demolition is to be carried out in this area. Re-inspect every 12 months or earlier if disturbed or removed in accordance with the Victorian OH&S Regulation 2017. All remedial/removal repairs require a Clearance Inspection & Certificate to be recorded by an approved and competent assessor.
