# Asbestos Report

YARRIAMBIACK SHIRE COUNCIL

PROPERTY ADDRESS:  
LB76 & 81 CARAVAN PARK  
20-26 WYCHUNGA STREET  
LASCELLES VIC 3482

INSPECTION DATE: 10 FEBRUARY 2021  
REFERENCE NUMBER: 62089

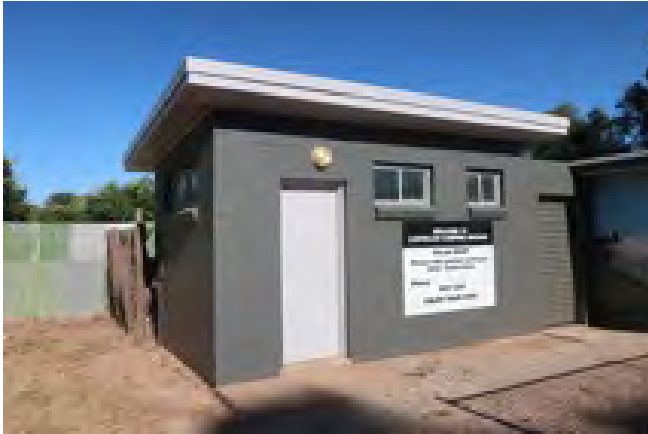
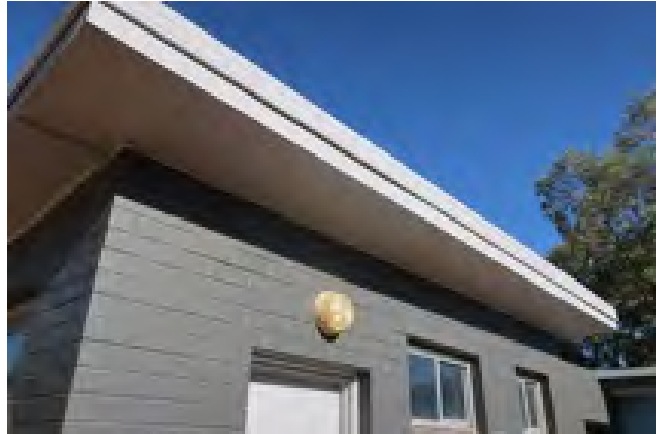
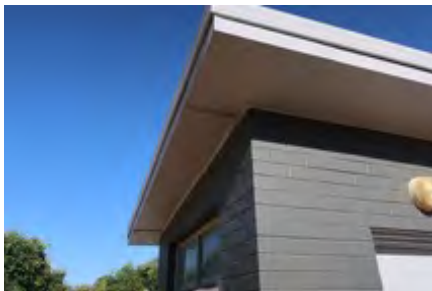
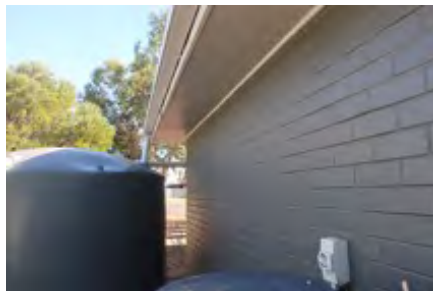
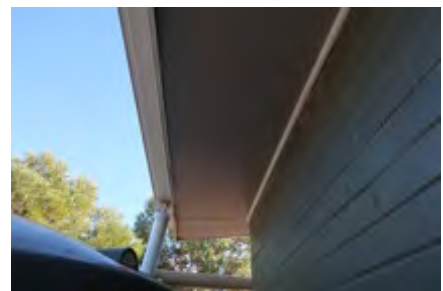
**Area 2**

**Laundry: entire perimeter of building. The Soffit (F C Sheeting) has Asbestos Containing Material (ACM) present.**

RISK ASSESSMENT					
Type of Asbestos or Hazardous Material	No sample taken - Visual ID	Condition	GOOD	Likelihood of Damage	L (Low) – possible
		Activity	Moderate		
		Sealed	Yes	Friability	Bonded (non-friable)
		Labelled	Y	Exposure Risk	Low - Negligible or low risk
		Quantity

Priority	MEDIUM	Label Required	Yes	Re- Audit Date	10 Feb 2022
Action	No remedial action required, unless disturbed				
Recommendation	Maintain paint or sealant to ACM surfaces. Particular attention should be given to side edges, ensure paint/sealant covers ALL exposed ACM surfaces.				
Legislative Requirements Victorian Regulation 2007	Warning labels should be affixed. Avoid mechanical damage and abrasion. Remove if refurbishment, structural alteration or demolition is to be carried out in this area. Re-inspect every 12 months or earlier if disturbed or removed in accordance with the Victorian OH&S Regulation 2017. All remedial/removal repairs require a Clearance Inspection & Certificate to be recorded by an approved and competent assessor.

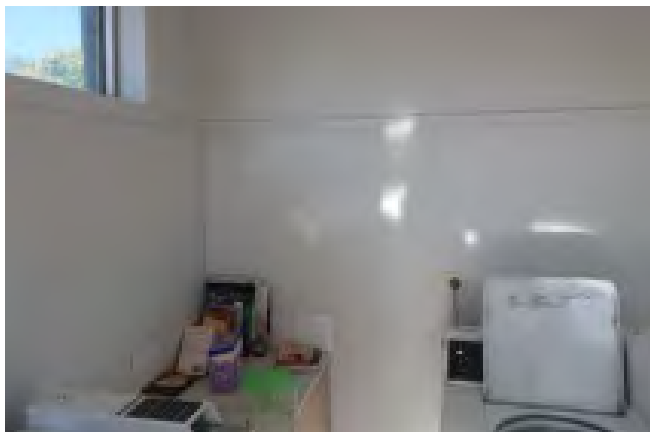
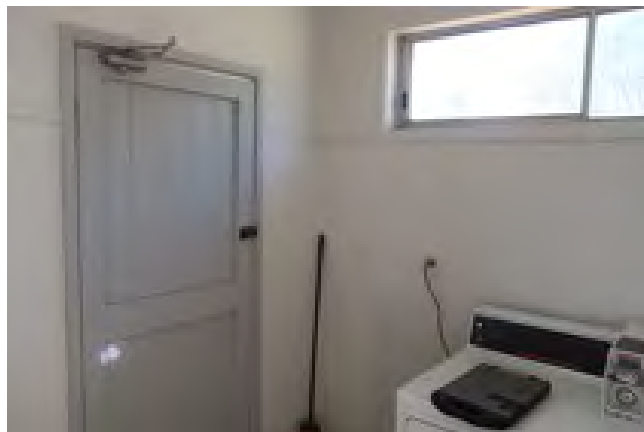
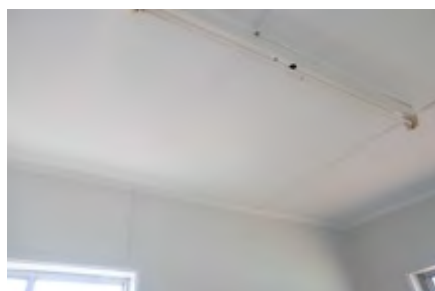
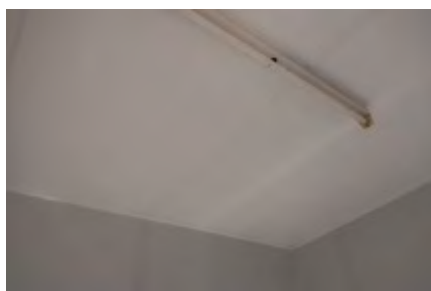
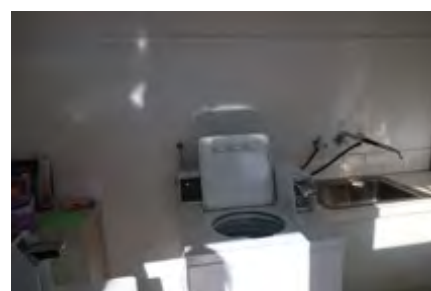
Type of Asbestos or Hazardous Material	No sample taken - Visual ID	Condition	GOOD	Likelihood of Damage	L (Low) – possible
		Activity	Moderate		
		Sealed	Yes	Friability	Bonded (non-friable)
		Labelled	Y	Exposure Risk	Low - Negligible or low risk
		Quantity

Priority	MEDIUM	Label Required	Yes	Re- Audit Date	10 Feb 2022
Action	No remedial action required, unless disturbed				
Recommendation	Maintain paint or sealant to ACM surfaces. Particular attention should be given to side edges, ensure paint/sealant covers ALL exposed ACM surfaces.				
Legislative Requirements Victorian Regulation 2007	Warning labels should be affixed. Avoid mechanical damage and abrasion. Remove if refurbishment, structural alteration or demolition is to be carried out in this area. Re-inspect every 12 months or earlier if disturbed or removed in accordance with the Victorian OH&S Regulation 2017. All remedial/removal repairs require a Clearance Inspection & Certificate to be recorded by an approved and competent assessor.

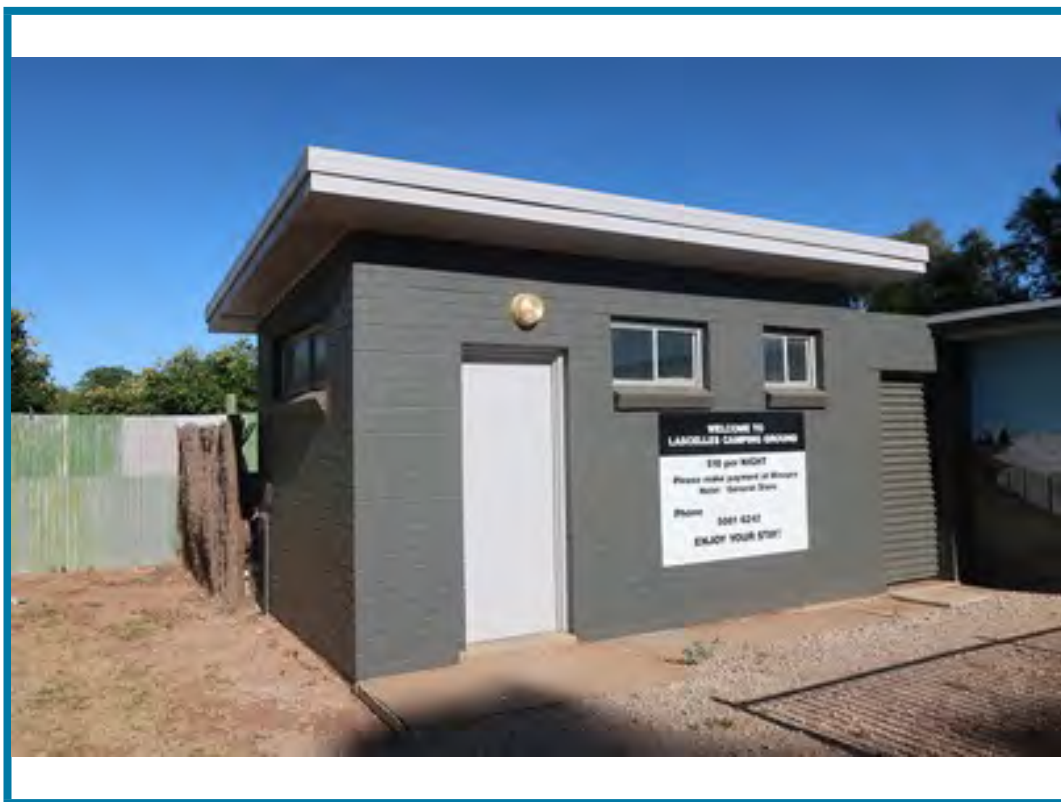
# Laundry

Location	Area	Component Materials	ACM Identified	Type Asbestos Assessment	Condition	Priority	Signage Required
Laundry - entire perimeter of building.	Soffit	F C Sheeting	Yes	No sample taken - Visual ID	GOOD	MEDIUM	Yes
