# Asbestos Report

YARRIAMBIACK SHIRE COUNCIL

PROPERTY ADDRESS:  
LB98 TENNIS COURTS / RECREATION  
CICELY STREET  
LASCELLES VIC 3482

INSPECTION DATE: 10 FEBRUARY 2021  
REFERENCE NUMBER: 62090

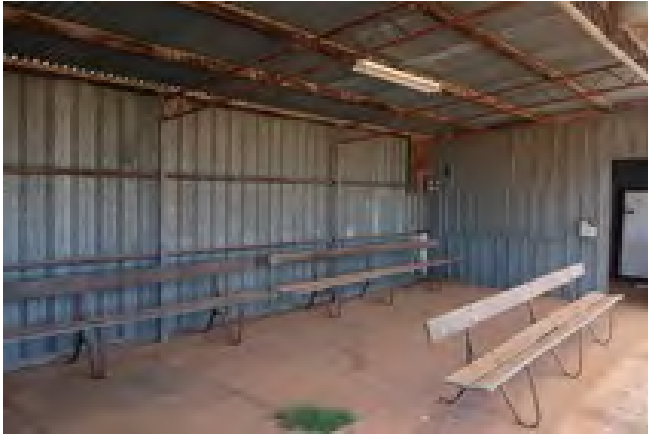
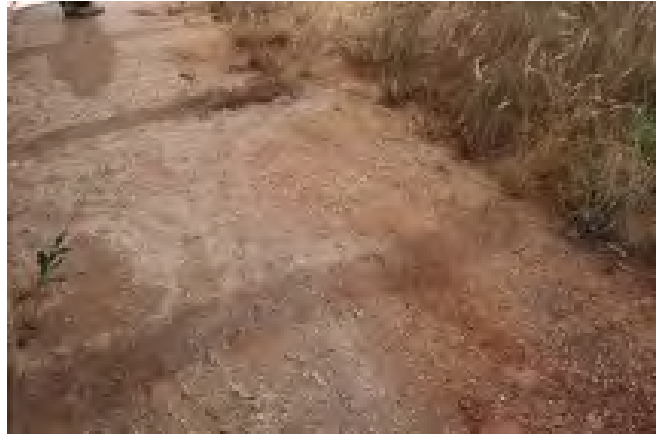
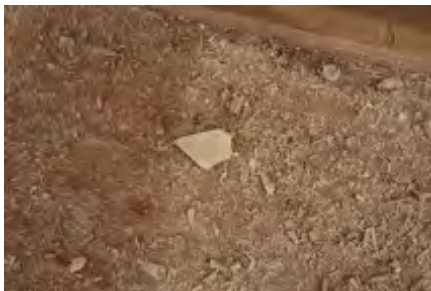
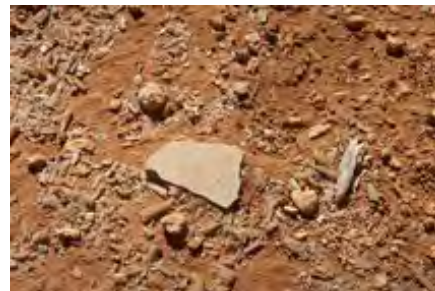
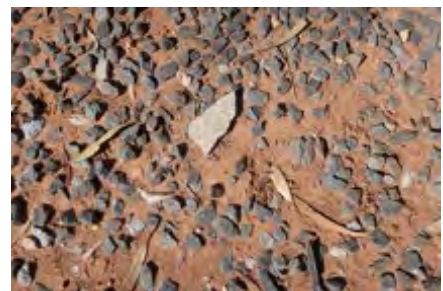
**Area 1**

**Shed LB98 Tennis Courts / Recreation: rear of building. The Debris - Broken (Debris) has Asbestos Containing Material (ACM) present.**

RISK ASSESSMENT					
Type of Asbestos or Hazardous Material	Chrysotile	Condition	POOR	Likelihood of Damage	H (High) - almost certain
	Sample taken 62090-001	Activity	Moderate		
		Sealed	No	Friability	Exposed Fibres
		Labelled	No	Exposure Risk	High - Short term exposure risk
		Quantity

Debris on Surface

RISK CONTROL					
Priority	IMMEDIATE	Label Required	Yes	Re- Audit Date	10 Feb 2022
Action	Restrict access and target for imminent removal				
Recommendation	Debris on Surface - The Debris requires immediate cleanup and disposal with specialised equipment and with licensed removalist to safely remove the asbestos debris.				
Legislative Requirements Victorian Regulation 2007	ACM debris visible. Recommend cleanup by licensed Asbestos Removalist. Warning labels should be affixed. Avoid mechanical damage and abrasion. Remove if refurbishment, structural alteration or demolition is to be carried out in this area. Re-inspect every 12 months or earlier if disturbed or removed in accordance with the Victorian OH&S Regulation 2017. All remedial/removal repairs require a Clearance Inspection & Certificate to be recorded by an approved and competent assessor.

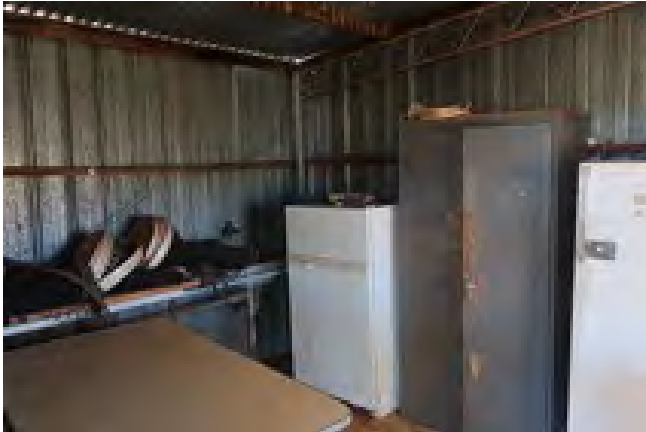
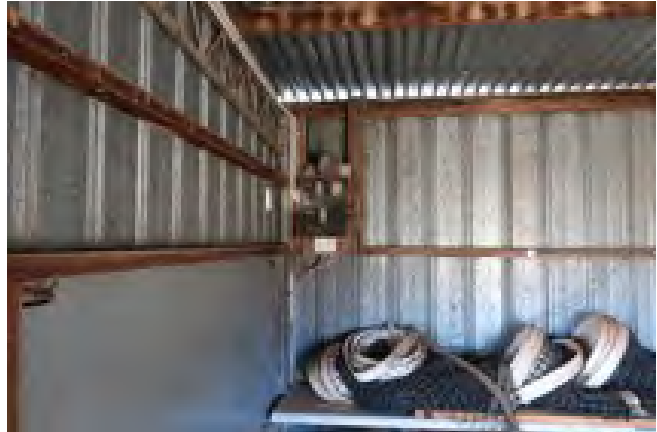
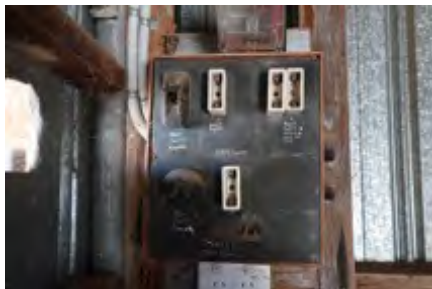
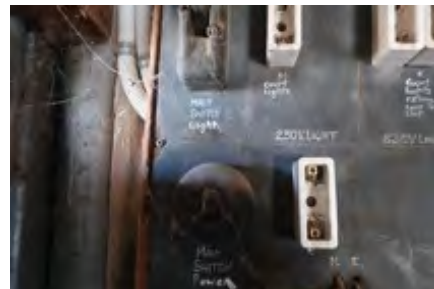
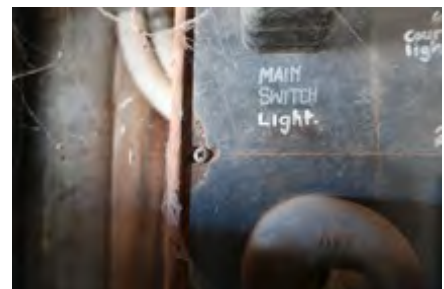
**Shed LB98 Tennis Courts / Recreation: Storage. The Electrical board (Backing Board (Zelemite)) has Asbestos Containing Material (ACM) present.**

RISK ASSESSMENT					
Type of Asbestos or Hazardous Material	No sample taken - Visual ID	Condition	AVERAGE	Likelihood of Damage	L (Low) – possible
		Activity	Moderate		
		Sealed	Yes	Friability	Exposed Fibres
		Labelled	Y	Exposure Risk	Medium - Moderate risk
		Quantity

Broken sections

Priority	HIGH	Label Required	Yes	Re- Audit Date	10 Feb 2022
Action	Remedial repairs required - seal exposed edges or replace or laminate over damaged material				
Recommendation	Broken sections - The damaged area requires immediate remedial repairs. It is recommended the asbestos sheeting be replaced (preferred) or edges sealed with approved sealant and then the area be concealed by laminating (sheeting).				
Legislative Requirements Victorian Regulation 2007	Damaged ACM visible in area. Requires IMMEDIATE ATTENTION. WARNING labels should be affixed. Avoid mechanical damage and abrasion. Remove if refurbishment, structural alteration or demolition is to be carried out in this area. Re-inspect every 12 months or earlier if disturbed or removed in accordance with the Victorian OH&S Regulation 2017. All remedial/removal repairs require a Clearance Inspection & Certificate to be recorded by an approved and competent assessor.
