Asbestos Report

YARRIAMBIACK SHIRE COUNCIL

PROPERTY ADDRESS:
LB38 ELDERLY CITIZEN CLUBROOMS
MAIN STREET
MINYIP VIC 3392

INSPECTION DATE: 10 FEBRUARY 2021
REFERENCE NUMBER: 62093

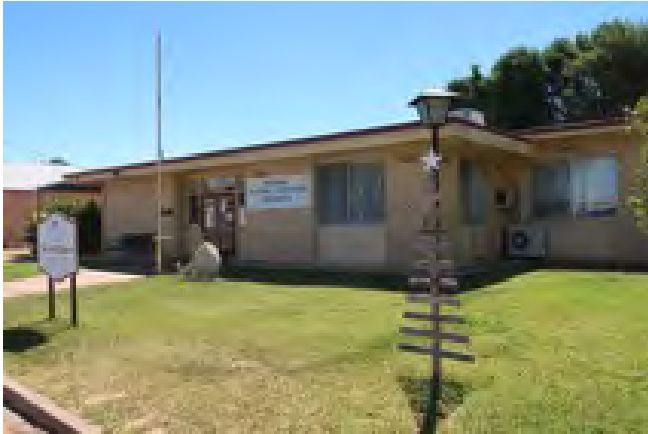
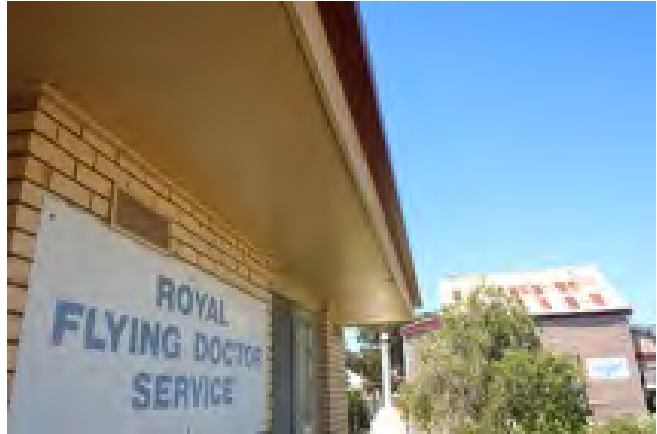
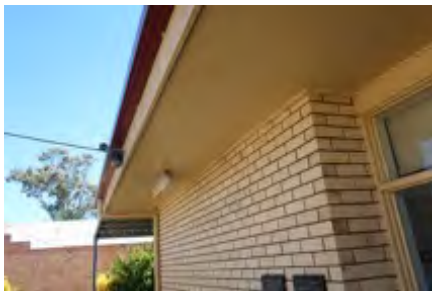
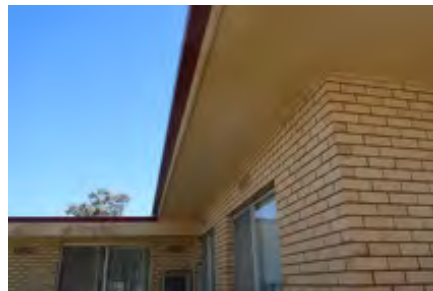
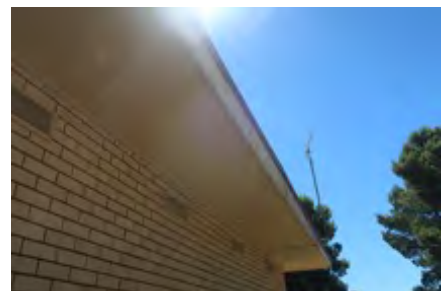
Clubrooms: entire perimeter of building. The Soffit (F C Sheeting) has Asbestos Containing Material (ACM) present.

RISK ASSESSMENT					
Type of Asbestos or Hazardous Material	No sample taken - Visual ID	Condition	GOOD	Likelihood of Damage	L (Low) – possible
		Activity	Moderate		
		Sealed	Yes	Friability	Bonded (non-friable)
		Labelled	No	Exposure Risk	Low - Negligible or low risk
		Quantity

RISK CONTROL					
Priority	MEDIUM	Label Required	Yes	Re- Audit Date	10 Feb 2022
Action	No remedial action required, unless disturbed				
Recommendation	Maintain paint or sealant to ACM surfaces. Particular attention should be given to side edges, ensure paint/sealant covers ALL exposed ACM surfaces.				
Legislative Requirements Victorian Regulation 2007	Warning labels should be affixed. Avoid mechanical damage and abrasion. Remove if refurbishment, structural alteration or demolition is to be carried out in this area. Re-inspect every 12 months or earlier if disturbed or removed in accordance with the Victorian OH&S Regulation 2017. All remedial/removal repairs require a Clearance Inspection & Certificate to be recorded by an approved and competent assessor.

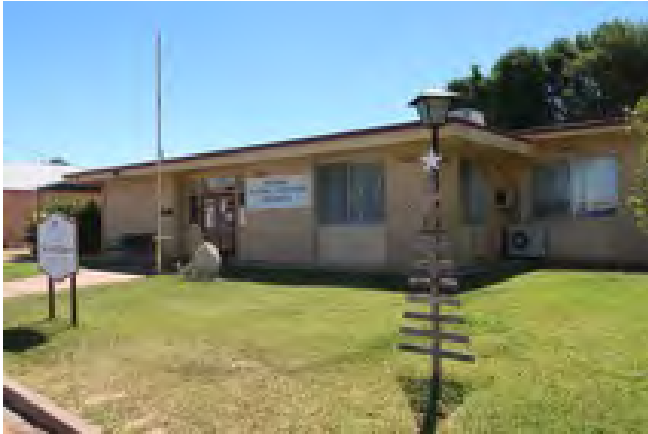
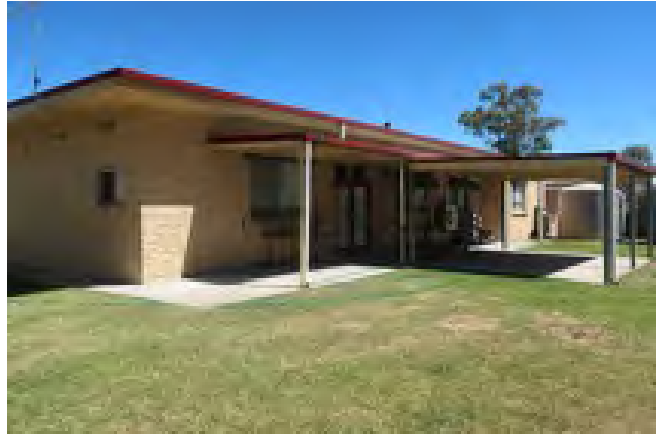
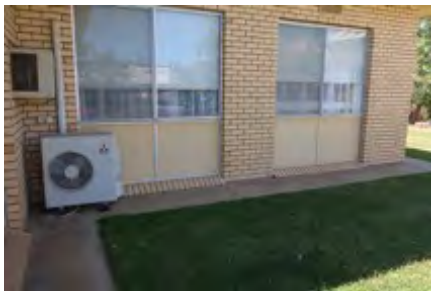
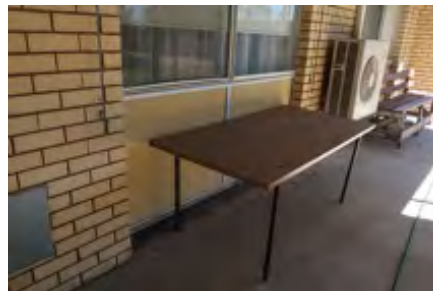
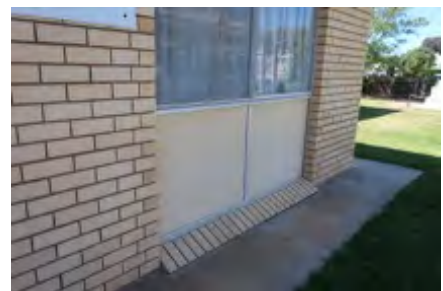
Clubrooms: front & rear of building. The Infill panel/s below windows (F C Sheeting) has Asbestos Containing Material (ACM) present.

RISK ASSESSMENT					
Type of Asbestos or Hazardous Material	No sample taken - Visual ID	Condition	GOOD	Likelihood of Damage	L (Low) – possible
		Activity	Moderate		
		Sealed	Yes	Friability	Bonded (non-friable)
		Labelled	Y	Exposure Risk	Low - Negligible or low risk
		Quantity

Priority	MEDIUM	Label Required	Yes	Re- Audit Date	10 Feb 2022
Action	No remedial action required, unless disturbed				
Recommendation	Maintain paint or sealant to ACM surfaces. Particular attention should be given to side edges, ensure paint/sealant covers ALL exposed ACM surfaces.				
Legislative Requirements Victorian Regulation 2007	Warning labels should be affixed. Avoid mechanical damage and abrasion. Remove if refurbishment, structural alteration or demolition is to be carried out in this area. Re-inspect every 12 months or earlier if disturbed or removed in accordance with the Victorian OH&S Regulation 2017. All remedial/removal repairs require a Clearance Inspection & Certificate to be recorded by an approved and competent assessor.

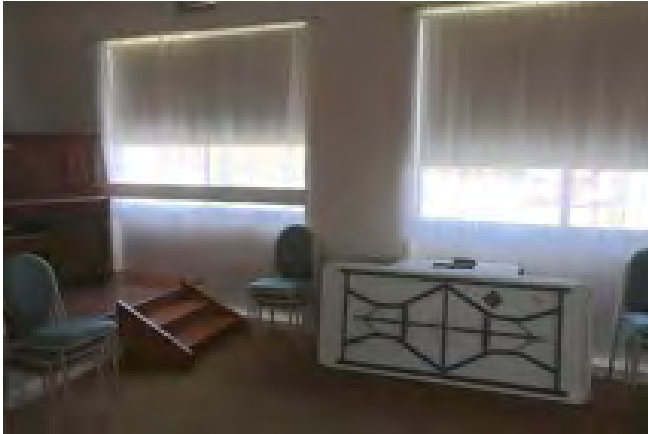
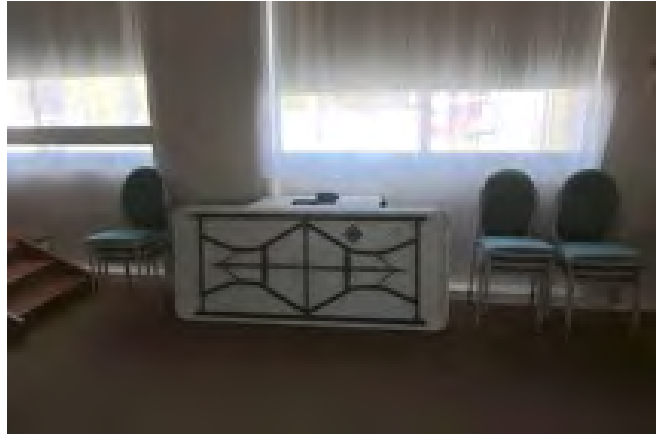
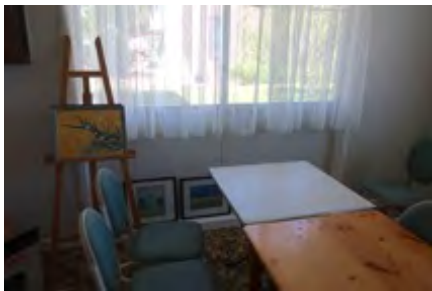
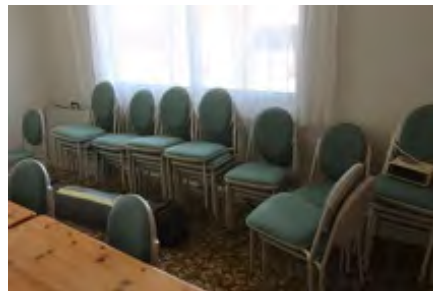
Type of Asbestos or Hazardous Material	No sample taken - Visual ID	Condition	AVERAGE	Likelihood of Damage	L (Low) – possible
		Activity	Moderate		
		Sealed	No	Friability	Bonded (non-friable)
		Labelled	Y	Exposure Risk	Medium - Moderate risk
		Quantity

Raw Material

Priority	HIGH	Label Required	Yes	Re- Audit Date	10 Feb 2022
Action	Remedial repairs required - seal raw material / edges				
Recommendation	Raw material sheeting - The area requires immediate remedial repairs. It is recommended the asbestos material be sealed with an approved membrane.				
Legislative Requirements Victorian Regulation 2007	Damaged ACM visible in area. Requires IMMEDIATE ATTENTION. WARNING labels should be affixed. Avoid mechanical damage and abrasion. Remove if refurbishment, structural alteration or demolition is to be carried out in this area. Re-inspect every 12 months or earlier if disturbed or removed in accordance with the Victorian OH&S Regulation 2017. All remedial/removal repairs require a Clearance Inspection & Certificate to be recorded by an approved and competent assessor.

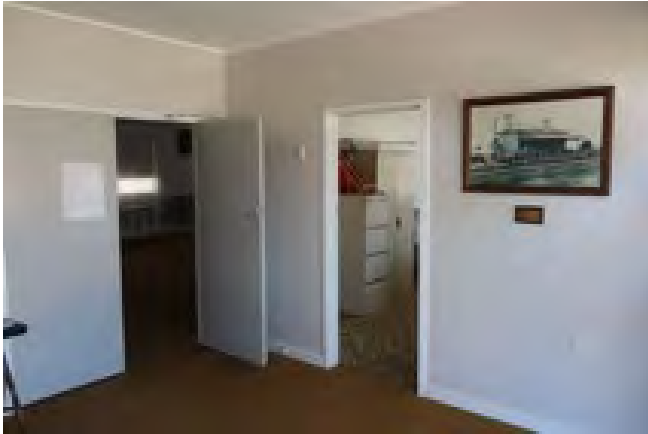
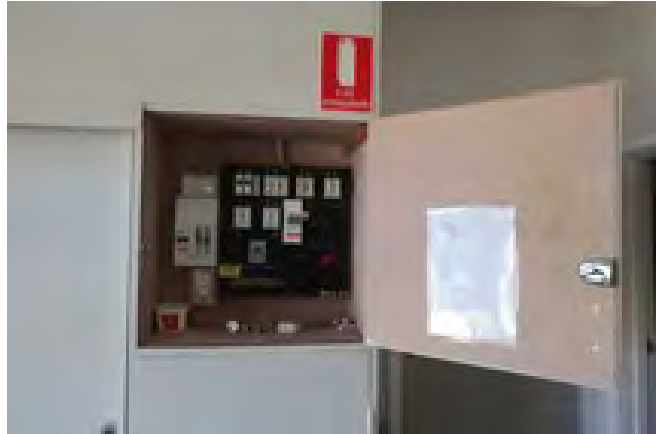
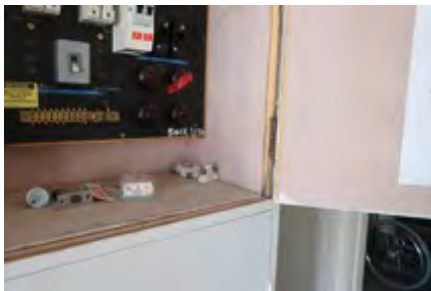
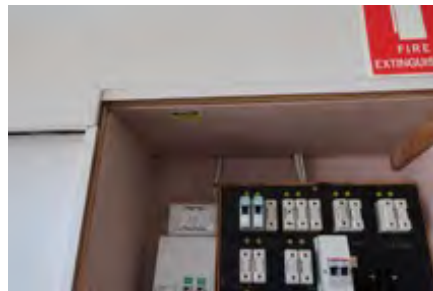
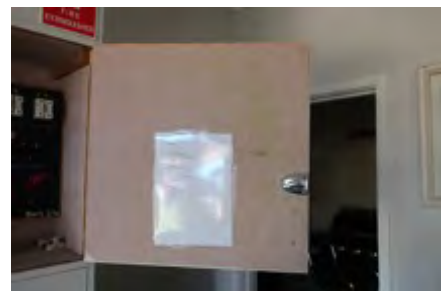
Clubrooms: Entrance. The Electrical Cabinet - lining (F C Sheeting) has Asbestos Containing Material (ACM) present.

RISK ASSESSMENT					
Type of Asbestos or Hazardous Material	No sample taken - Visual ID	Condition	AVERAGE	Likelihood of Damage	L (Low) – possible
		Activity	Moderate	Friability	Bonded (non-friable)
		Sealed	No	Exposure Risk	Medium - Moderate risk
		Labelled	Y		
		Quantity

Raw Material

RISK CONTROL					
Priority	HIGH	Label Required	Yes	Re- Audit Date	10 Feb 2022
Action	Remedial repairs required - seal raw material / edges				
Recommendation	Raw material sheeting - The area requires immediate remedial repairs. It is recommended the asbestos material be sealed with an approved membrane.				
Legislative Requirements Victorian Regulation 2007	Damaged ACM visible in area. Requires IMMEDIATE ATTENTION. WARNING labels should be affixed. Avoid mechanical damage and abrasion. Remove if refurbishment, structural alteration or demolition is to be carried out in this area. Re-inspect every 12 months or earlier if disturbed or removed in accordance with the Victorian OH&S Regulation 2017. All remedial/removal repairs require a Clearance Inspection & Certificate to be recorded by an approved and competent assessor.

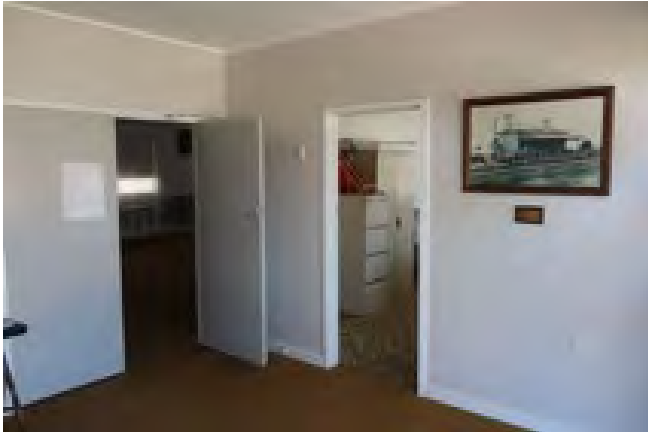
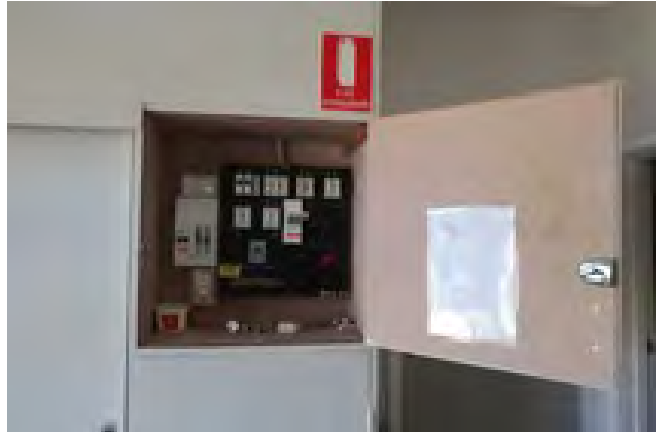
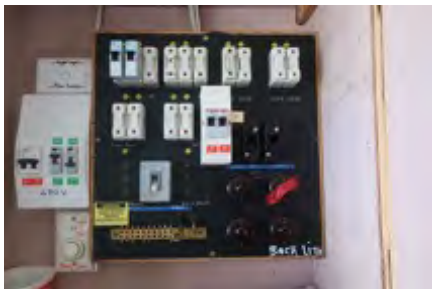
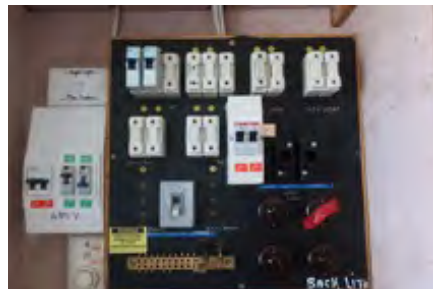
Clubrooms: Entrance. The A: Electrical board; B: Ceramic Fuses (A: Zelemite; B: Cloth Inserts) has Asbestos Containing Material (ACM) present.

RISK ASSESSMENT					
Type of Asbestos or Hazardous Material	Chrysotile	Condition	GOOD	Likelihood of Damage	L (Low) – possible
	Sample taken 62093-001 A: Zelemite;	Activity	Moderate		
		Sealed	Yes	Friability	Bonded (non-friable)
		Labelled	Y	Exposure Risk	Low - Negligible or low risk
		Quantity

RISK CONTROL					
Priority	MEDIUM	Label Required	Yes	Re- Audit Date	10 Feb 2022
Action	No remedial action required, unless disturbed				
Recommendation	Maintain paint or sealant to ACM surfaces. Particular attention should be given to side edges, ensure paint/sealant covers ALL exposed ACM surfaces. Do not remove the fuses without asbestos controls - test for cloth inserts				
Legislative Requirements Victorian Regulation 2007	Warning labels should be affixed. Avoid mechanical damage and abrasion. Remove if refurbishment, structural alteration or demolition is to be carried out in this area. Re-inspect every 12 months or earlier if disturbed or removed in accordance with the Victorian OH&S Regulation 2017. All remedial/removal repairs require a Clearance Inspection & Certificate to be recorded by an approved and competent assessor.

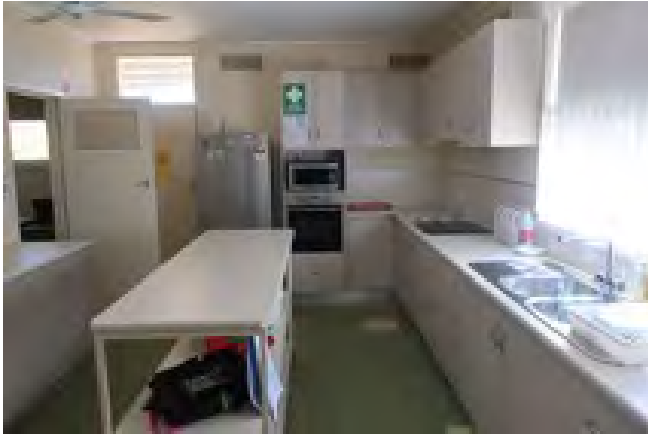
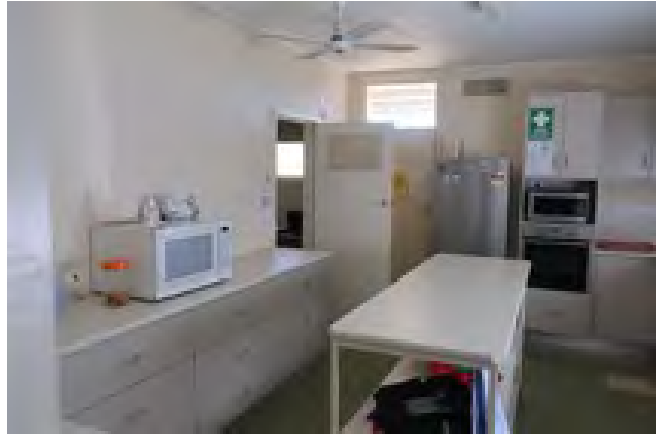
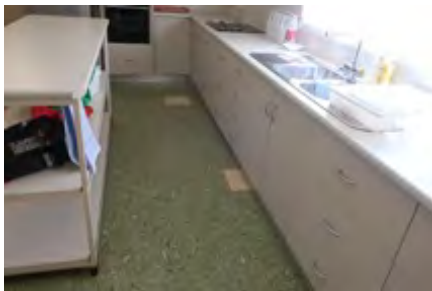
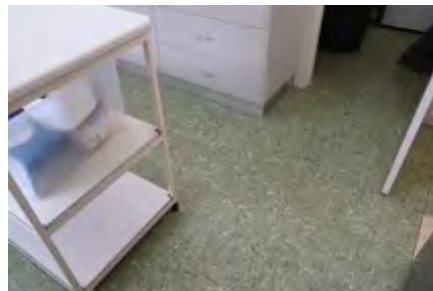
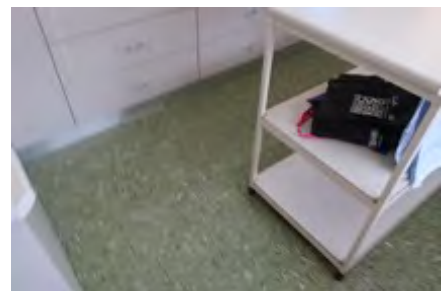
Clubrooms: Kitchen. The Floor (Vinyl Tiles) has Asbestos Containing Material (ACM) present.

RISK ASSESSMENT					
Type of Asbestos or Hazardous Material	Chrysotile	Condition	GOOD	Likelihood of Damage	L (Low) – possible
	Sample taken 62093-002	Activity	Moderate	Friability	Bonded (non-friable)
		Sealed	Yes	Exposure Risk	Low - Negligible or low risk
		Labelled	No		
		Quantity

Priority	MEDIUM	Label Required	Yes	Re- Audit Date	10 Feb 2022
Action	No remedial action required, unless disturbed				
Recommendation	Maintain paint or sealant to ACM surfaces. Particular attention should be given to side edges, ensure paint/sealant covers ALL exposed ACM surfaces.				
Legislative Requirements Victorian Regulation 2007	Warning labels should be affixed. Avoid mechanical damage and abrasion. Remove if refurbishment, structural alteration or demolition is to be carried out in this area. Re-inspect every 12 months or earlier if disturbed or removed in accordance with the Victorian OH&S Regulation 2017. All remedial/removal repairs require a Clearance Inspection & Certificate to be recorded by an approved and competent assessor.

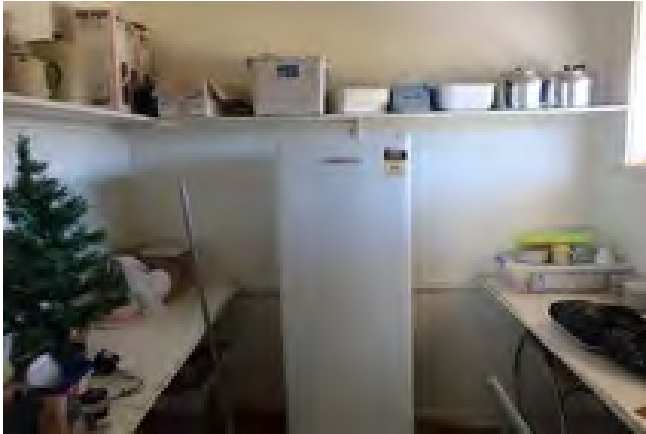
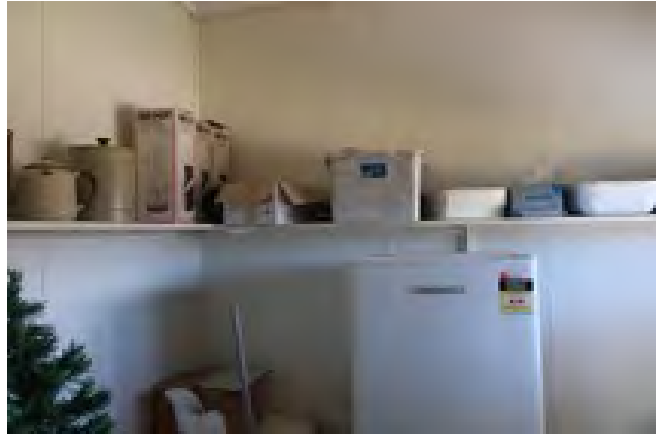
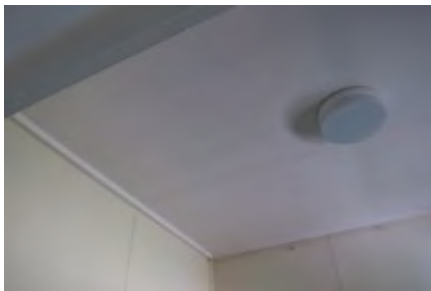
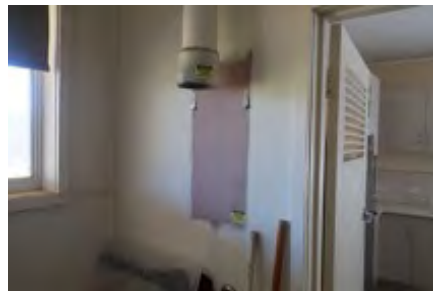
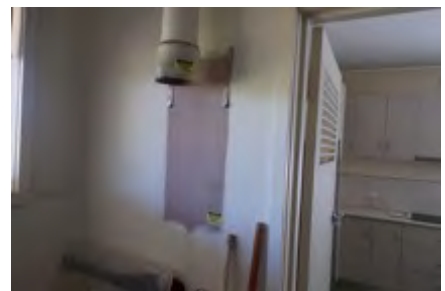
Clubrooms: Kitchen storage. The Walls and Ceiling (F C Sheeting) has Asbestos Containing Material (ACM) present.

RISK ASSESSMENT					
Type of Asbestos or Hazardous Material	Chrysotile	Condition	GOOD	Likelihood of Damage	L (Low) – possible
	Sample taken 62093-003	Activity	Moderate		
		Sealed	Yes	Friability	Bonded (non-friable)
		Labelled	Y	Exposure Risk	Low - Negligible or low risk
		Quantity

RISK CONTROL					
Priority	MEDIUM	Label Required	Yes	Re- Audit Date	10 Feb 2022
Action	No remedial action required, unless disturbed				
Recommendation	Maintain paint or sealant to ACM surfaces. Particular attention should be given to side edges, ensure paint/sealant covers ALL exposed ACM surfaces.				
Legislative Requirements Victorian Regulation 2007	Warning labels should be affixed. Avoid mechanical damage and abrasion. Remove if refurbishment, structural alteration or demolition is to be carried out in this area. Re-inspect every 12 months or earlier if disturbed or removed in accordance with the Victorian OH&S Regulation 2017. All remedial/removal repairs require a Clearance Inspection & Certificate to be recorded by an approved and competent assessor.

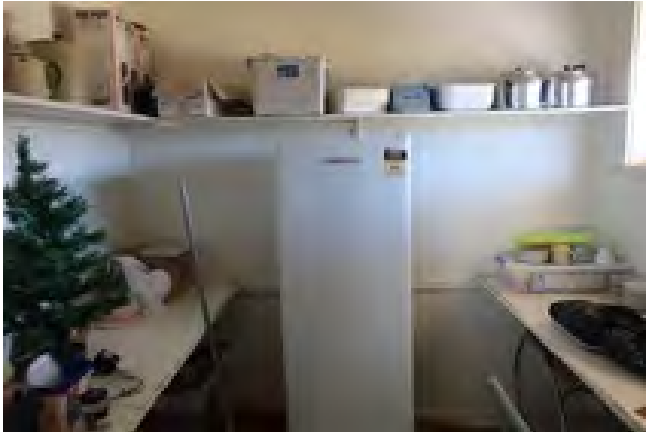
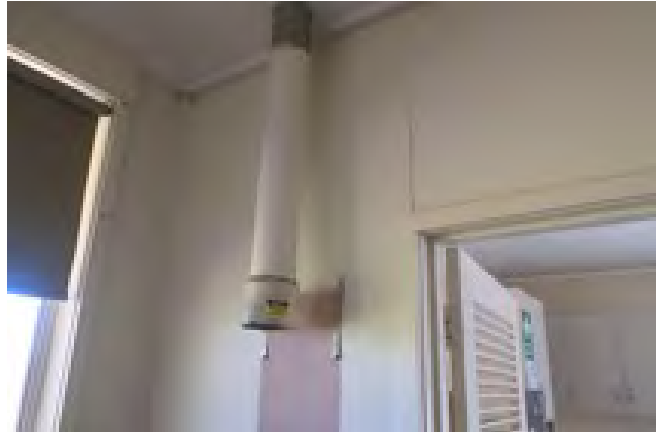
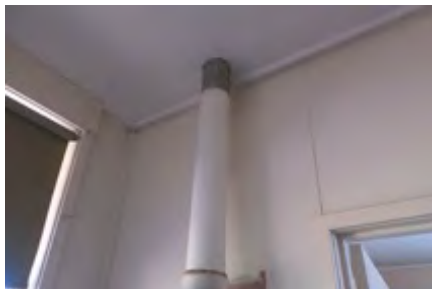
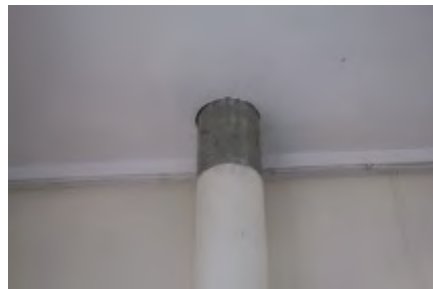
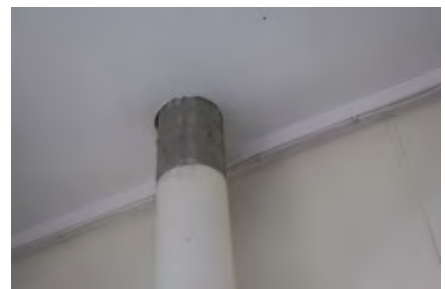
Area 3**Clubrooms: Kitchen storage. The Vent Pipe (Fibrous Cement Product) has Asbestos Containing Material (ACM) present.****RISK ASSESSMENT**

Type of Asbestos or Hazardous Material	No sample taken - Visual ID	Condition	AVERAGE	Likelihood of Damage	L (Low) – possible
		Activity	Low		
		Sealed	No	Friability	Bonded (non-friable)
		Labelled	No	Exposure Risk	Medium - Moderate risk
		Quantity

Raw Material

Priority	HIGH	Label Required	Yes	Re- Audit Date	10 Feb 2022
Action	Remedial repairs required - seal raw material / edges				
Recommendation	Raw material sheeting - The area requires immediate remedial repairs. It is recommended the asbestos material be sealed with an approved membrane.				
Legislative Requirements Victorian Regulation 2007	<p>Damaged ACM visible in area. Requires IMMEDIATE ATTENTION. WARNING labels should be affixed. Avoid mechanical damage and abrasion. Remove if refurbishment, structural alteration or demolition is to be carried out in this area. Re-inspect every 12 months or earlier if disturbed or removed in accordance with the Victorian OH&S Regulation 2017.</p> <p>All remedial/removal repairs require a Clearance Inspection & Certificate to be recorded by an approved and competent assessor.</p>

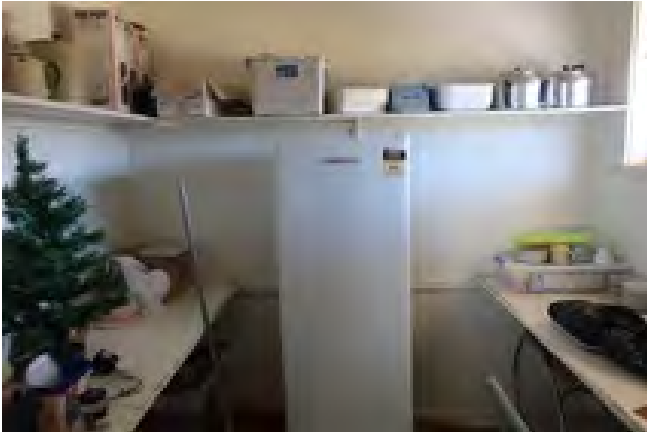
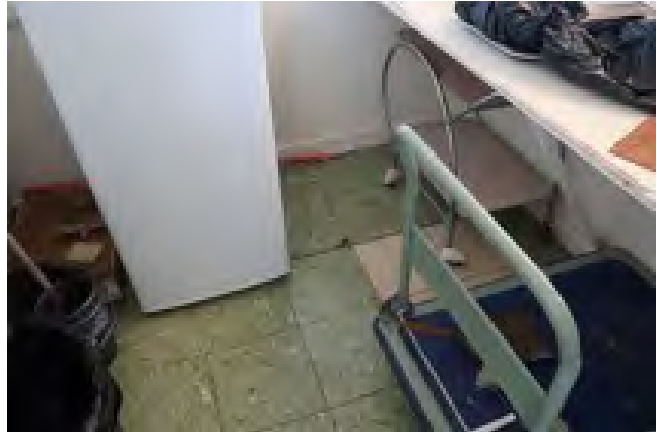
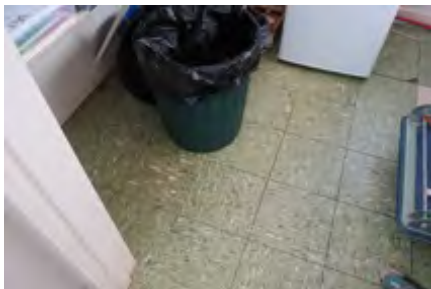
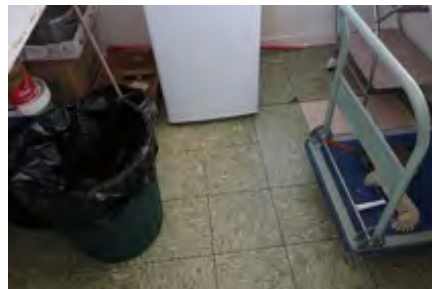
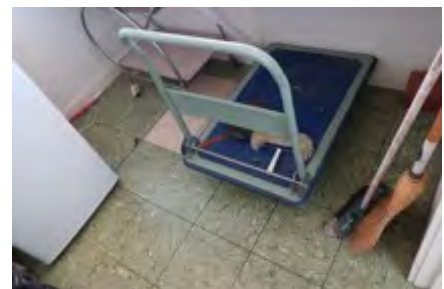
Clubrooms: Kitchen storage. The Floor (Vinyl Tiles) has Asbestos Containing Material (ACM) present.

RISK ASSESSMENT					
Type of Asbestos or Hazardous Material	Chrysotile	Condition	GOOD	Likelihood of Damage	L (Low) – possible
	Same as Sample - 62093 -002	Activity	Moderate		
		Sealed	Yes	Friability	Bonded (non-friable)
		Labelled	Y	Exposure Risk	Low - Negligible or low risk
		Quantity

RISK CONTROL					
Priority	MEDIUM	Label Required	Yes	Re- Audit Date	10 Feb 2022
Action	No remedial action required, unless disturbed				
Recommendation	Maintain paint or sealant to ACM surfaces. Particular attention should be given to side edges, ensure paint/sealant covers ALL exposed ACM surfaces.				
Legislative Requirements Victorian Regulation 2007	Warning labels should be affixed. Avoid mechanical damage and abrasion. Remove if refurbishment, structural alteration or demolition is to be carried out in this area. Re-inspect every 12 months or earlier if disturbed or removed in accordance with the Victorian OH&S Regulation 2017. All remedial/removal repairs require a Clearance Inspection & Certificate to be recorded by an approved and competent assessor.
