Asbestos Report

YARRIAMBIACK SHIRE COUNCIL

PROPERTY ADDRESS:
LB30A PRESCHOOL
29 MAIN STREET
MINYIP VIC 3392

INSPECTION DATE: 10 FEBRUARY 2021
REFERENCE NUMBER: 62094

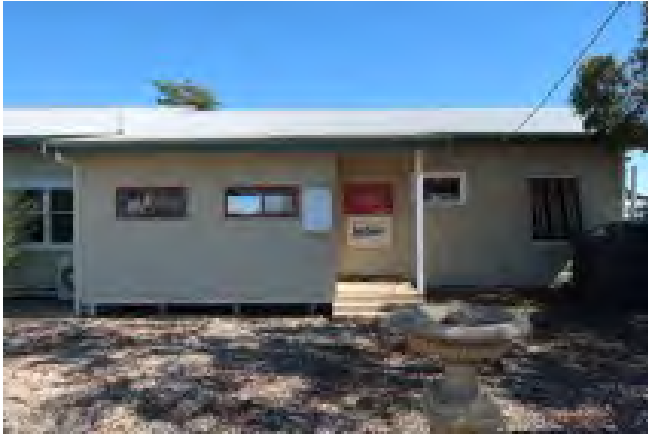
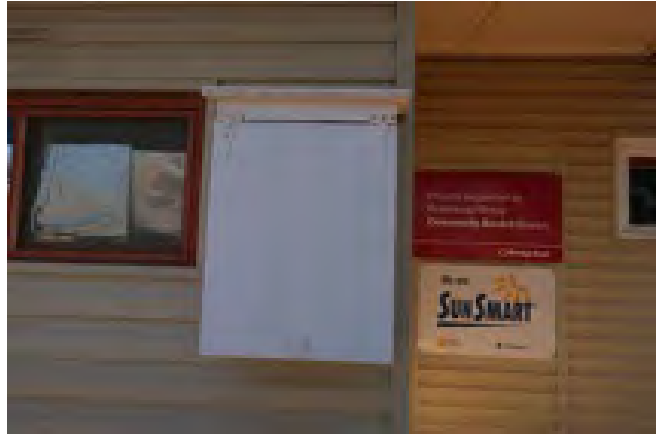
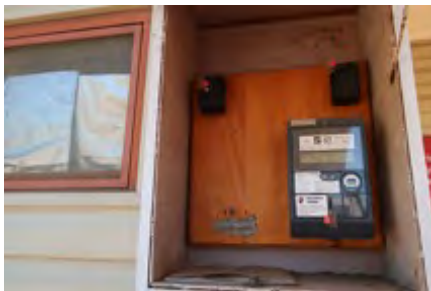
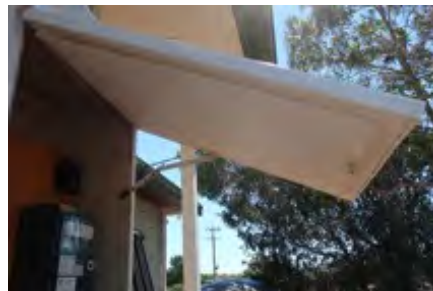
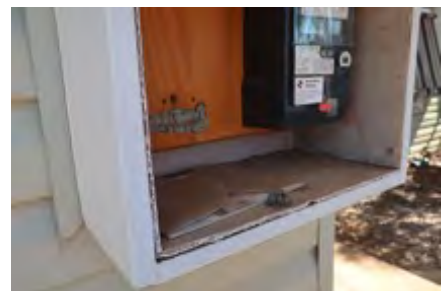
Area 1

Type of Asbestos or Hazardous Material	No sample taken - Visual ID	Condition	AVERAGE	Likelihood of Damage	L (Low) – possible
		Activity	Moderate		
		Sealed	No	Friability	Bonded (non-friable)
		Labelled	Y	Exposure Risk	Medium - Moderate risk
		Quantity

Raw Material

Priority	HIGH	Label Required	Yes	Re- Audit Date	10 Feb 2022
Action	Remedial repairs required - seal raw material / edges				
Recommendation	Raw material sheeting - The area requires immediate remedial repairs. It is recommended the asbestos material be sealed with an approved membrane.				
Legislative Requirements Victorian Regulation 2007	Damaged ACM visible in area. Requires IMMEDIATE ATTENTION. WARNING labels should be affixed. Avoid mechanical damage and abrasion. Remove if refurbishment, structural alteration or demolition is to be carried out in this area. Re-inspect every 12 months or earlier if disturbed or removed in accordance with the Victorian OH&S Regulation 2017. All remedial/removal repairs require a Clearance Inspection & Certificate to be recorded by an approved and competent assessor.

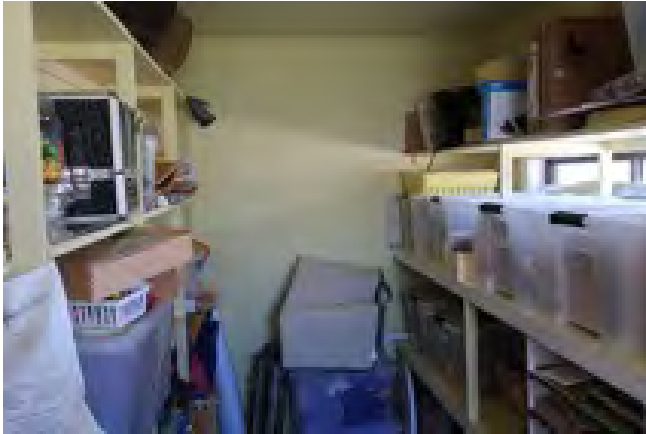
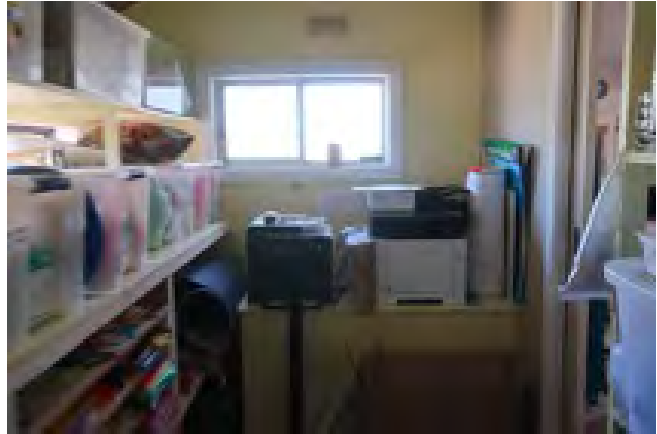
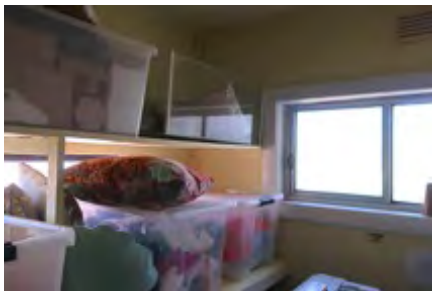
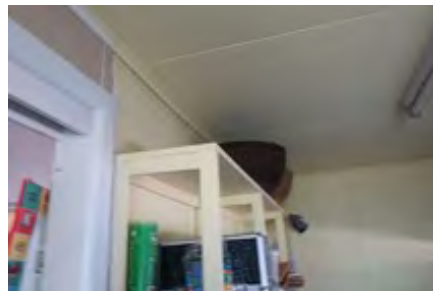
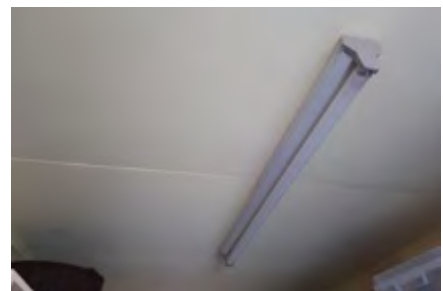
LB30A Preschool: Office - storeroom. The Walls and Ceiling (F C Sheeting) has Asbestos Containing Material (ACM) present.

RISK ASSESSMENT					
Type of Asbestos or Hazardous Material	Chrysotile	Condition	GOOD	Likelihood of Damage	L (Low) – possible
	Sample taken 62094-002	Activity	Moderate		
		Sealed	Yes	Friability	Bonded (non-friable)
		Labelled	No	Exposure Risk	Low - Negligible or low risk
		Quantity

Maintain paint or sealant

Priority	MEDIUM	Label Required	Yes	Re- Audit Date	10 Feb 2022
Action	No remedial action required, unless disturbed				
Recommendation	Maintain paint or sealant to ACM surfaces. Particular attention should be given to side edges, ensure paint/sealant covers ALL exposed ACM surfaces.				
Legislative Requirements Victorian Regulation 2007	Warning labels should be affixed. Avoid mechanical damage and abrasion. Remove if refurbishment, structural alteration or demolition is to be carried out in this area. Re-inspect every 12 months or earlier if disturbed or removed in accordance with the Victorian OH&S Regulation 2017. All remedial/removal repairs require a Clearance Inspection & Certificate to be recorded by an approved and competent assessor.

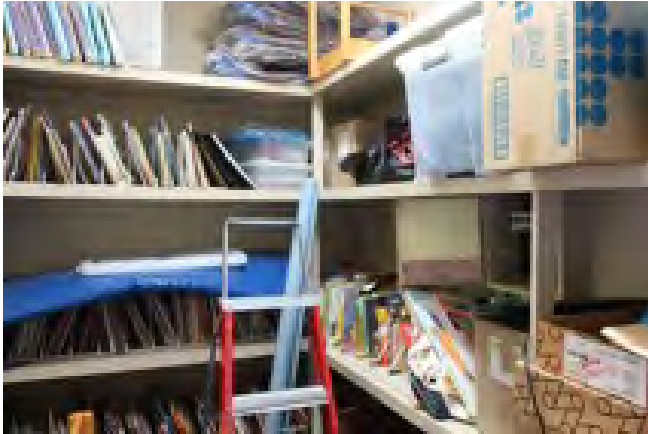
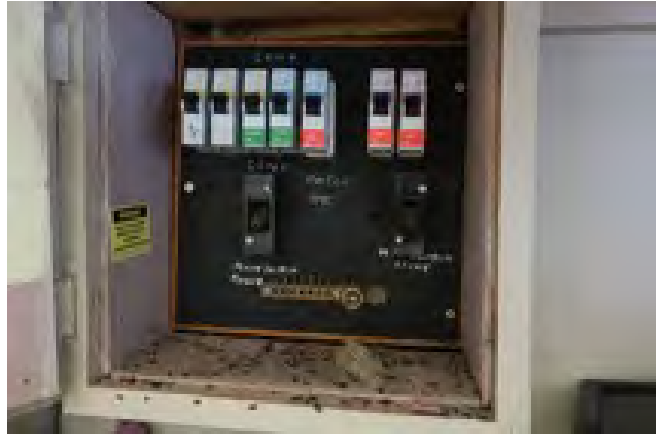
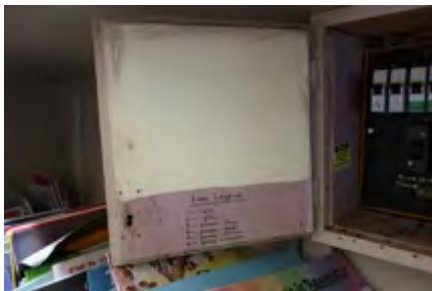
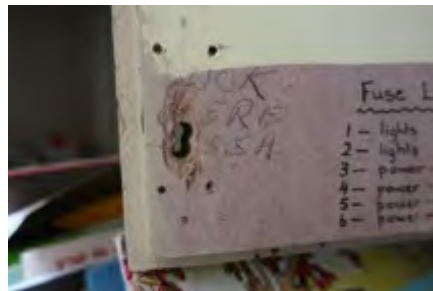
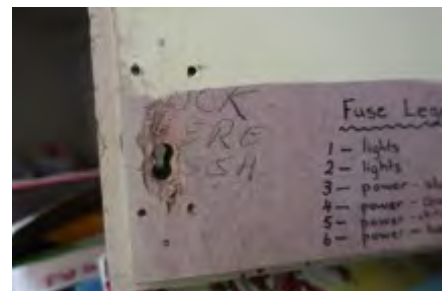
LB30A Preschool: Storeroom. The Electrical Cabinet - lining (F C Sheeting) has Asbestos Containing Material (ACM) present.

RISK ASSESSMENT					
Type of Asbestos or Hazardous Material	No sample taken - Visual ID	Condition	AVERAGE	Likelihood of Damage	L (Low) – possible
		Activity	Moderate	Friability	Bonded (non-friable)
		Sealed	No	Exposure Risk	Medium - Moderate risk
		Labelled	Y		
		Quantity

Raw Material

RISK CONTROL					
Priority	HIGH	Label Required	Yes	Re- Audit Date	10 Feb 2022
Action	Remedial repairs required - seal raw material / edges				
Recommendation	Raw material sheeting - The area requires immediate remedial repairs. It is recommended the asbestos material be sealed with an approved membrane.				
Legislative Requirements Victorian Regulation 2007	Damaged ACM visible in area. Requires IMMEDIATE ATTENTION. WARNING labels should be affixed. Avoid mechanical damage and abrasion. Remove if refurbishment, structural alteration or demolition is to be carried out in this area. Re-inspect every 12 months or earlier if disturbed or removed in accordance with the Victorian OH&S Regulation 2017. All remedial/removal repairs require a Clearance Inspection & Certificate to be recorded by an approved and competent assessor.

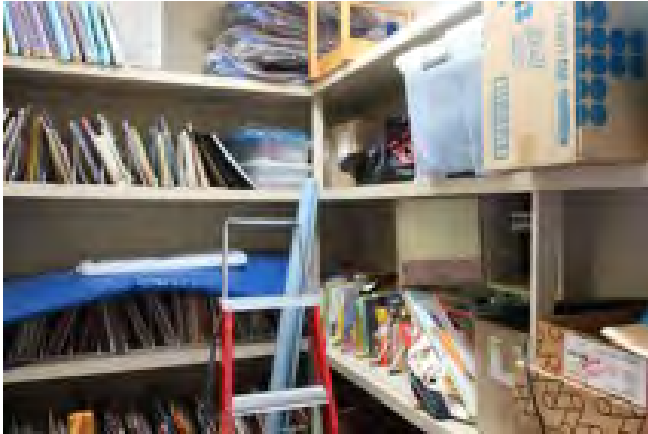
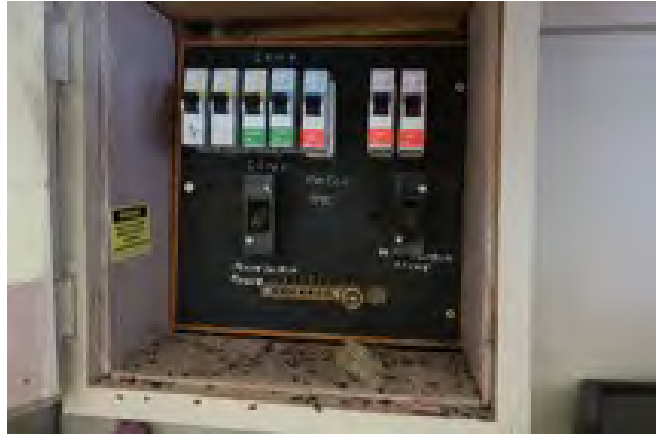
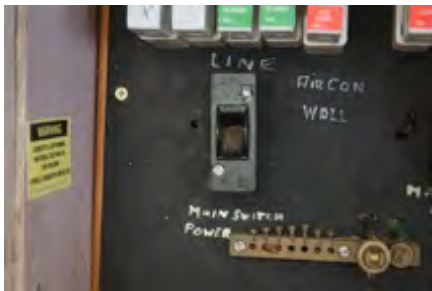
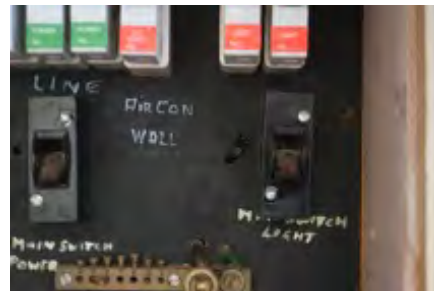
LB30A Preschool: Storeroom. The Electrical board (Backing Board (Zelemite)) has Asbestos Containing Material (ACM) present.

RISK ASSESSMENT					
Type of Asbestos or Hazardous Material	No sample taken - Visual ID	Condition	AVERAGE	Likelihood of Damage	L (Low) – possible
		Activity	Moderate		
		Sealed	Yes	Friability	Exposed Fibres
		Labelled	Y	Exposure Risk	Medium - Moderate risk
		Quantity

Penetration Holes

RISK CONTROL					
Priority	HIGH	Label Required	Yes	Re- Audit Date	10 Feb 2022
Action	Remedial repairs required - seal raw material / edges				
Recommendation	Penetration Holes - The exposed edges require approved sealant. It is further recommended the gaps be filled with sealant.				
Legislative Requirements Victorian Regulation 2007	Damaged ACM visible in area. Requires IMMEDIATE ATTENTION. WARNING labels should be affixed. Avoid mechanical damage and abrasion. Remove if refurbishment, structural alteration or demolition is to be carried out in this area. Re-inspect every 12 months or earlier if disturbed or removed in accordance with the Victorian OH&S Regulation 2017. All remedial/removal repairs require a Clearance Inspection & Certificate to be recorded by an approved and competent assessor.
