Asbestos Report

YARRIAMBIACK SHIRE COUNCIL

PROPERTY ADDRESS:
LR2B CARAVAN PARK
48 LAKE STREET
MURTOA VIC 3390

INSPECTION DATE: 10 FEBRUARY 2021
REFERENCE NUMBER: 62095

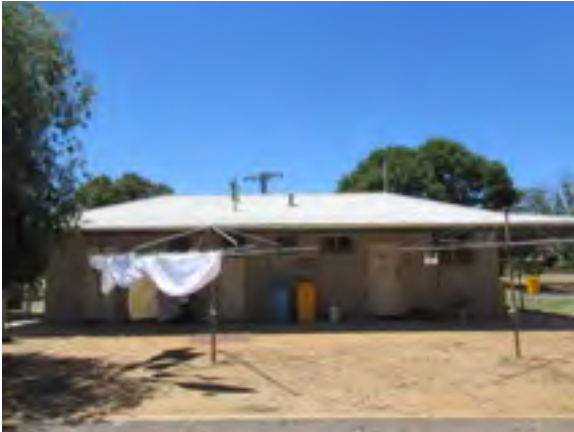
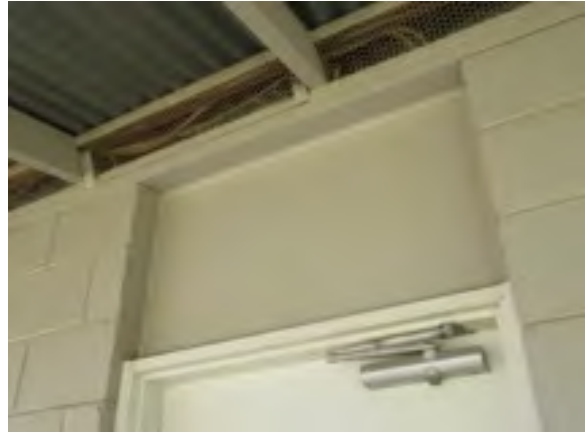
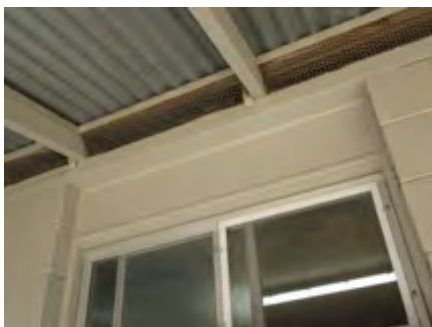
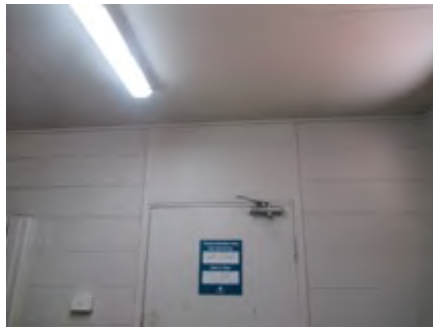
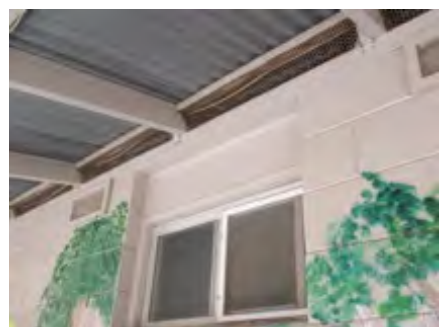
Area 3

Toilet block: External & Internal. The Infill panel/s above windows (F C Sheeting) has Asbestos Containing Material (ACM) present.

RISK ASSESSMENT					
Type of Asbestos or Hazardous Material	No sample taken - Visual ID	Condition	GOOD	Likelihood of Damage	L (Low) – possible
		Activity	Moderate		
		Sealed	Yes	Friability	Bonded (non-friable)
		Labelled	Y	Exposure Risk	Low - Negligible or low risk
		Quantity

Priority	MEDIUM	Label Required	Yes	Re- Audit Date	10 Feb 2022
Action	No remedial action required, unless disturbed				
Recommendation	Maintain paint or sealant to ACM surfaces. Particular attention should be given to side edges, ensure paint/sealant covers ALL exposed ACM surfaces.				
Legislative Requirements Victorian Regulation 2007	Warning labels should be affixed. Avoid mechanical damage and abrasion. Remove if refurbishment, structural alteration or demolition is to be carried out in this area. Re-inspect every 12 months or earlier if disturbed or removed in accordance with the Victorian OH&S Regulation 2017. All remedial/removal repairs require a Clearance Inspection & Certificate to be recorded by an approved and competent assessor.

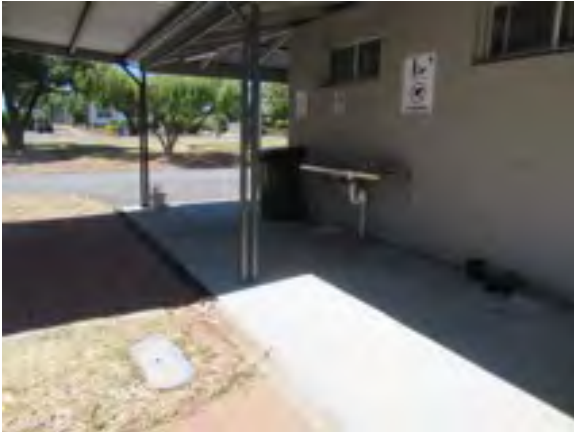
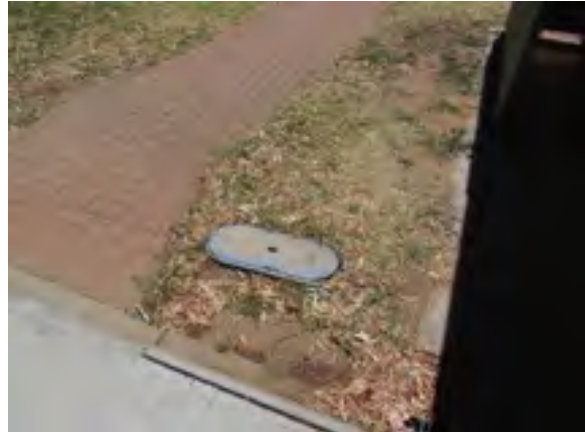
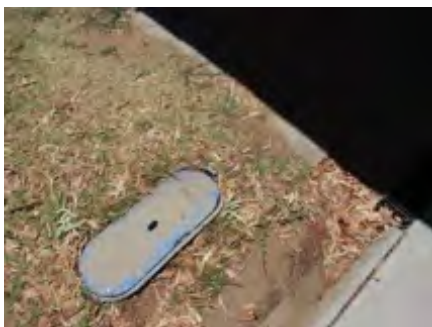
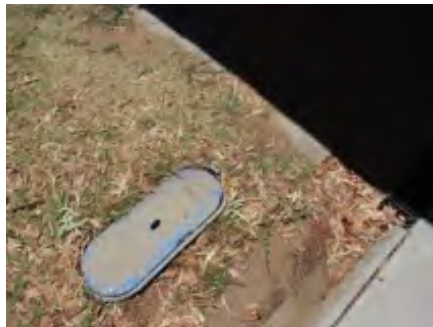
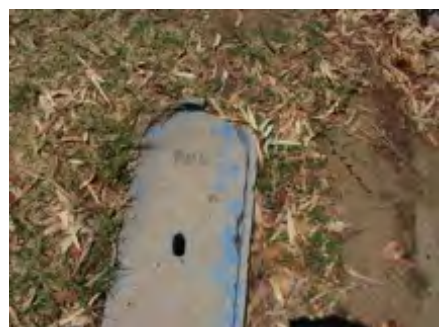
Toilet block: front of building. The Service pit (Fibrous Cement Product) has Asbestos Containing Material (ACM) present.

RISK ASSESSMENT					
Type of Asbestos or Hazardous Material	No sample taken - Visual ID	Condition	AVERAGE	Likelihood of Damage	M (Medium) - likely
		Activity	Moderate		
		Sealed	No	Friability	Bonded (non-friable)
		Labelled	Y	Exposure Risk	Medium - Moderate risk
		Quantity

Raw material sheeting - The area requires immediate remedial repairs. It is recommended the asbestos material be sealed with an approved membrane.

RISK CONTROL					
Priority	HIGH	Label Required	Yes	Re- Audit Date	10 Feb 2022
Action	Remedial repairs required - seal raw material / edges				
Recommendation	Raw material sheeting - The area requires immediate remedial repairs. It is recommended the asbestos material be sealed with an approved membrane.				
Legislative Requirements Victorian Regulation 2007	Damaged ACM visible in area. Requires IMMEDIATE ATTENTION. WARNING labels should be affixed. Avoid mechanical damage and abrasion. Remove if refurbishment, structural alteration or demolition is to be carried out in this area. Re-inspect every 12 months or earlier if disturbed or removed in accordance with the Victorian OH&S Regulation 2017. All remedial/removal repairs require a Clearance Inspection & Certificate to be recorded by an approved and competent assessor.

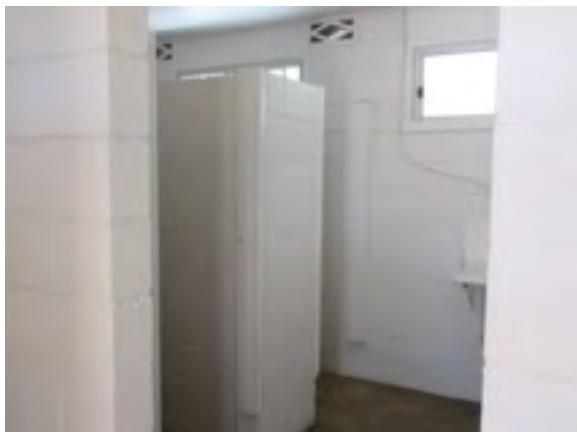
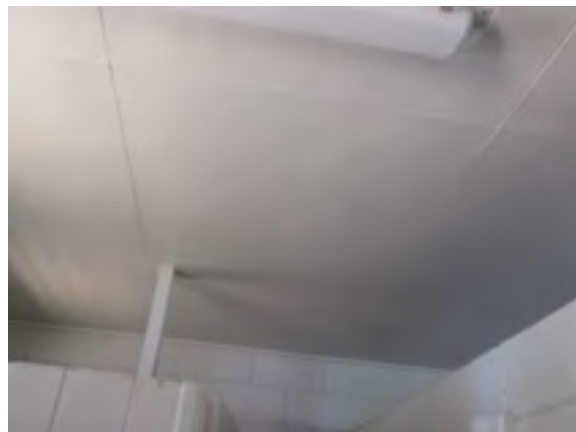
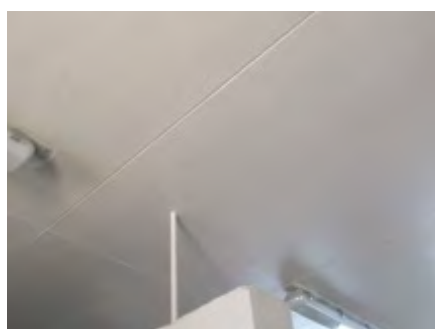
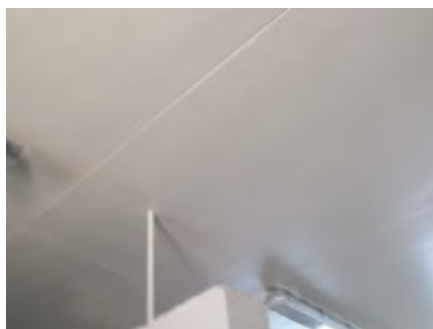
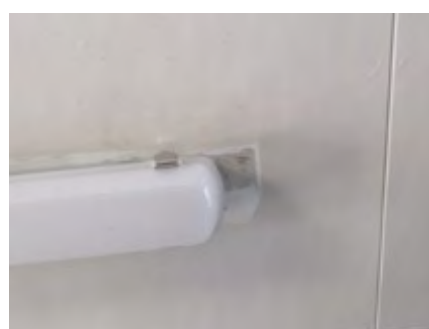
Area 4**Toilet block: Female bathroom. The Ceiling (F C Sheeting) has Asbestos Containing Material (ACM) present.****RISK ASSESSMENT**

Type of Asbestos or Hazardous Material	Chrysotile	Condition	GOOD	Likelihood of Damage	L (Low) – possible
	Same as Sample - 62095 -001	Activity	Moderate		
		Sealed	Yes	Friability	Bonded (non-friable)
		Labelled	Y	Exposure Risk	Low - Negligible or low risk
		Quantity

Priority	MEDIUM	Label Required	Yes	Re- Audit Date	10 Feb 2022
Action	No remedial action required, unless disturbed				
Recommendation	Maintain paint or sealant to ACM surfaces. Particular attention should be given to side edges, ensure paint/sealant covers ALL exposed ACM surfaces.				
Legislative Requirements Victorian Regulation 2007	Warning labels should be affixed. Avoid mechanical damage and abrasion. Remove if refurbishment, structural alteration or demolition is to be carried out in this area. Re-inspect every 12 months or earlier if disturbed or removed in accordance with the Victorian OH&S Regulation 2017. All remedial/removal repairs require a Clearance Inspection & Certificate to be recorded by an approved and competent assessor.

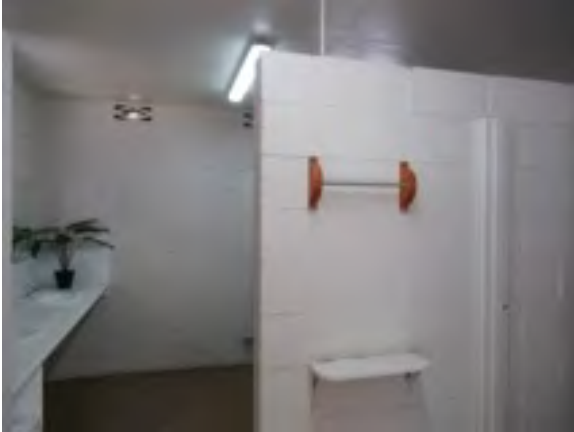
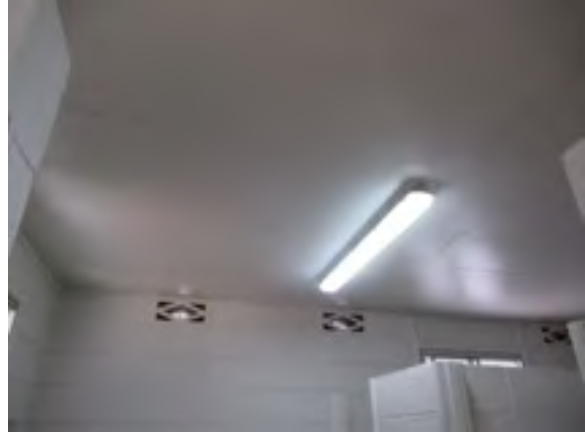
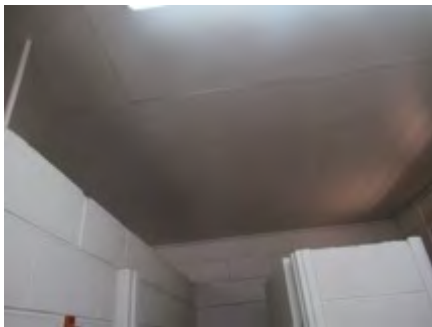
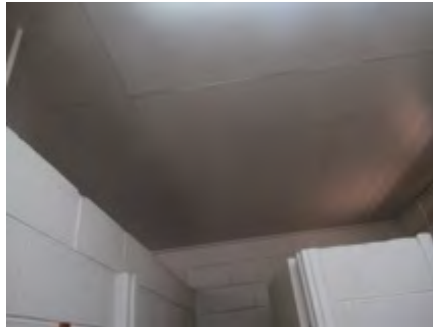
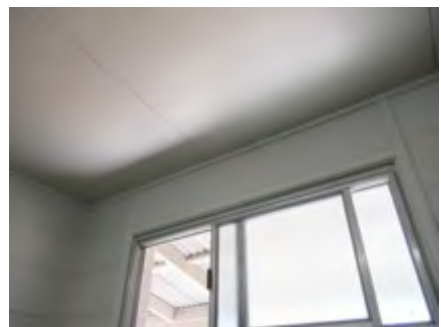
Toilet block: Male bathroom. The Ceiling (F C Sheeting) has Asbestos Containing Material (ACM) present.

RISK ASSESSMENT					
Type of Asbestos or Hazardous Material	Chrysotile	Condition	GOOD	Likelihood of Damage	L (Low) – possible
	Sample taken 62095-001	Activity	Moderate		
		Sealed	Yes	Friability	Bonded (non-friable)
		Labelled	Y	Exposure Risk	Low - Negligible or low risk
		Quantity

Priority	MEDIUM	Label Required	Yes	Re- Audit Date	10 Feb 2022
Action	No remedial action required, unless disturbed				
Recommendation	Maintain paint or sealant to ACM surfaces. Particular attention should be given to side edges, ensure paint/sealant covers ALL exposed ACM surfaces.				
Legislative Requirements Victorian Regulation 2007	Warning labels should be affixed. Avoid mechanical damage and abrasion. Remove if refurbishment, structural alteration or demolition is to be carried out in this area. Re-inspect every 12 months or earlier if disturbed or removed in accordance with the Victorian OH&S Regulation 2017. All remedial/removal repairs require a Clearance Inspection & Certificate to be recorded by an approved and competent assessor.

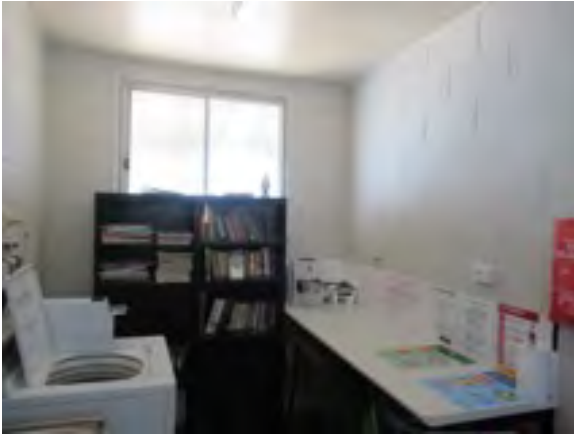
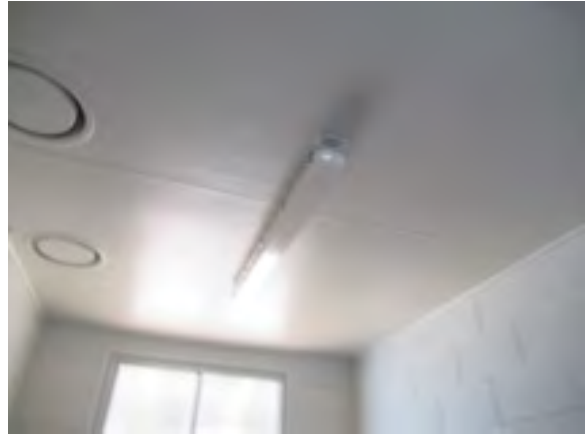
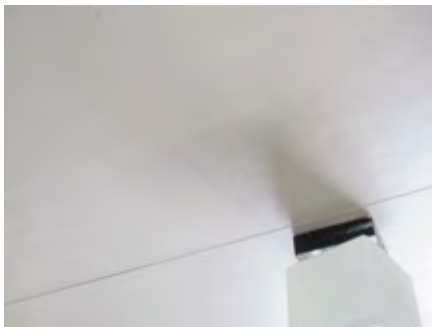
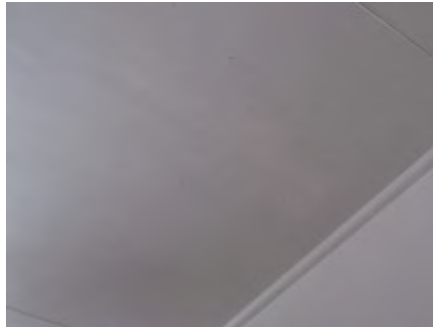
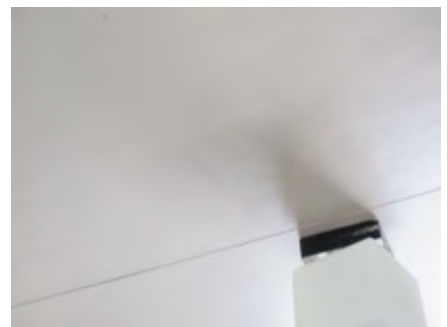
Toilet block Laundry. The Ceiling (F C Sheeting) has Asbestos Containing Material (ACM) present.

RISK ASSESSMENT					
Type of Asbestos or Hazardous Material	Chrysotile	Condition	GOOD	Likelihood of Damage	L (Low) – possible
	Same as Sample - 62095 -001	Activity	Moderate		
		Sealed	Yes	Friability	Bonded (non-friable)
		Labelled	Y	Exposure Risk	Low - Negligible or low risk
		Quantity

RISK CONTROL					
Priority	MEDIUM	Label Required	Yes	Re- Audit Date	10 Feb 2022
Action	No remedial action required, unless disturbed				
Recommendation	Maintain paint or sealant to ACM surfaces. Particular attention should be given to side edges, ensure paint/sealant covers ALL exposed ACM surfaces.				
Legislative Requirements Victorian Regulation 2007	Warning labels should be affixed. Avoid mechanical damage and abrasion. Remove if refurbishment, structural alteration or demolition is to be carried out in this area. Re-inspect every 12 months or earlier if disturbed or removed in accordance with the Victorian OH&S Regulation 2017. All remedial/removal repairs require a Clearance Inspection & Certificate to be recorded by an approved and competent assessor.
