# Asbestos Report

YARRIAMBIACK SHIRE COUNCIL

PROPERTY ADDRESS:  
LR4B IWC. / PRESCHOOL  
38-40 MARMA STREET  
MURTOA VIC 3390

INSPECTION DATE: 10 FEBRUARY 2021  
REFERENCE NUMBER: 62096

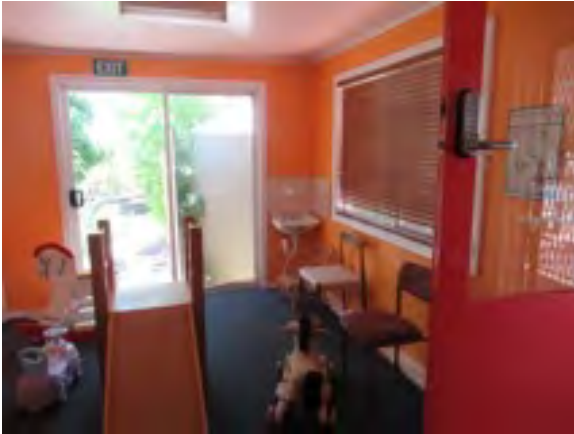
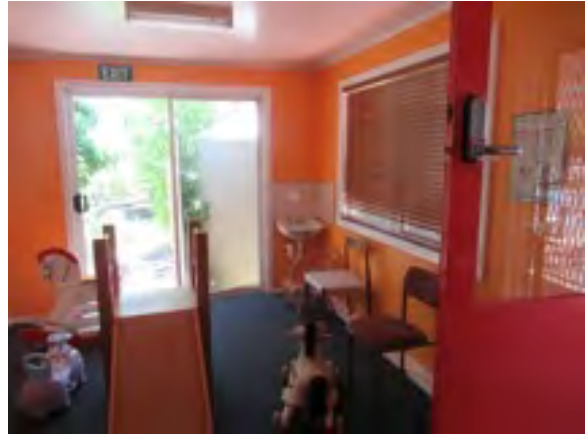
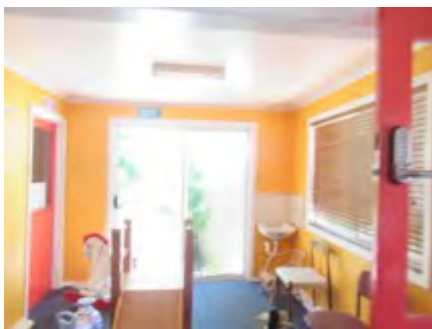
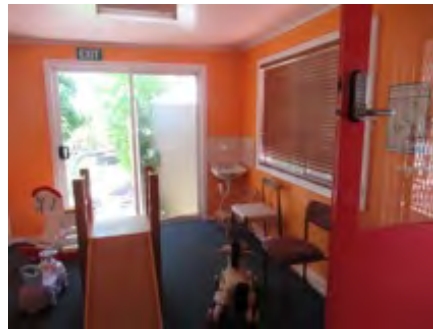
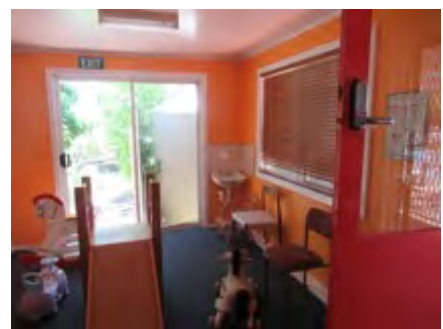
**Area 2**

**LR4B IWC. / Preschool: Rear Entry. The Walls and Ceiling (F C Sheeting) has Asbestos Containing Material (ACM) present.**

RISK ASSESSMENT					
Type of Asbestos or Hazardous Material	Chrysotile	Condition	GOOD	Likelihood of Damage	L (Low) – possible
	Sample taken 62096-002	Activity	Moderate		
		Sealed	Yes	Friability	Bonded (non-friable)
		Labelled	Y	Exposure Risk	Low - Negligible or low risk
		Quantity

Priority	MEDIUM	Label Required	Yes	Re- Audit Date	10 Feb 2022
Action	No remedial action required, unless disturbed				
Recommendation	Maintain paint or sealant to ACM surfaces. Particular attention should be given to side edges, ensure paint/sealant covers ALL exposed ACM surfaces.				
Legislative Requirements Victorian Regulation 2007	Warning labels should be affixed. Avoid mechanical damage and abrasion. Remove if refurbishment, structural alteration or demolition is to be carried out in this area. Re-inspect every 12 months or earlier if disturbed or removed in accordance with the Victorian OH&S Regulation 2017. All remedial/removal repairs require a Clearance Inspection & Certificate to be recorded by an approved and competent assessor.

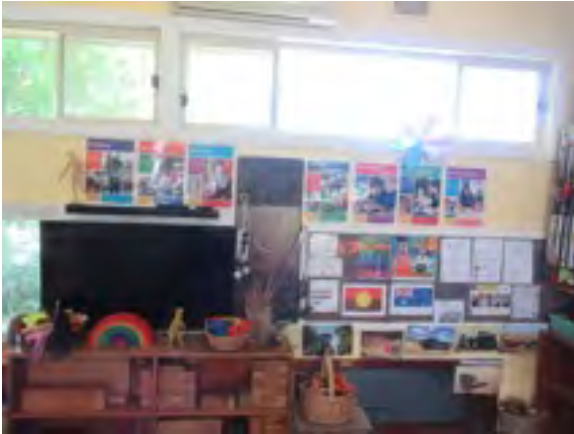
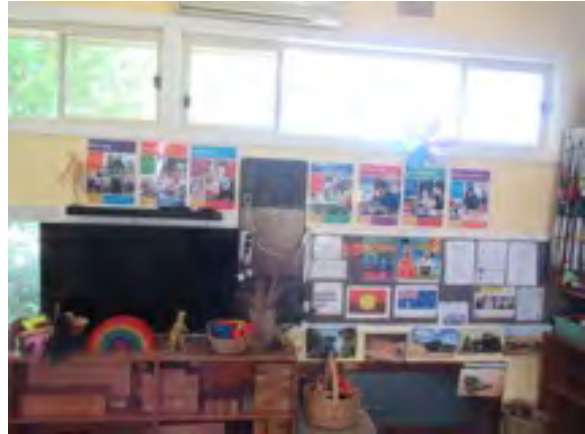
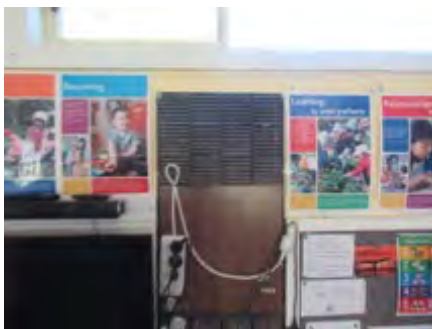
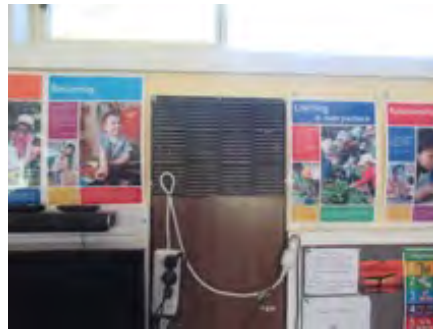
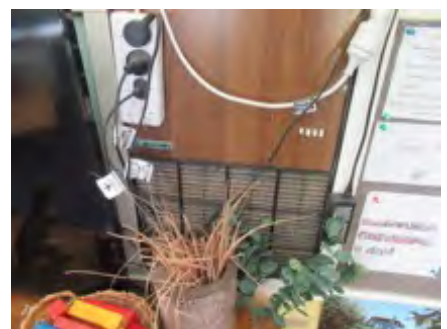
**LR4B IWC. / Preschool: Play Room. The Airconditioner - Heater Element board (Backing board) has Asbestos Containing Material (ACM) present.**

RISK ASSESSMENT					
Type of Asbestos or Hazardous Material	No sample taken - Visual ID	Condition	GOOD	Likelihood of Damage	VL (Very Low)- unlikely or rare
		Activity	Low		
		Sealed	Yes	Friability	Bonded (non-friable)
		Labelled	Y	Exposure Risk	Low - Negligible or low risk
		Quantity

Priority	MEDIUM	Label Required	Yes	Re- Audit Date	10 Feb 2022
Action	No remedial action required, unless disturbed				
Recommendation	Maintain paint or sealant to ACM surfaces. Particular attention should be given to side edges, ensure paint/sealant covers ALL exposed ACM surfaces.				
Legislative Requirements Victorian Regulation 2007	Warning labels should be affixed. Avoid mechanical damage and abrasion. Remove if refurbishment, structural alteration or demolition is to be carried out in this area. Re-inspect every 12 months or earlier if disturbed or removed in accordance with the Victorian OH&S Regulation 2017. All remedial/removal repairs require a Clearance Inspection & Certificate to be recorded by an approved and competent assessor.
