# Asbestos Report

YARRIAMBIACK SHIRE COUNCIL

PROPERTY ADDRESS:  
LB36 SHIRE DEPOT / WORKSHOP  
1469 WIMMERA HIGHWAY  
MURTOA VIC 3390

INSPECTION DATE: 10 FEBRUARY 2021  
REFERENCE NUMBER: 62098

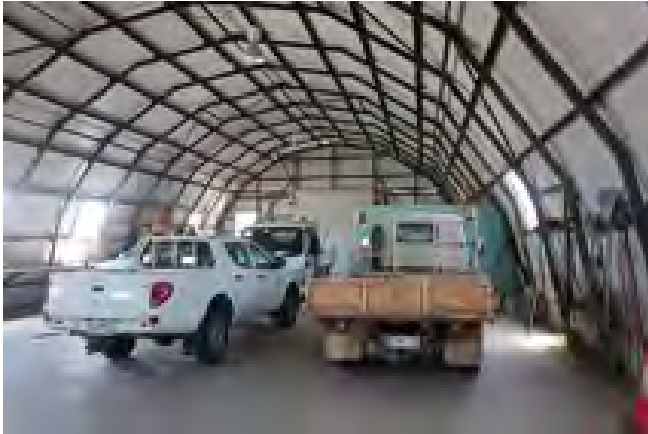
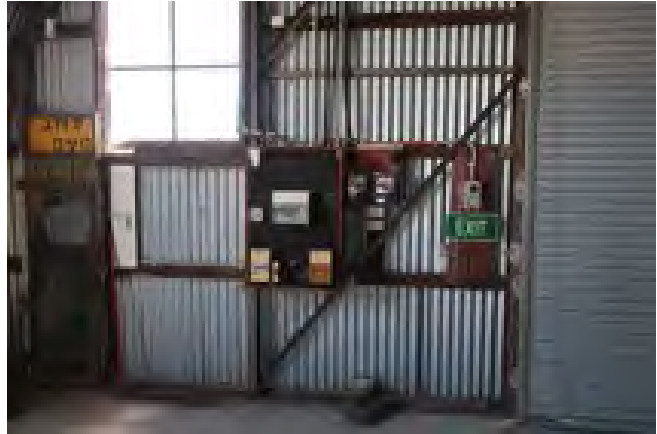
**Area 3**

**Main building LB36 Shire Depot / Workshop: Garage 1. The Electrical board (Backing Board (Zelemite)) has Asbestos Containing Material (ACM) present.**

RISK ASSESSMENT					
Type of Asbestos or Hazardous Material	Chrysotile	Condition	AVERAGE	Likelihood of Damage	L (Low) – possible
	Sample taken 62098-002	Activity	Moderate	Friability	Exposed Fibres
		Sealed	Yes	Exposure Risk	Medium - Moderate risk
		Labelled	Y		
		Quantity

Priority	HIGH	Label Required	Yes	Re- Audit Date	10 Feb 2022
Action	Remedial repairs required - seal raw material / edges				
Recommendation	Penetration Holes - The exposed edges require approved sealant. It is further recommended the gaps be filled with sealant.				
Legislative Requirements Victorian Regulation 2007	Damaged ACM visible in area. Requires IMMEDIATE ATTENTION. WARNING labels should be affixed. Avoid mechanical damage and abrasion. Remove if refurbishment, structural alteration or demolition is to be carried out in this area. Re-inspect every 12 months or earlier if disturbed or removed in accordance with the Victorian OH&S Regulation 2017. All remedial/removal repairs require a Clearance Inspection & Certificate to be recorded by an approved and competent assessor.

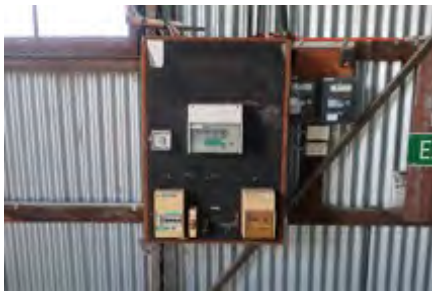
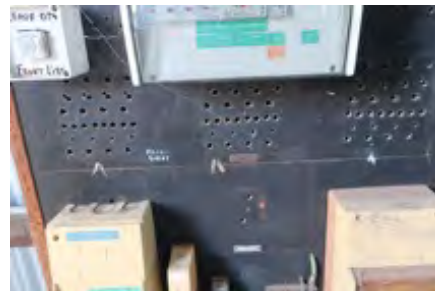
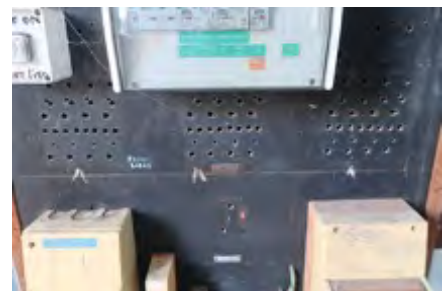
Penetration Holes

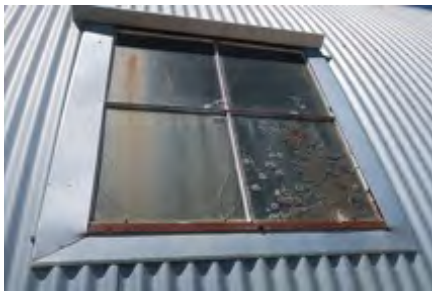
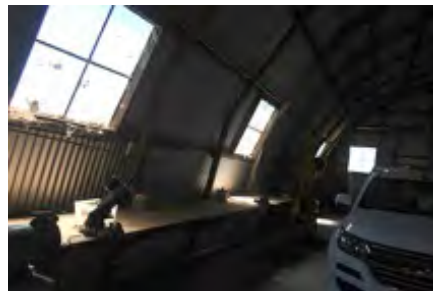
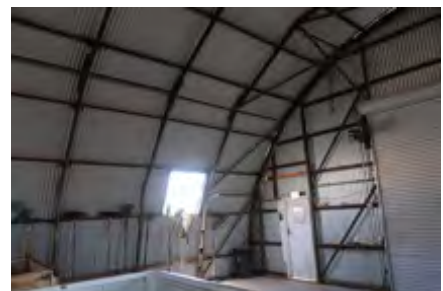
<b>Type of Asbestos or Hazardous Material</b>	No sample taken - Visual ID	<b>Condition</b>	GOOD	<b>Likelihood of Damage</b>	L (Low) – possible
		<b>Activity</b>	Moderate		
		<b>Sealed</b>	Yes	<b>Friability</b>	Bonded (non-friable)
		<b>Labelled</b>	Y	<b>Exposure Risk</b>	Low - Negligible or low risk
		<b>Quantity</b>

<b>Priority</b>	MEDIUM	<b>Label Required</b>	Yes	<b>Re- Audit Date</b>	10 Feb 2022
<b>Action</b>	No remedial action required, unless disturbed				
<b>Recommendation</b>	Maintain paint or sealant to ACM surfaces. Particular attention should be given to side edges, ensure paint/sealant covers ALL exposed ACM surfaces.				
<b>Legislative Requirements Victorian Regulation 2007</b>	Warning labels should be affixed. Avoid mechanical damage and abrasion. Remove if refurbishment, structural alteration or demolition is to be carried out in this area. Re-inspect every 12 months or earlier if disturbed or removed in accordance with the Victorian OH&S Regulation 2017. All remedial/removal repairs require a Clearance Inspection & Certificate to be recorded by an approved and competent assessor.

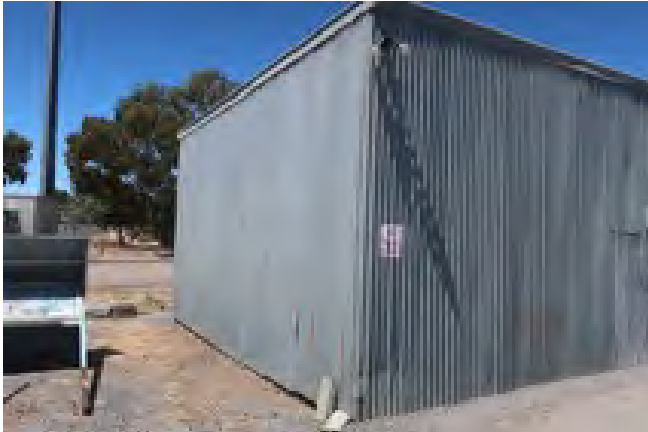
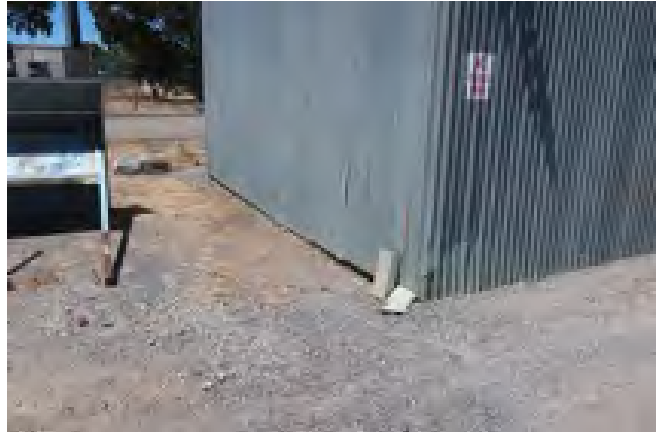
**Area 1**

**4 - Shed: left side of builing. The Debris - Broken (Debris) has Asbestos Containing Material (ACM) present.**

RISK ASSESSMENT					
Type of Asbestos or Hazardous Material	Chrysotile	Condition	POOR	Likelihood of Damage	H (High) - almost certain
	Sample taken 62098-007	Activity	Moderate		
		Sealed	No	Friability	Exposed Fibres
		Labelled	No	Exposure Risk	High - Short term exposure risk
		Quantity

RISK CONTROL					
Priority	IMMEDIATE	Label Required	Yes	Re- Audit Date	10 Feb 2022
Action	Restrict access and target for imminent removal				
Recommendation	Debris on Surface - The Debris requires immediate cleanup and disposal with specialised equipment and with licensed removalist to safely remove the asbestos debris.				
Legislative Requirements Victorian Regulation 2007	ACM debris visible. Recommend cleanup by licensed Asbestos Removalist. Warning labels should be affixed. Avoid mechanical damage and abrasion. Remove if refurbishment, structural alteration or demolition is to be carried out in this area. Re-inspect every 12 months or earlier if disturbed or removed in accordance with the Victorian OH&S Regulation 2017. All remedial/removal repairs require a Clearance Inspection & Certificate to be recorded by an approved and competent assessor.

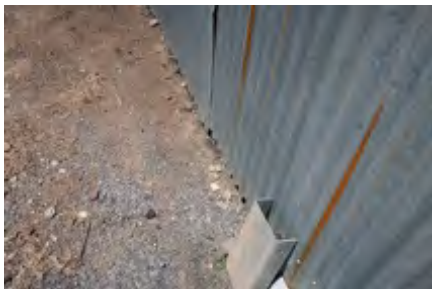
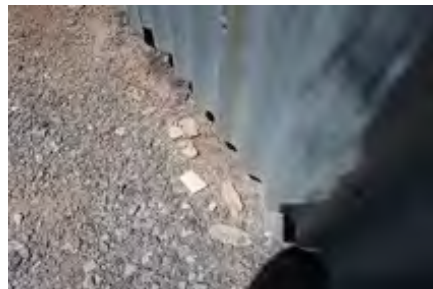
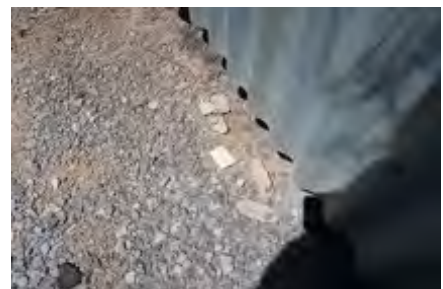
Debris on Surface

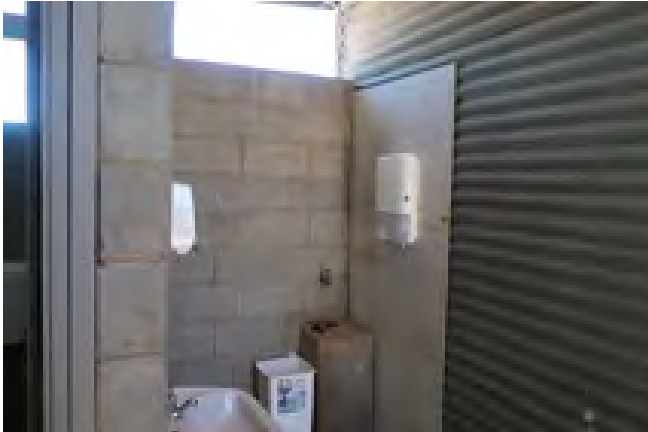
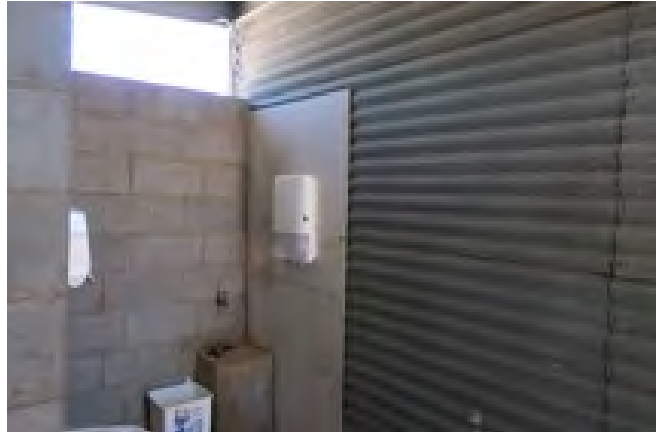
**Area 2**

**5 - Toilet block: Bathroom - wash area 1. The Wall - panel (F C Sheeting) has Asbestos Containing Material (ACM) present.**

RISK ASSESSMENT					
Type of Asbestos or Hazardous Material	Chrysotile	Condition	AVERAGE	Likelihood of Damage	L (Low) – possible
	Sample taken 62098-009	Activity	Moderate	Friability	Bonded (non-friable)
		Sealed	No	Exposure Risk	Medium - Moderate risk
		Labelled	Y		
		Quantity

RISK CONTROL					
Priority	HIGH	Label Required	Yes	Re- Audit Date	10 Feb 2022
Action	Remedial repairs required - seal raw material / edges				
Recommendation	Raw material sheeting - The area requires immediate remedial repairs. It is recommended the asbestos material be sealed with an approved membrane. <b>Reuse of asbestos materials -</b>				
Legislative Requirements Victorian Regulation 2007	Damaged ACM visible in area. Requires IMMEDIATE ATTENTION. WARNING labels should be affixed. Avoid mechanical damage and abrasion. Remove if refurbishment, structural alteration or demolition is to be carried out in this area. Re-inspect every 12 months or earlier if disturbed or removed in accordance with the Victorian OH&S Regulation 2017. All remedial/removal repairs require a Clearance Inspection & Certificate to be recorded by an approved and competent assessor.
