Asbestos Report

YARRIAMBIACK SHIRE COUNCIL

PROPERTY ADDRESS:
LR23 TIP LICENCE
1281 WIMMERA HIGHWAY
MURTOA VIC 3390

INSPECTION DATE: 10 FEBRUARY 2021
REFERENCE NUMBER: 62100

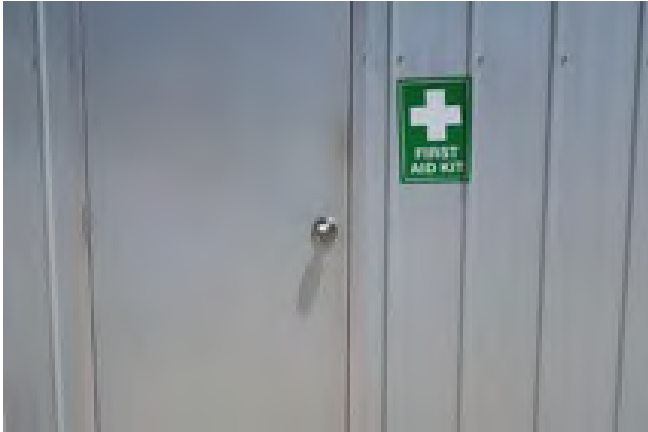
Area 4

Shed 1: Until the area is inspected, it should be managed as if it Asbestos Containing Material (ACM) is present.

RISK ASSESSMENT					
Type of Asbestos or Hazardous Material	No sample taken - No Access	Condition		Likelihood of Damage	
		Activity			
		Sealed		Friability	
		Labelled	No	Exposure Risk	
		Quantity

RISK CONTROL					
Priority	HIGH	Label Required	Yes	Re- Audit Date	10 Feb 2022
Action					
Recommendation					
Legislative Requirements Victorian Regulation 2007	Unable to Gain Access. Assume asbestos in area and provide monitoring if work undertaken in these areas. If access is made available, contact Global Asbestos Audits for re-inspection

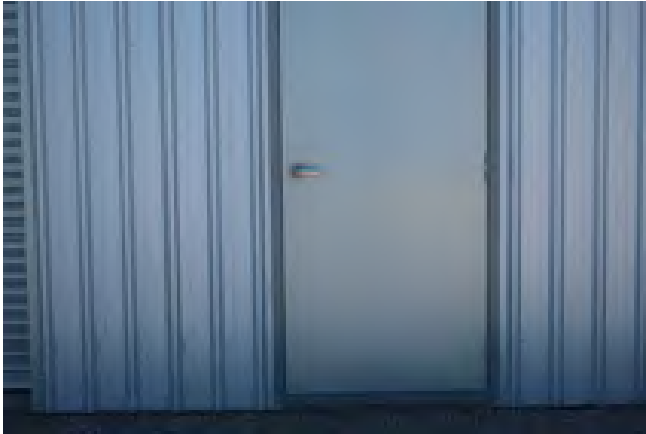
Area 5

Type of Asbestos or Hazardous Material	No sample taken - No Access	Condition		Likelihood of Damage	
		Activity			
		Sealed		Friability	
		Labelled	No	Exposure Risk	
		Quantity

Priority	HIGH	Label Required	Yes	Re- Audit Date	10 Feb 2022
Action					
Recommendation					
Legislative Requirements Victorian Regulation 2007	Unable to Gain Access. Assume asbestos in area and provide monitoring if work undertaken in these areas. If access is made available, contact Global Asbestos Audits for re-inspection

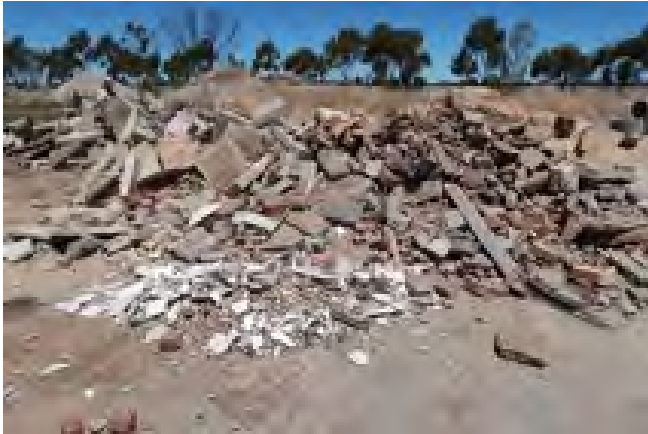
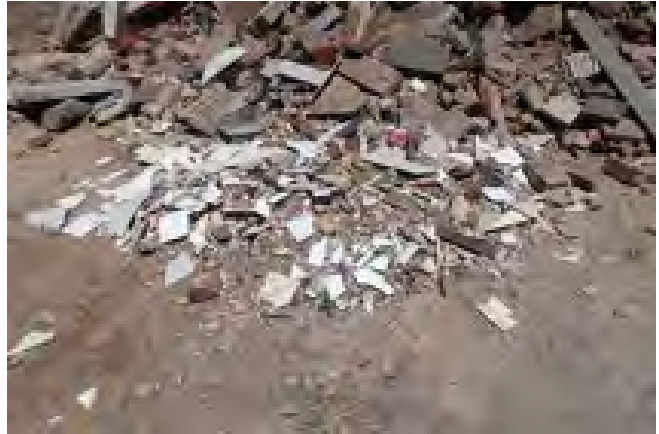
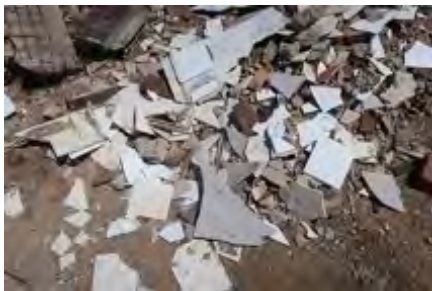
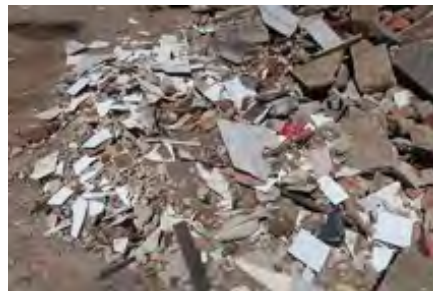
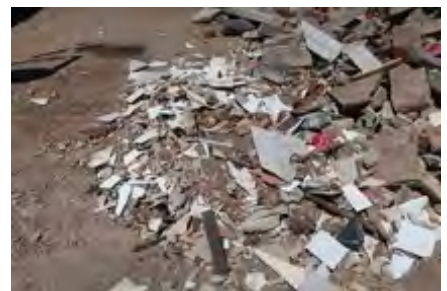
Area 2

Tip pile: The Debris - Broken (Debris) has Asbestos Containing Material (ACM) present.

RISK ASSESSMENT					
Type of Asbestos or Hazardous Material	Chrysotile	Condition	POOR	Likelihood of Damage	H (High) - almost certain
	Sample taken 62100-001	Activity	Moderate		
		Sealed	No	Friability	
		Labelled	No	Exposure Risk	High - Short term exposure risk
		Quantity

Debris on Surface

RISK CONTROL					
Priority	IMMEDIATE	Label Required	Yes	Re- Audit Date	10 Feb 2022
Action	Restrict access and target for imminent removal				
Recommendation	<p>Preliminary soil testing should be done to establish level of contamination & potential exposure. Debris on Surface - The Debris requires immediate cleanup and disposal with specialised equipment and with licensed removalist to safely remove the asbestos debris.</p> <p>In the meantime a wetting down program should be implemented and include minimal disturbance.</p>				
Legislative Requirements Victorian Regulation 2007	<p>ACM debris visible. Recommend cleanup by licensed Asbestos Removalist. Warning labels should be affixed. Avoid mechanical damage and abrasion. Remove before any disturbance in this area. Re-inspect every 12 months or earlier if disturbed or removed in accordance with the Victorian OH&S Regulation 2017.</p> <p>All remedial/removal repairs require a Clearance Inspection & Certificate to be recorded by an approved and competent assessor.</p>

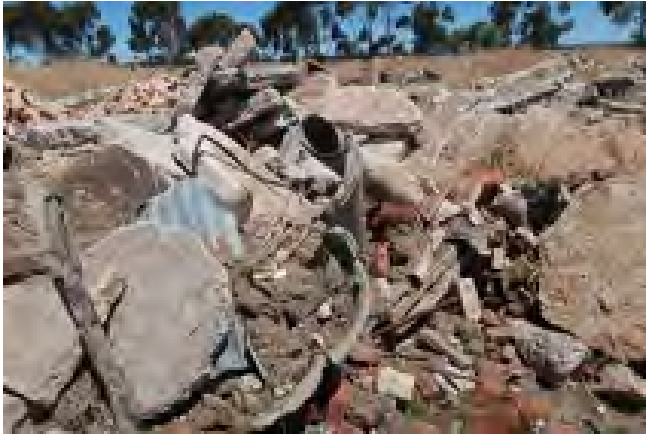
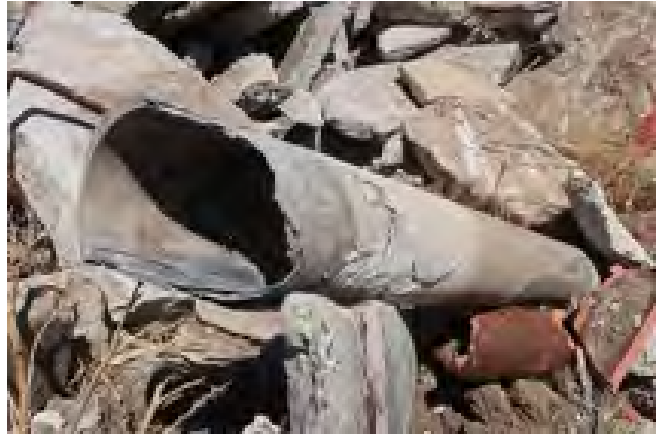
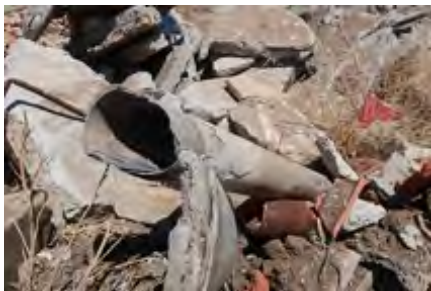
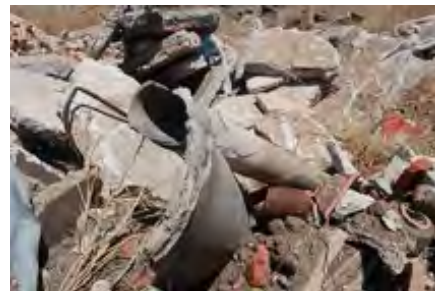
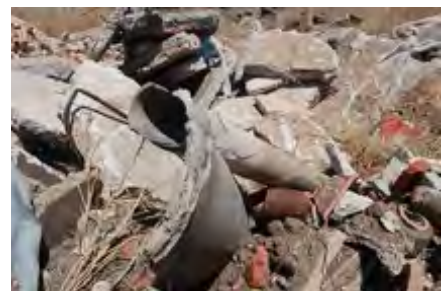
Tip pile: The Pipe(s) (Debris/waste) has Asbestos Containing Material (ACM) present.

RISK ASSESSMENT					
Type of Asbestos or Hazardous Material	Chrysotile Amosite Crocidolite Sample taken 62100-002	Condition	POOR	Likelihood of Damage	L (Low) – possible
		Activity	Moderate		
		Sealed	No	Friability	Exposed Fibres
		Labelled	No	Exposure Risk	High - Short term exposure risk
		Quantity

Debris/waste on Surface

RISK CONTROL					
Priority	IMMEDIATE	Label Required	Yes	Re- Audit Date	10 Feb 2022
Action	Restrict access and target for imminent removal				
Recommendation	<p>Preliminary soil testing should be done to establish level of contamination & potential exposure. Debris on Surface - The Debris requires immediate cleanup and disposal with specialised equipment and with licensed removalist to safely remove the asbestos debris.</p> <p>In the meantime a wetting down program should be implemented and include minimal disturbance.</p>				
Legislative Requirements Victorian Regulation 2007	<p>ACM debris visible. Recommend cleanup by licensed Asbestos Removalist. Warning labels should be affixed. Avoid mechanical damage and abrasion. Remove before any disturbance in this area. Re-inspect every 12 months or earlier if disturbed or removed in accordance with the Victorian OH&S Regulation 2017.</p> <p>All remedial/removal repairs require a Clearance Inspection & Certificate to be recorded by an approved and competent assessor.</p>

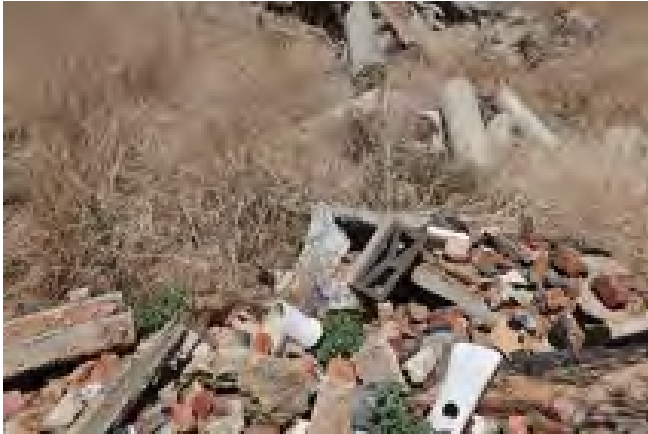
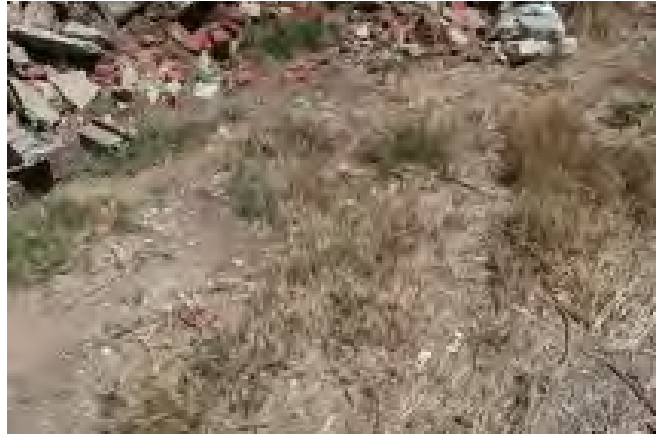
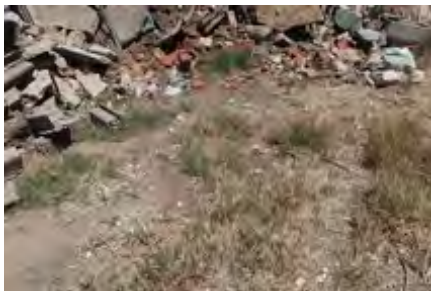
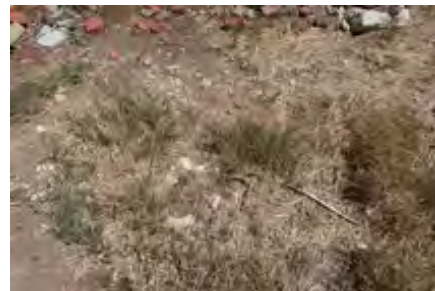
Tip pile: surrounding areas. The Debris - Broken (Debris) has Asbestos Containing Material (ACM) present.

RISK ASSESSMENT					
Type of Asbestos or Hazardous Material	Chrysotile	Condition	POOR	Likelihood of Damage	H (High) - almost certain
	Same as Sample - 62100-001	Activity	Moderate		
		Sealed	No	Friability	Friable
		Labelled	No	Exposure Risk	High - Short term exposure risk
		Quantity

Debris on Surface

RISK CONTROL					
Priority	IMMEDIATE	Label Required	Yes	Re- Audit Date	10 Feb 2022
Action	Restrict access and target for imminent removal				
Recommendation	<p>Preliminary soil testing should be done to establish level of contamination & potential exposure. Debris on Surface - The Debris requires immediate cleanup and disposal with specialised equipment and with licensed removalist to safely remove the asbestos debris.</p> <p>In the meantime a wetting down program should be implemented and include minimal disturbance.</p>				
Legislative Requirements Victorian Regulation 2007	<p>ACM debris visible. Recommend cleanup by licensed Asbestos Removalist. Warning labels should be affixed. Avoid mechanical damage and abrasion. Remove before any disturbance in this area. Re-inspect every 12 months or earlier if disturbed or removed in accordance with the Victorian OH&S Regulation 2017.</p> <p>All remedial/removal repairs require a Clearance Inspection & Certificate to be recorded by an approved and competent assessor.</p>
