Asbestos Report

YARRIAMBIACK SHIRE COUNCIL

PROPERTY ADDRESS:
LB82 TOILET BLOCK
34-36 MARMA STREET
MURTOA VIC 3390

INSPECTION DATE: 10 FEBRUARY 2021
REFERENCE NUMBER: 62101

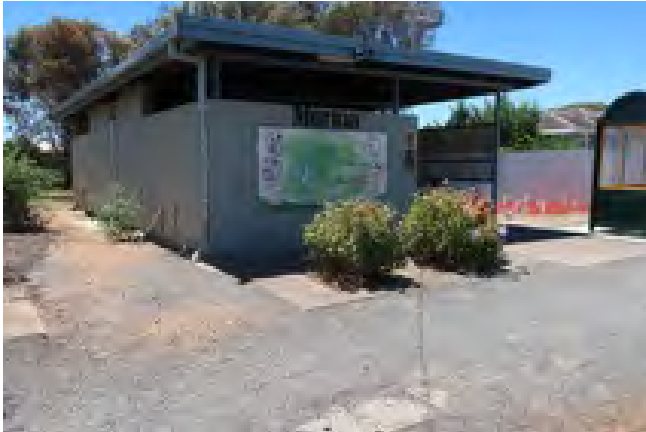
External

Area 1**Toilet block LB82 Toilet Block: front of building. The Service pit (Fibrous Cement Product) has Asbestos Containing Material (ACM) present.****RISK ASSESSMENT**

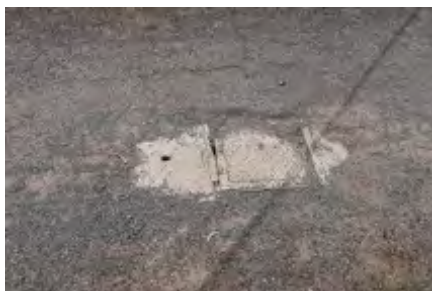
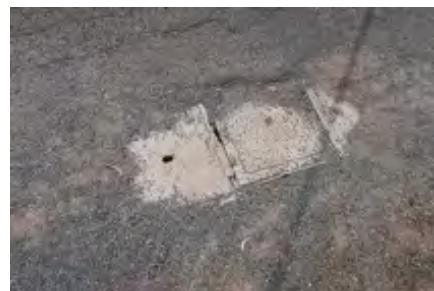
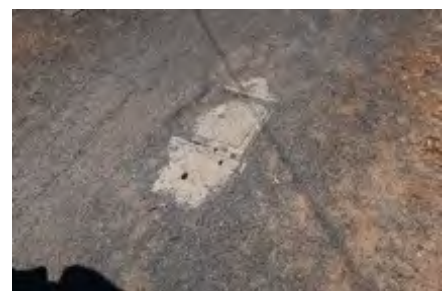
Type of Asbestos or Hazardous Material	Chrysotile	Condition	AVERAGE	Likelihood of Damage	M (Medium) - likely
	Amosite	Activity	Moderate		
	Sample taken 62101-001	Sealed	No	Friability	Bonded (non-friable)
		Labelled	Y	Exposure Risk	Medium - Moderate risk
		Quantity

Raw Material

Priority	HIGH	Label Required	Yes	Re- Audit Date	10 Feb 2022
Action	Remedial repairs required - seal raw material / edges				
Recommendation	Raw material sheeting - The area requires immediate remedial repairs. It is recommended the asbestos material be sealed with an approved membrane.				
Legislative Requirements Victorian Regulation 2007	<p>Damaged ACM visible in area. Requires IMMEDIATE ATTENTION. WARNING labels should be affixed. Avoid mechanical damage and abrasion. Remove if refurbishment, structural alteration or demolition is to be carried out in this area. Re-inspect every 12 months or earlier if disturbed or removed in accordance with the Victorian OH&S Regulation 2017.</p> <p>All remedial/removal repairs require a Clearance Inspection & Certificate to be recorded by an approved and competent assessor.</p>

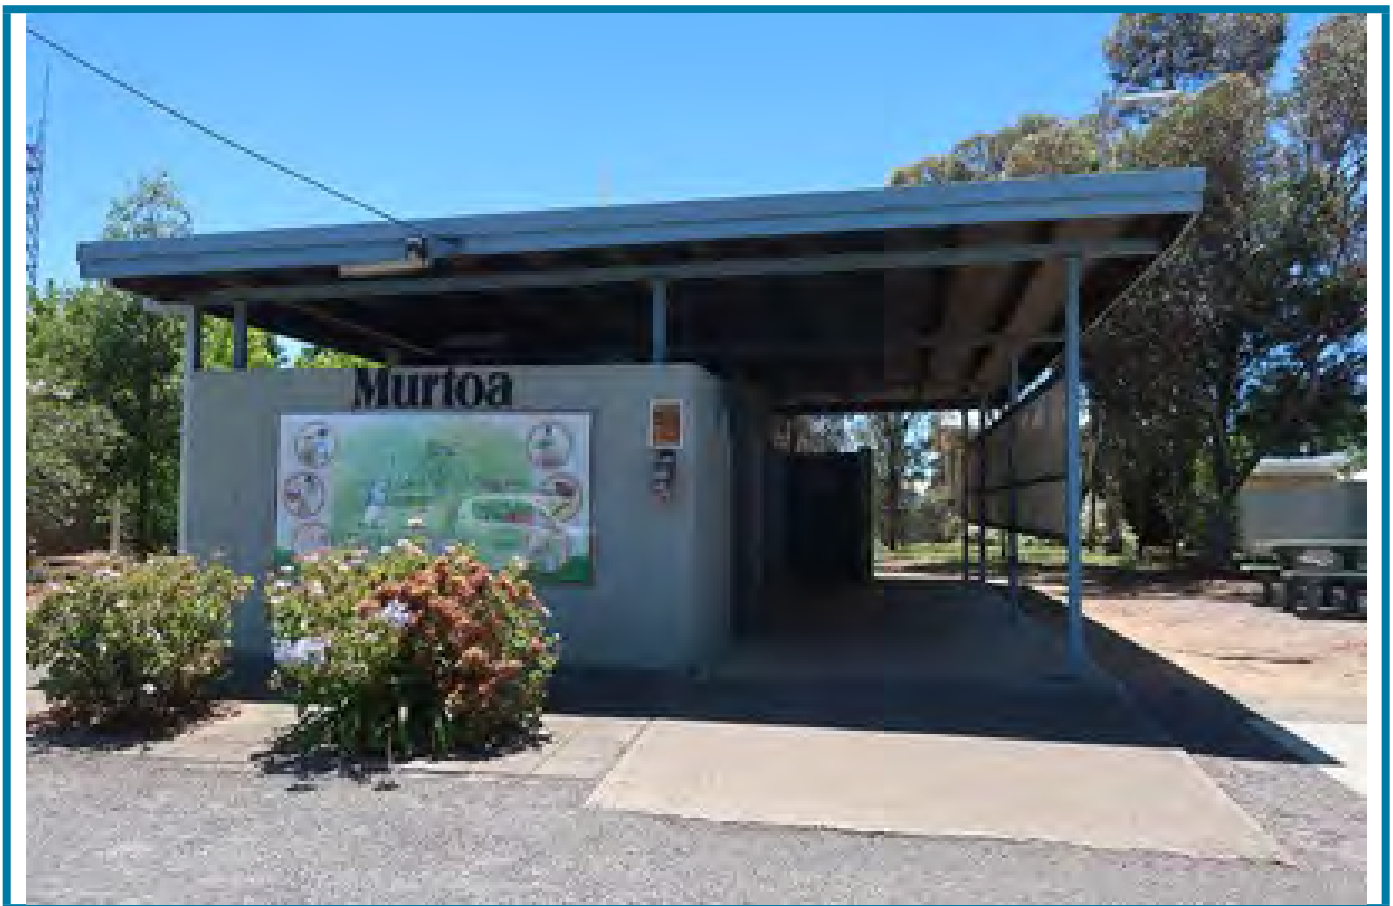
Location	Area	Component Materials	ACM Identified	Type Asbestos Assessment	ConditionPriority	Signage Required
Toilet block LB82 Toilet Block - entire perimeter of building.		No Asbestos Materials	No	No sample taken - Visual ID
