# Asbestos Report

YARRIAMBIACK SHIRE COUNCIL

PROPERTY ADDRESS:  
LB56 UNIT 1  
1/42 MCDONALD STREET  
MURTOA VIC 3390

INSPECTION DATE: 10 FEBRUARY 2021  
REFERENCE NUMBER: 62103

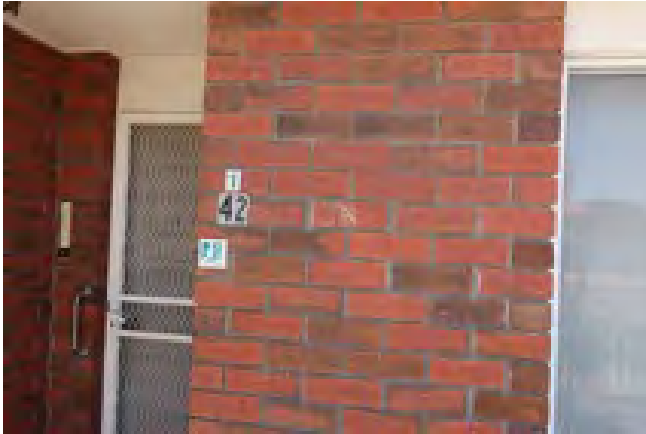
Room

**Area 1*****Dwelling LB56 Unit 1: . Until the area is inspected, it should be managed as if it Asbestos Containing Material (ACM) is present.*****RISK ASSESSMENT**

<b>Type of Asbestos or Hazardous Material</b>	No sample taken - No Access	<b>Condition</b>		<b>Likelihood of Damage</b>	
		<b>Activity</b>			
		<b>Sealed</b>		<b>Friability</b>	
		<b>Labelled</b>	No	<b>Exposure Risk</b>	
		<b>Quantity</b>

<b>Priority</b>	HIGH	<b>Label Required</b>	Yes	<b>Re- Audit Date</b>	10 Feb 2022
<b>Action</b>					
<b>Recommendation</b>					
<b>Legislative Requirements Victorian Regulation 2007</b>	Unable to Gain Access. Assume asbestos in area and provide monitoring if work undertaken in these areas. If access is made available, contact Global Asbestos Audits for re-inspection

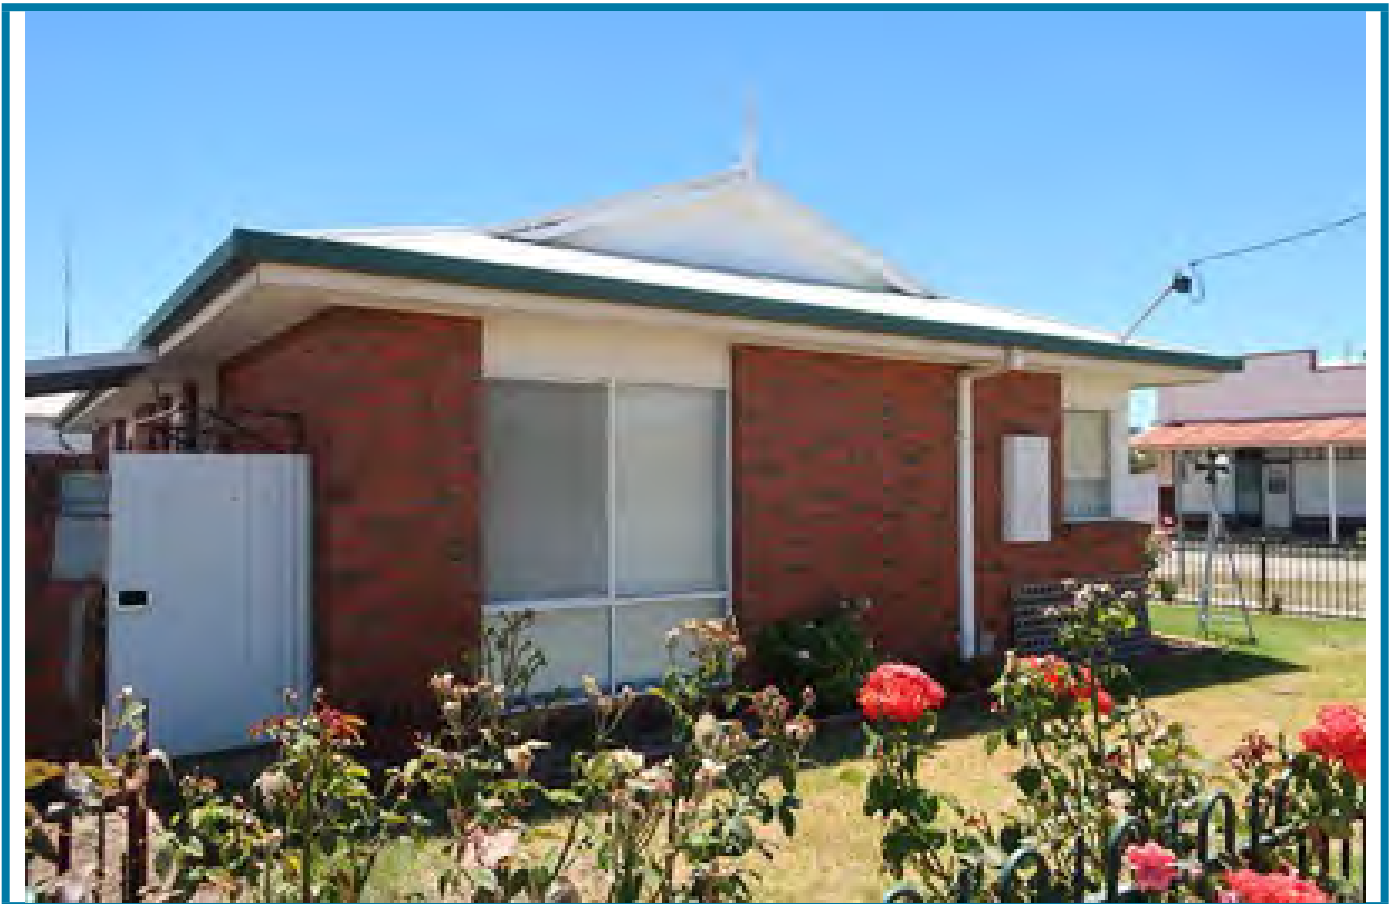
Location	Area	Component Materials	ACM Identified	Type Asbestos Assessment	Condition	Priority	Signage Required
Dwelling LB56 Unit 1 - entire perimeter of building.	Soffit	F C Sheeting	No	No sample taken - Visual ID
