Asbestos Report

YARRIAMBIACK SHIRE COUNCIL

PROPERTY ADDRESS:
LR29 RUBBISH TIP
38 PATCHEWOLLOCK TIP ROAD
PATCHEWOLLOCK VIC 3491

INSPECTION DATE: 10 FEBRUARY 2021
REFERENCE NUMBER: 62105

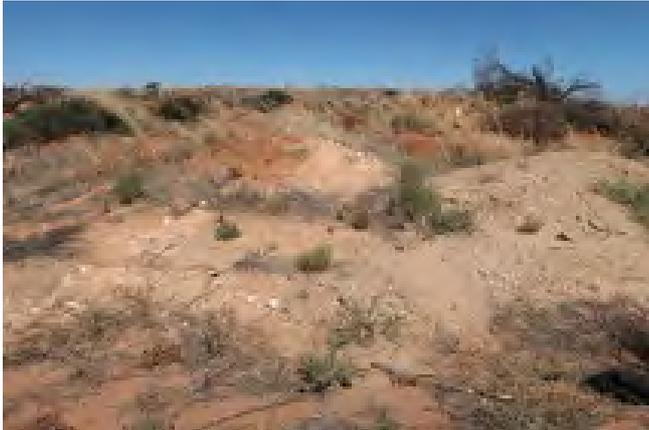
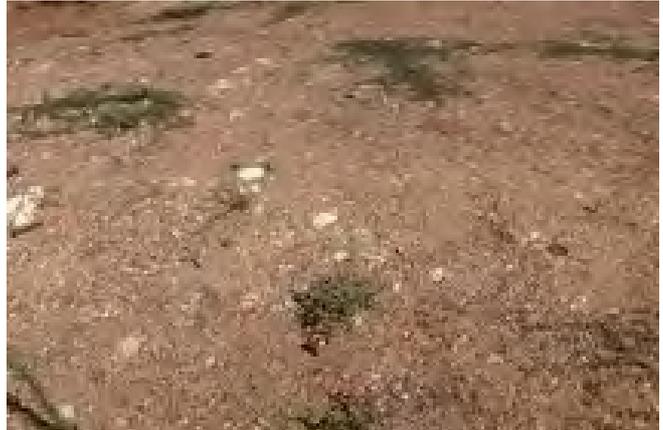
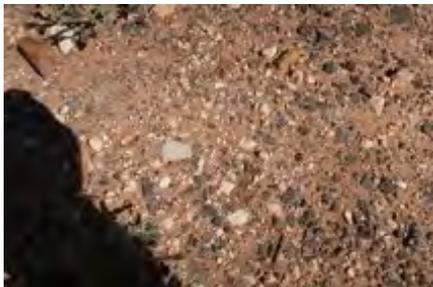
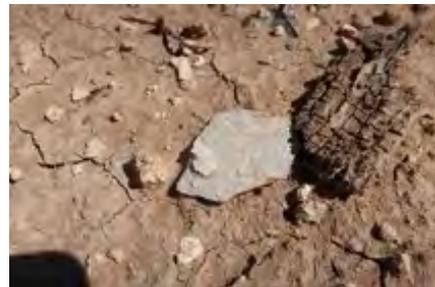
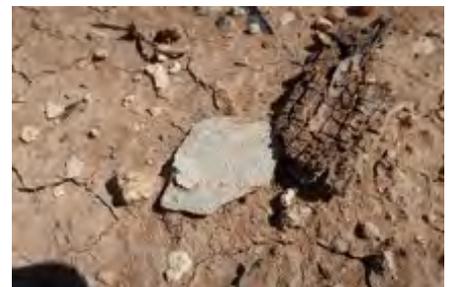
Area 1**Grounds: The Debris - Broken (Debris) has Asbestos Containing Material (ACM) present.****RISK ASSESSMENT**

Type of Asbestos or Hazardous Material	Chrysotile	Condition	POOR	Likelihood of Damage	H (High) - almost certain
	Sample taken 62105-001	Activity	Moderate		
		Sealed	No	Friability	Exposed Fibres
		Labelled	No	Exposure Risk	High - Short term exposure risk
		Quantity

Debris on Surface

Priority	IMMEDIATE	Label Required	Yes	Re- Audit Date	10 Feb 2022
Action	Restrict access and target for imminent removal				
Recommendation	<p>Preliminary soil testing should be done to establish level of contamination & potential exposure. Debris on Surface - The Debris requires immediate cleanup and disposal with specialised equipment and with licensed removalist to safely remove the asbestos debris.</p> <p>In the meantime a wetting down program should be implemented and include minimal disturbance.</p>				
Legislative Requirements Victorian Regulation 2007	<p>ACM debris visible. Recommend cleanup by licensed Asbestos Removalist. Warning labels should be affixed. Avoid mechanical damage and abrasion. Remove before any disturbance in this area. Re-inspect every 12 months or earlier if disturbed or removed in accordance with the Victorian OH&S Regulation 2017.</p> <p>All remedial/removal repairs require a Clearance Inspection & Certificate to be recorded by an approved and competent assessor.</p>

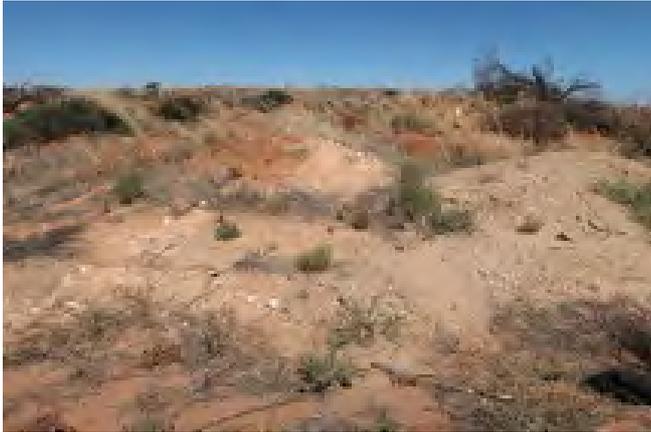
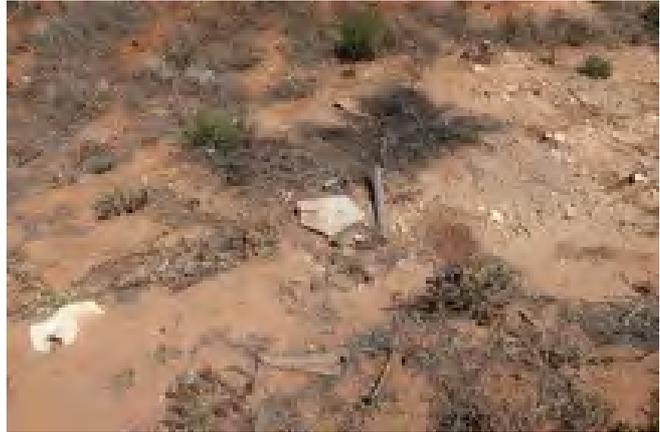
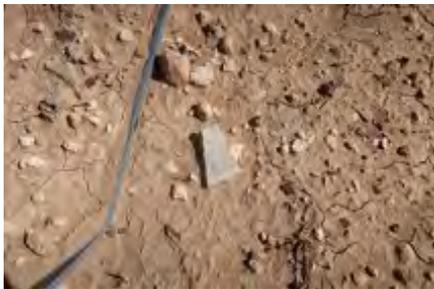
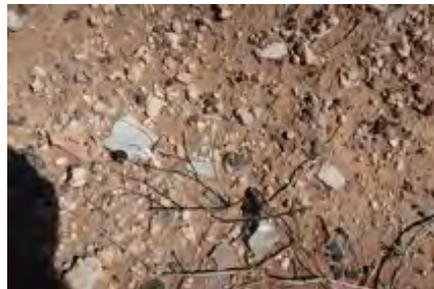
Grounds: The Debris - Broken (Debris) has Asbestos Containing Material (ACM) present.

RISK ASSESSMENT					
Type of Asbestos or Hazardous Material	Chrysotile	Condition	POOR	Likelihood of Damage	H (High) - almost certain
	Same as Sample - 62105-001	Activity	Moderate		
		Sealed	No	Friability	Exposed Fibres
		Labelled	No	Exposure Risk	High - Short term exposure risk
		Quantity

Debris on Surface

RISK CONTROL					
Priority	IMMEDIATE	Label Required	Yes	Re- Audit Date	10 Feb 2022
Action	Restrict access and target for imminent removal				
Recommendation	<p>Preliminary soil testing should be done to establish level of contamination & potential exposure. Debris on Surface - The Debris requires immediate cleanup and disposal with specialised equipment and with licensed removalist to safely remove the asbestos debris.</p> <p>In the meantime a wetting down program should be implemented and include minimal disturbance.</p>				
Legislative Requirements Victorian Regulation 2007	<p>ACM debris visible. Recommend cleanup by licensed Asbestos Removalist. Warning labels should be affixed. Avoid mechanical damage and abrasion. Remove before any disturbance in this area. Re-inspect every 12 months or earlier if disturbed or removed in accordance with the Victorian OH&S Regulation 2017.</p> <p>All remedial/removal repairs require a Clearance Inspection & Certificate to be recorded by an approved and competent assessor.</p>

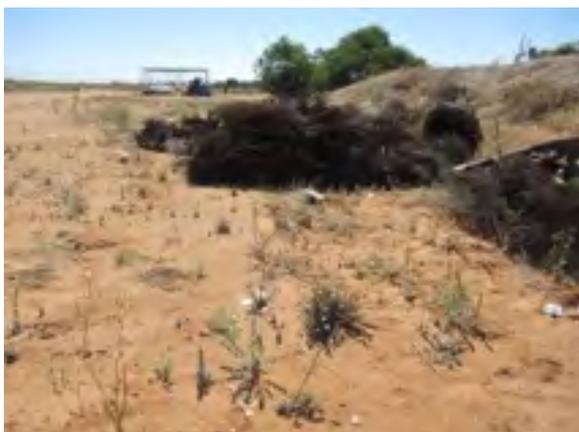
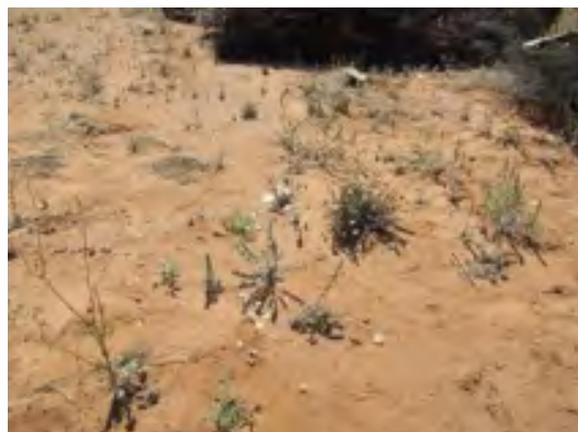
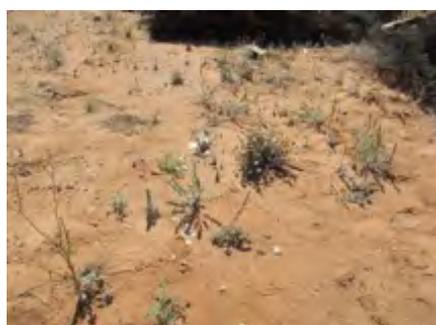
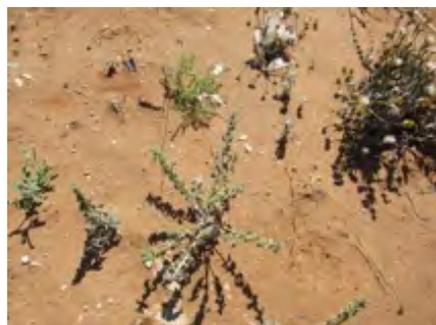
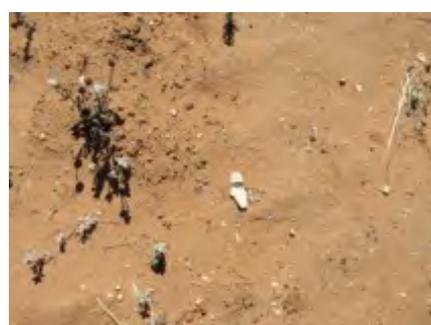
Grounds: The Debris - Broken (Debris) has Asbestos Containing Material (ACM) present.

RISK ASSESSMENT					
Type of Asbestos or Hazardous Material	Chrysotile	Condition	POOR	Likelihood of Damage	H (High) - almost certain
	Same as Sample - 62105 -001	Activity	Moderate		
		Sealed	No	Friability	Exposed Fibres
		Labelled	No	Exposure Risk	High - Short term exposure risk
		Quantity

Debris on Surface

RISK CONTROL					
Priority	IMMEDIATE	Label Required	Yes	Re- Audit Date	10 Feb 2022
Action	Restrict access and target for imminent removal				
Recommendation	<p>Preliminary soil testing should be done to establish level of contamination & potential exposure. Debris on Surface - The Debris requires immediate cleanup and disposal with specialised equipment and with licensed removalist to safely remove the asbestos debris.</p> <p>In the meantime a wetting down program should be implemented and include minimal disturbance.</p>				
Legislative Requirements Victorian Regulation 2007	<p>ACM debris visible. Recommend cleanup by licensed Asbestos Removalist. Warning labels should be affixed. Avoid mechanical damage and abrasion. Remove before any disturbance in this area. Re-inspect every 12 months or earlier if disturbed or removed in accordance with the Victorian OH&S Regulation 2017.</p> <p>All remedial/removal repairs require a Clearance Inspection & Certificate to be recorded by an approved and competent assessor.</p>

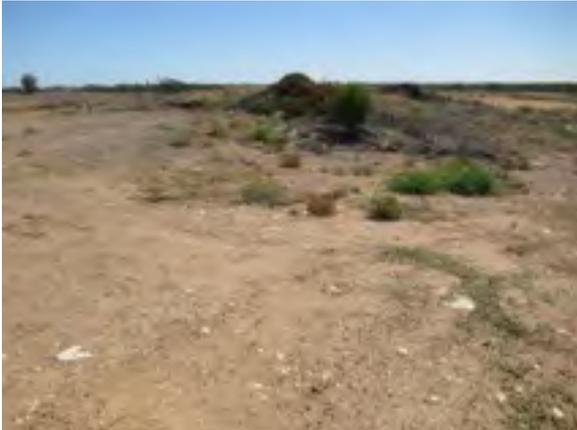
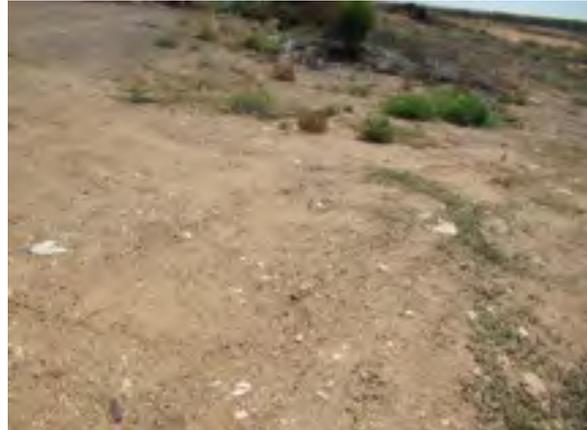
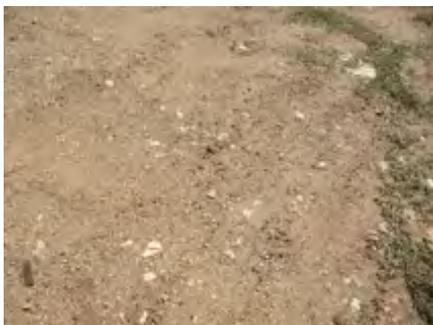
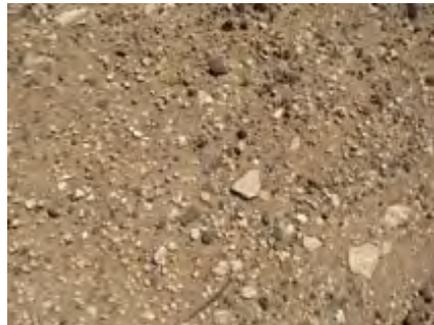
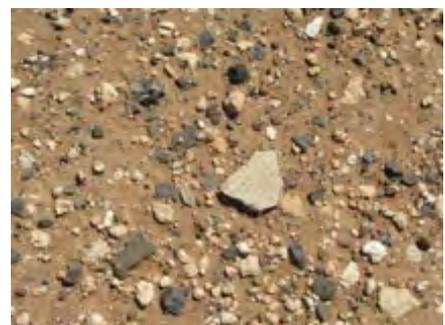
Grounds: Tip pile. The Debris - Broken (Debris) has Asbestos Containing Material (ACM) present.

RISK ASSESSMENT					
Type of Asbestos or Hazardous Material	Chrysotile	Condition	POOR	Likelihood of Damage	H (High) - almost certain
	Same as Sample - 62105-001	Activity	Moderate		
		Sealed	No	Friability	Exposed Fibres
		Labelled	No	Exposure Risk	High - Short term exposure risk
		Quantity

Debris on Surface

RISK CONTROL					
Priority	IMMEDIATE	Label Required	Yes	Re- Audit Date	10 Feb 2022
Action	Restrict access and target for imminent removal				
Recommendation	<p>Preliminary soil testing should be done to establish level of contamination & potential exposure. Debris on Surface - The Debris requires immediate cleanup and disposal with specialised equipment and with licensed removalist to safely remove the asbestos debris.</p> <p>In the meantime a wetting down program should be implemented and include minimal disturbance.</p>				
Legislative Requirements Victorian Regulation 2007	<p>ACM debris visible. Recommend cleanup by licensed Asbestos Removalist. Warning labels should be affixed. Avoid mechanical damage and abrasion. Remove before any disturbance in this area. Re-inspect every 12 months or earlier if disturbed or removed in accordance with the Victorian OH&S Regulation 2017.</p> <p>All remedial/removal repairs require a Clearance Inspection & Certificate to be recorded by an approved and competent assessor.</p>

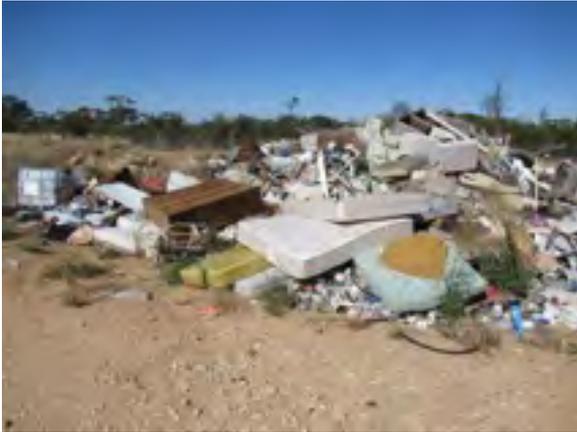
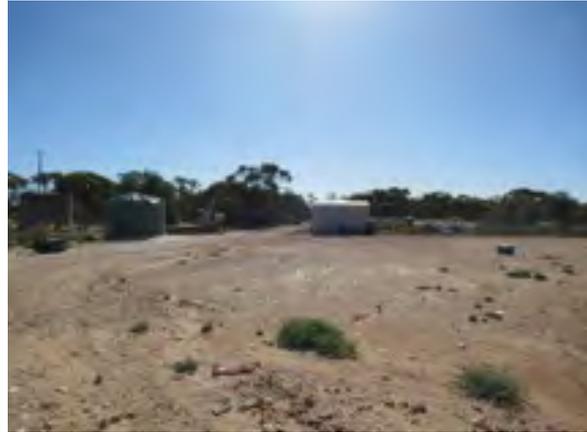
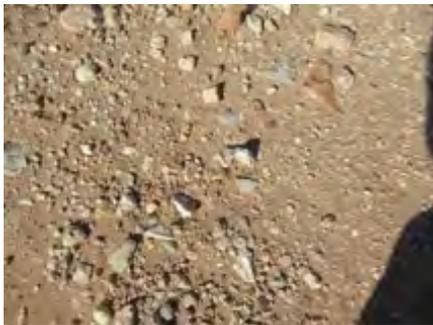
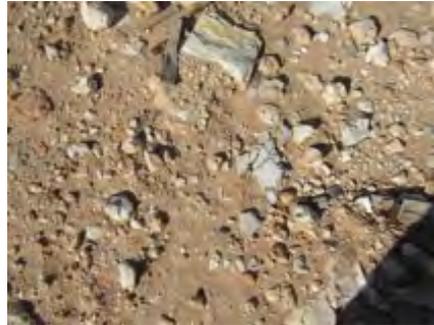
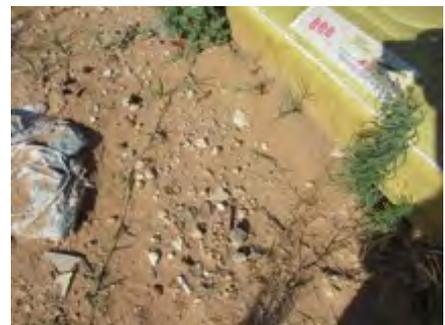
Grounds: Tip pile. The Debris - Broken (Debris) has Asbestos Containing Material (ACM) present.

RISK ASSESSMENT					
Type of Asbestos or Hazardous Material	Chrysotile	Condition	POOR	Likelihood of Damage	H (High) - almost certain
	Same as Sample - 62105-001	Activity	Moderate		
		Sealed	No	Friability	Exposed Fibres
		Labelled	No	Exposure Risk	High - Short term exposure risk
		Quantity

Debris on Surface

RISK CONTROL					
Priority	IMMEDIATE	Label Required	Yes	Re- Audit Date	10 Feb 2022
Action	Restrict access and target for imminent removal				
Recommendation	<p>Preliminary soil testing should be done to establish level of contamination & potential exposure. Debris on Surface - The Debris requires immediate cleanup and disposal with specialised equipment and with licensed removalist to safely remove the asbestos debris.</p> <p>In the meantime a wetting down program should be implemented and include minimal disturbance.</p>				
Legislative Requirements Victorian Regulation 2007	<p>ACM debris visible. Recommend cleanup by licensed Asbestos Removalist. Warning labels should be affixed. Avoid mechanical damage and abrasion. Remove before any disturbance in this area. Re-inspect every 12 months or earlier if disturbed or removed in accordance with the Victorian OH&S Regulation 2017.</p> <p>All remedial/removal repairs require a Clearance Inspection & Certificate to be recorded by an approved and competent assessor.</p>

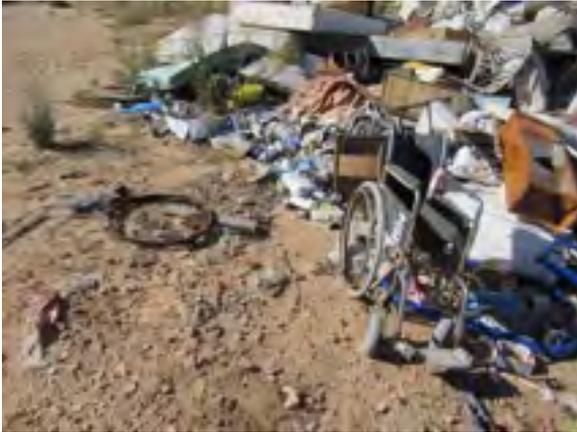
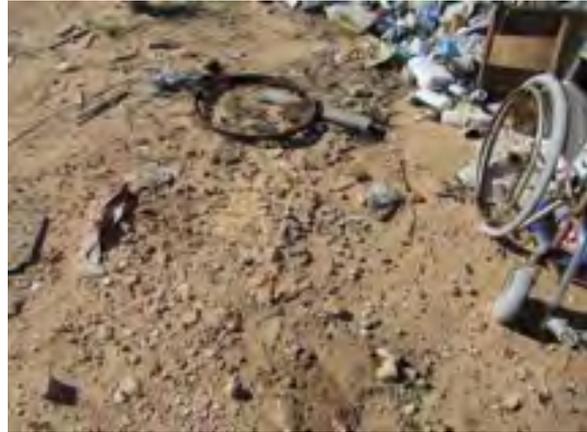
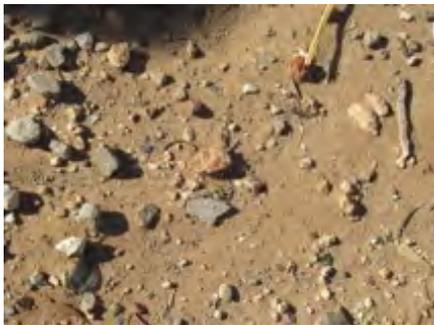
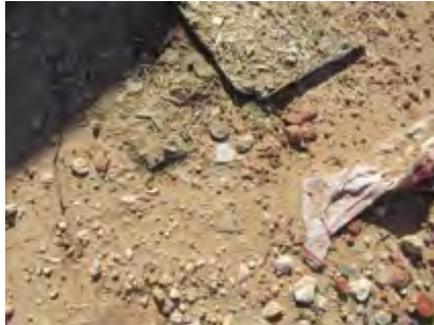
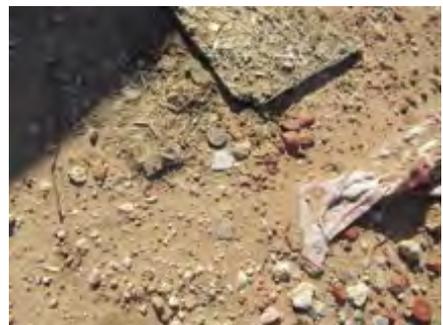
Grounds: Tip pile. The Debris - Broken (Debris) has Asbestos Containing Material (ACM) present.

RISK ASSESSMENT					
Type of Asbestos or Hazardous Material	Chrysotile	Condition	POOR	Likelihood of Damage	H (High) - almost certain
	Same as Sample - 62105 -001	Activity	Moderate		
		Sealed	No	Friability	Exposed Fibres
		Labelled	No	Exposure Risk	High - Short term exposure risk
		Quantity

Debris on Surface

RISK CONTROL					
Priority	IMMEDIATE	Label Required	Yes	Re- Audit Date	10 Feb 2022
Action	Restrict access and target for imminent removal				
Recommendation	<p>Preliminary soil testing should be done to establish level of contamination & potential exposure. Debris on Surface - The Debris requires immediate cleanup and disposal with specialised equipment and with licensed removalist to safely remove the asbestos debris.</p> <p>In the meantime a wetting down program should be implemented and include minimal disturbance.</p>				
Legislative Requirements Victorian Regulation 2007	<p>ACM debris visible. Recommend cleanup by licensed Asbestos Removalist. Warning labels should be affixed. Avoid mechanical damage and abrasion. Remove before any disturbance in this area. Re-inspect every 12 months or earlier if disturbed or removed in accordance with the Victorian OH&S Regulation 2017.</p> <p>All remedial/removal repairs require a Clearance Inspection & Certificate to be recorded by an approved and competent assessor.</p>

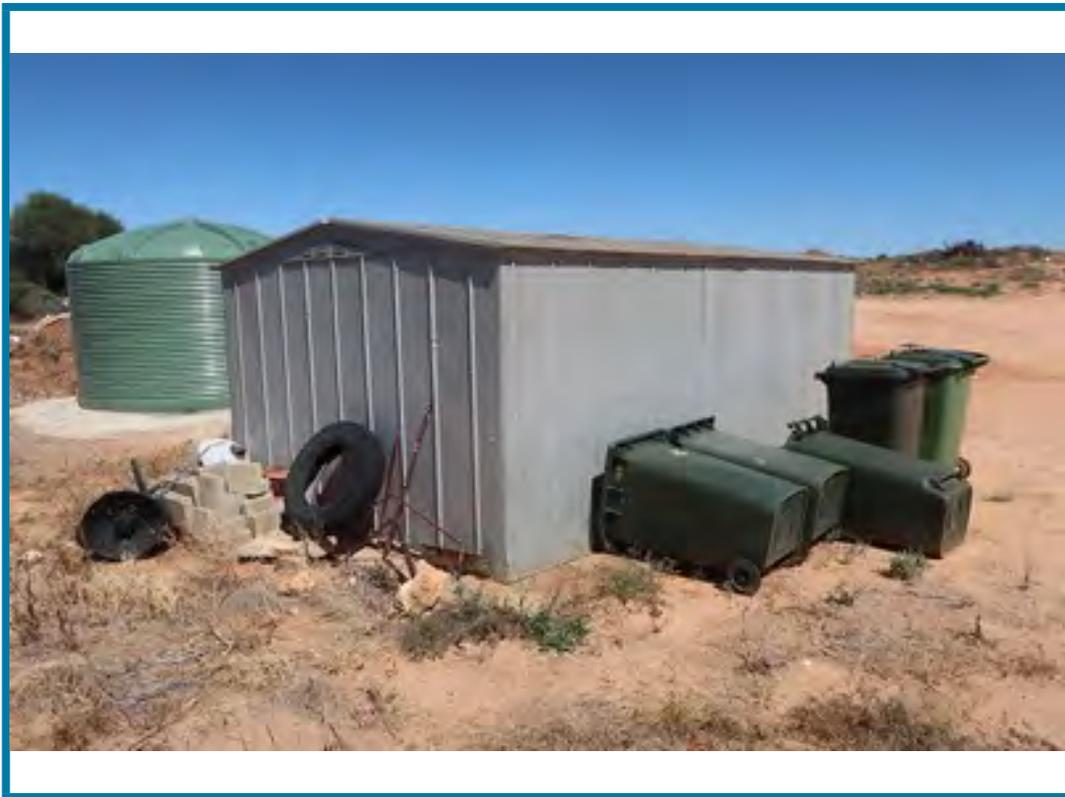
Location	Area	Component Materials	ACM Identified	Type Asbestos Assessment	Condition	Priority	Signage Required
Shed LR29 Rubbish Tip - entire perimeter of building.		No Asbestos Materials	No	No sample taken - Visual ID
