# Asbestos Report

YARRIAMBIACK SHIRE COUNCIL

PROPERTY ADDRESS:  
LB40 ELDERLY CITIZEN CLUBROOMS  
21 DYER STREET  
RUPANYUP VIC 3388

INSPECTION DATE: 10 FEBRUARY 2021  
REFERENCE NUMBER: 62109

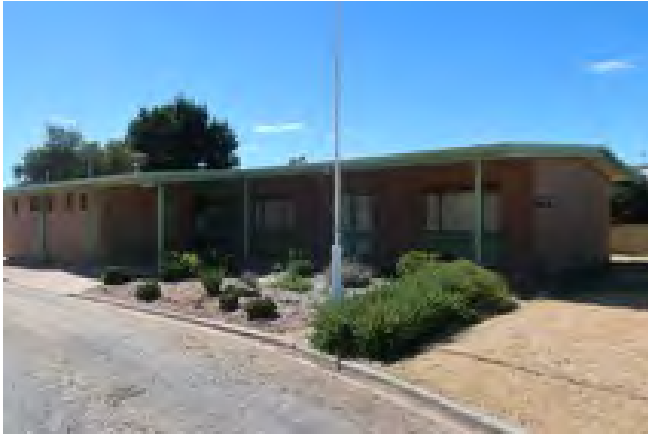
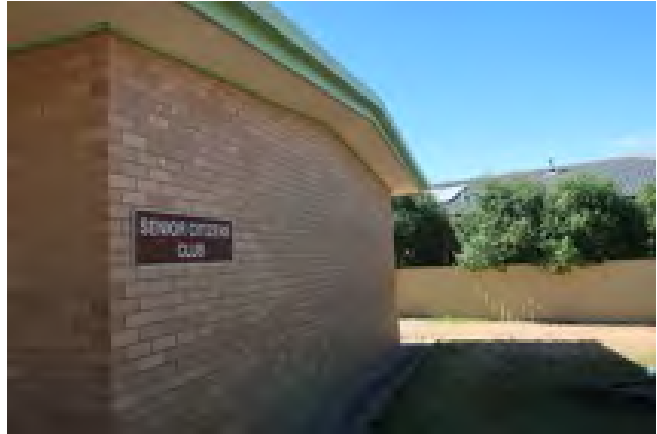
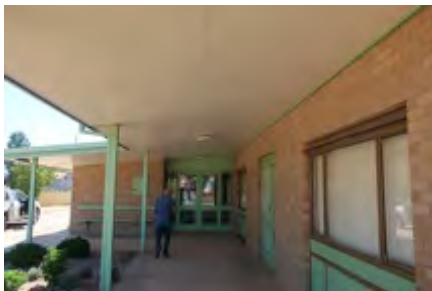
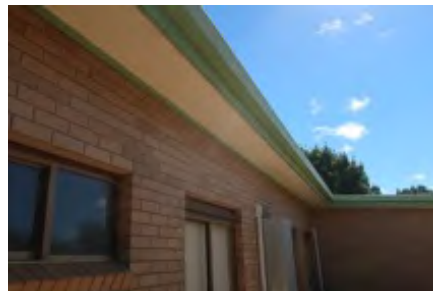
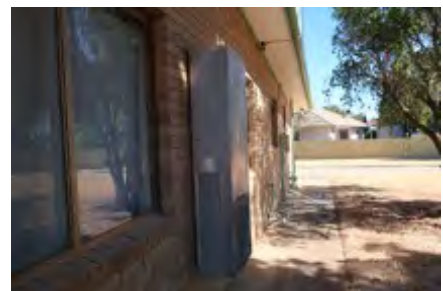
**Area 4**

**LB40 Elderly Citizen Clubrooms: entire perimeter of building. The Soffit (F C Sheeting) has Asbestos Containing Material (ACM) present.**

RISK ASSESSMENT					
Type of Asbestos or Hazardous Material	No sample taken - Visual ID	Condition	GOOD	Likelihood of Damage	L (Low) – possible
		Activity	Moderate		
		Sealed	Yes	Friability	Bonded (non-friable)
		Labelled	Y	Exposure Risk	Low - Negligible or low risk
		Quantity

RISK CONTROL					
Priority	MEDIUM	Label Required	Yes	Re- Audit Date	10 Feb 2022
Action	No remedial action required, unless disturbed				
Recommendation	Maintain paint or sealant to ACM surfaces. Particular attention should be given to side edges, ensure paint/sealant covers ALL exposed ACM surfaces.				
Legislative Requirements Victorian Regulation 2007	Warning labels should be affixed. Avoid mechanical damage and abrasion. Remove if refurbishment, structural alteration or demolition is to be carried out in this area. Re-inspect every 12 months or earlier if disturbed or removed in accordance with the Victorian OH&S Regulation 2017. All remedial/removal repairs require a Clearance Inspection & Certificate to be recorded by an approved and competent assessor.

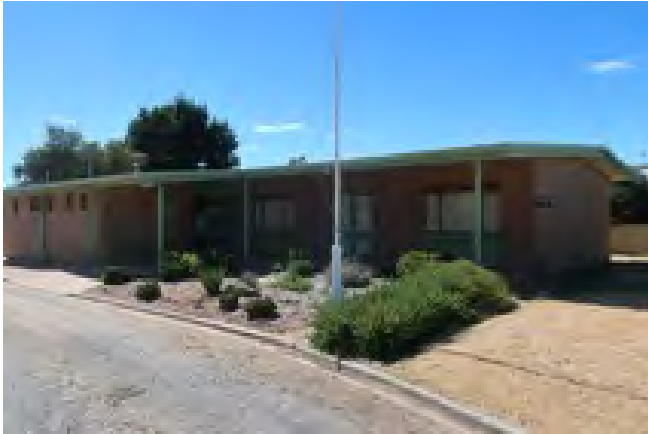
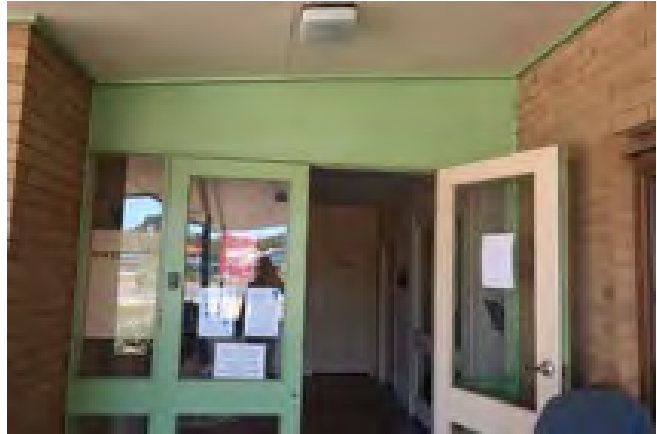
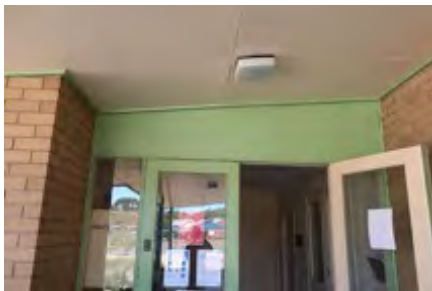
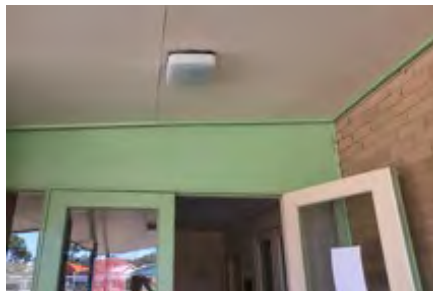
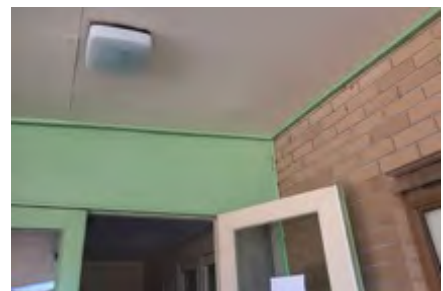
**LB40 Elderly Citizen Clubrooms: front of building. The Infill panel/s above door (F C Sheeting) has Asbestos Containing Material (ACM) present.**

RISK ASSESSMENT					
Type of Asbestos or Hazardous Material	No sample taken - Visual ID	Condition	GOOD	Likelihood of Damage	L (Low) – possible
		Activity	Moderate		
		Sealed	Yes	Friability	Bonded (non-friable)
		Labelled	Y	Exposure Risk	Low - Negligible or low risk
		Quantity

RISK CONTROL					
Priority	MEDIUM	Label Required	Yes	Re- Audit Date	10 Feb 2022
Action	No remedial action required, unless disturbed				
Recommendation	Maintain paint or sealant to ACM surfaces. Particular attention should be given to side edges, ensure paint/sealant covers ALL exposed ACM surfaces.				
Legislative Requirements Victorian Regulation 2007	Warning labels should be affixed. Avoid mechanical damage and abrasion. Remove if refurbishment, structural alteration or demolition is to be carried out in this area. Re-inspect every 12 months or earlier if disturbed or removed in accordance with the Victorian OH&S Regulation 2017. All remedial/removal repairs require a Clearance Inspection & Certificate to be recorded by an approved and competent assessor.

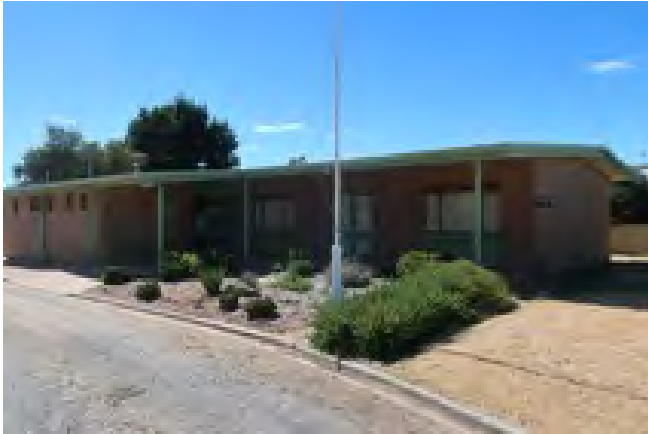
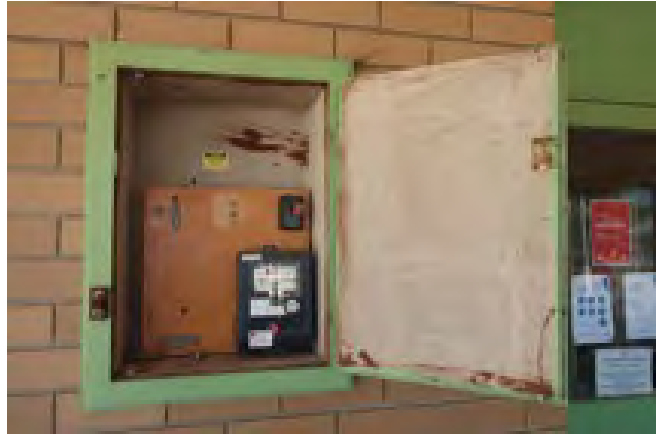
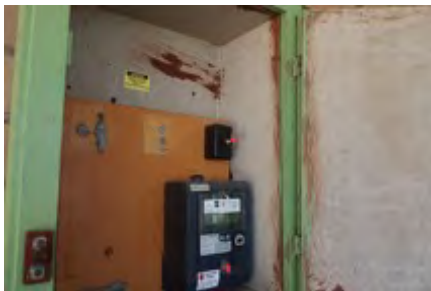
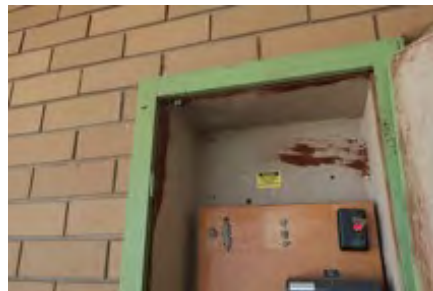
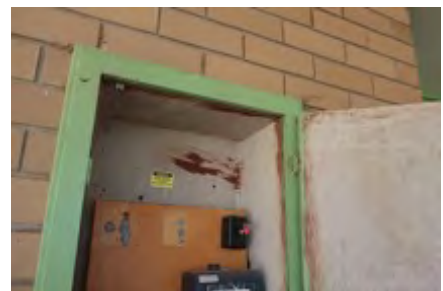
**LB40 Elderly Citizen Clubrooms: front of building. The Electrical Cabinet - lining (F C Sheeting) has Asbestos Containing Material (ACM) present.**

RISK ASSESSMENT					
Type of Asbestos or Hazardous Material	Chrysotile	Condition	AVERAGE	Likelihood of Damage	L (Low) – possible
	Sample taken 62109-002	Activity	Moderate		
		Sealed	No	Friability	Bonded (non-friable)
		Labelled	Y	Exposure Risk	Medium - Moderate risk
		Quantity

RISK CONTROL					
Priority	HIGH	Label Required	Yes	Re- Audit Date	10 Feb 2022
Action	Remedial repairs required - seal raw material / edges				
Recommendation	Raw material sheeting - The area requires immediate remedial repairs. It is recommended the asbestos material be sealed with an approved membrane.				
Legislative Requirements Victorian Regulation 2007	Damaged ACM visible in area. Requires IMMEDIATE ATTENTION. WARNING labels should be affixed. Avoid mechanical damage and abrasion. Remove if refurbishment, structural alteration or demolition is to be carried out in this area. Re-inspect every 12 months or earlier if disturbed or removed in accordance with the Victorian OH&S Regulation 2017. All remedial/removal repairs require a Clearance Inspection & Certificate to be recorded by an approved and competent assessor.

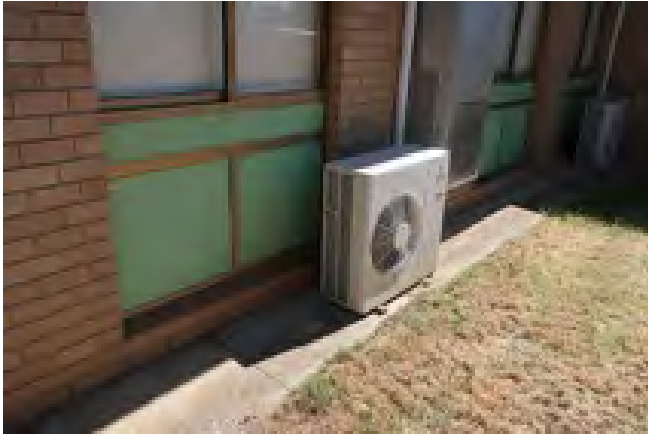
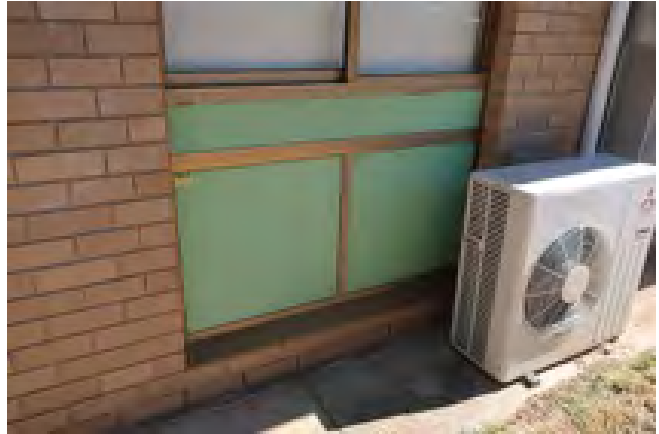
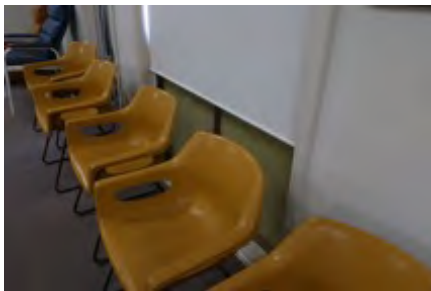
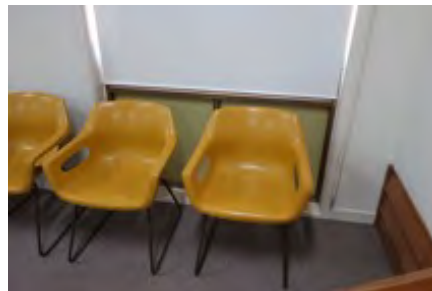
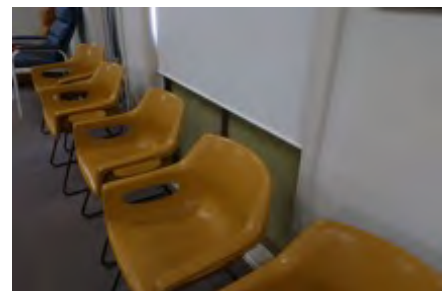
**LB40 Elderly Citizen Clubrooms: Internal & External. The Infill panel/s below windows (F C Sheeting) has Asbestos Containing Material (ACM) present.**

RISK ASSESSMENT					
Type of Asbestos or Hazardous Material	Chrysotile	Condition	GOOD	Likelihood of Damage	L (Low) – possible
	Sample taken 62109-001	Activity	Moderate		
		Sealed	Yes	Friability	Bonded (non-friable)
		Labelled	Y	Exposure Risk	Low - Negligible or low risk
		Quantity

RISK CONTROL					
Priority	MEDIUM	Label Required	Yes	Re- Audit Date	10 Feb 2022
Action	No remedial action required, unless disturbed				
Recommendation	Maintain paint or sealant to ACM surfaces. Particular attention should be given to side edges, ensure paint/sealant covers ALL exposed ACM surfaces.				
Legislative Requirements Victorian Regulation 2007	Warning labels should be affixed. Avoid mechanical damage and abrasion. Remove if refurbishment, structural alteration or demolition is to be carried out in this area. Re-inspect every 12 months or earlier if disturbed or removed in accordance with the Victorian OH&S Regulation 2017. All remedial/removal repairs require a Clearance Inspection & Certificate to be recorded by an approved and competent assessor.

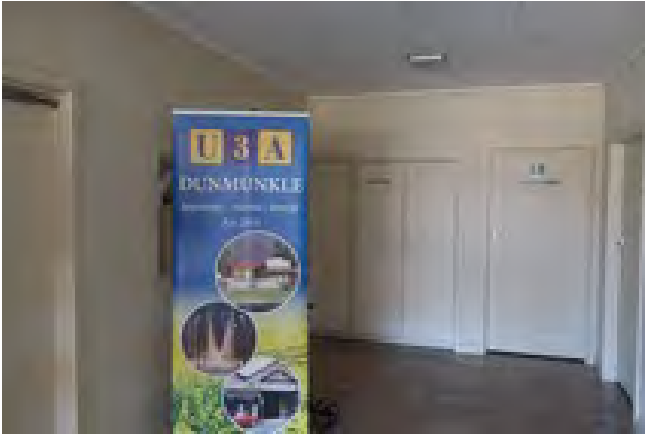
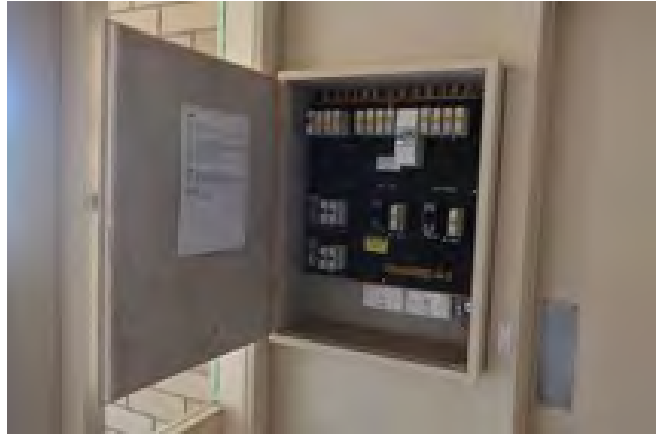
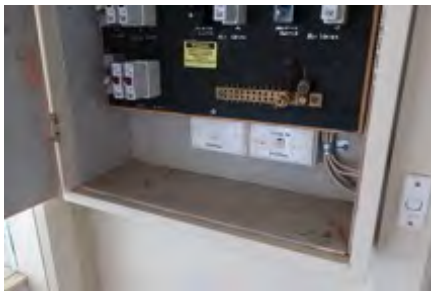
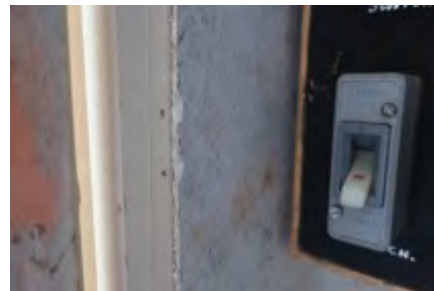
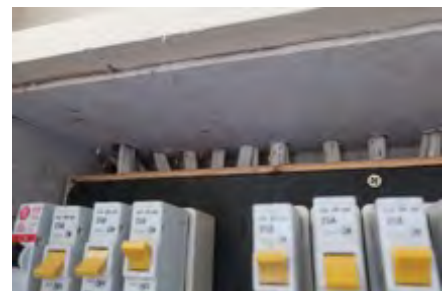
**Area 2****LB40 Elderly Citizen Clubrooms: Entrance 1. The Electrical Cabinet - lining (F C Sheeting) has Asbestos Containing Material (ACM) present.****RISK ASSESSMENT**

<b>Type of Asbestos or Hazardous Material</b>	No sample taken - Visual ID	<b>Condition</b>	AVERAGE	<b>Likelihood of Damage</b>	L (Low) – possible
		<b>Activity</b>	Moderate		
		<b>Sealed</b>	No	<b>Friability</b>	Bonded (non-friable)
		<b>Labelled</b>	Y	<b>Exposure Risk</b>	Medium - Moderate risk
		<b>Quantity</b>

<b>Priority</b>	HIGH	<b>Label Required</b>	Yes	<b>Re- Audit Date</b>	10 Feb 2022
<b>Action</b>	Remedial repairs required - seal raw material / edges				
<b>Recommendation</b>	Raw material sheeting - The area requires immediate remedial repairs. It is recommended the asbestos material be sealed with an approved membrane.				
<b>Legislative Requirements Victorian Regulation 2007</b>	<p>Damaged ACM visible in area. Requires IMMEDIATE ATTENTION. WARNING labels should be affixed. Avoid mechanical damage and abrasion. Remove if refurbishment, structural alteration or demolition is to be carried out in this area. Re-inspect every 12 months or earlier if disturbed or removed in accordance with the Victorian OH&amp;S Regulation 2017.</p> <p>All remedial/removal repairs require a Clearance Inspection &amp; Certificate to be recorded by an approved and competent assessor.</p>

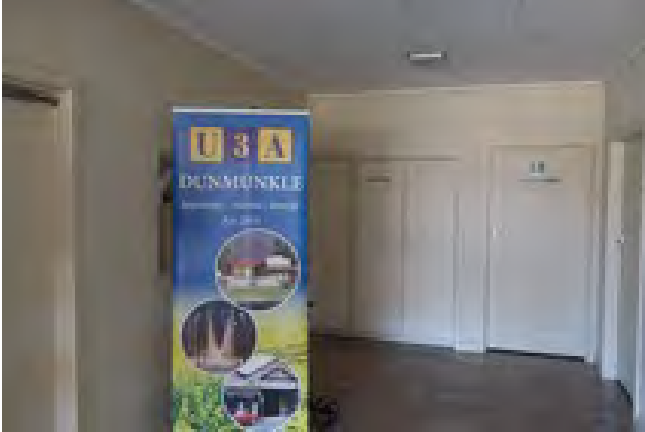
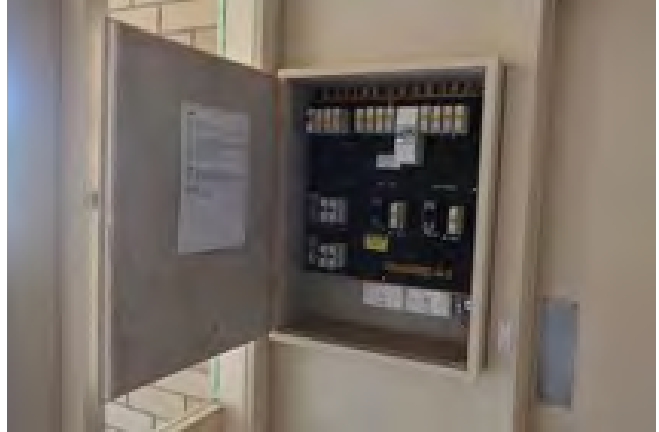
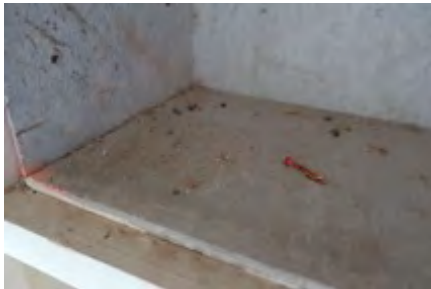
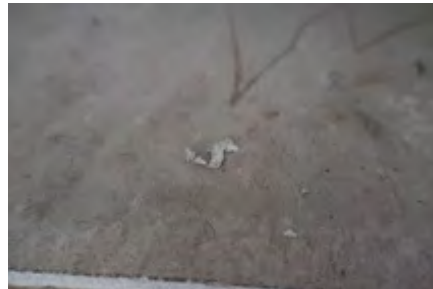
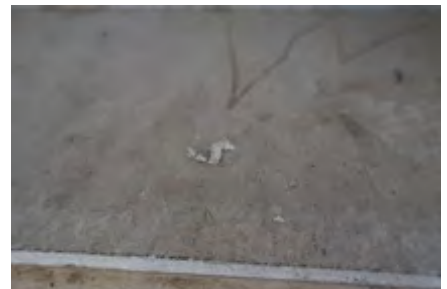
**Area 1****LB40 Elderly Citizen Clubrooms: Entrance 1. The Electrical Cabinet (Debris) has Asbestos Containing Material (ACM) present.****RISK ASSESSMENT**

<b>Type of Asbestos or Hazardous Material</b>	No sample taken - Visual ID	<b>Condition</b>	POOR	<b>Likelihood of Damage</b>	H (High) - almost certain
		<b>Activity</b>	Low		
		<b>Sealed</b>	No	<b>Friability</b>	Exposed Fibres
		<b>Labelled</b>	Y	<b>Exposure Risk</b>	High - Short term exposure risk
		<b>Quantity</b>

<b>Priority</b>	IMMEDIATE	<b>Label Required</b>	Yes	<b>Re- Audit Date</b>	10 Feb 2022
<b>Action</b>	Restrict access and target for imminent removal				
<b>Recommendation</b>	Debris on Surface - The Debris requires immediate cleanup and disposal with specialised equipment and with licensed removalist to safely remove the asbestos debris.				
<b>Legislative Requirements Victorian Regulation 2007</b>	ACM debris visible. Recommend cleanup by licensed Asbestos Removalist. Warning labels should be affixed. Avoid mechanical damage and abrasion. Remove if refurbishment, structural alteration or demolition is to be carried out in this area. Re-inspect every 12 months or earlier if disturbed or removed in accordance with the Victorian OH&S Regulation 2017. All remedial/removal repairs require a Clearance Inspection & Certificate to be recorded by an approved and competent assessor.

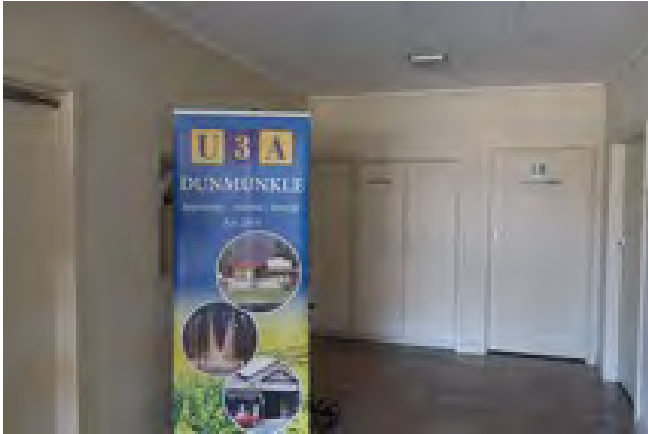
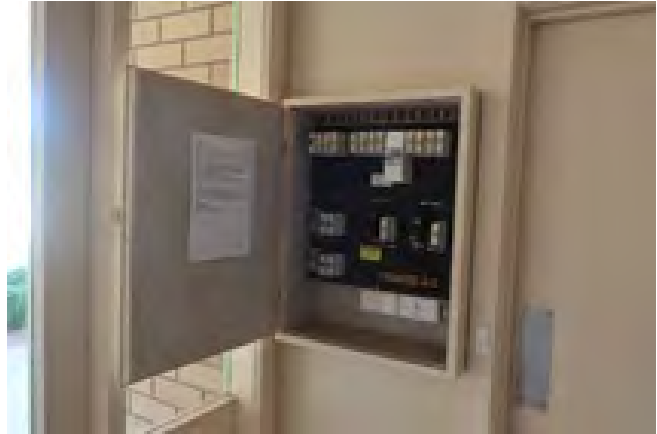
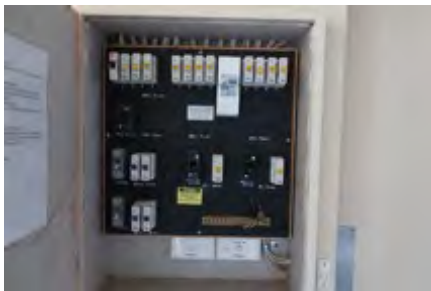
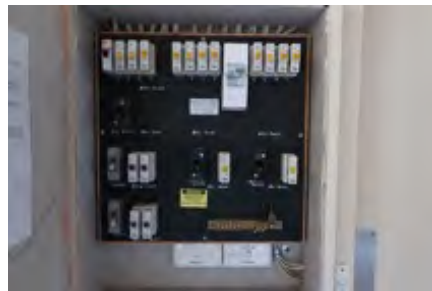
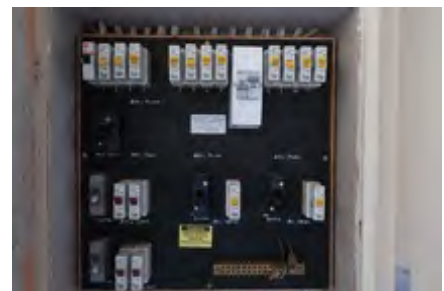
**LB40 Elderly Citizen Clubrooms: Entrance 1. The Electrical board (Backing Board (Zelemite)) has Asbestos Containing Material (ACM) present.**

RISK ASSESSMENT					
Type of Asbestos or Hazardous Material	Chrysotile	Condition	GOOD	Likelihood of Damage	L (Low) – possible
	Sample taken 62109-003	Activity	Moderate		
		Sealed	Yes	Friability	Bonded (non-friable)
		Labelled	Y	Exposure Risk	Low - Negligible or low risk
		Quantity

RISK CONTROL					
Priority	MEDIUM	Label Required	Yes	Re- Audit Date	10 Feb 2022
Action	No remedial action required, unless disturbed				
Recommendation	Maintain paint or sealant to ACM surfaces. Particular attention should be given to side edges, ensure paint/sealant covers ALL exposed ACM surfaces.				
Legislative Requirements Victorian Regulation 2007	Warning labels should be affixed. Avoid mechanical damage and abrasion. Remove if refurbishment, structural alteration or demolition is to be carried out in this area. Re-inspect every 12 months or earlier if disturbed or removed in accordance with the Victorian OH&S Regulation 2017. All remedial/removal repairs require a Clearance Inspection & Certificate to be recorded by an approved and competent assessor.

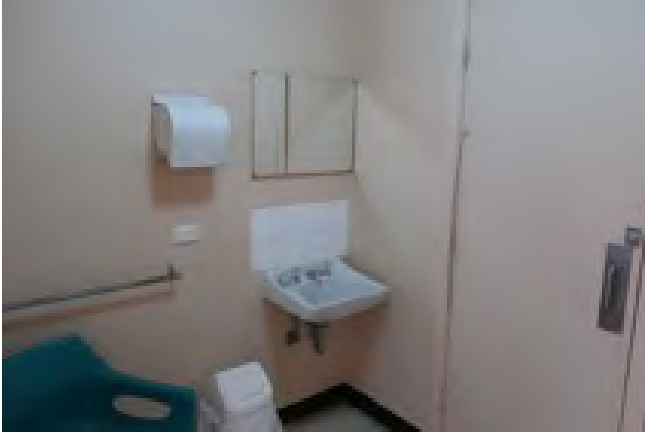
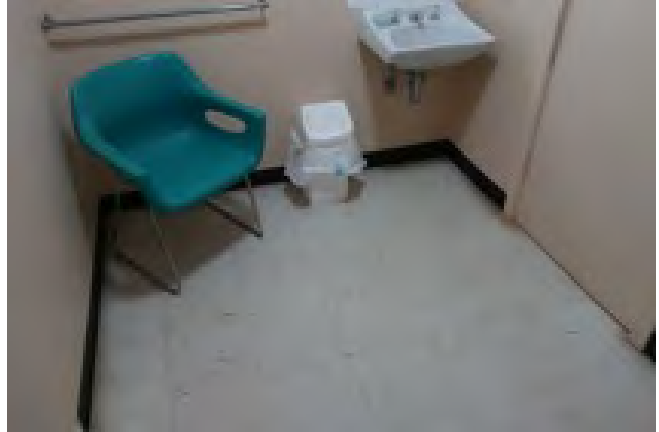
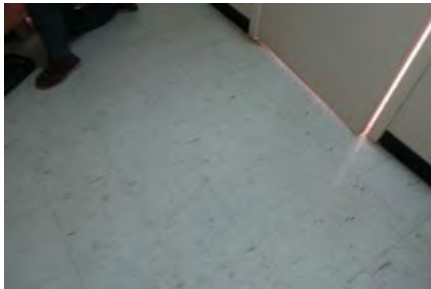
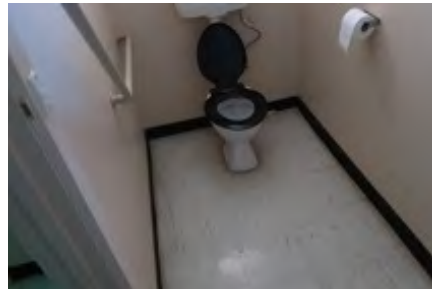
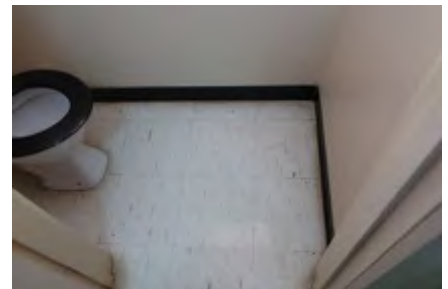
**Area 11****LB40 Elderly Citizen Clubrooms: Male bathroom 2. The Floor (Vinyl Tiles) has Asbestos Containing Material (ACM) present.****RISK ASSESSMENT**

<b>Type of Asbestos or Hazardous Material</b>	Chrysotile	<b>Condition</b>	GOOD	<b>Likelihood of Damage</b>	L (Low) – possible
	Sample taken 62109-004	<b>Activity</b>	Moderate		
		<b>Sealed</b>	Yes	<b>Friability</b>	Bonded (non-friable)
		<b>Labelled</b>	Y	<b>Exposure Risk</b>	Low - Negligible or low risk
		<b>Quantity</b>

<b>Priority</b>	MEDIUM	<b>Label Required</b>	Yes	<b>Re- Audit Date</b>	10 Feb 2022
<b>Action</b>	No remedial action required, unless disturbed				
<b>Recommendation</b>	Maintain paint or sealant to ACM surfaces. Particular attention should be given to side edges, ensure paint/sealant covers ALL exposed ACM surfaces.				
<b>Legislative Requirements Victorian Regulation 2007</b>	Warning labels should be affixed. Avoid mechanical damage and abrasion. Remove if refurbishment, structural alteration or demolition is to be carried out in this area. Re-inspect every 12 months or earlier if disturbed or removed in accordance with the Victorian OH&S Regulation 2017. All remedial/removal repairs require a Clearance Inspection & Certificate to be recorded by an approved and competent assessor.

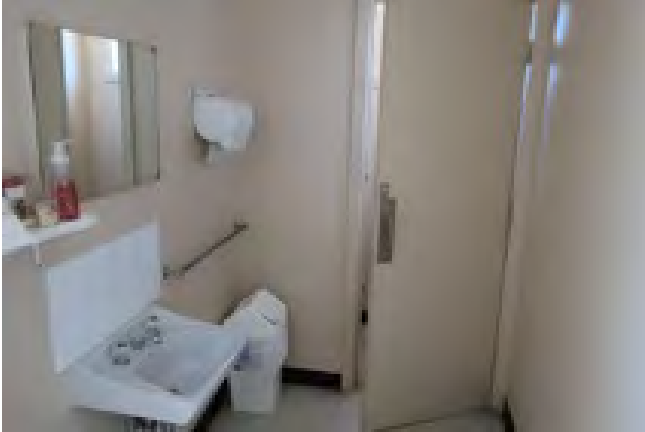
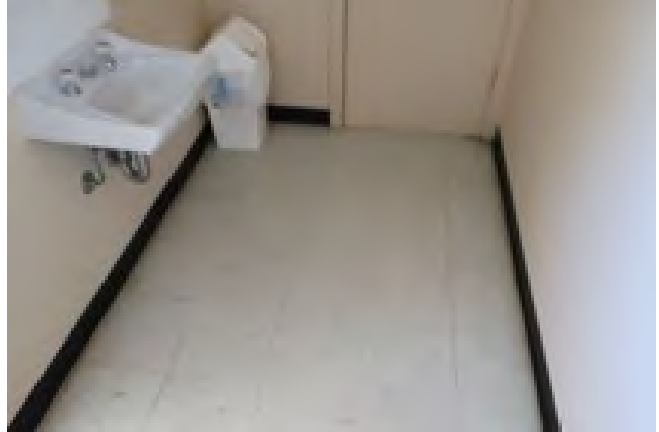
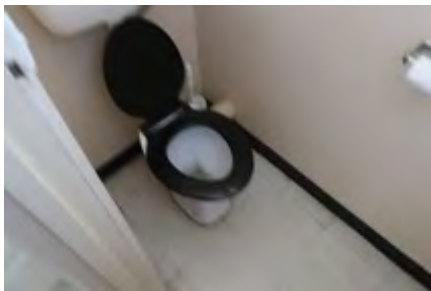
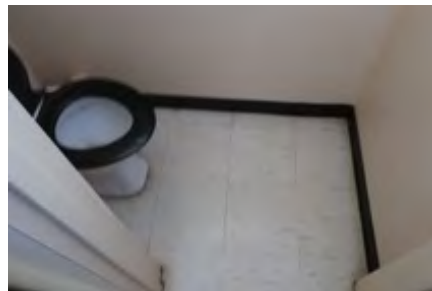
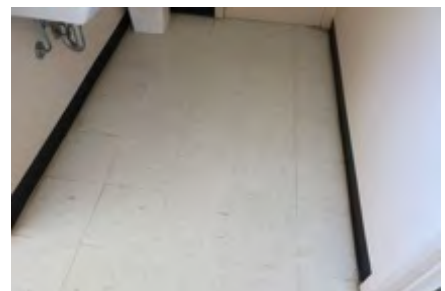
**Area 6****LB40 Elderly Citizen Clubrooms: Female bathroom 3. The Floor (Vinyl Tiles) has Asbestos Containing Material (ACM) present.****RISK ASSESSMENT**

<b>Type of Asbestos or Hazardous Material</b>	Chrysotile	<b>Condition</b>	GOOD	<b>Likelihood of Damage</b>	L (Low) – possible
	Same as Sample - 62109 -004	<b>Activity</b>	Moderate		
		<b>Sealed</b>	Yes	<b>Friability</b>	Bonded (non-friable)
		<b>Labelled</b>	Y	<b>Exposure Risk</b>	Low - Negligible or low risk
		<b>Quantity</b>

<b>Priority</b>	MEDIUM	<b>Label Required</b>	Yes	<b>Re- Audit Date</b>	10 Feb 2022
<b>Action</b>	No remedial action required, unless disturbed				
<b>Recommendation</b>	Maintain paint or sealant to ACM surfaces. Particular attention should be given to side edges, ensure paint/sealant covers ALL exposed ACM surfaces.				
<b>Legislative Requirements Victorian Regulation 2007</b>	Warning labels should be affixed. Avoid mechanical damage and abrasion. Remove if refurbishment, structural alteration or demolition is to be carried out in this area. Re-inspect every 12 months or earlier if disturbed or removed in accordance with the Victorian OH&S Regulation 2017. All remedial/removal repairs require a Clearance Inspection & Certificate to be recorded by an approved and competent assessor.

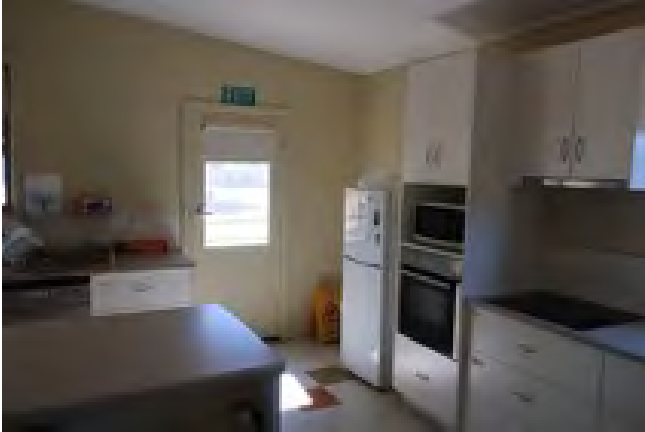
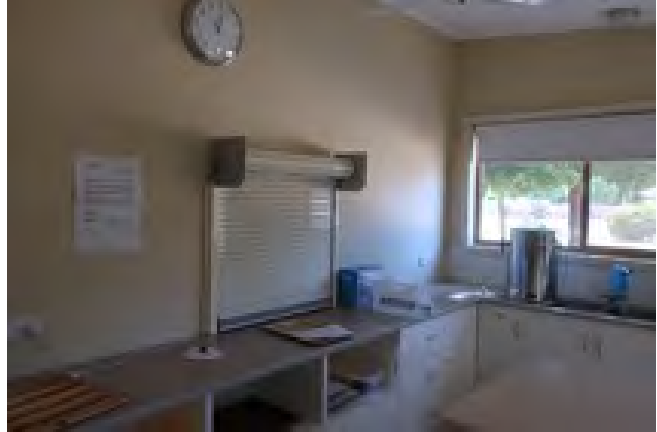
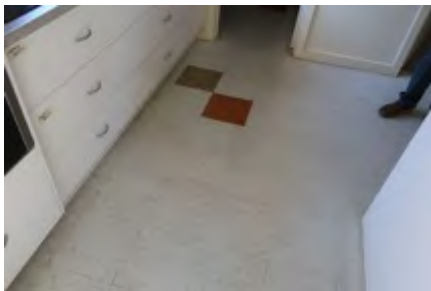
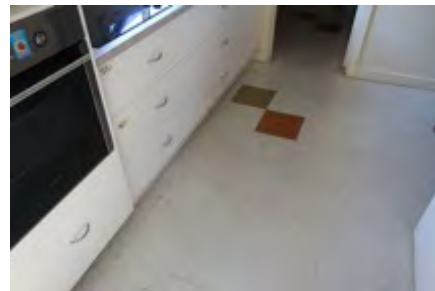
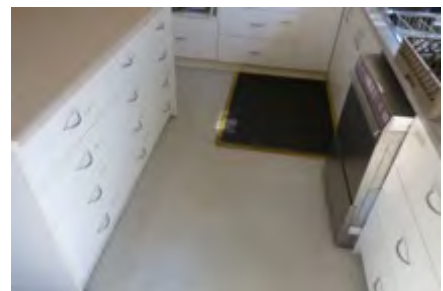
**Area 9****LB40 Elderly Citizen Clubrooms: Kitchen 10. The Floor (Vinyl Tiles) has Asbestos Containing Material (ACM) present.****RISK ASSESSMENT**

<b>Type of Asbestos or Hazardous Material</b>	Chrysotile	<b>Condition</b>	GOOD	<b>Likelihood of Damage</b>	L (Low) – possible
	Same as Sample - 62109 -004	<b>Activity</b>	Moderate		
		<b>Sealed</b>	Yes	<b>Friability</b>	Bonded (non-friable)
		<b>Labelled</b>	Y	<b>Exposure Risk</b>	Low - Negligible or low risk
		<b>Quantity</b>

<b>Priority</b>	MEDIUM	<b>Label Required</b>	Yes	<b>Re- Audit Date</b>	10 Feb 2022
<b>Action</b>	No remedial action required, unless disturbed				
<b>Recommendation</b>	Maintain paint or sealant to ACM surfaces. Particular attention should be given to side edges, ensure paint/sealant covers ALL exposed ACM surfaces.				
<b>Legislative Requirements Victorian Regulation 2007</b>	Warning labels should be affixed. Avoid mechanical damage and abrasion. Remove if refurbishment, structural alteration or demolition is to be carried out in this area. Re-inspect every 12 months or earlier if disturbed or removed in accordance with the Victorian OH&S Regulation 2017. All remedial/removal repairs require a Clearance Inspection & Certificate to be recorded by an approved and competent assessor.

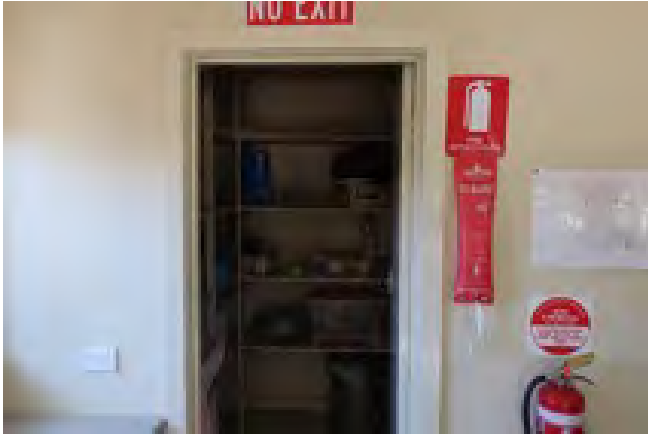
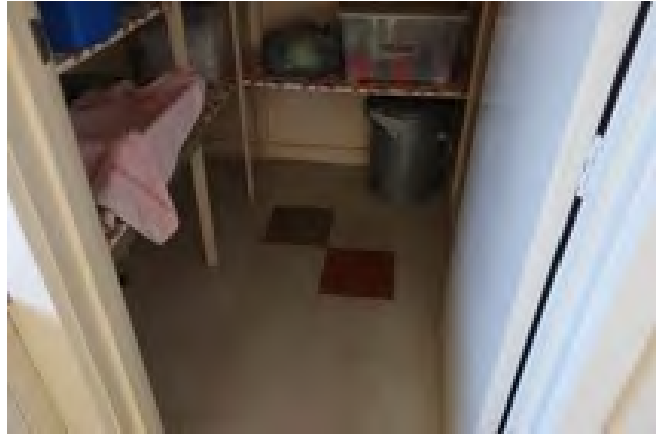
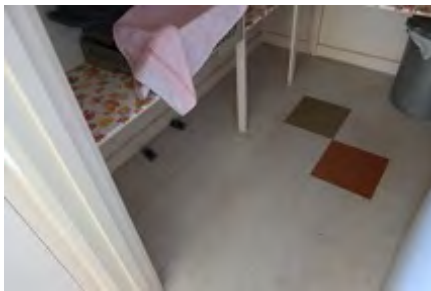
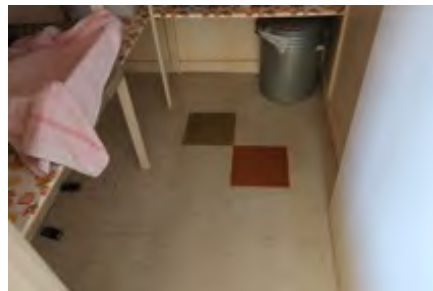
**LB40 Elderly Citizen Clubrooms: Kitchen pantry 10.1. The Floor (Vinyl Tiles) has Asbestos Containing Material (ACM) present.**

RISK ASSESSMENT					
Type of Asbestos or Hazardous Material	Chrysotile	Condition	GOOD	Likelihood of Damage	L (Low) – possible
	Same as Sample - 62109 -004	Activity	Moderate		
		Sealed	Yes	Friability	Bonded (non-friable)
		Labelled	Y	Exposure Risk	Low - Negligible or low risk
		Quantity

RISK CONTROL					
Priority	MEDIUM	Label Required	Yes	Re- Audit Date	10 Feb 2022
Action	No remedial action required, unless disturbed				
Recommendation	Maintain paint or sealant to ACM surfaces. Particular attention should be given to side edges, ensure paint/sealant covers ALL exposed ACM surfaces.				
Legislative Requirements Victorian Regulation 2007	Warning labels should be affixed. Avoid mechanical damage and abrasion. Remove if refurbishment, structural alteration or demolition is to be carried out in this area. Re-inspect every 12 months or earlier if disturbed or removed in accordance with the Victorian OH&S Regulation 2017. All remedial/removal repairs require a Clearance Inspection & Certificate to be recorded by an approved and competent assessor.

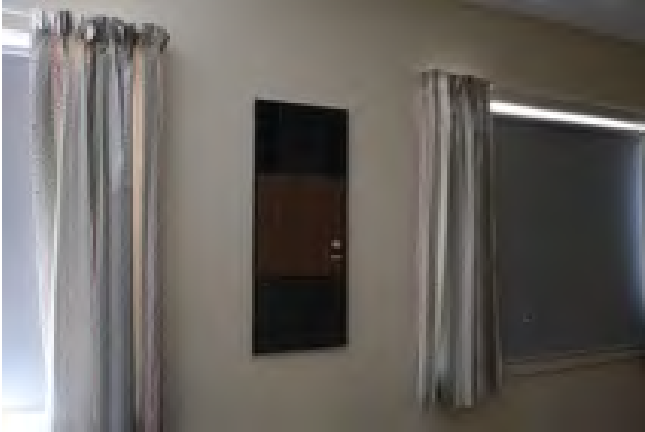
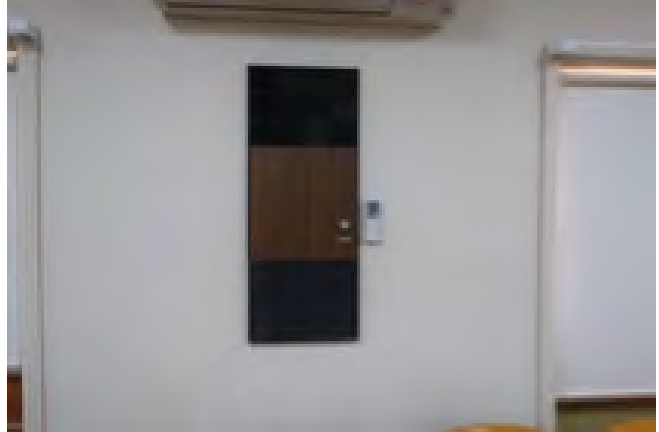
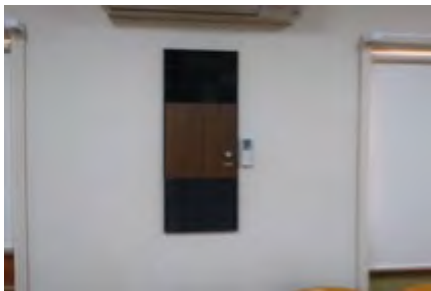
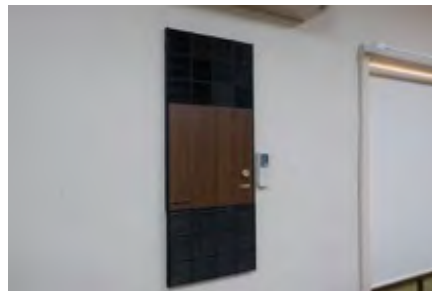
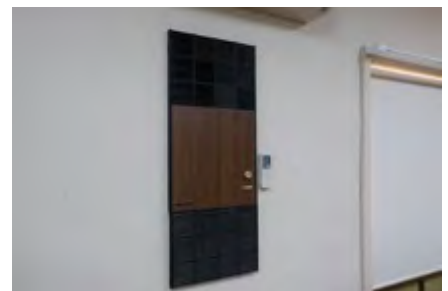
**Area 12****LB40 Elderly Citizen Clubrooms: Various rooms. The Air Conditioner - Heater element (Insulation board) has Asbestos Containing Material (ACM) present.****RISK ASSESSMENT**

<b>Type of Asbestos or Hazardous Material</b>	No sample taken - Visual ID	<b>Condition</b>	GOOD	<b>Likelihood of Damage</b>	L (Low) – possible
		<b>Activity</b>	Moderate		
		<b>Sealed</b>	Yes	<b>Friability</b>	Bonded (non-friable)
		<b>Labelled</b>	Y	<b>Exposure Risk</b>	Low - Negligible or low risk
		<b>Quantity</b>

<b>Priority</b>	MEDIUM	<b>Label Required</b>	Yes	<b>Re- Audit Date</b>	10 Feb 2022
<b>Action</b>	No remedial action required, unless disturbed				
<b>Recommendation</b>	Maintain paint or sealant to ACM surfaces. Particular attention should be given to side edges, ensure paint/sealant covers ALL exposed ACM surfaces.				
<b>Legislative Requirements Victorian Regulation 2007</b>	Warning labels should be affixed. Avoid mechanical damage and abrasion. Remove if refurbishment, structural alteration or demolition is to be carried out in this area. Re-inspect every 12 months or earlier if disturbed or removed in accordance with the Victorian OH&S Regulation 2017. All remedial/removal repairs require a Clearance Inspection & Certificate to be recorded by an approved and competent assessor.
