# Asbestos Report

YARRIAMBIACK SHIRE COUNCIL

PROPERTY ADDRESS:  
LB115 IWC / PRESCHOOL  
55 CROMIE STREET  
RUPANYUP VIC 3388

INSPECTION DATE: 10 FEBRUARY 2021  
REFERENCE NUMBER: 62110

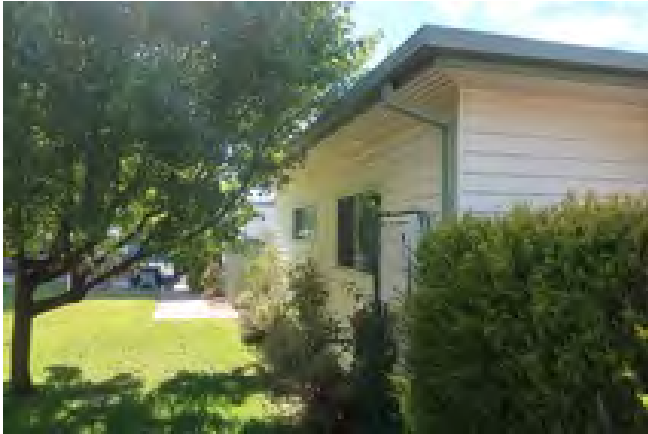
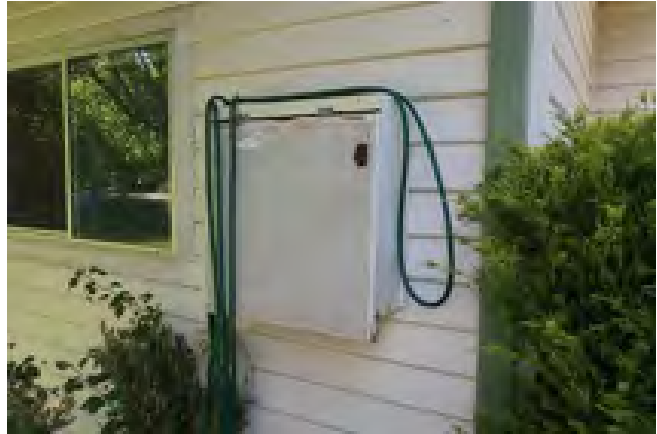
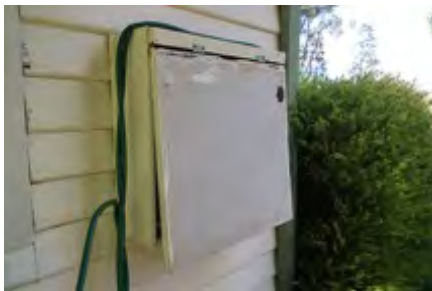
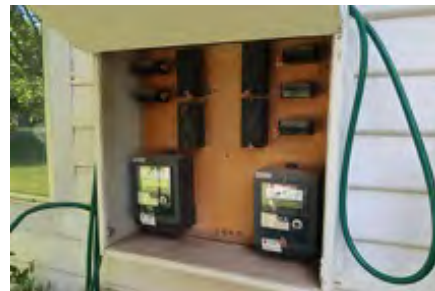
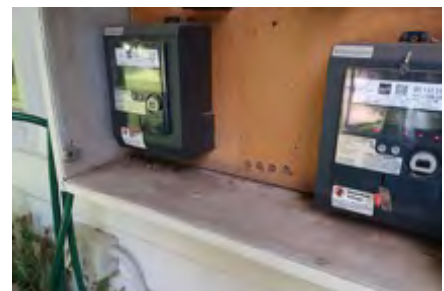
<b>Type of Asbestos or Hazardous Material</b>	No sample taken - Visual ID	<b>Condition</b>	AVERAGE	<b>Likelihood of Damage</b>	L (Low) – possible
		<b>Activity</b>	Moderate		
		<b>Sealed</b>	No	<b>Friability</b>	Bonded (non-friable)
		<b>Labelled</b>	Y	<b>Exposure Risk</b>	Medium - Moderate risk
		<b>Quantity</b>

Raw Material

<b>Priority</b>	HIGH	<b>Label Required</b>	Yes	<b>Re- Audit Date</b>	10 Feb 2022
<b>Action</b>	Remedial repairs required - seal raw material / edges				
<b>Recommendation</b>	Raw material sheeting - The area requires immediate remedial repairs. It is recommended the asbestos material be sealed with an approved membrane.				
<b>Legislative Requirements Victorian Regulation 2007</b>	Damaged ACM visible in area. Requires IMMEDIATE ATTENTION. WARNING labels should be affixed. Avoid mechanical damage and abrasion. Remove if refurbishment, structural alteration or demolition is to be carried out in this area. Re-inspect every 12 months or earlier if disturbed or removed in accordance with the Victorian OH&S Regulation 2017. All remedial/removal repairs require a Clearance Inspection & Certificate to be recorded by an approved and competent assessor.

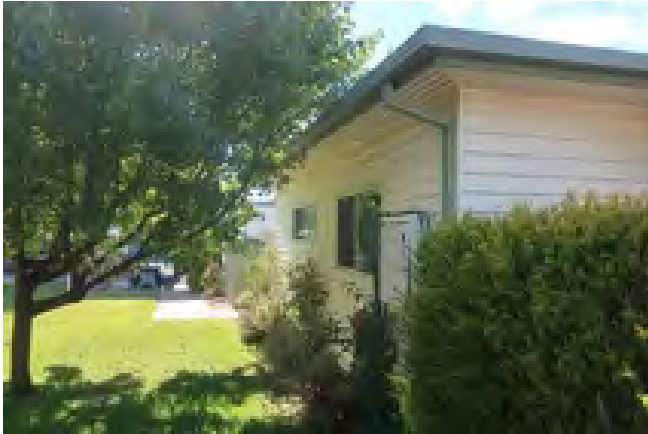
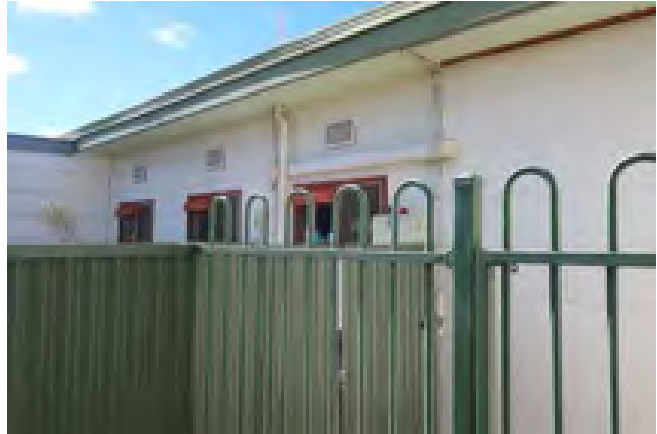
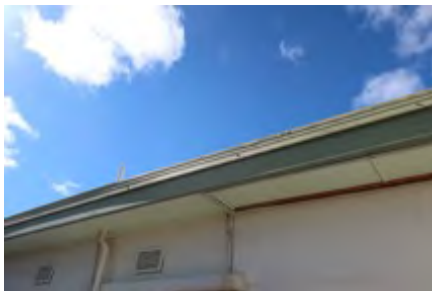
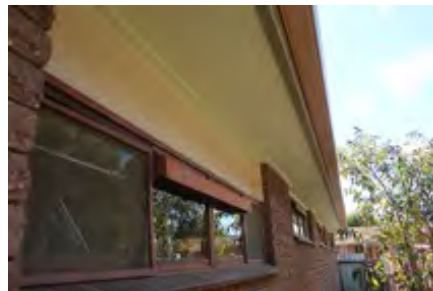
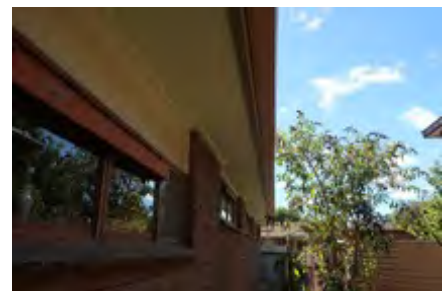
**LB115 IWC / Preschool: left & right side of building. The Soffit (F C Sheeting) has Asbestos Containing Material (ACM) present.**

RISK ASSESSMENT					
Type of Asbestos or Hazardous Material	No sample taken - Visual ID	Condition	GOOD	Likelihood of Damage	L (Low) – possible
		Activity	Moderate		
		Sealed	Yes	Friability	Bonded (non-friable)
		Labelled	Y	Exposure Risk	Low - Negligible or low risk
		Quantity

Priority	MEDIUM	Label Required	Yes	Re- Audit Date	10 Feb 2022
Action	No remedial action required, unless disturbed				
Recommendation	Maintain paint or sealant to ACM surfaces. Particular attention should be given to side edges, ensure paint/sealant covers ALL exposed ACM surfaces.				
Legislative Requirements Victorian Regulation 2007	Warning labels should be affixed. Avoid mechanical damage and abrasion. Remove if refurbishment, structural alteration or demolition is to be carried out in this area. Re-inspect every 12 months or earlier if disturbed or removed in accordance with the Victorian OH&S Regulation 2017. All remedial/removal repairs require a Clearance Inspection & Certificate to be recorded by an approved and competent assessor.

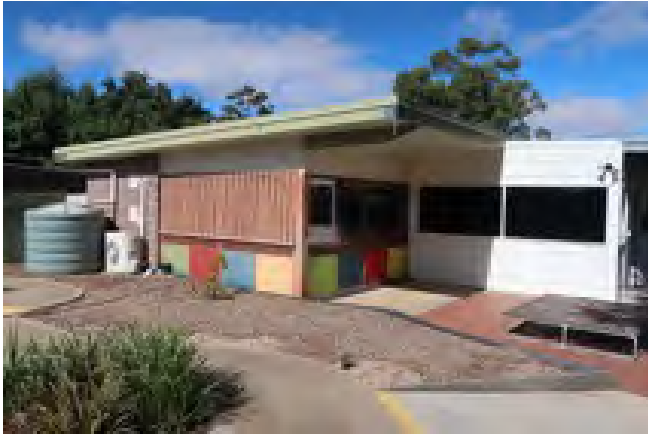
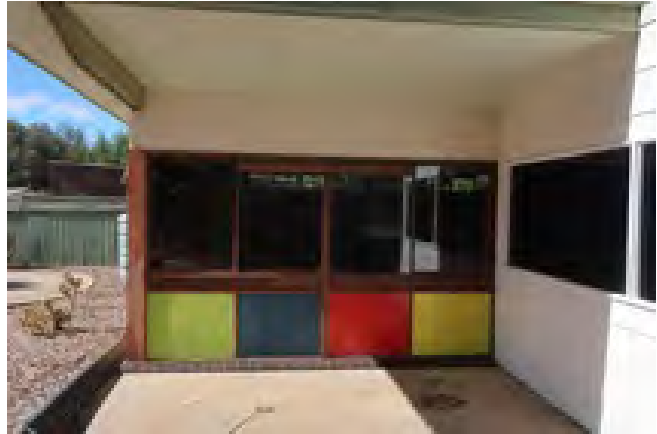
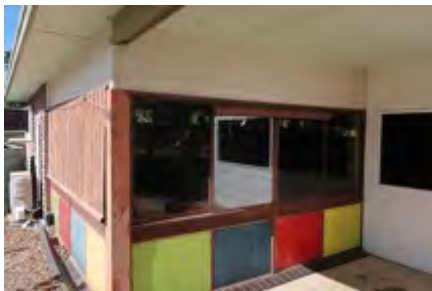
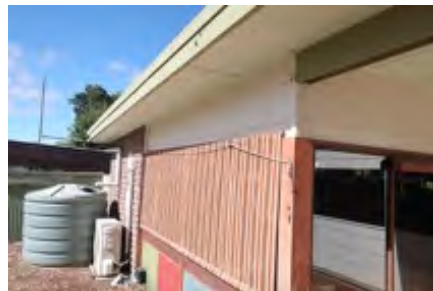
**LB115 IWC / Preschool: rear of building. The Soffit (F C Sheeting) has Asbestos Containing Material (ACM) present.**

RISK ASSESSMENT					
Type of Asbestos or Hazardous Material	No sample taken - Visual ID	Condition	GOOD	Likelihood of Damage	L (Low) – possible
		Activity	Moderate		
		Sealed	Yes	Friability	Bonded (non-friable)
		Labelled	Y	Exposure Risk	Low - Negligible or low risk
		Quantity

RISK CONTROL					
Priority	MEDIUM	Label Required	Yes	Re- Audit Date	10 Feb 2022
Action	No remedial action required, unless disturbed				
Recommendation	Maintain paint or sealant to ACM surfaces. Particular attention should be given to side edges, ensure paint/sealant covers ALL exposed ACM surfaces.				
Legislative Requirements Victorian Regulation 2007	Warning labels should be affixed. Avoid mechanical damage and abrasion. Remove if refurbishment, structural alteration or demolition is to be carried out in this area. Re-inspect every 12 months or earlier if disturbed or removed in accordance with the Victorian OH&S Regulation 2017. All remedial/removal repairs require a Clearance Inspection & Certificate to be recorded by an approved and competent assessor.

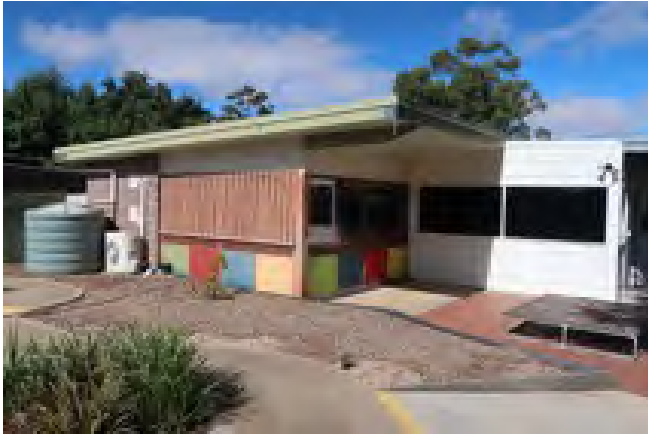
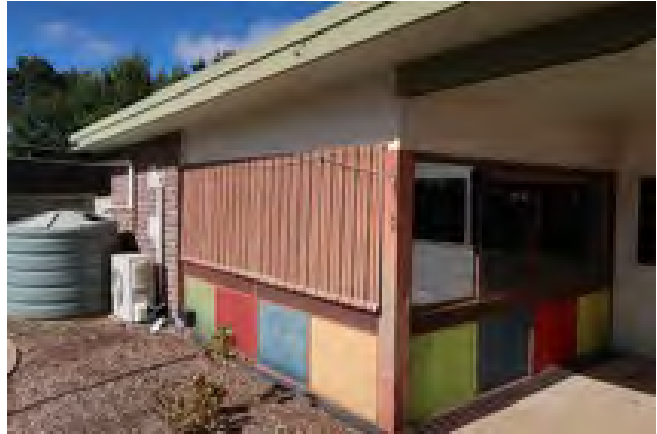
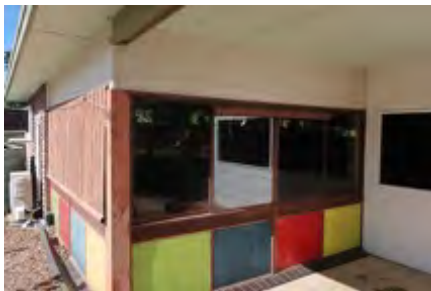
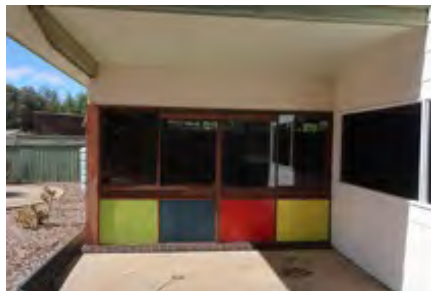
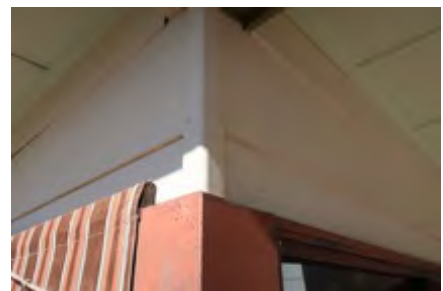
**LB115 IWC / Preschool: rear of building. The Wall - planking (F C Sheet) has Asbestos Containing Material (ACM) present.**

RISK ASSESSMENT					
Type of Asbestos or Hazardous Material	Chrysotile	Condition	GOOD	Likelihood of Damage	L (Low) – possible
	Sample taken 62110-008	Activity	Moderate		
		Sealed	Yes	Friability	Bonded (non-friable)
		Labelled	Y	Exposure Risk	Low - Negligible or low risk
		Quantity

Priority	MEDIUM	Label Required	Yes	Re- Audit Date	10 Feb 2022
Action	No remedial action required, unless disturbed				
Recommendation	Maintain paint or sealant to ACM surfaces. Particular attention should be given to side edges, ensure paint/sealant covers ALL exposed ACM surfaces.				
Legislative Requirements Victorian Regulation 2007	Warning labels should be affixed. Avoid mechanical damage and abrasion. Remove if refurbishment, structural alteration or demolition is to be carried out in this area. Re-inspect every 12 months or earlier if disturbed or removed in accordance with the Victorian OH&S Regulation 2017. All remedial/removal repairs require a Clearance Inspection & Certificate to be recorded by an approved and competent assessor.

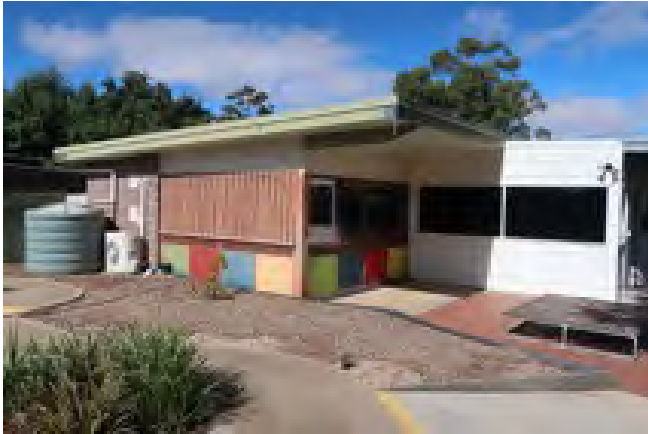
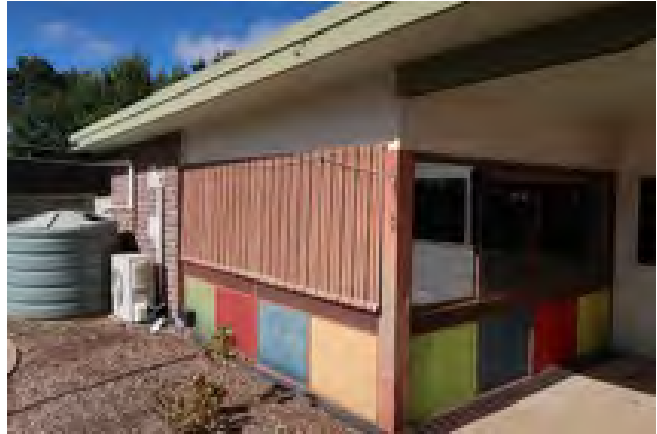
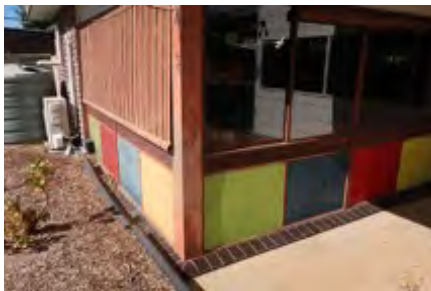
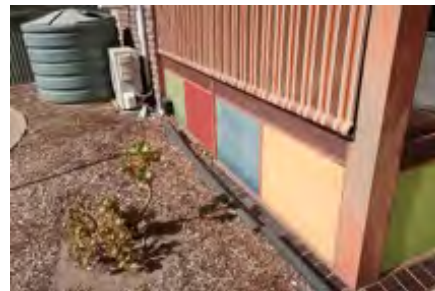
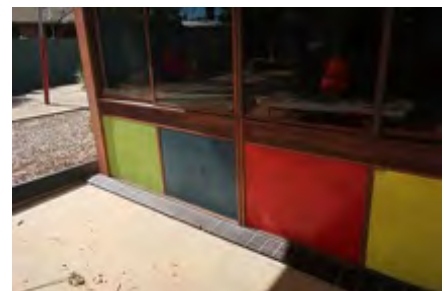
**LB115 IWC / Preschool: rear of building. The Infill panel/s below windows (F C Sheeting) has Asbestos Containing Material (ACM) present.**

RISK ASSESSMENT					
Type of Asbestos or Hazardous Material	Chrysotile	Condition	GOOD	Likelihood of Damage	L (Low) – possible
	Sample taken 62110-004	Activity	Moderate	Friability	Bonded (non-friable)
		Sealed	Yes	Exposure Risk	Low - Negligible or low risk
		Labelled	Y		
		Quantity

RISK CONTROL					
Priority	MEDIUM	Label Required	Yes	Re- Audit Date	10 Feb 2022
Action	No remedial action required, unless disturbed				
Recommendation	Maintain paint or sealant to ACM surfaces. Particular attention should be given to side edges, ensure paint/sealant covers ALL exposed ACM surfaces.				
Legislative Requirements Victorian Regulation 2007	Warning labels should be affixed. Avoid mechanical damage and abrasion. Remove if refurbishment, structural alteration or demolition is to be carried out in this area. Re-inspect every 12 months or earlier if disturbed or removed in accordance with the Victorian OH&S Regulation 2017. All remedial/removal repairs require a Clearance Inspection & Certificate to be recorded by an approved and competent assessor.

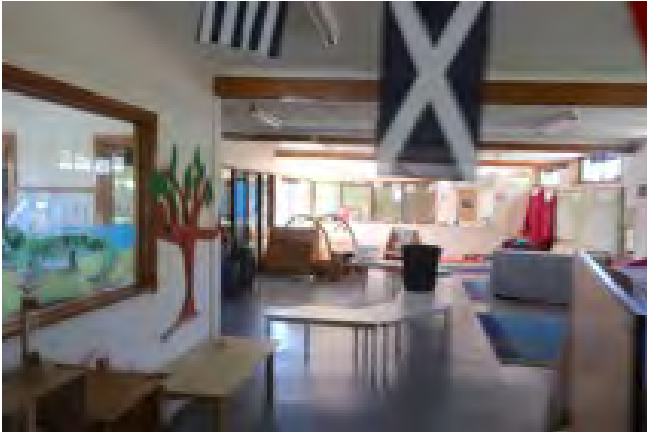
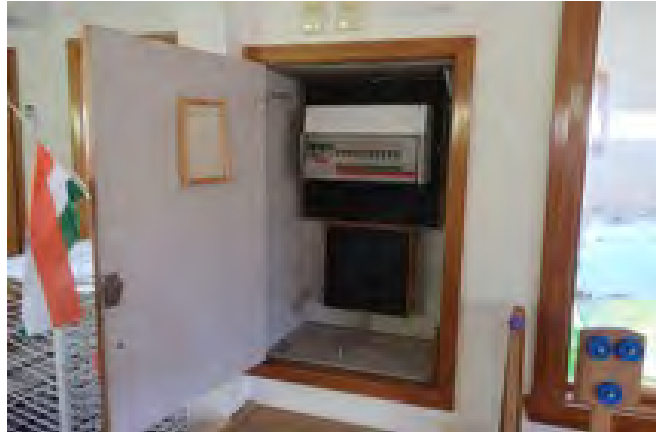
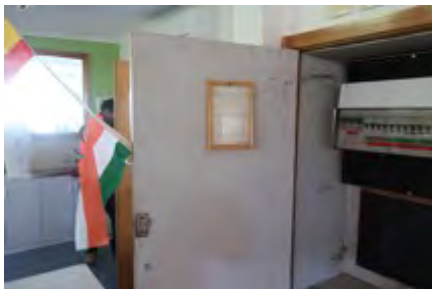
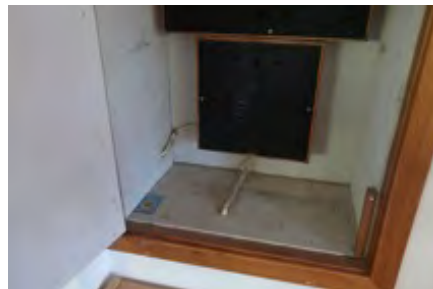
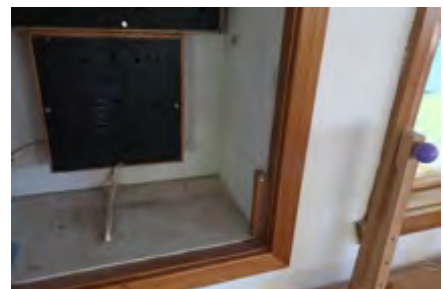
**Open room 6. The Electrical Cabinet - lining (F C Sheeting) has Asbestos Containing Material (ACM) present.**

RISK ASSESSMENT					
Type of Asbestos or Hazardous Material	Chrysotile	Condition	AVERAGE	Likelihood of Damage	L (Low) – possible
	Sample taken 62110-001	Activity	Moderate		
		Sealed	No	Friability	Bonded (non-friable)
		Labelled	Y	Exposure Risk	Medium - Moderate risk
		Quantity

Raw Material

RISK CONTROL					
Priority	HIGH	Label Required	Yes	Re- Audit Date	10 Feb 2022
Action	Remedial repairs required - seal raw material / edges				
Recommendation	Raw material sheeting - The area requires immediate remedial repairs. It is recommended the asbestos material be sealed with an approved membrane.				
Legislative Requirements Victorian Regulation 2007	Damaged ACM visible in area. Requires IMMEDIATE ATTENTION. WARNING labels should be affixed. Avoid mechanical damage and abrasion. Remove if refurbishment, structural alteration or demolition is to be carried out in this area. Re-inspect every 12 months or earlier if disturbed or removed in accordance with the Victorian OH&S Regulation 2017. All remedial/removal repairs require a Clearance Inspection & Certificate to be recorded by an approved and competent assessor.

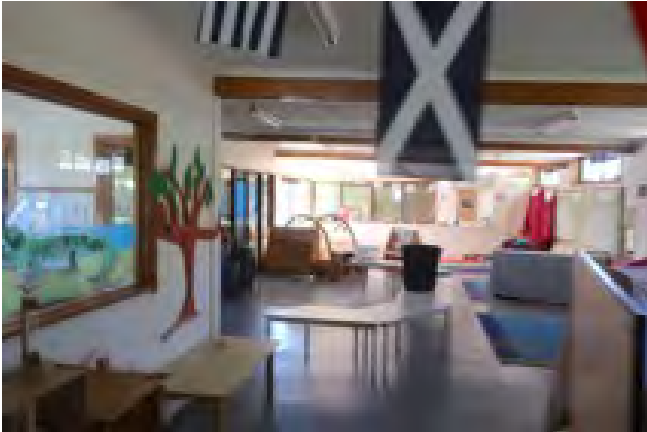
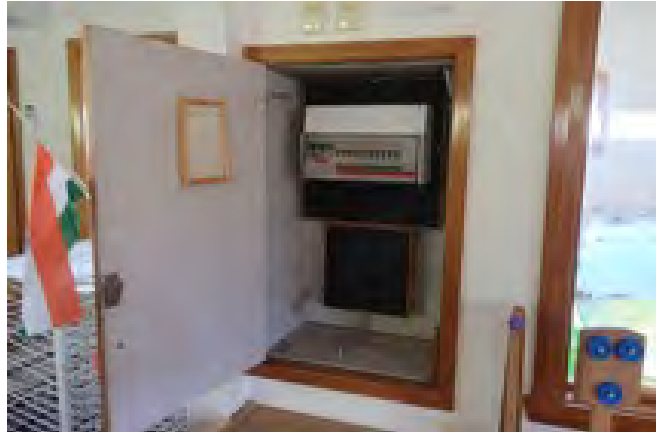
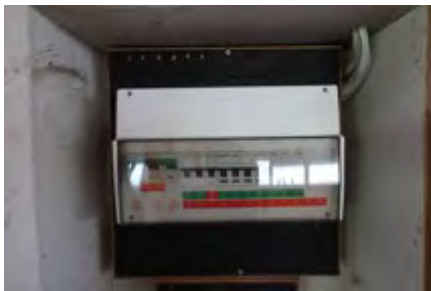
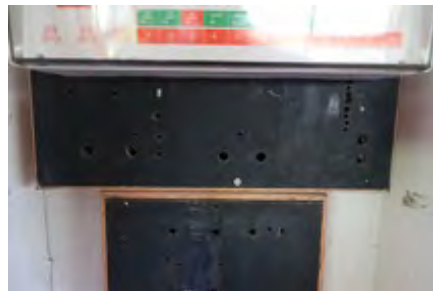
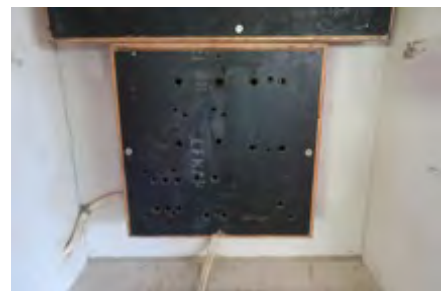
**LB115 IWC / Preschool: Open room 6. The Electrical boards x2 (Backing Board (Zelemite)) has Asbestos Containing Material (ACM) present.**

RISK ASSESSMENT					
Type of Asbestos or Hazardous Material	Chrysotile	Condition	AVERAGE	Likelihood of Damage	L (Low) – possible
	Sample taken 62110-002	Activity	Moderate	Friability	Exposed Fibres
		Sealed	Yes	Exposure Risk	Medium - Moderate risk
		Labelled	Y		
		Quantity

Penetration Holes

RISK CONTROL					
Priority	HIGH	Label Required	Yes	Re- Audit Date	10 Feb 2022
Action	Remedial repairs required - seal raw material / edges				
Recommendation	Penetration Holes - The exposed edges require approved sealant. It is further recommended the gaps be filled with sealant.				
Legislative Requirements Victorian Regulation 2007	Damaged ACM visible in area. Requires IMMEDIATE ATTENTION. WARNING labels should be affixed. Avoid mechanical damage and abrasion. Remove if refurbishment, structural alteration or demolition is to be carried out in this area. Re-inspect every 12 months or earlier if disturbed or removed in accordance with the Victorian OH&S Regulation 2017. All remedial/removal repairs require a Clearance Inspection & Certificate to be recorded by an approved and competent assessor.

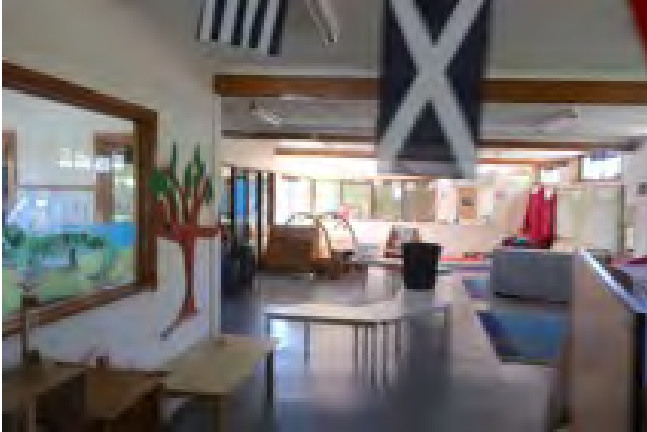
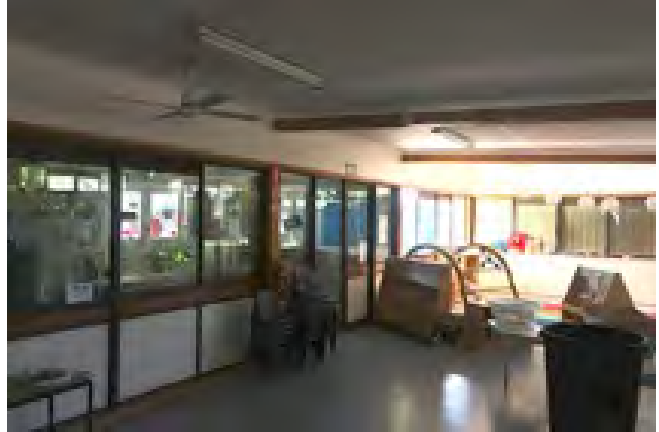
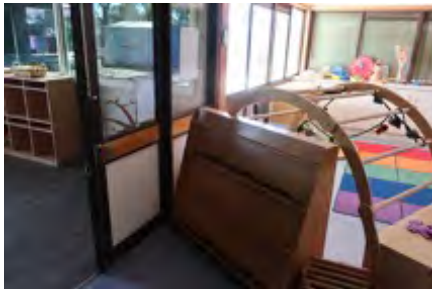
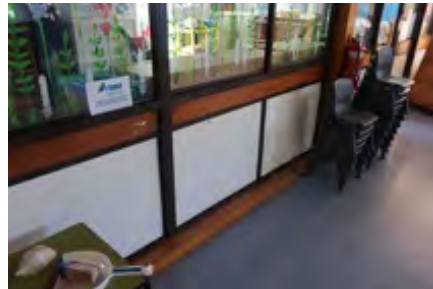
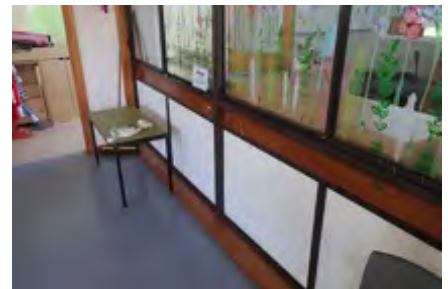
**LB115 IWC / Preschool: Open room 6. The Infill panel/s below windows (F C Sheeting) has Asbestos Containing Material (ACM) present.**

RISK ASSESSMENT					
Type of Asbestos or Hazardous Material	Chrysotile	Condition	GOOD	Likelihood of Damage	L (Low) – possible
	Same as Sample - 62110 -004	Activity	Moderate		
		Sealed	Yes	Friability	Bonded (non-friable)
		Labelled	Y	Exposure Risk	Low - Negligible or low risk
		Quantity

Priority	MEDIUM	Label Required	Yes	Re- Audit Date	10 Feb 2022
Action	No remedial action required, unless disturbed				
Recommendation	Maintain paint or sealant to ACM surfaces. Particular attention should be given to side edges, ensure paint/sealant covers ALL exposed ACM surfaces.				
Legislative Requirements Victorian Regulation 2007	Warning labels should be affixed. Avoid mechanical damage and abrasion. Remove if refurbishment, structural alteration or demolition is to be carried out in this area. Re-inspect every 12 months or earlier if disturbed or removed in accordance with the Victorian OH&S Regulation 2017. All remedial/removal repairs require a Clearance Inspection & Certificate to be recorded by an approved and competent assessor.

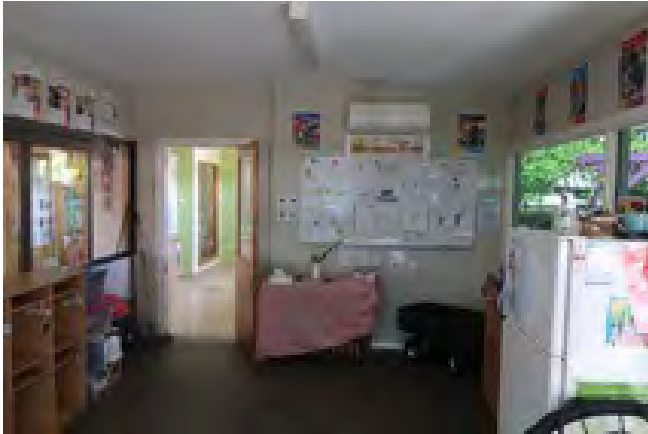
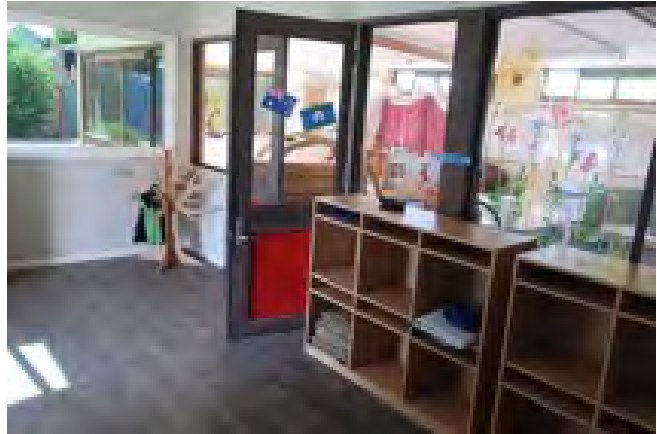
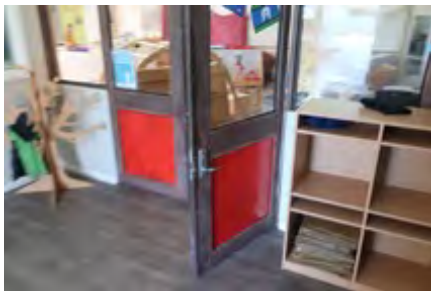
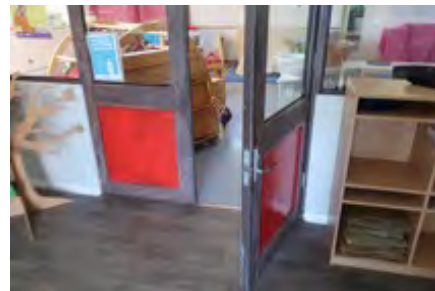
**LB115 IWC / Preschool: Classroom 7. The Infill panel/s below windows (F C Sheeting) has Asbestos Containing Material (ACM) present.**

RISK ASSESSMENT					
Type of Asbestos or Hazardous Material	Chrysotile	Condition	GOOD	Likelihood of Damage	L (Low) – possible
	Same as Sample - 62110 -004	Activity	Moderate		
		Sealed	Yes	Friability	Bonded (non-friable)
		Labelled	Y	Exposure Risk	Low - Negligible or low risk
		Quantity

Priority	MEDIUM	Label Required	Yes	Re- Audit Date	10 Feb 2022
Action	No remedial action required, unless disturbed				
Recommendation	Maintain paint or sealant to ACM surfaces. Particular attention should be given to side edges, ensure paint/sealant covers ALL exposed ACM surfaces.				
Legislative Requirements Victorian Regulation 2007	Warning labels should be affixed. Avoid mechanical damage and abrasion. Remove if refurbishment, structural alteration or demolition is to be carried out in this area. Re-inspect every 12 months or earlier if disturbed or removed in accordance with the Victorian OH&S Regulation 2017. All remedial/removal repairs require a Clearance Inspection & Certificate to be recorded by an approved and competent assessor.

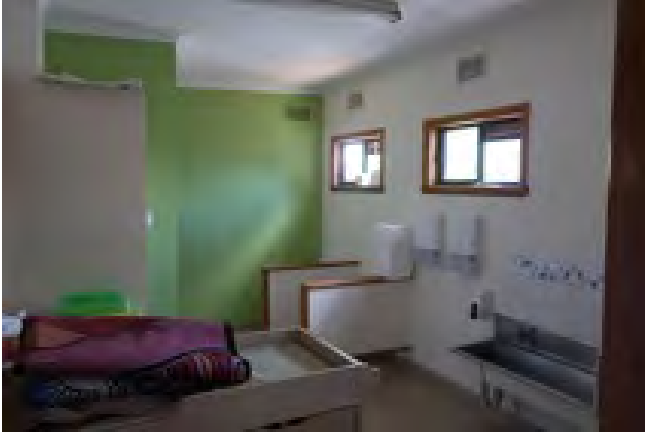
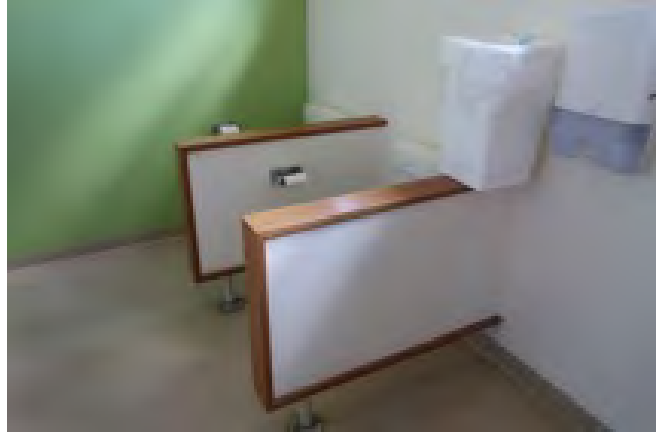
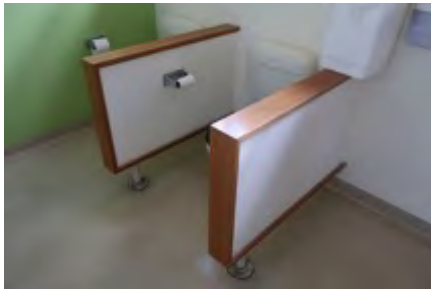
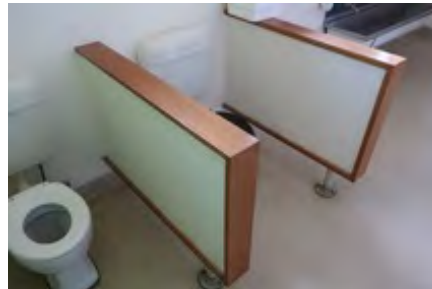
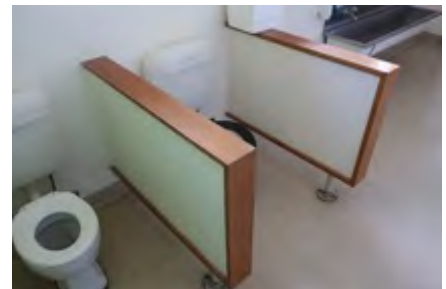
**Area 4****I: Bathroom 7.1. The Cubical Walls (F C Sheet) has Asbestos Containing Material (ACM) present.****RISK ASSESSMENT**

<b>Type of Asbestos or Hazardous Material</b>	Chrysotile	<b>Condition</b>	GOOD	<b>Likelihood of Damage</b>	L (Low) – possible
	Sample taken 62110-003	<b>Activity</b>	Moderate		
		<b>Sealed</b>	Yes	<b>Friability</b>	Bonded (non-friable)
		<b>Labelled</b>	No	<b>Exposure Risk</b>	Low - Negligible or low risk
		<b>Quantity</b>

<b>Priority</b>	MEDIUM	<b>Label Required</b>	Yes	<b>Re- Audit Date</b>	10 Feb 2022
<b>Action</b>	No remedial action required, unless disturbed				
<b>Recommendation</b>	Maintain paint or sealant to ACM surfaces. Particular attention should be given to side edges, ensure paint/sealant covers ALL exposed ACM surfaces.				
<b>Legislative Requirements Victorian Regulation 2007</b>	Warning labels should be affixed. Avoid mechanical damage and abrasion. Remove if refurbishment, structural alteration or demolition is to be carried out in this area. Re-inspect every 12 months or earlier if disturbed or removed in accordance with the Victorian OH&S Regulation 2017. All remedial/removal repairs require a Clearance Inspection & Certificate to be recorded by an approved and competent assessor.

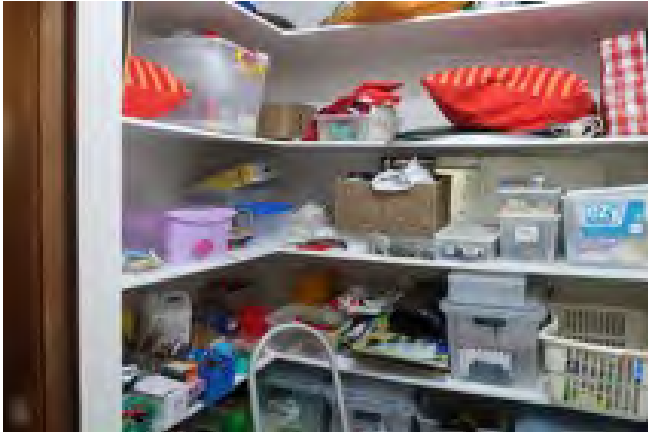
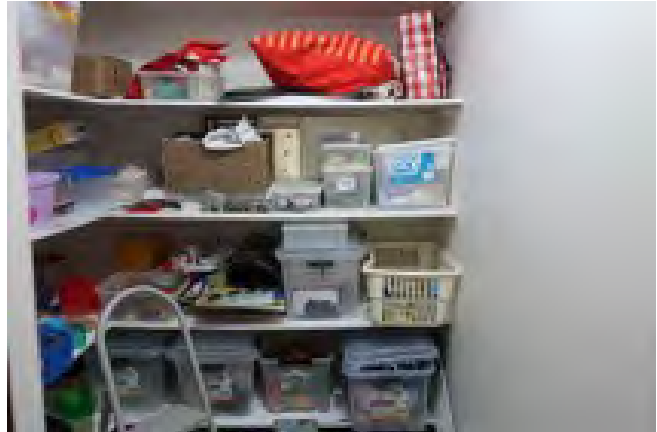
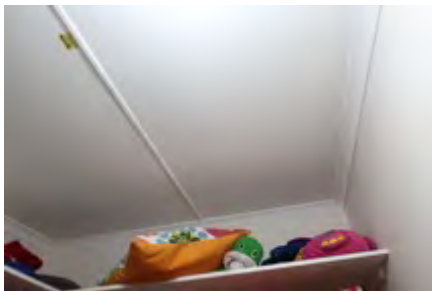
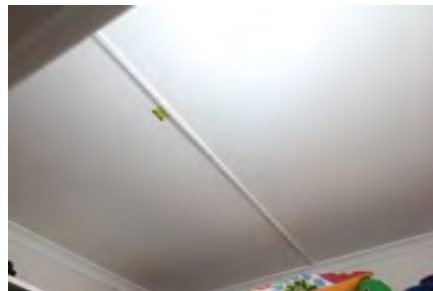
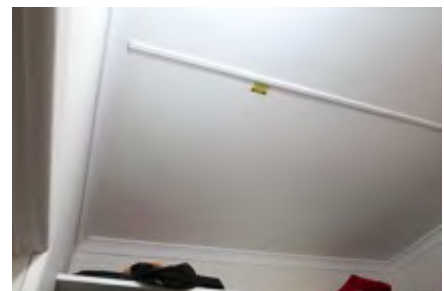
**Toy Store 8. The Ceiling (F C Sheeting) has Asbestos Containing Material (ACM) present.**

RISK ASSESSMENT					
Type of Asbestos or Hazardous Material	Chrysotile	Condition	GOOD	Likelihood of Damage	L (Low) – possible
	Sample taken 62110-007	Activity	Moderate		
		Sealed	Yes	Friability	Bonded (non-friable)
		Labelled	Y	Exposure Risk	Low - Negligible or low risk
		Quantity

RISK CONTROL					
Priority	MEDIUM	Label Required	Yes	Re- Audit Date	10 Feb 2022
Action	No remedial action required, unless disturbed				
Recommendation	Maintain paint or sealant to ACM surfaces. Particular attention should be given to side edges, ensure paint/sealant covers ALL exposed ACM surfaces.				
Legislative Requirements Victorian Regulation 2007	Warning labels should be affixed. Avoid mechanical damage and abrasion. Remove if refurbishment, structural alteration or demolition is to be carried out in this area. Re-inspect every 12 months or earlier if disturbed or removed in accordance with the Victorian OH&S Regulation 2017. All remedial/removal repairs require a Clearance Inspection & Certificate to be recorded by an approved and competent assessor.
