# Asbestos Report

YARRIAMBIACK SHIRE COUNCIL

PROPERTY ADDRESS:  
LR25 RUBBISH TIP  
141 BOYDS ROAD  
RUPANYUP VIC 3388

INSPECTION DATE: 10 FEBRUARY 2021  
REFERENCE NUMBER: 62113

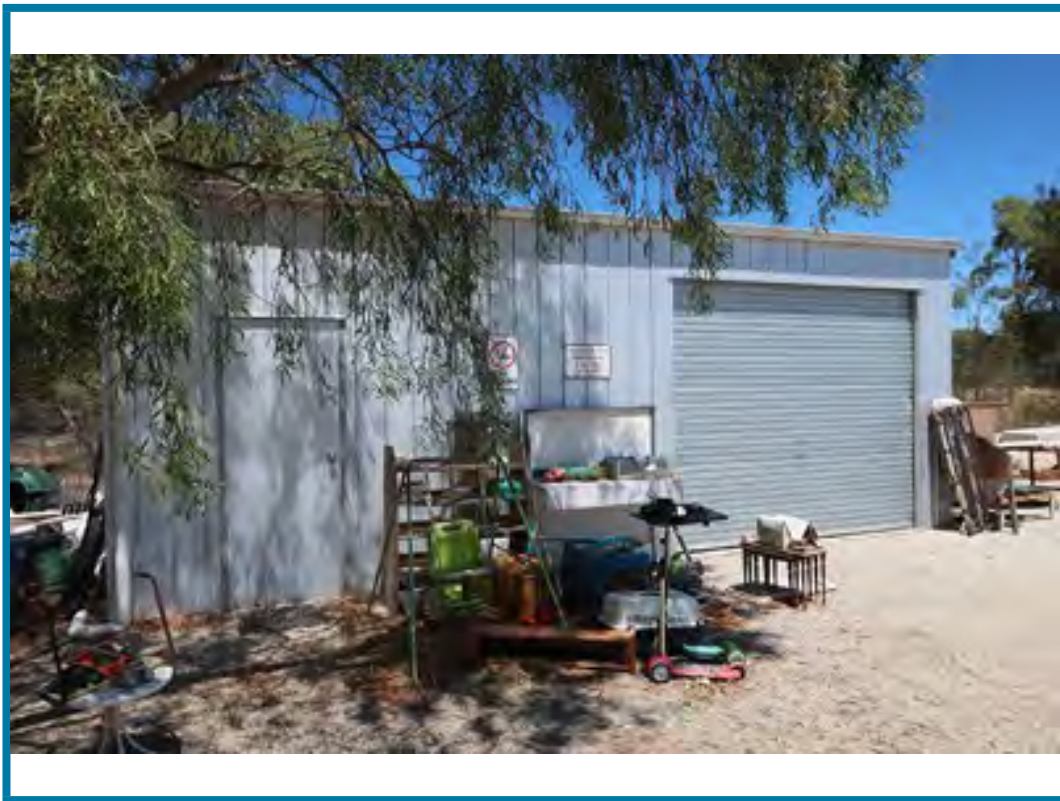
# Second chance shed

Location	Area	Component Materials	ACM Identified	Type Asbestos Assessment	Condition Priority	Signage Required
Second chance shed - entire perimeter of building.		No Asbestos Materials	No	No sample taken - Visual ID

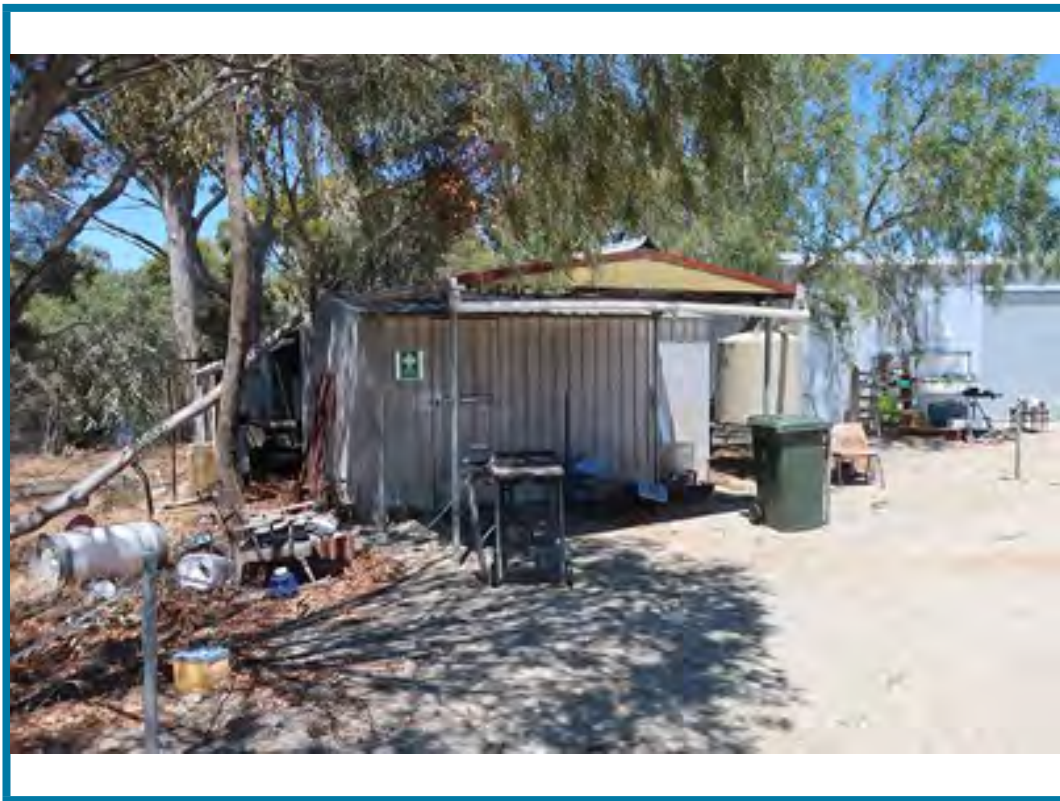
# Shed

<b>Location</b>	<b>Area</b>	<b>Component Materials</b>	<b>ACM Identified</b>	<b>Type Asbestos Assessment</b>	<b>ConditionPriority</b>	<b>Signage Required</b>
Shed - entire perimeter of building.		No Asbestos Materials	No	No sample taken - Visual ID
