Asbestos Report

YARRIAMBIACK SHIRE COUNCIL

PROPERTY ADDRESS:
LB50 SES HEADQUARTERS
2 WOOD STREET
RUPANYUP VIC 3388

INSPECTION DATE: 10 FEBRUARY 2021
REFERENCE NUMBER: 62114

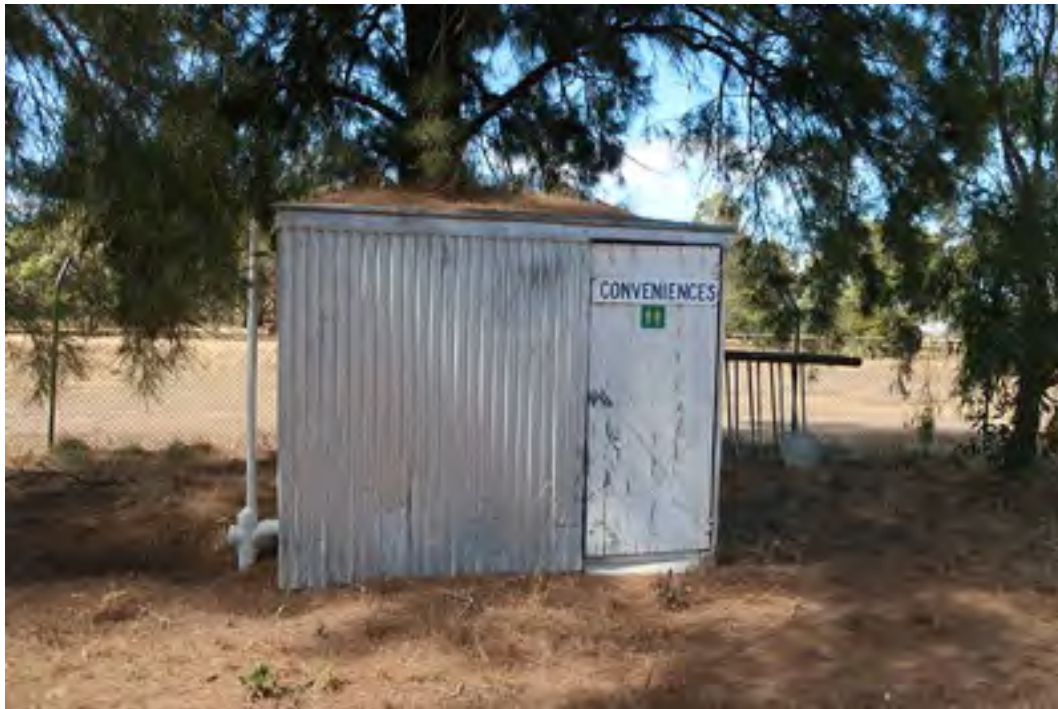
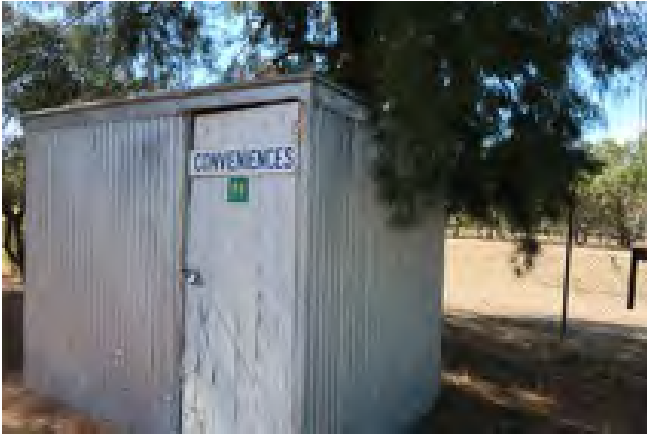
Area 1

Toilet: . Until the area is inspected, it should be managed as if it Asbestos Containing Material (ACM) is present.

RISK ASSESSMENT					
Type of Asbestos or Hazardous Material	No sample taken - No Access	Condition		Likelihood of Damage	
		Activity			
		Sealed		Friability	
		Labelled	No	Exposure Risk	
		Quantity

RISK CONTROL					
Priority	HIGH	Label Required	Yes	Re- Audit Date	10 Feb 2022
Action					
Recommendation					
Legislative Requirements Victorian Regulation 2007	Unable to Gain Access. Assume asbestos in area and provide monitoring if work undertaken in these areas. If access is made available, contact Global Asbestos Audits for re-inspection

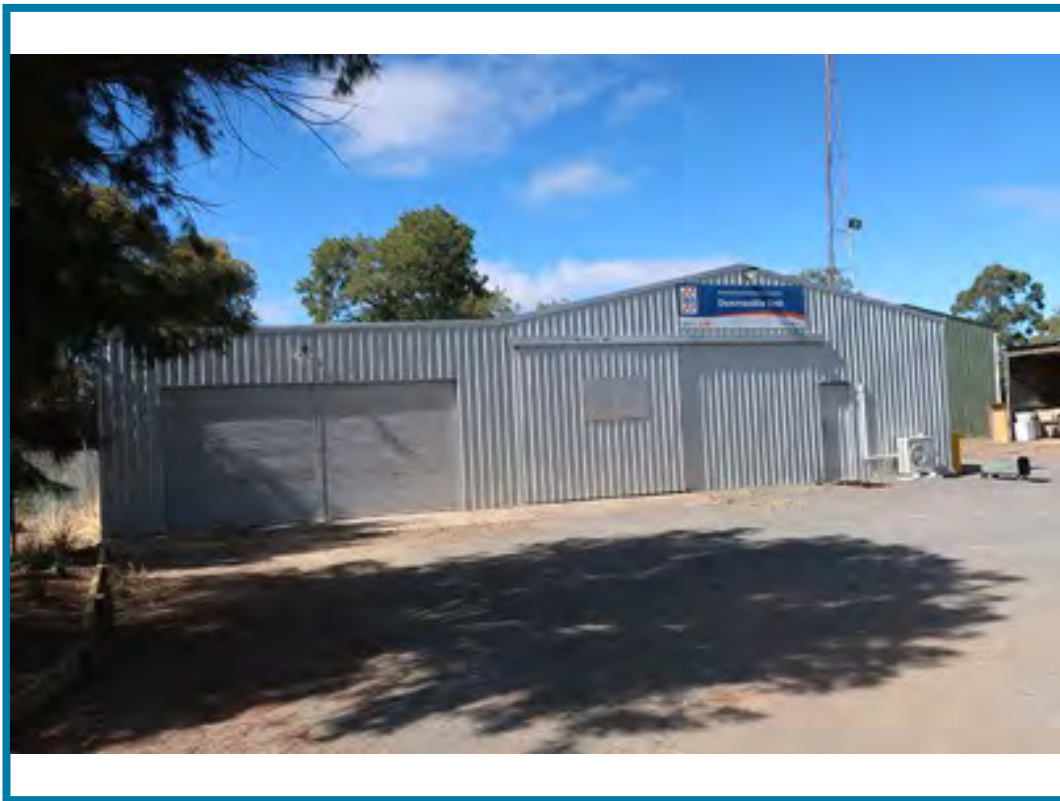
Location	Area	Component Materials	ACM Identified	Type Asbestos Assessment	ConditionPriority	Signage Required
Main building LB50 SES Headquarters - entire perimeter of building.		No Asbestos Materials	No	No sample taken - Visual ID

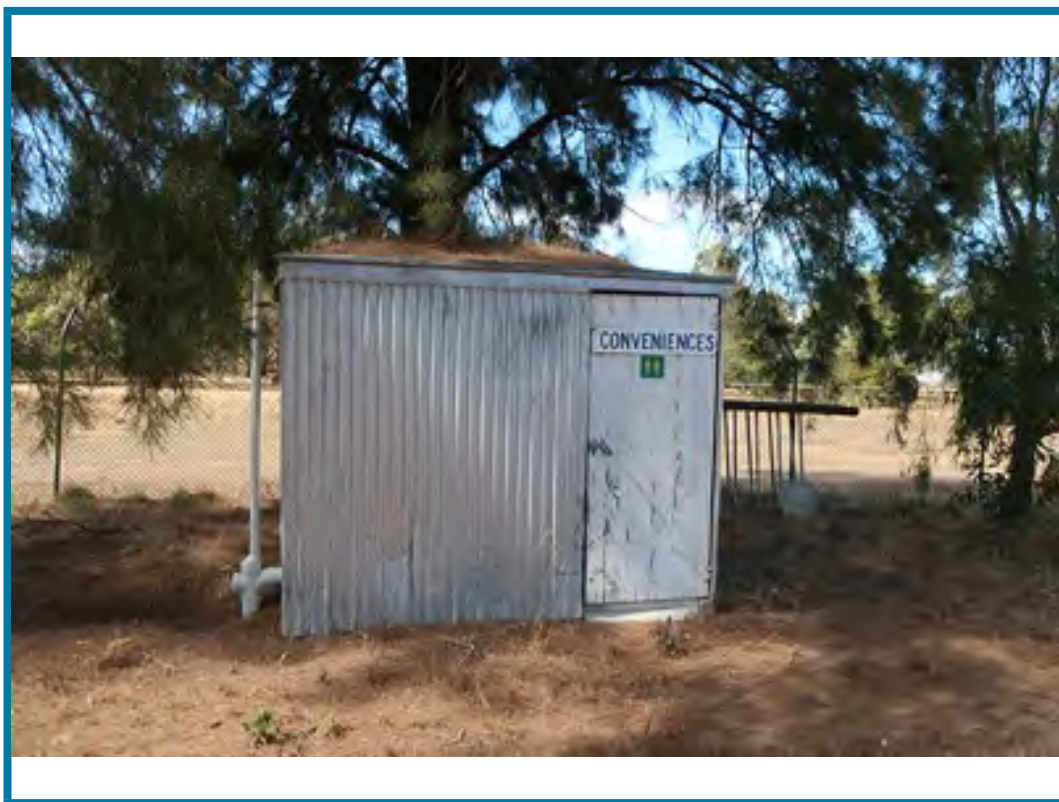
Location	Area	Component Materials	ACM Identified	Type Asbestos Assessment	Condition	Priority	Signage Required
Toilet - entire perimeter of building.		No Asbestos Materials	No	No sample taken - Visual ID
