Asbestos Report

YARRIAMBIACK SHIRE COUNCIL

PROPERTY ADDRESS:
LB24 HALL
463 SHEEP HILLS-MINYIP ROAD
SHEEP HILLS VIC 3392

INSPECTION DATE: 10 FEBRUARY 2021
REFERENCE NUMBER: 62117

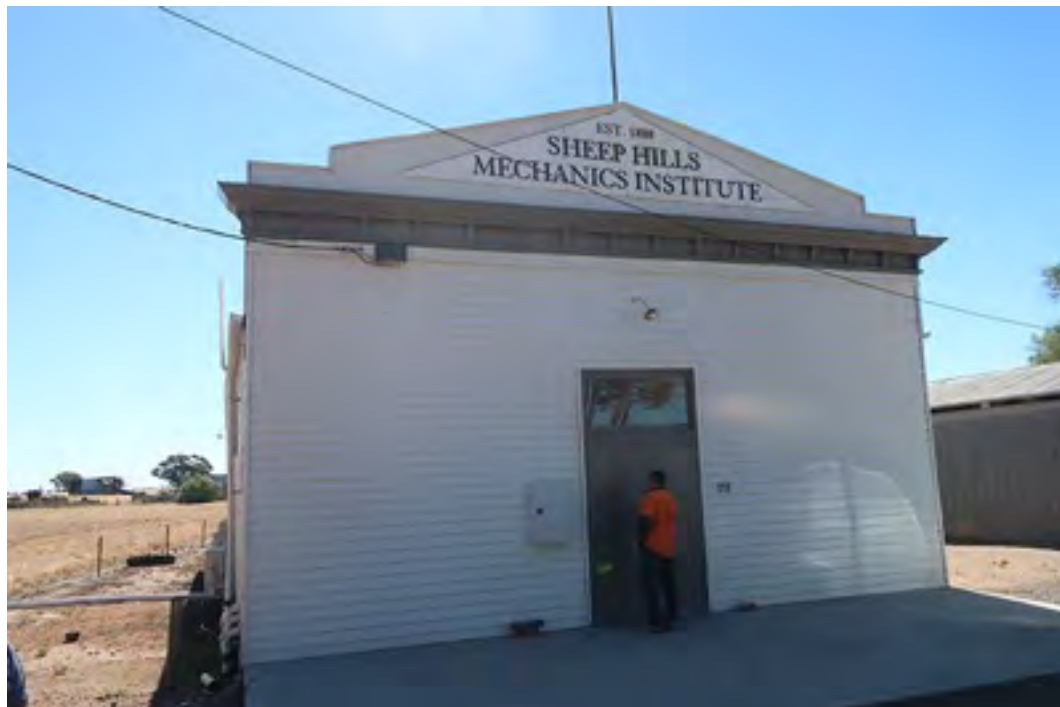
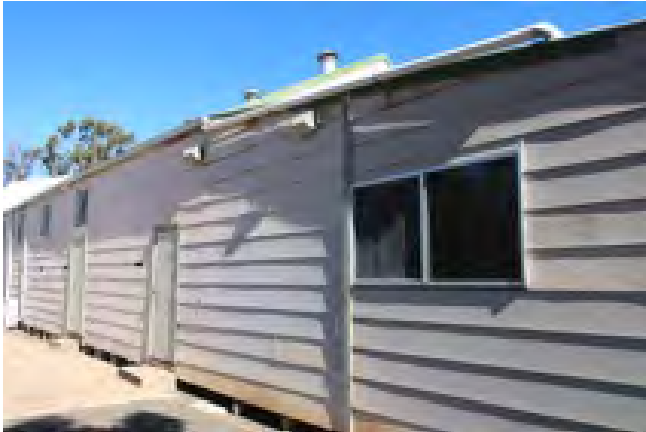
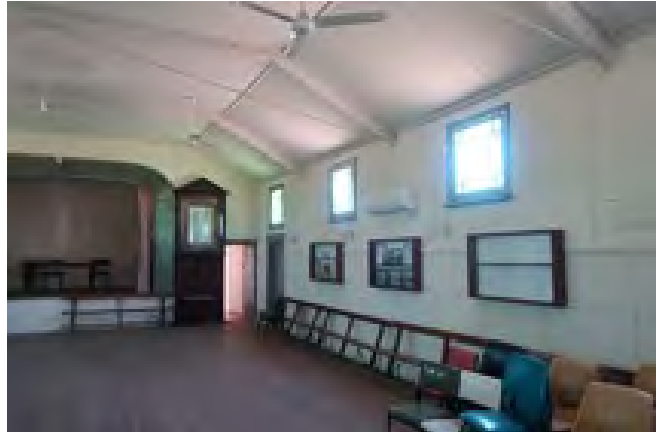
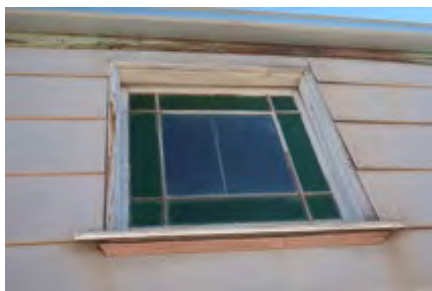
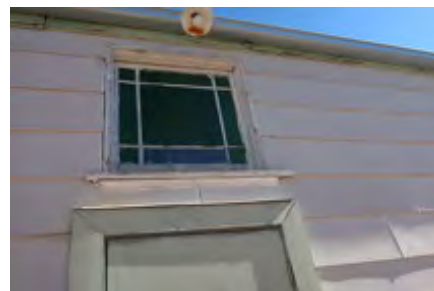
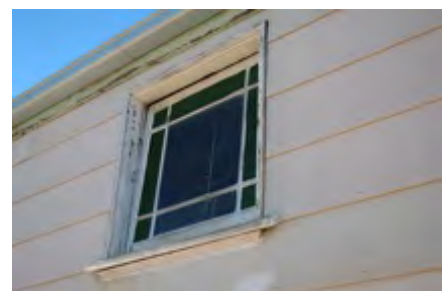
Area 9**Hall: Exterior & Interior. The Windows (Putty) has Asbestos Containing Material (ACM) present.****RISK ASSESSMENT**

| Type of Asbestos or Hazardous Material | No sample taken - Visual ID | Condition | GOOD | Likelihood of Damage | L (Low) – possible |
| | | Labelled | Y | Exposure Risk | Low - Negligible or low risk |

| Recommendation | Maintain paint or sealant to ACM surfaces. Particular attention should be given to side edges, ensure paint/sealant covers ALL exposed ACM surfaces. | | | | |

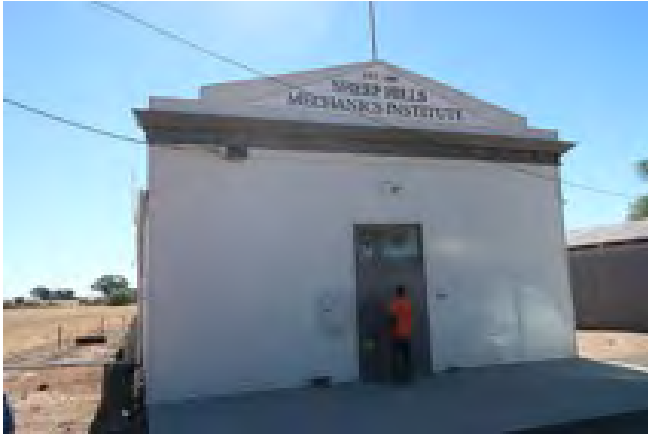
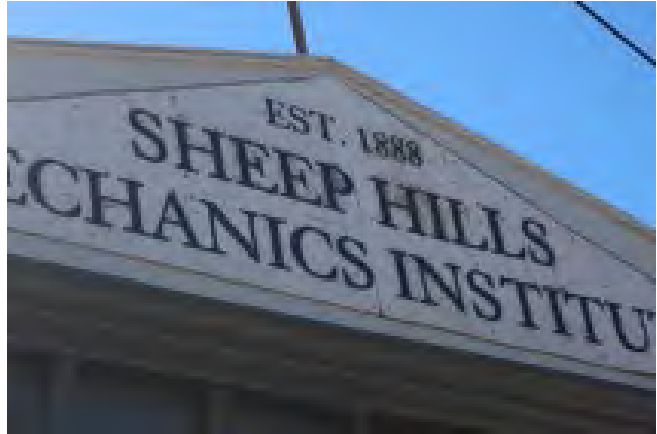
| RISK ASSESSMENT | | | | | |
|--|---|---|---|---|---|
| Type of Asbestos or Hazardous Material | No sample taken - Visual ID | Condition | GOOD | Likelihood of Damage | L (Low) – possible |
| | | Labelled | No | Exposure Risk | Low - Negligible or low risk |

| RISK CONTROL | | | | | |
|--|--|---|---|---|---|
| Recommendation | Maintain paint or sealant to ACM surfaces. Particular attention should be given to side edges, ensure paint/sealant covers ALL exposed ACM surfaces. | | | | |

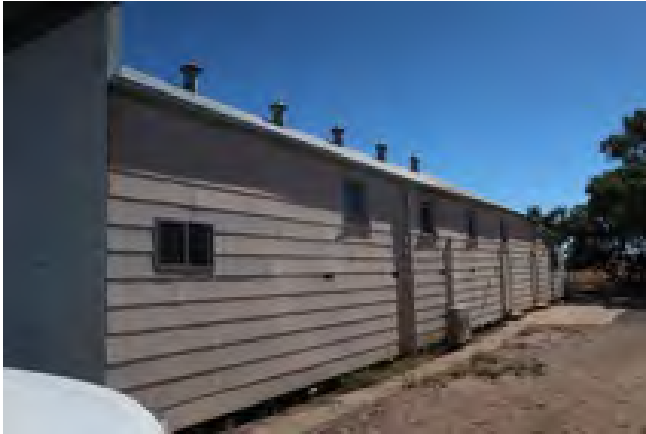
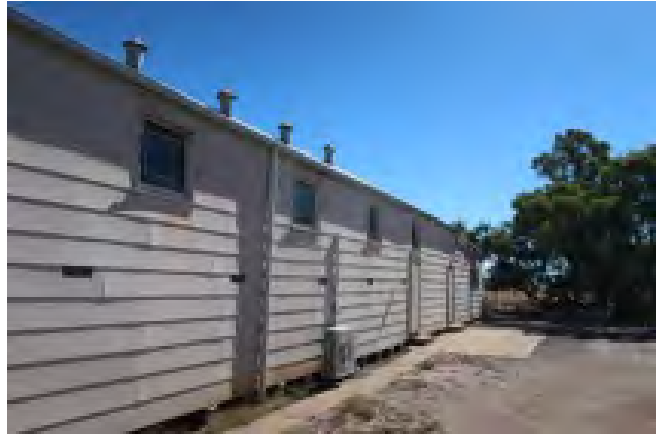
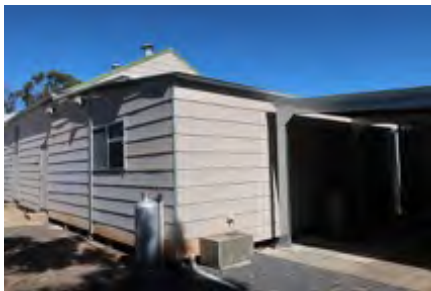
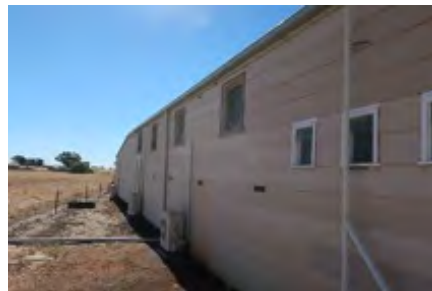
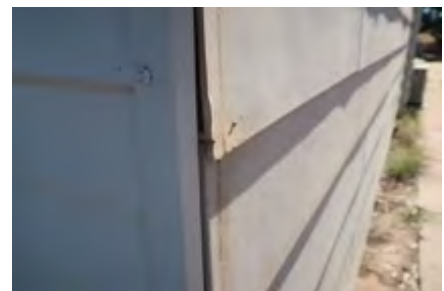
| RISK ASSESSMENT | | | | | |
|--|---|---|---|---|---|
| Type of Asbestos or Hazardous Material | Chrysotile | Condition | AVERAGE | Likelihood of Damage | L (Low) – possible |

| RISK CONTROL | | | | | |
|--|---|---|---|---|---|
| Action | Remedial repairs required - seal raw material / edges | | | | |

| RISK CONTROL | | | | | |
|--|---|---|---|---|---|
| Recommendation | Raw material sheeting - The area requires immediate remedial repairs. It is recommended the asbestos material be sealed with an approved membrane. | | | | |

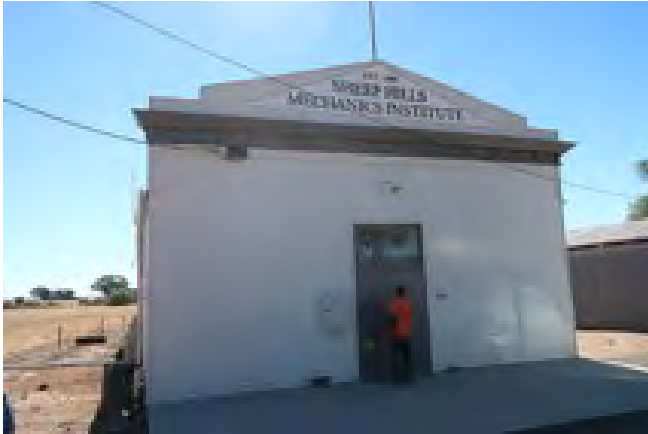
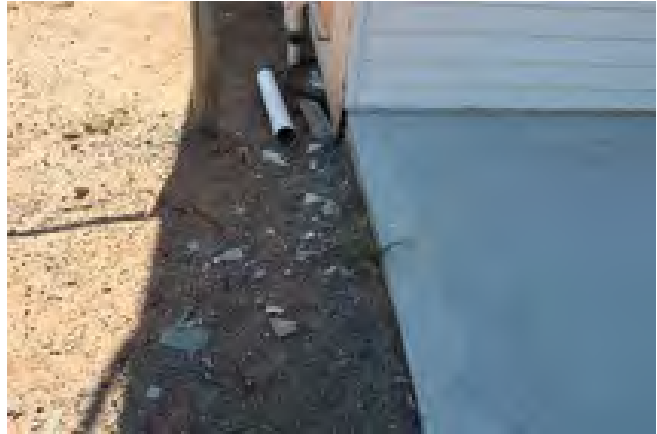
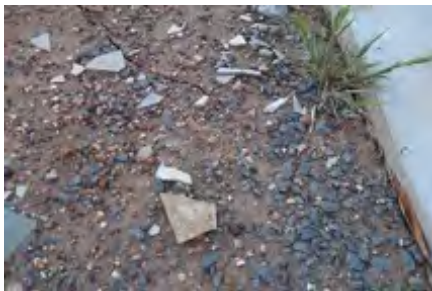
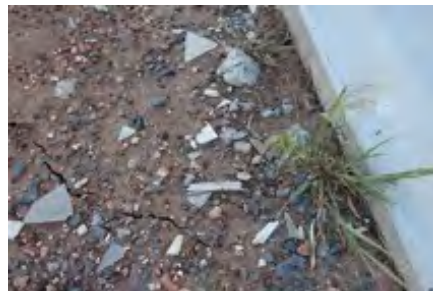
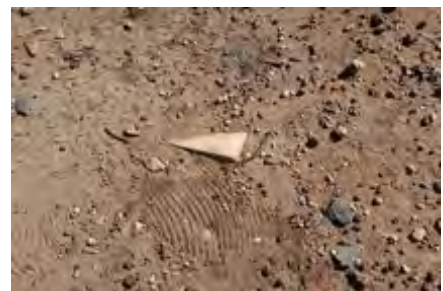
Hall: front of building. The Debris - Broken (Debris) has Asbestos Containing Material (ACM) present.

| RISK ASSESSMENT | | | | | |
|--|---|---|---|---|---|
| Type of Asbestos or Hazardous Material | No sample taken - Visual ID | Condition | POOR | Likelihood of Damage | H (High) - almost certain |
| | | Labelled | No | Exposure Risk | High - Short term exposure risk |

| RISK CONTROL | | | | | |
|--|--|---|---|---|---|
| Recommendation | Debris on Surface - The Debris requires immediate cleanup and disposal with specialised equipment and with licensed removalist to safely remove the asbestos debris. | | | | |

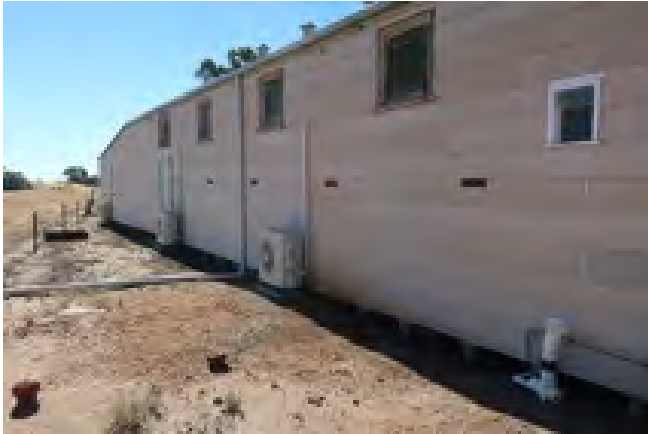
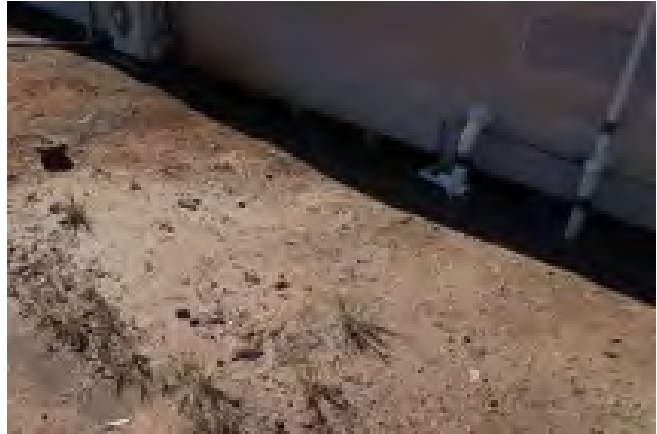
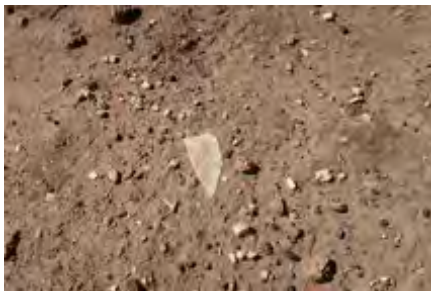
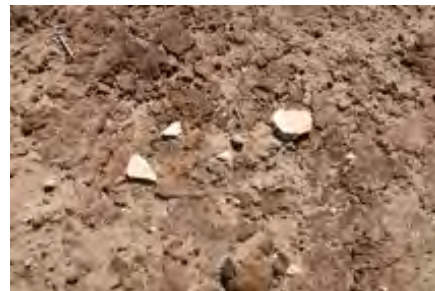
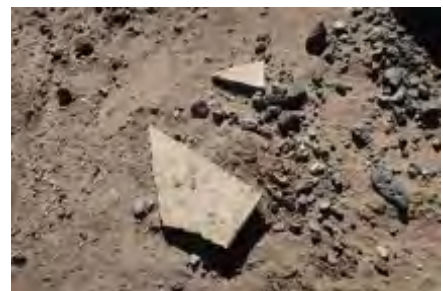
Hall: left side of building. The Debris - Broken (Debris) has Asbestos Containing Material (ACM) present.

| RISK ASSESSMENT | | | | | |
|--|---|---|---|---|---|
| Type of Asbestos or Hazardous Material | No sample taken - Visual ID | Condition | POOR | Likelihood of Damage | H (High) - almost certain |
| | | Labelled | No | Exposure Risk | High - Short term exposure risk |

| RISK CONTROL | | | | | |
|--|--|---|---|---|---|
| Recommendation | Debris on Surface - The Debris requires immediate cleanup and disposal with specialised equipment and with licensed removalist to safely remove the asbestos debris. | | | | |

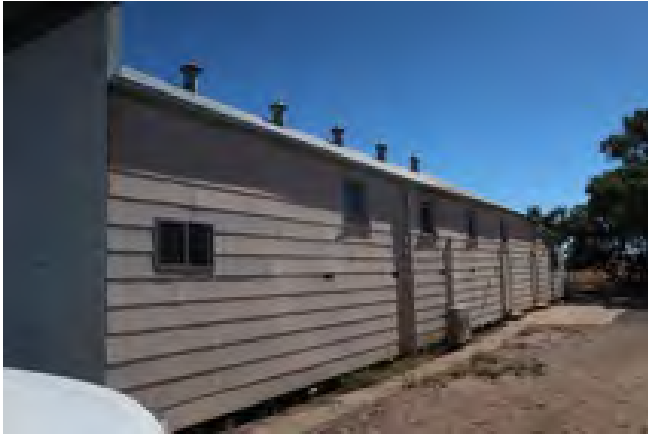
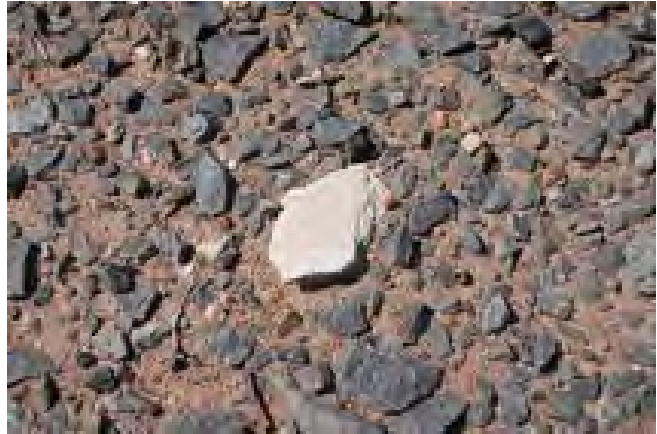
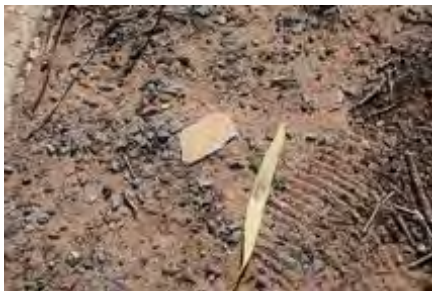
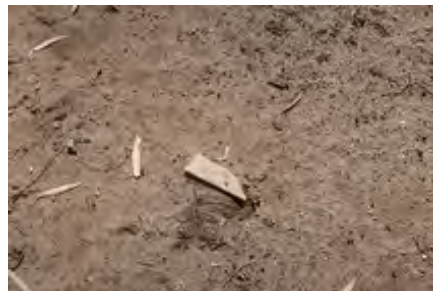
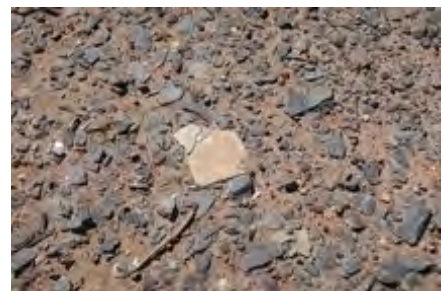
Hall: right side of building. The Debris - Broken (Debris) has Asbestos Containing Material (ACM) present.

| RISK ASSESSMENT | | | | | |
|--|---|---|---|---|---|
| Type of Asbestos or Hazardous Material | No sample taken - Visual ID | Condition | POOR | Likelihood of Damage | H (High) - almost certain |
| | | Labelled | No | Exposure Risk | High - Short term exposure risk |

| RISK CONTROL | | | | | |
|--|--|---|---|---|---|
| Recommendation | Debris on Surface - The Debris requires immediate cleanup and disposal with specialised equipment and with licensed removalist to safely remove the asbestos debris. | | | | |

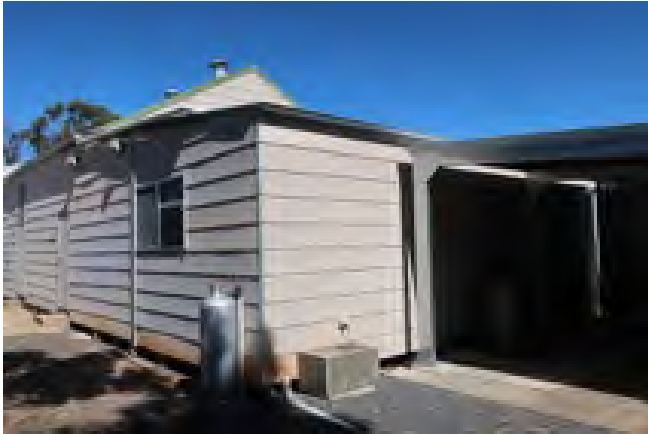
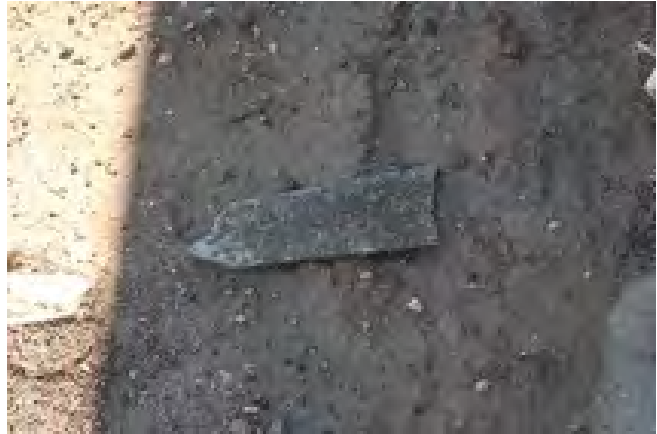
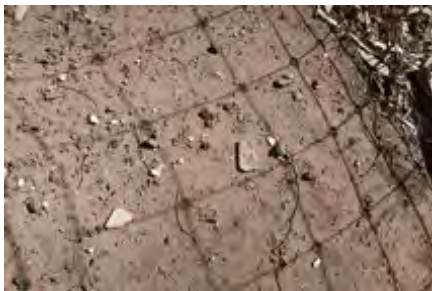
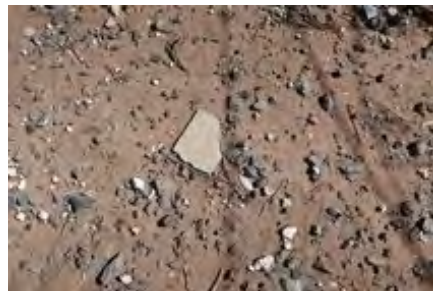
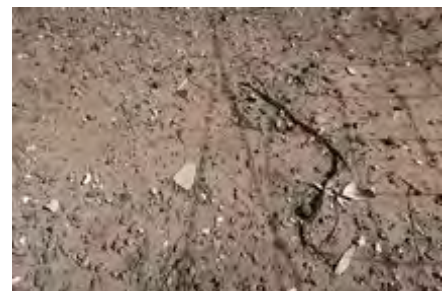
Hall: rear of building. The Debris - Broken (Debris) has Asbestos Containing Material (ACM) present.

| RISK ASSESSMENT | | | | | |
|--|---|---|---|---|---|
| Type of Asbestos or Hazardous Material | No sample taken - Visual ID | Condition | POOR | Likelihood of Damage | H (High) - almost certain |
| | | Labelled | No | Exposure Risk | High - Short term exposure risk |

| RISK CONTROL | | | | | |
|--|--|---|---|---|---|
| Recommendation | Debris on Surface - The Debris requires immediate cleanup and disposal with specialised equipment and with licensed removalist to safely remove the asbestos debris. | | | | |

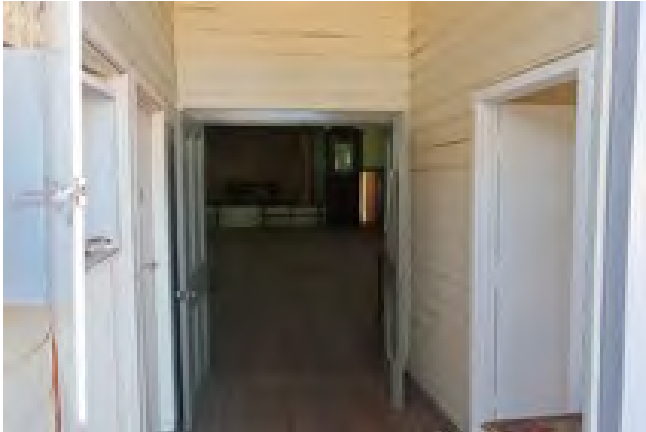
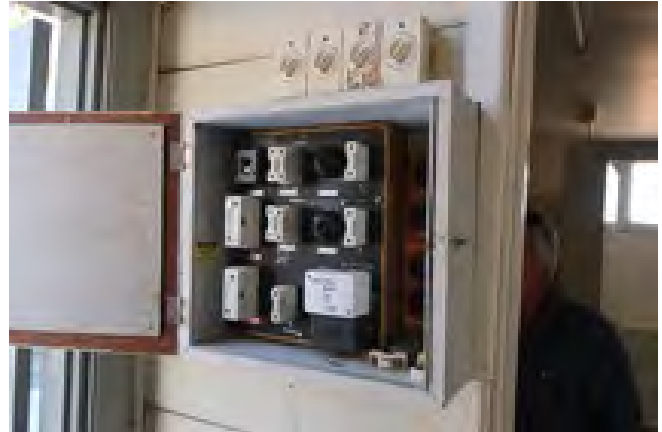
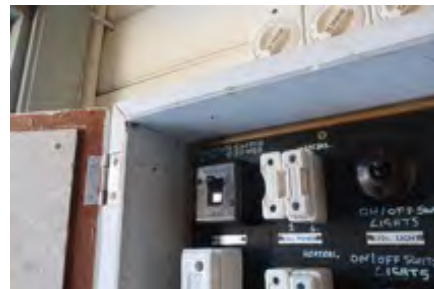
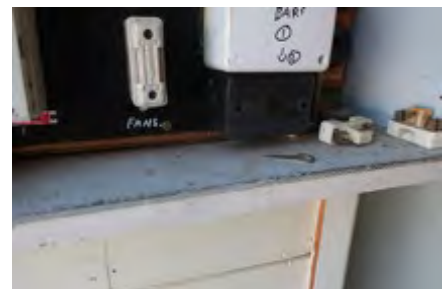
| RISK ASSESSMENT | | | | | |
|--|---|---|---|---|---|
| Type of Asbestos or Hazardous Material | No sample taken - Visual ID | Condition | AVERAGE | Likelihood of Damage | H (High) - almost certain |

| Recommendation | Raw material sheeting - The area requires immediate remedial repairs. It is recommended the asbestos material be sealed with an approved membrane. | | | | |

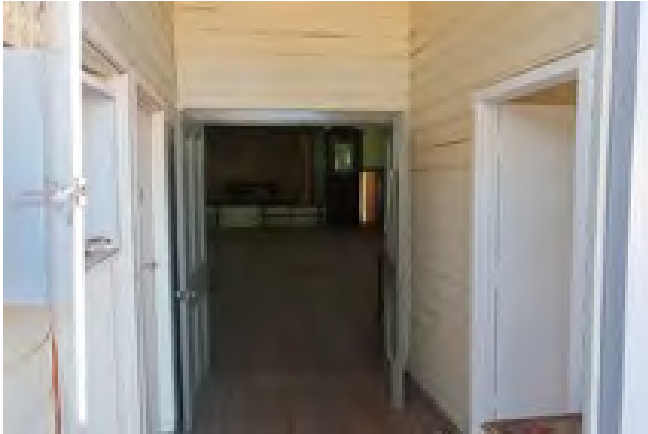
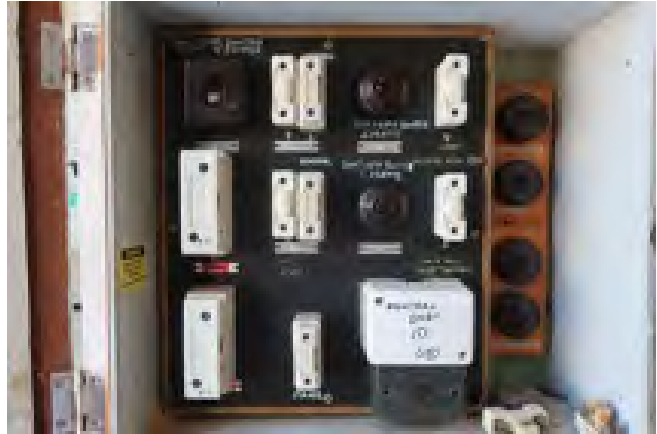
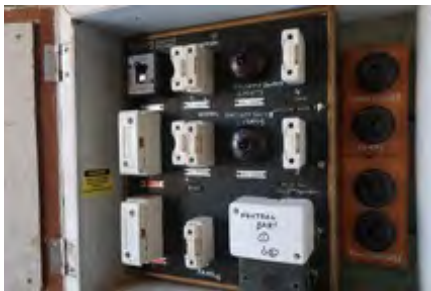
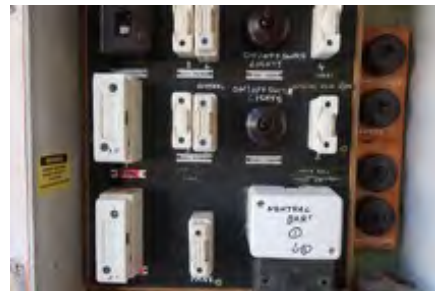
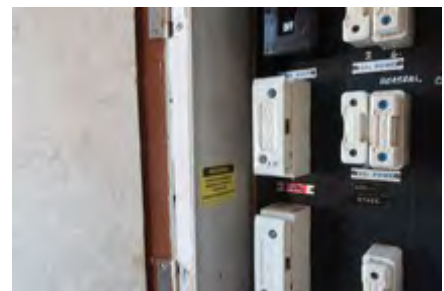
| RISK ASSESSMENT | | | | | |
|--|---|---|---|---|---|
| Type of Asbestos or Hazardous Material | Chrysotile | Condition | GOOD | Likelihood of Damage | L (Low) – possible |
| | | Labelled | Y | Exposure Risk | Low - Negligible or low risk |

| RISK CONTROL | | | | | |
|--|---|---|---|---|---|
| Recommendation | Maintain paint or sealant to ACM surfaces. Particular attention should be given to side edges, ensure paint/sealant covers ALL exposed ACM surfaces. Do not remove the fuses without asbestos controls - test for cloth inserts | | | | |

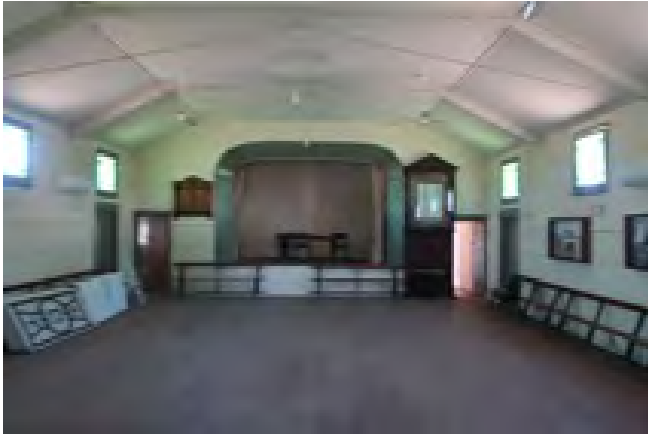
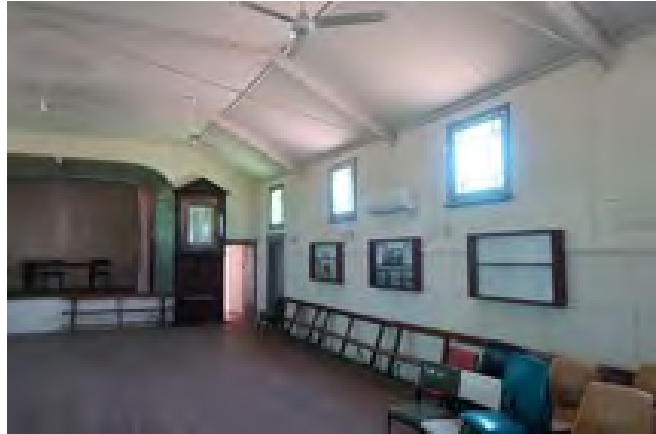
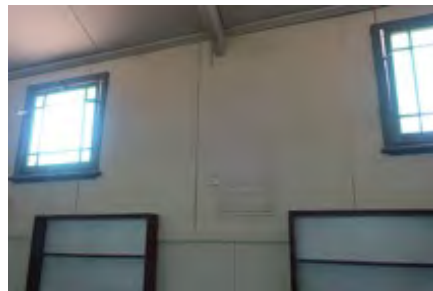
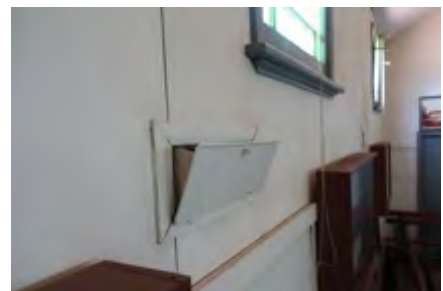
| Type of Asbestos or Hazardous Material | Chrysotile | Condition | GOOD | Likelihood of Damage | L (Low) – possible |
| | | Labelled | Y | Exposure Risk | Low - Negligible or low risk |

| Recommendation | Maintain paint or sealant to ACM surfaces. Particular attention should be given to side edges, ensure paint/sealant covers ALL exposed ACM surfaces. | | | | |

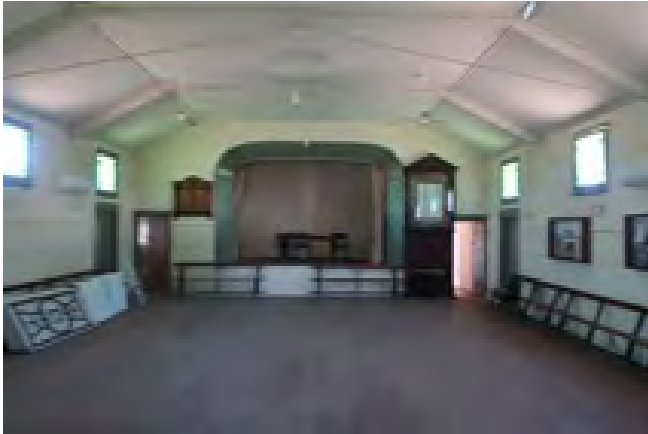
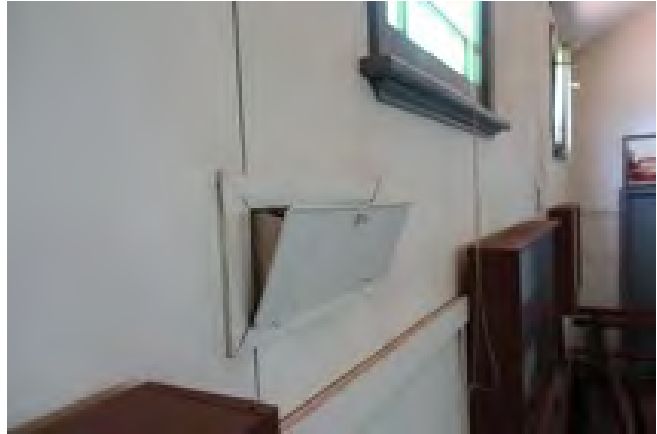
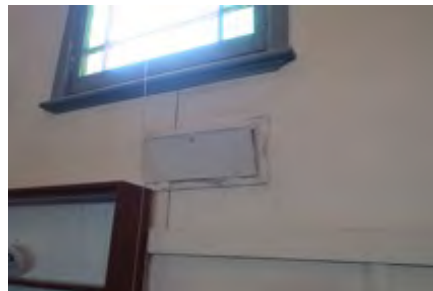
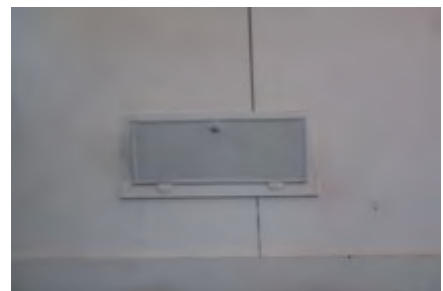
| RISK ASSESSMENT | | | | | | |
|--|---|---|---|---|---|---|
| Type of Asbestos or Hazardous Material | No sample taken - Visual ID | Condition | AVERAGE | Likelihood of Damage | H (High) - almost certain | |
| | | Labelled | Y | Exposure Risk | | Medium - Moderate risk |

| RISK CONTROL | | | | | |
|--|---|---|---|---|---|
| Priority | IMMEDIATE | Label Required | Yes | Re- Audit Date | 10 Feb 2022 |

| RISK CONTROL | | | | | |
|--|---|---|---|---|---|
| Recommendation | Seal vents closed - Restrict use of vents - the operation causes disturbance to the asbestos - Raw material sheeting - The area requires immediate remedial repairs. It is recommended the asbestos material be sealed with an approved membrane. | | | | |

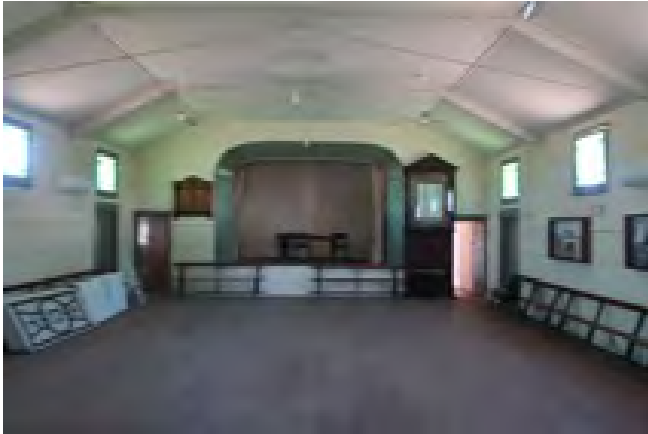
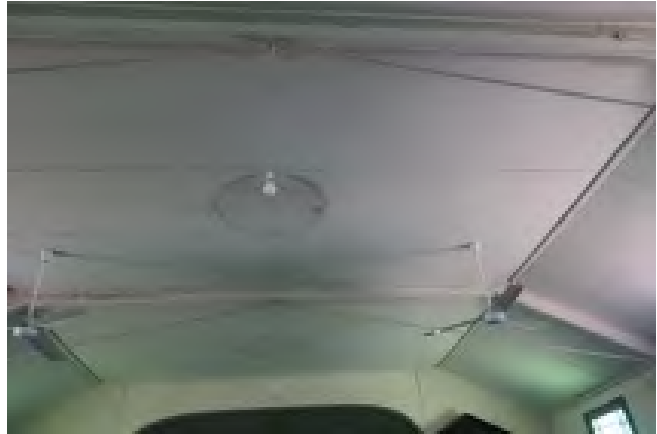
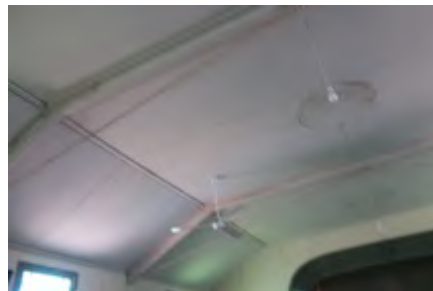
| RISK ASSESSMENT | | | | | |
|--|---|---|---|---|---|
| Type of Asbestos or Hazardous Material | No sample taken - Visual ID | Condition | GOOD | Likelihood of Damage | L (Low) – possible |
| | | Labelled | Y | Exposure Risk | Low - Negligible or low risk |

| RISK CONTROL | | | | | |
|--|--|---|---|---|---|
| Recommendation | Maintain paint or sealant to ACM surfaces. Particular attention should be given to side edges, ensure paint/sealant covers ALL exposed ACM surfaces. | | | | |

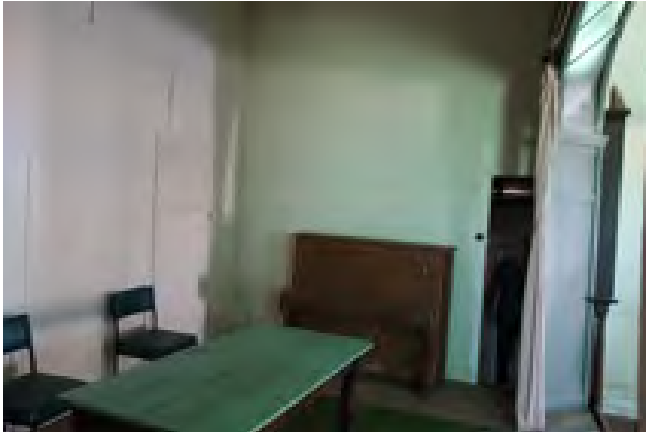
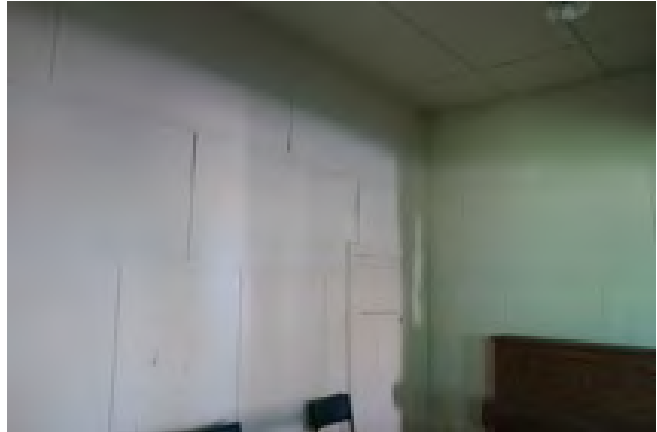
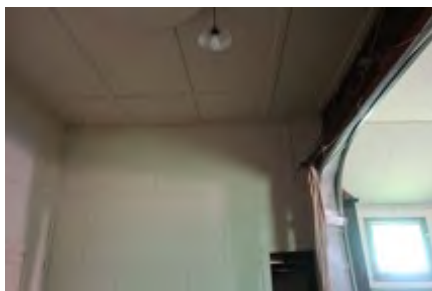
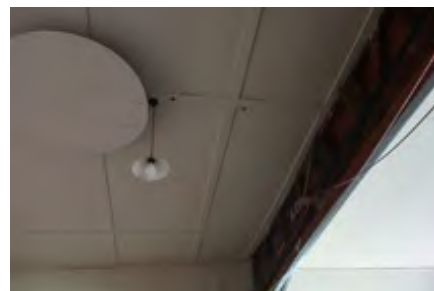
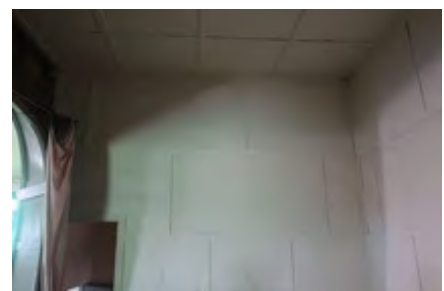
| Type of Asbestos or Hazardous Material | No sample taken - Visual ID | Condition | GOOD | Likelihood of Damage | L (Low) – possible |
| | | Labelled | Y | Exposure Risk | Low - Negligible or low risk |

| Recommendation | Maintain paint or sealant to ACM surfaces. Particular attention should be given to side edges, ensure paint/sealant covers ALL exposed ACM surfaces. | | | | |

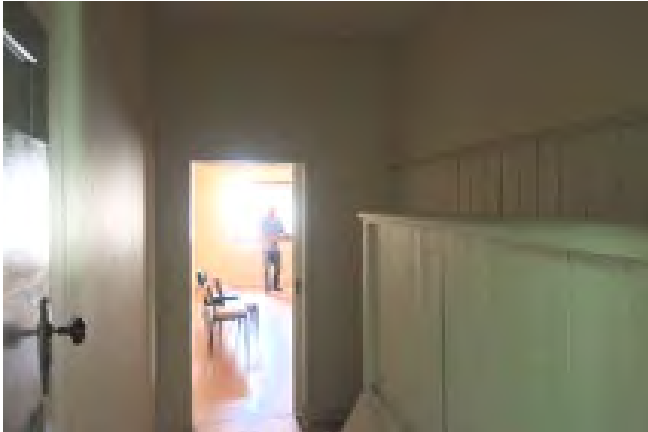
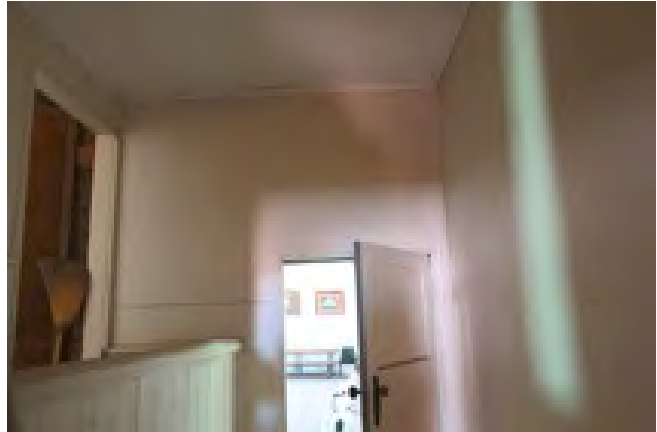
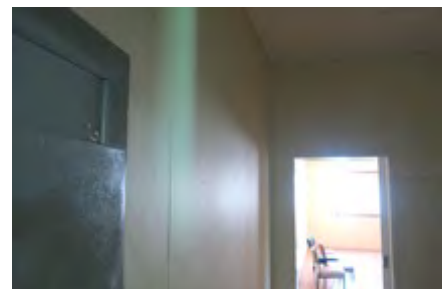
| RISK ASSESSMENT | | | | | |
|--|---|---|---|---|---|
| Type of Asbestos or Hazardous Material | Chrysotile | Condition | GOOD | Likelihood of Damage | L (Low) – possible |
| | | Labelled | Y | Exposure Risk | Low - Negligible or low risk |

| RISK CONTROL | | | | | |
|--|---|---|---|---|---|
| Recommendation | Maintain paint or sealant to ACM surfaces. Particular attention should be given to side edges, ensure paint/sealant covers ALL exposed ACM surfaces. | | | | |

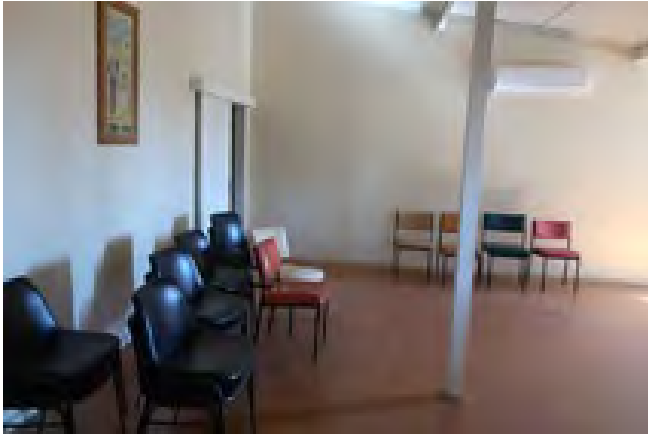
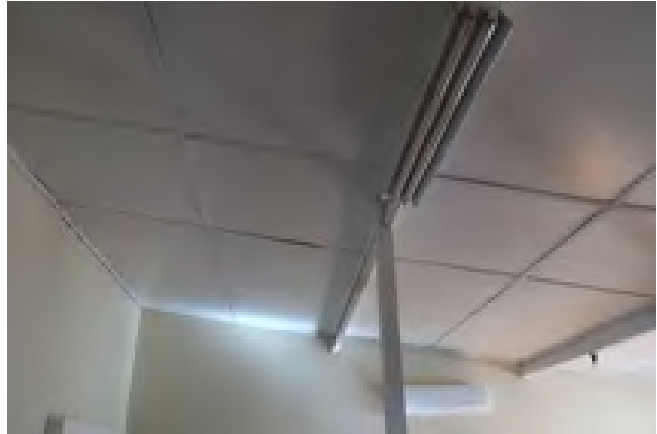
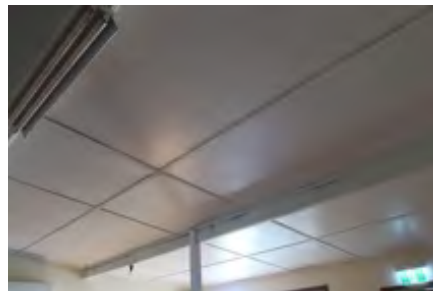
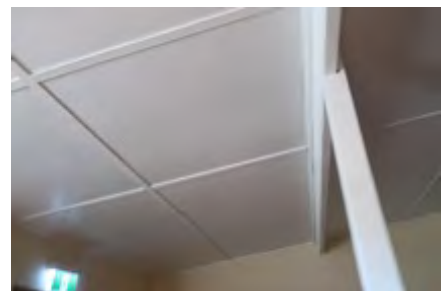
| RISK ASSESSMENT | | | | | |
|--|---|---|---|---|---|
| Type of Asbestos or Hazardous Material | No sample taken - Visual ID | Condition | GOOD | Likelihood of Damage | L (Low) – possible |
| | | Labelled | Y | Exposure Risk | Low - Negligible or low risk |
