Asbestos Report

YARRIAMBIACK SHIRE COUNCIL

PROPERTY ADDRESS:
RUBBISH TIP
3270 SUNRAYSIA HIGHWAY
SPEED VIC 3489

INSPECTION DATE: 11 FEBRUARY 2021
REFERENCE NUMBER: 62118

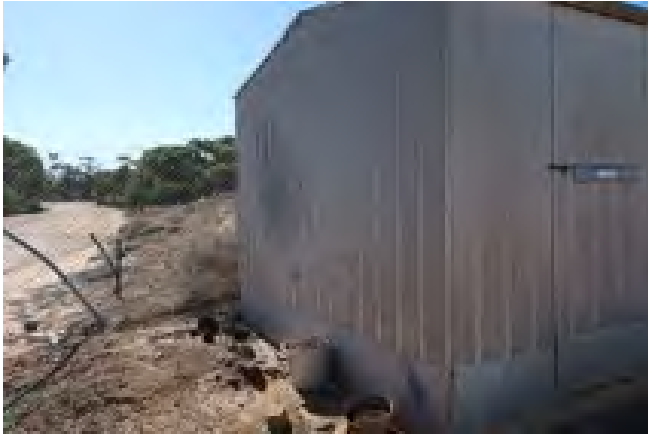
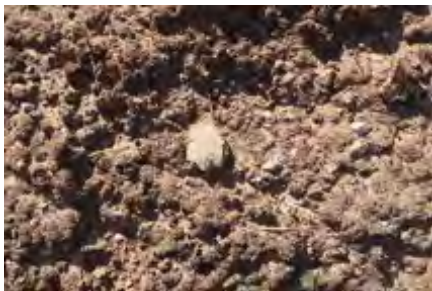
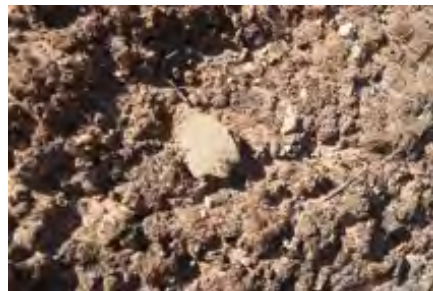
Area 2

Shed Rubbish Tip: left side of building. The Debris - Broken (Debris) has Asbestos Containing Material (ACM) present.

RISK ASSESSMENT					
Type of Asbestos or Hazardous Material	No sample taken - Visual ID	Condition	POOR	Likelihood of Damage	H (High) - almost certain
		Activity	Moderate		
		Sealed	No	Friability	Exposed Fibres
		Labelled	No	Exposure Risk	High - Short term exposure risk
		Quantity

RISK CONTROL					
Priority	IMMEDIATE	Label Required	Yes	Re- Audit Date	11 Feb 2022
Action	Restrict access and target for imminent removal				
Recommendation	<p>Preliminary soil testing should be done to establish level of contamination & potential exposure. Debris on Surface - The Debris requires immediate cleanup and disposal with specialised equipment and with licensed removalist to safely remove the asbestos debris.</p> <p>In the meantime a wetting down program should be implemented and include minimal disturbance.</p>				
Legislative Requirements Victorian Regulation 2007	<p>URGENT - ACM visible in area. The ACM appears to be of a friable nature. The services of an "A" class Asbestos removal consultant are urgently required. Immediately cease any access to the area and affix warning signs to all entry points. Avoid physical and mechanical damage. Avoid mechanical damage and abrasion. Re-inspect every 12 months or earlier if disturbed or removed in accordance with the Victorian OH&S Regulation 2017.</p> <p>All remedial/removal repairs require a Clearance Inspection & Certificate to be recorded by an approved and competent assessor.</p>

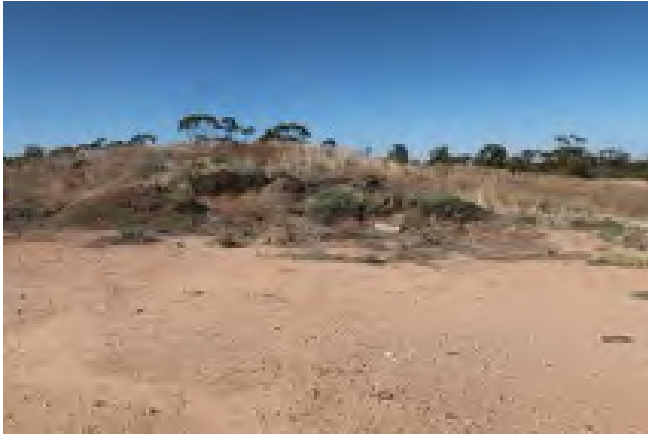
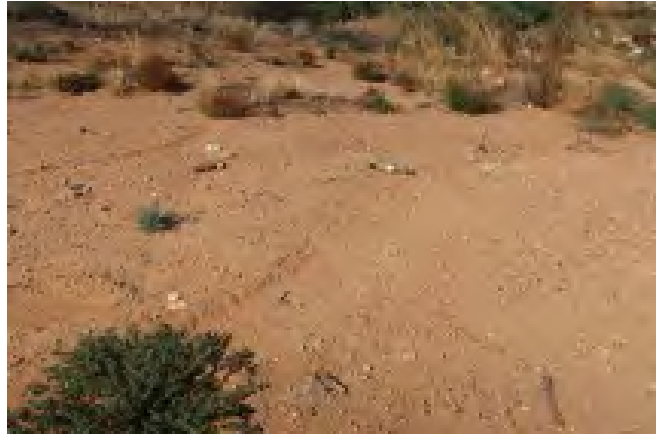
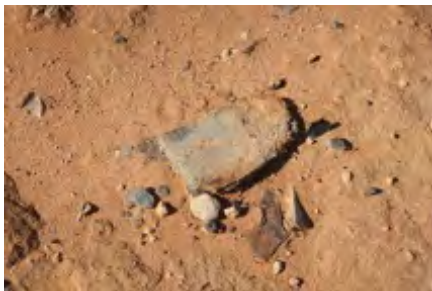
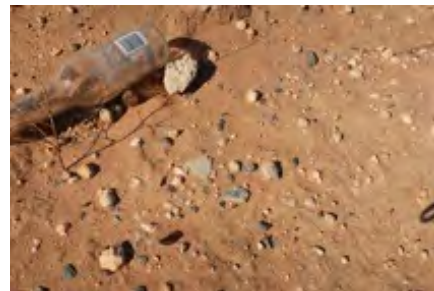
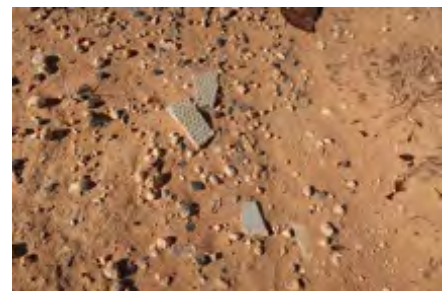
Area 1

Grounds: The Debris - Broken (Debris) has Asbestos Containing Material (ACM) present.

RISK ASSESSMENT					
Type of Asbestos or Hazardous Material	No sample taken - Visual ID	Condition	POOR	Likelihood of Damage	H (High) - almost certain
		Activity	Moderate		
		Sealed	No	Friability	Friable
		Labelled	No	Exposure Risk	High - Short term exposure risk
		Quantity

RISK CONTROL					
Priority	IMMEDIATE	Label Required	Yes	Re- Audit Date	11 Feb 2022
Action	Restrict access and target for imminent removal				
Recommendation	<p>Preliminary soil testing should be done to establish level of contamination & potential exposure. Debris on Surface - The Debris requires immediate cleanup and disposal with specialised equipment and with licensed removalist to safely remove the asbestos debris.</p> <p>In the meantime a wetting down program should be implemented and include minimal disturbance.</p>				
Legislative Requirements Victorian Regulation 2007	<p>URGENT - ACM visible in area. The ACM appears to be of a friable nature. The services of an "A" class Asbestos removal consultant are urgently required. Immediately cease any access to the area and affix warning signs to all entry points. Avoid physical and mechanical damage. Avoid mechanical damage and abrasion. Re-inspect every 12 months or earlier if disturbed or removed in accordance with the Victorian OH&S Regulation 2017.</p> <p>All remedial/removal repairs require a Clearance Inspection & Certificate to be recorded by an approved and competent assessor.</p>
