Asbestos Report

YARRIAMBIACK SHIRE COUNCIL

PROPERTY ADDRESS:
LB91 INFANT WELFARE CENTRE
8 BOSCHERT STREET
TEMPY VIC 3489

INSPECTION DATE: 11 FEBRUARY 2021
REFERENCE NUMBER: 62119

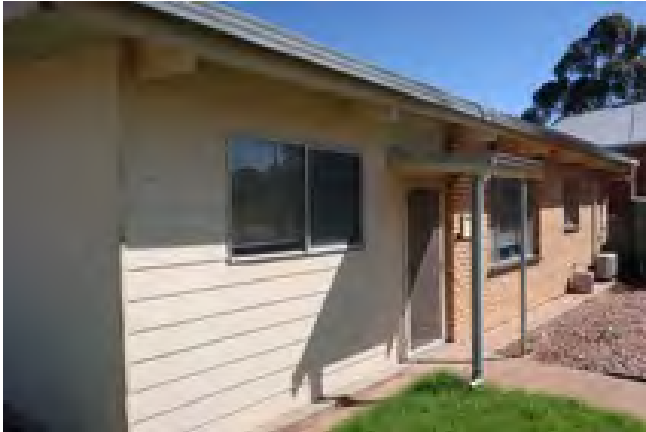
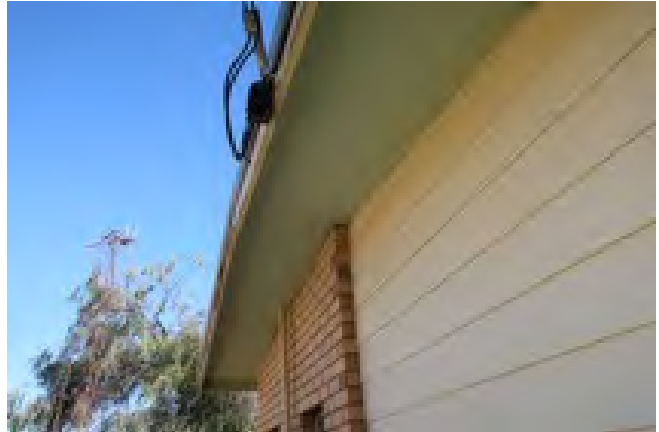
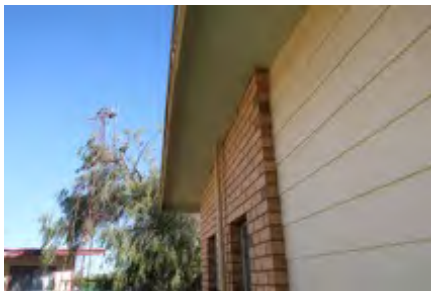
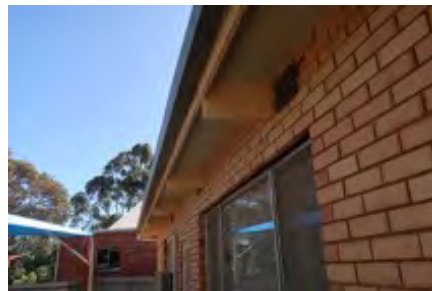
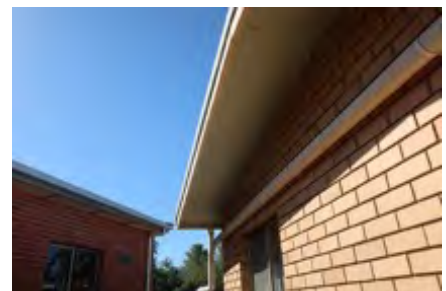
Area 2**Main building: entire perimeter of building. The Soffit (F C Sheeting) has Asbestos Containing Material (ACM) present.****RISK ASSESSMENT**

Type of Asbestos or Hazardous Material	Chrysotile	Condition	GOOD	Likelihood of Damage	L (Low) – possible
	Sample taken 62119-001	Activity	Moderate		
		Sealed	Yes	Friability	Bonded (non-friable)
		Labelled	Y	Exposure Risk	Low - Negligible or low risk
		Quantity

Priority	MEDIUM	Label Required	Yes	Re- Audit Date	11 Feb 2022
Action	No remedial action required, unless disturbed				
Recommendation	Maintain paint or sealant to ACM surfaces. Particular attention should be given to side edges, ensure paint/sealant covers ALL exposed ACM surfaces.				
Legislative Requirements Victorian Regulation 2007	Warning labels should be affixed. Avoid mechanical damage and abrasion. Remove if refurbishment, structural alteration or demolition is to be carried out in this area. Re-inspect every 12 months or earlier if disturbed or removed in accordance with the Victorian OH&S Regulation 2017. All remedial/removal repairs require a Clearance Inspection & Certificate to be recorded by an approved and competent assessor.

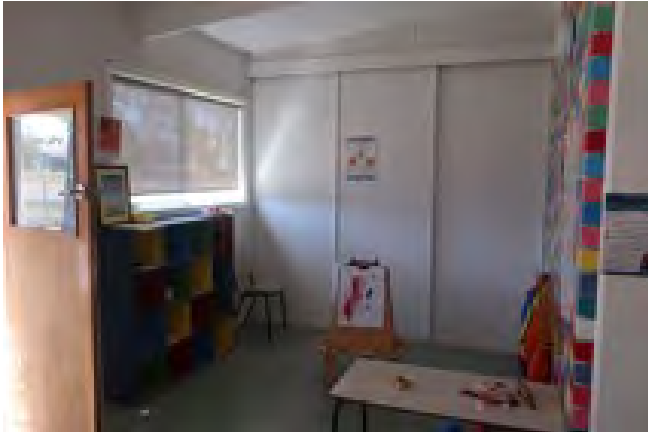
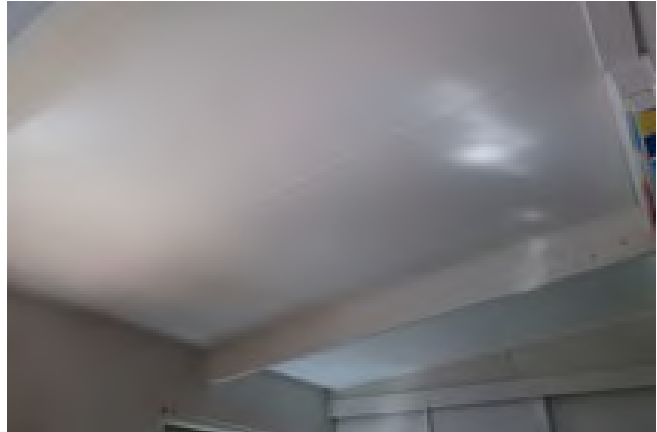
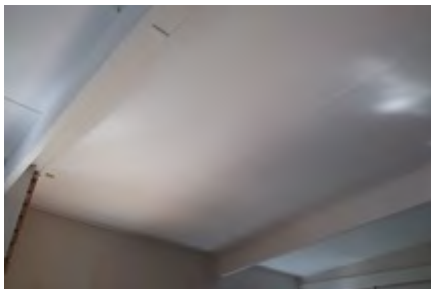
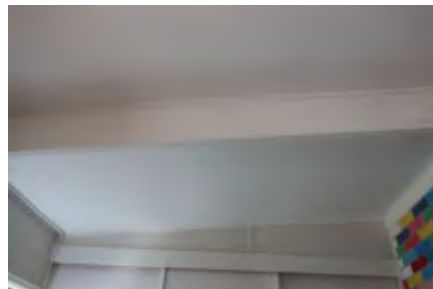
Main building: Entry 1. The Ceiling (PVC Strips) (F C Sheeting) has Asbestos Containing Material (ACM) present.

RISK ASSESSMENT					
Type of Asbestos or Hazardous Material	Chrysotile	Condition	GOOD	Likelihood of Damage	L (Low) – possible
	Sample taken 62119-003	Activity	Moderate		
		Sealed	Yes	Friability	Bonded (non-friable)
		Labelled	Y	Exposure Risk	Low - Negligible or low risk
		Quantity

RISK CONTROL					
Priority	MEDIUM	Label Required	Yes	Re- Audit Date	11 Feb 2022
Action	No remedial action required, unless disturbed				
Recommendation	Maintain paint or sealant to ACM surfaces. Particular attention should be given to side edges, ensure paint/sealant covers ALL exposed ACM surfaces.				
Legislative Requirements Victorian Regulation 2007	Warning labels should be affixed. Avoid mechanical damage and abrasion. Remove if refurbishment, structural alteration or demolition is to be carried out in this area. Re-inspect every 12 months or earlier if disturbed or removed in accordance with the Victorian OH&S Regulation 2017. All remedial/removal repairs require a Clearance Inspection & Certificate to be recorded by an approved and competent assessor.

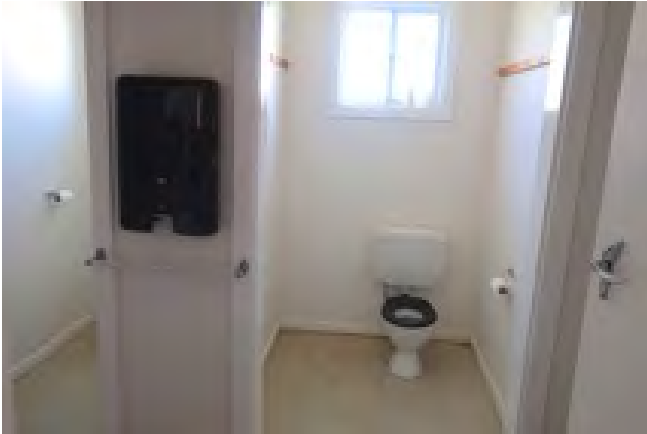
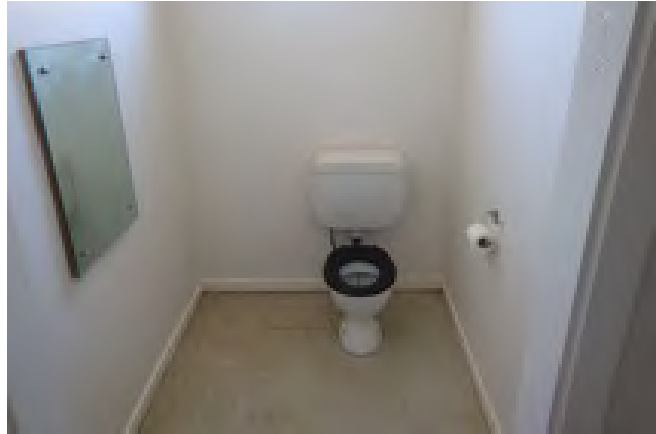
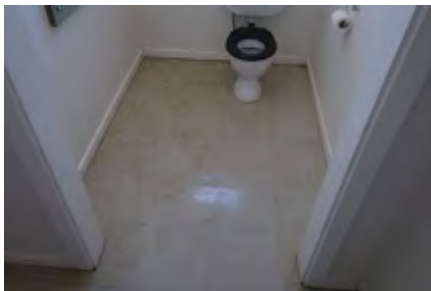
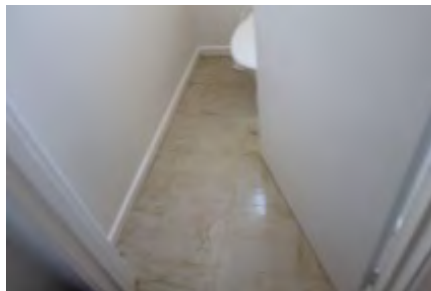
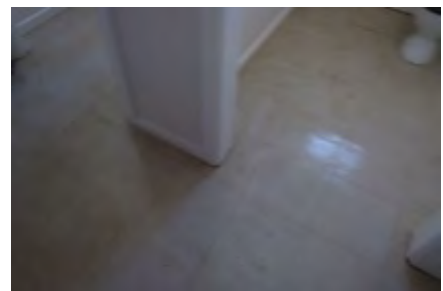
Main building: Bathroom 5. The Floor (Vinyl Tiles) has Asbestos Containing Material (ACM) present.

RISK ASSESSMENT					
Type of Asbestos or Hazardous Material	Chrysotile	Condition	GOOD	Likelihood of Damage	L (Low) – possible
	Sample taken 62119-005	Activity	Moderate		
		Sealed	Yes	Friability	Bonded (non-friable)
		Labelled	Y	Exposure Risk	Low - Negligible or low risk
		Quantity

Priority	MEDIUM	Label Required	Yes	Re- Audit Date	11 Feb 2022
Action	No remedial action required, unless disturbed				
Recommendation	Maintain paint or sealant to ACM surfaces. Particular attention should be given to side edges, ensure paint/sealant covers ALL exposed ACM surfaces.				
Legislative Requirements Victorian Regulation 2007	Warning labels should be affixed. Avoid mechanical damage and abrasion. Remove if refurbishment, structural alteration or demolition is to be carried out in this area. Re-inspect every 12 months or earlier if disturbed or removed in accordance with the Victorian OH&S Regulation 2017. All remedial/removal repairs require a Clearance Inspection & Certificate to be recorded by an approved and competent assessor.

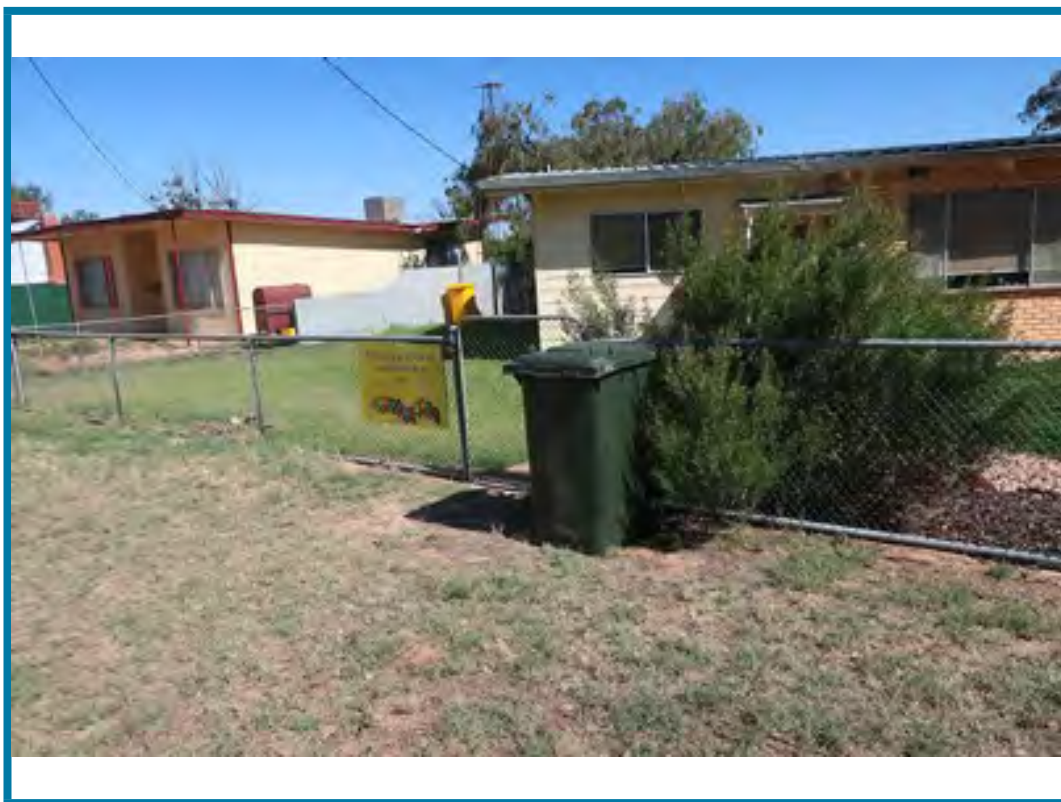
Location	Area	Component Materials	ACM Identified	Type Asbestos Assessment	Condition	Priority	Signage Required
Main building - entire perimeter of building.	Soffit	F C Sheeting	Yes	Chrysotile	GOOD	MEDIUM	Yes
				Sample taken 62119-001			
				GOOD MEDIUM			
				Refer to the Abestos Register for more information.			
Main building - front & left side of building.	Walls - planking	F C Sheeting	No	No Asbestos Detected			
				Sample taken 62119-002			
Main building - Entry 1.	Electrical board	No Asbestos Materials	No	No sample taken - Visual ID			
Main building - Entry 1.	Ceiling (PVC Strips)	F C Sheeting	Yes	Chrysotile	GOOD	MEDIUM	Yes
				Sample taken 62119-003			
				GOOD MEDIUM			
				Refer to the Abestos Register for more information.			
Main building - Entry 1.	Ceiling (thick joiner strip)	F C Sheeting	No	No Asbestos Detected			
				Sample taken 62119-004

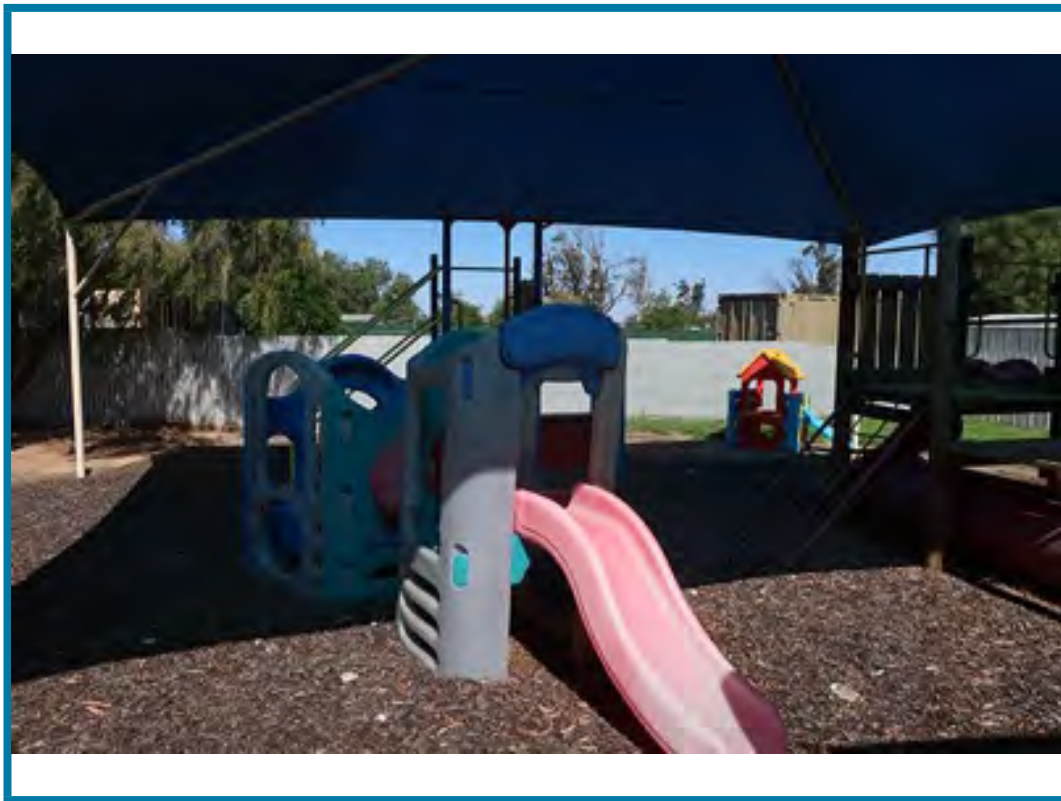
Location	Area	Component Materials	ACM Identified	Type Asbestos Assessment	Condition	Priority	Signage Required
Playground - Playground.		No Asbestos Materials	No	No sample taken - Visual ID

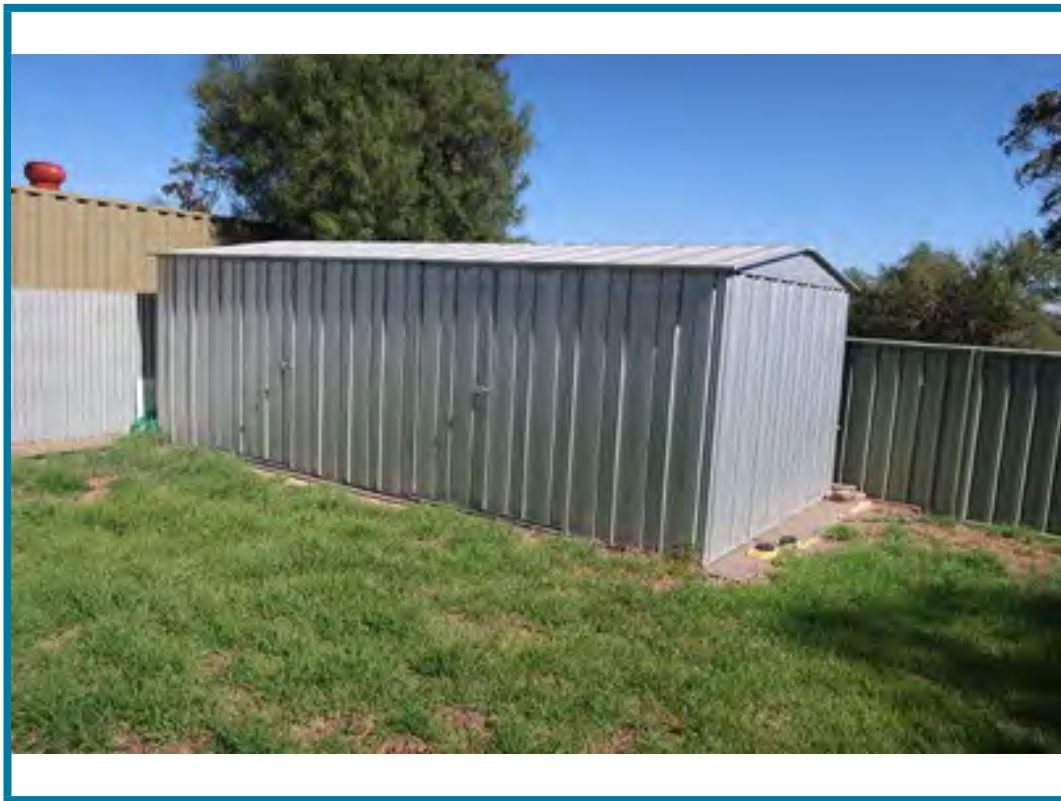
Location	Area	Component Materials	ACM Identified	Type Asbestos Assessment	Condition Priority	Signage Required
Shed - entire perimeter of building.		No Asbestos Materials	No	No sample taken - Visual ID
