Asbestos Report

YARRIAMBIACK SHIRE COUNCIL

PROPERTY ADDRESS:
LB25 MEMORIAL PARK PAVILLION
2 STATION STREET
TEMPY VIC 3489

INSPECTION DATE: 11 FEBRUARY 2021
REFERENCE NUMBER: 62120

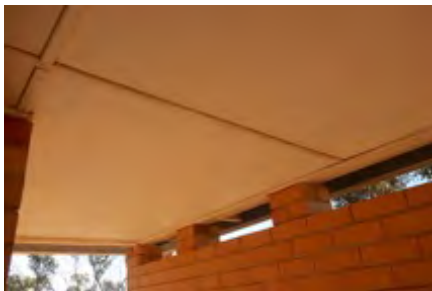
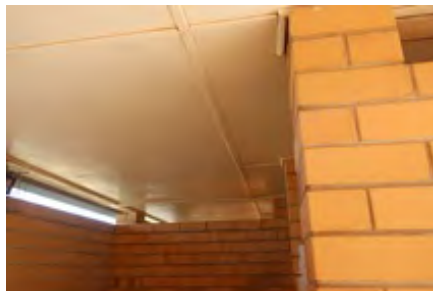
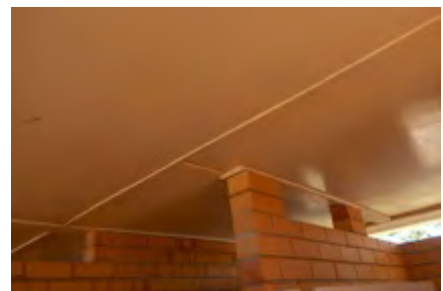
Area 8

| RISK ASSESSMENT | | | | | |
|--|---|---|---|---|---|
| Type of Asbestos or Hazardous Material | Chrysotile | Condition | GOOD | Likelihood of Damage | L (Low) – possible |

Maintain paint or sealant

| Recommendation | Maintain paint or sealant to ACM surfaces. Particular attention should be given to side edges, ensure paint/sealant covers ALL exposed ACM surfaces. | | | | |

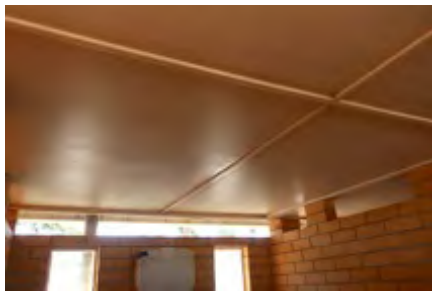
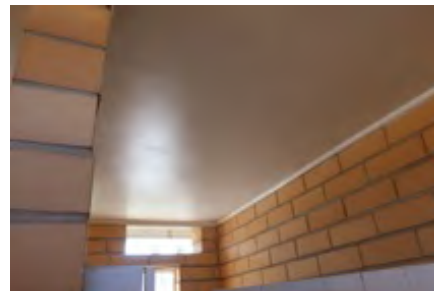
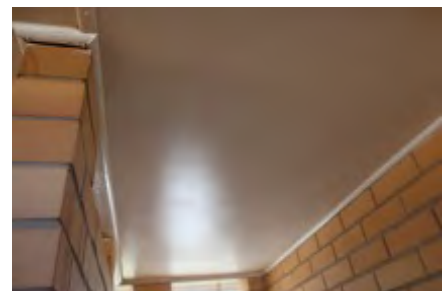
| Type of Asbestos or Hazardous Material | Chrysotile | Condition | GOOD | Likelihood of Damage | L (Low) – possible |

Maintain paint or sealant

| Recommendation | Maintain paint or sealant to ACM surfaces. Particular attention should be given to side edges, ensure paint/sealant covers ALL exposed ACM surfaces. | | | | |

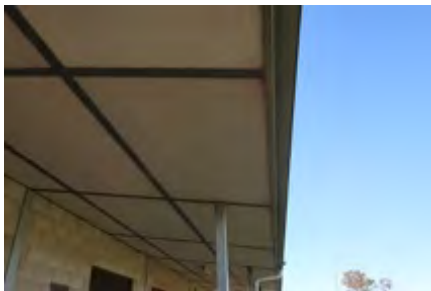
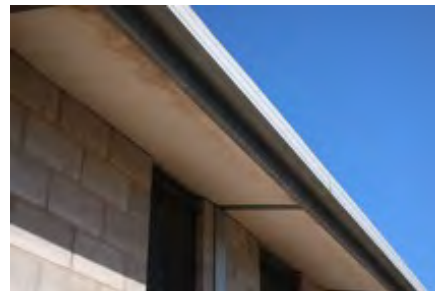
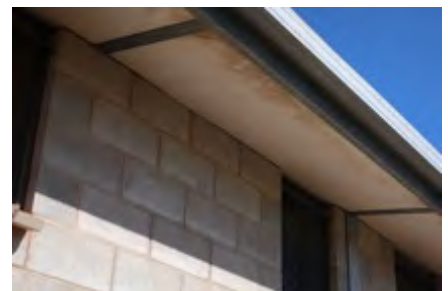
Area 5

| RISK ASSESSMENT | | | | | |
|--|---|---|---|---|---|
| Type of Asbestos or Hazardous Material | No sample taken - Visual ID | Condition | GOOD | Likelihood of Damage | L (Low) – possible |

Maintain paint or sealant

| RISK CONTROL | | | | | |
|--|---|---|---|---|---|
| Recommendation | Maintain paint or sealant to ACM surfaces. Particular attention should be given to side edges, ensure paint/sealant covers ALL exposed ACM surfaces. | | | | |

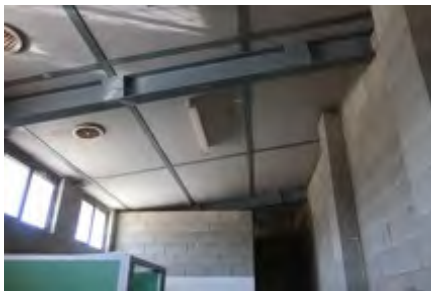
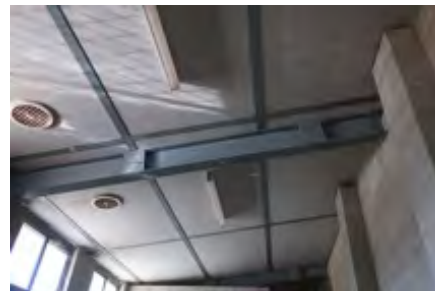
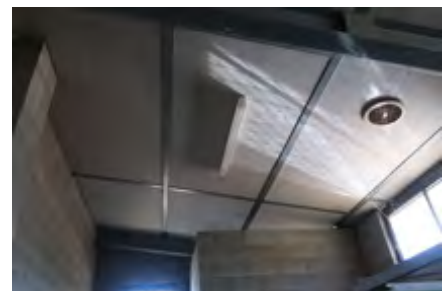
| RISK ASSESSMENT | | | | | |
|--|---|---|---|---|---|
| Type of Asbestos or Hazardous Material | No sample taken - Visual ID | Condition | GOOD | Likelihood of Damage | L (Low) – possible |

Maintain paint or sealant

| Recommendation | Maintain paint or sealant to ACM surfaces. Particular attention should be given to side edges, ensure paint/sealant covers ALL exposed ACM surfaces. | | | | |

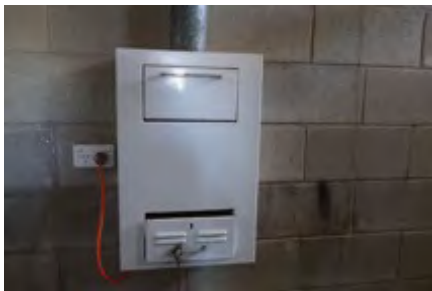
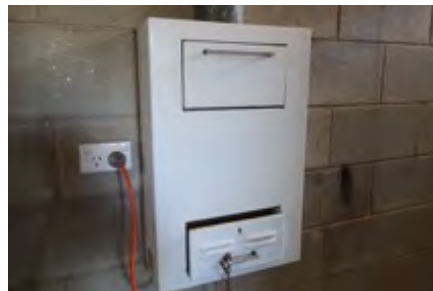
| Type of Asbestos or Hazardous Material | No sample taken - Visual ID | Condition | GOOD | Likelihood of Damage | L (Low) – possible |

Maintain seal

| Recommendation | Maintain paint or sealant to ACM surfaces. Particular attention should be given to side edges, ensure paint/sealant covers ALL exposed ACM surfaces. | | | | |

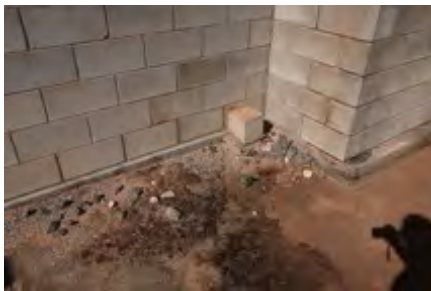
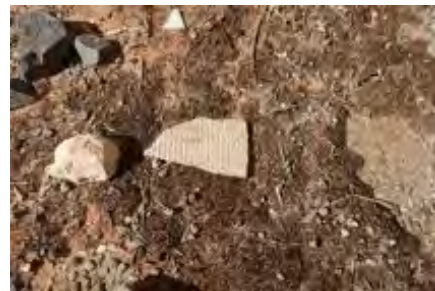
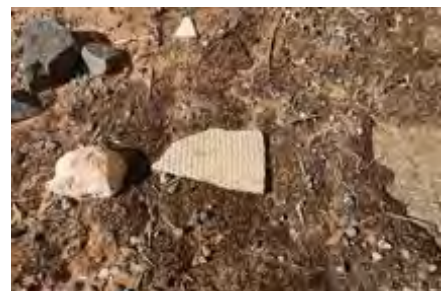
Clubrooms: right side of building. The Debris - Broken (Debris) has Asbestos Containing Material (ACM) present.

| Type of Asbestos or Hazardous Material | No sample taken - Visual ID | Condition | POOR | Likelihood of Damage | H (High) - almost certain |
| | | Labelled | No | Exposure Risk | High - Short term exposure risk |

Debris on Surface

| Recommendation | Debris on Surface - The Debris requires immediate cleanup and disposal with specialised equipment and with licensed removalist to safely remove the asbestos debris. | | | | |

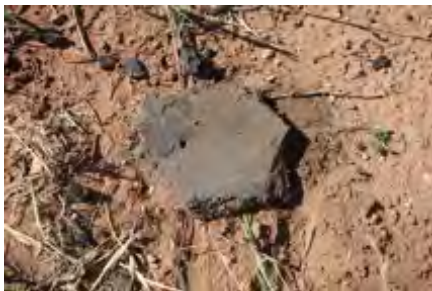
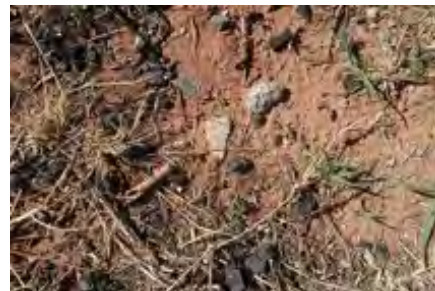
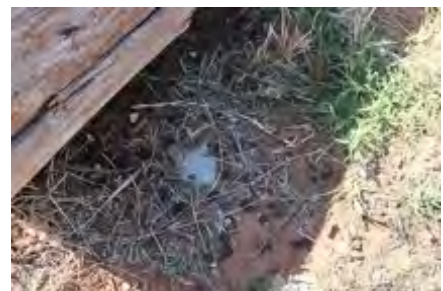
Area 2

Grounds: Seating area. The Debris - Broken (Debris) has Asbestos Containing Material (ACM) present.

| RISK ASSESSMENT | | | | | |
|--|---|---|---|---|---|
| Type of Asbestos or Hazardous Material | No sample taken - Visual ID | Condition | POOR | Likelihood of Damage | H (High) - almost certain |
| | | Labelled | No | Exposure Risk | High - Short term exposure risk |

Debris on Surface

| RISK CONTROL | | | | | |
|--|--|---|---|---|---|
| Recommendation | Debris on Surface - The Debris requires immediate cleanup and disposal with specialised equipment and with licensed removalist to safely remove the asbestos debris. | | | | |

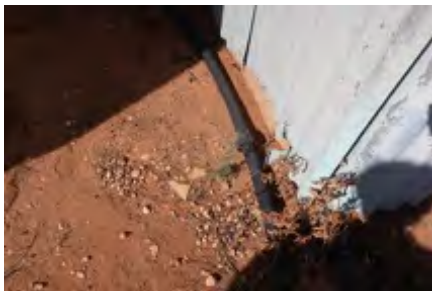
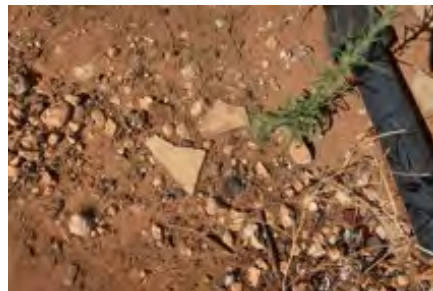
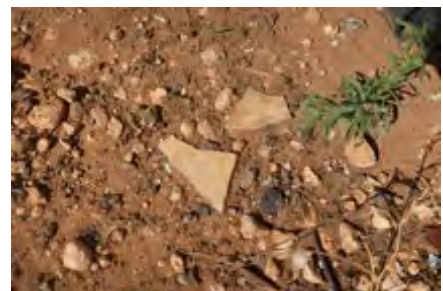
Area 3

Shed: left side of building. The Debris - Broken (Debris) has Asbestos Containing Material (ACM) present.

| RISK ASSESSMENT | | | | | |
|--|---|---|---|---|---|
| Type of Asbestos or Hazardous Material | No sample taken - Visual ID | Condition | POOR | Likelihood of Damage | H (High) - almost certain |
| | | Labelled | No | Exposure Risk | High - Short term exposure risk |

Debris on Surface

| RISK CONTROL | | | | | |
|--|--|---|---|---|---|
| Recommendation | Debris on Surface - The Debris requires immediate cleanup and disposal with specialised equipment and with licensed removalist to safely remove the asbestos debris. | | | | |

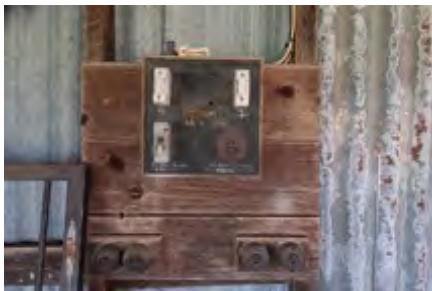
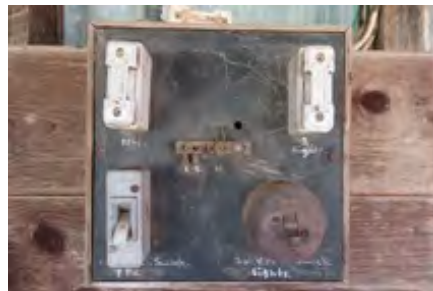
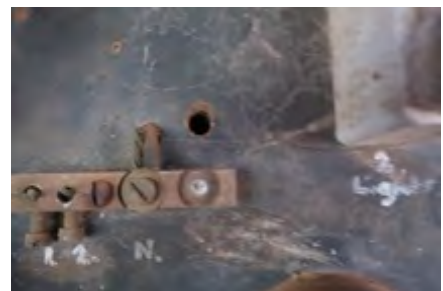
| RISK ASSESSMENT | | | | | |
|--|---|---|---|---|---|
| Type of Asbestos or Hazardous Material | No sample taken - Visual ID | Condition | AVERAGE | Likelihood of Damage | L (Low) – possible |
| | | Labelled | Y | Exposure Risk | Medium - Moderate risk |

Penetration Holes

| Action | Remedial repairs required - seal raw material / edges | | | | |
| Recommendation | Penetration Holes - The exposed edges require approved sealant. It is further recommended the gaps be filled with sealant. | | | | |
