Asbestos Report

YARRIAMBIACK SHIRE COUNCIL

PROPERTY ADDRESS:
LB79 PUBLIC HALL
6 BOSCHERT STREET
TEMPY VIC 3489

INSPECTION DATE: 11 FEBRUARY 2021
REFERENCE NUMBER: 62121

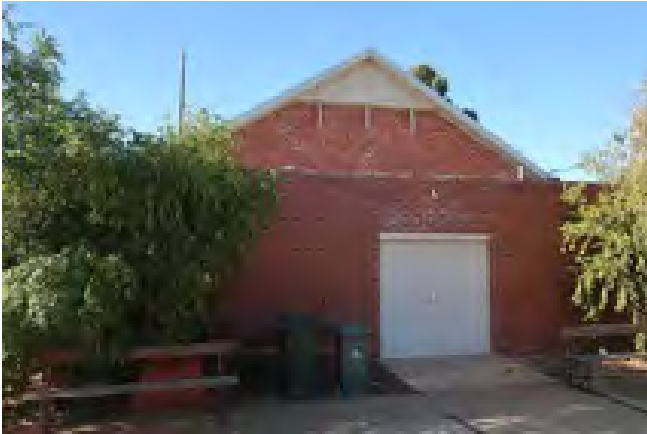
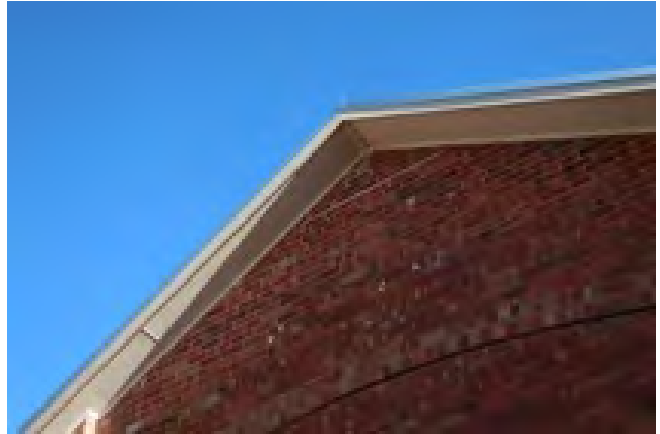
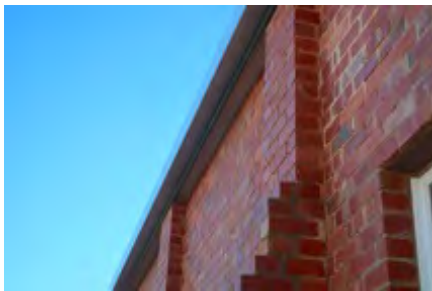
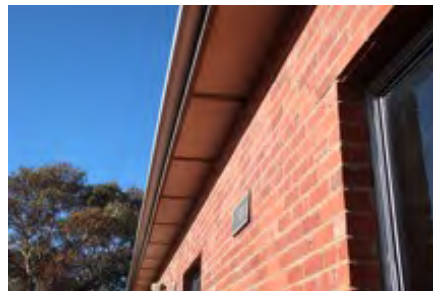
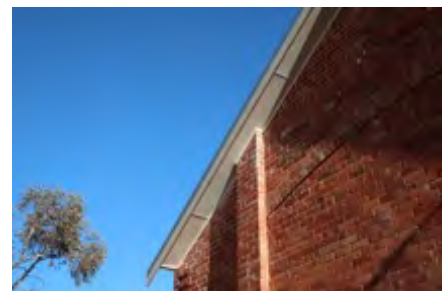
Area 6

Hall: entire perimeter of building. The Soffit (F C Sheeting) has Asbestos Containing Material (ACM) present.

RISK ASSESSMENT					
Type of Asbestos or Hazardous Material	No sample taken - Visual ID	Condition	GOOD	Likelihood of Damage	L (Low) – possible
		Activity	Moderate		
		Sealed	Yes	Friability	Bonded (non-friable)
		Labelled	Y	Exposure Risk	Low - Negligible or low risk
		Quantity

RISK CONTROL					
Priority	MEDIUM	Label Required	Yes	Re- Audit Date	11 Feb 2022
Action	No remedial action required, unless disturbed				
Recommendation	Maintain paint or sealant to ACM surfaces. Particular attention should be given to side edges, ensure paint/sealant covers ALL exposed ACM surfaces.				
Legislative Requirements Victorian Regulation 2007	Warning labels should be affixed. Avoid mechanical damage and abrasion. Remove if refurbishment, structural alteration or demolition is to be carried out in this area. Re-inspect every 12 months or earlier if disturbed or removed in accordance with the Victorian OH&S Regulation 2017. All remedial/removal repairs require a Clearance Inspection & Certificate to be recorded by an approved and competent assessor.

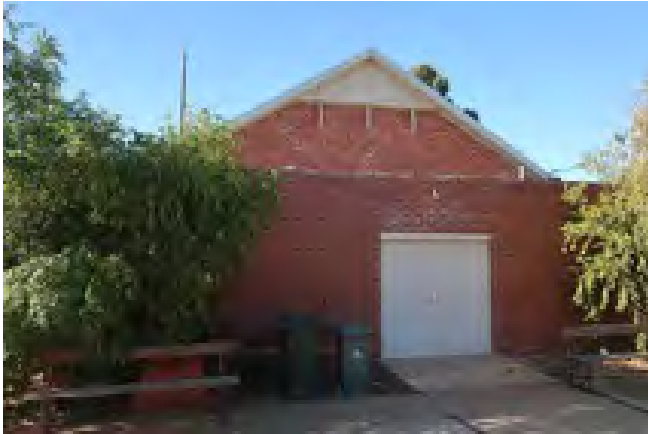
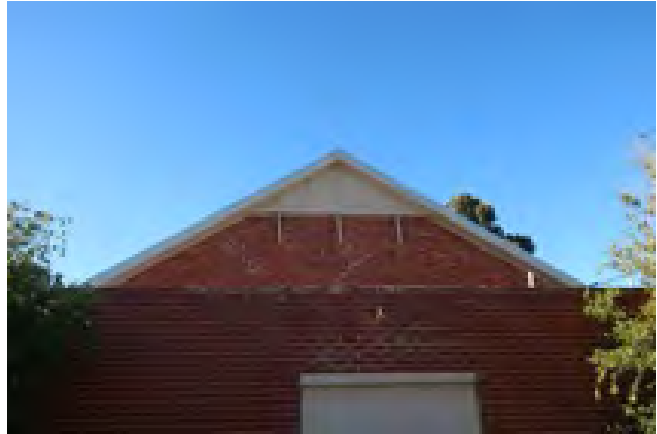
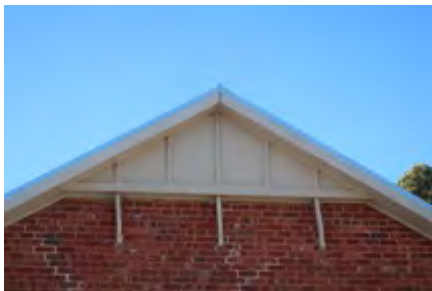
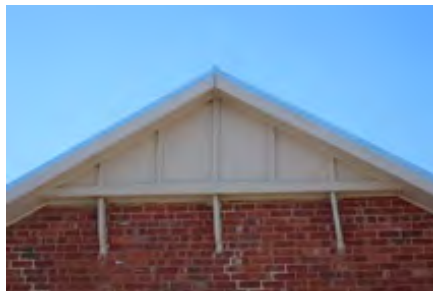
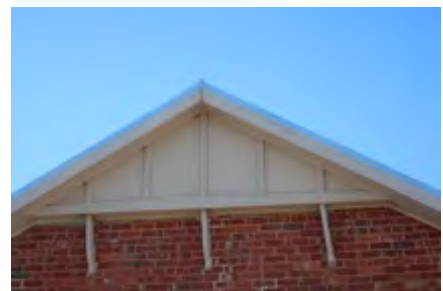
Hall: front of building. The Gable Ends (F C Sheeting) has Asbestos Containing Material (ACM) present.

RISK ASSESSMENT					
Type of Asbestos or Hazardous Material	No sample taken - Visual ID	Condition	GOOD	Likelihood of Damage	L (Low) – possible
		Activity	Low		
		Sealed	Yes	Friability	Bonded (non-friable)
		Labelled	Y	Exposure Risk	Low - Negligible or low risk
		Quantity

RISK CONTROL					
Priority	MEDIUM	Label Required	Yes	Re- Audit Date	11 Feb 2022
Action	No remedial action required, unless disturbed				
Recommendation	Maintain paint or sealant to ACM surfaces. Particular attention should be given to side edges, ensure paint/sealant covers ALL exposed ACM surfaces.				
Legislative Requirements Victorian Regulation 2007	Warning labels should be affixed. Avoid mechanical damage and abrasion. Remove if refurbishment, structural alteration or demolition is to be carried out in this area. Re-inspect every 12 months or earlier if disturbed or removed in accordance with the Victorian OH&S Regulation 2017. All remedial/removal repairs require a Clearance Inspection & Certificate to be recorded by an approved and competent assessor.

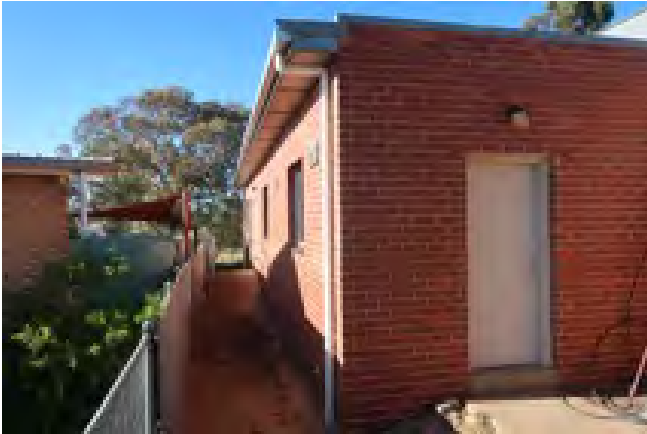
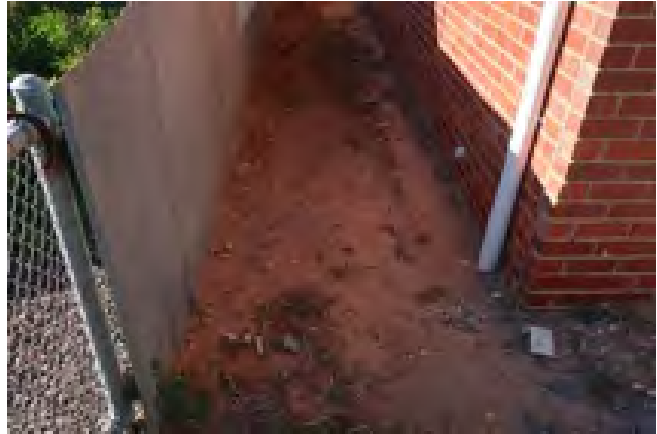
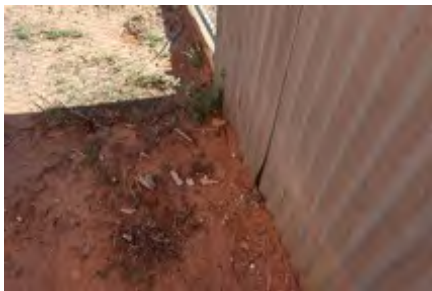
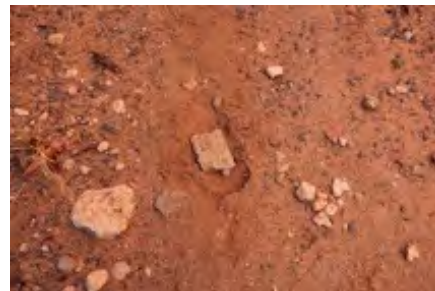
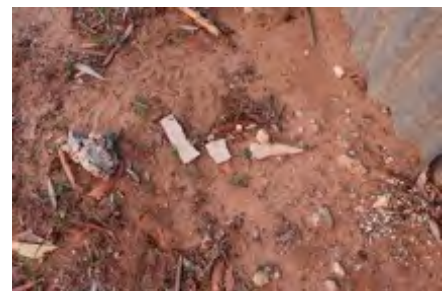
Hall: left side of building. The Debris - Broken (Debris) has Asbestos Containing Material (ACM) present.

RISK ASSESSMENT					
Type of Asbestos or Hazardous Material	Chrysotile	Condition	POOR	Likelihood of Damage	H (High) - almost certain
	Amosite	Activity	Moderate		
	Same as Sample - 62121-001	Sealed	No	Friability	Exposed Fibres
		Labelled	No	Exposure Risk	High - Short term exposure risk
		Quantity

RISK CONTROL					
Priority	IMMEDIATE	Label Required	Yes	Re- Audit Date	11 Feb 2022
Action	Restrict access and target for imminent removal				
Recommendation	Debris on Surface - The Debris requires immediate cleanup and disposal with specialised equipment and with licensed removalist to safely remove the asbestos debris.				
Legislative Requirements Victorian Regulation 2007	ACM debris visible. Recommend cleanup by licensed Asbestos Removalist. Warning labels should be affixed. Avoid mechanical damage and abrasion. Remove if refurbishment, structural alteration or demolition is to be carried out in this area. Re-inspect every 12 months or earlier if disturbed or removed in accordance with the Victorian OH&S Regulation 2017. All remedial/removal repairs require a Clearance Inspection & Certificate to be recorded by an approved and competent assessor.

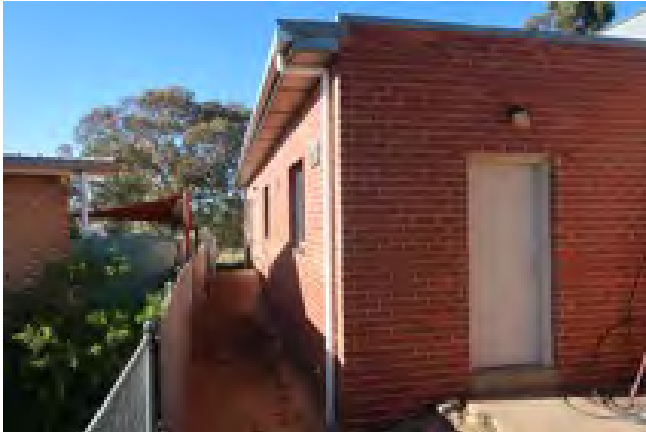
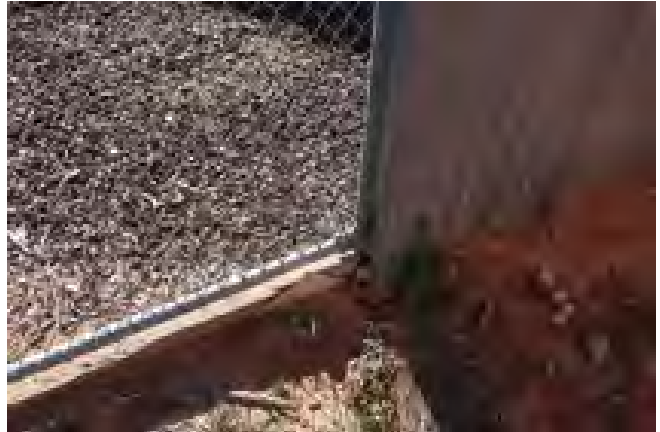
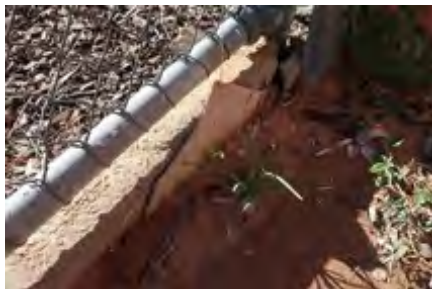
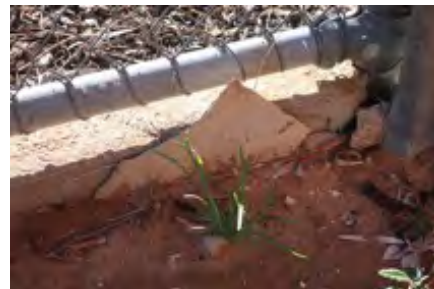
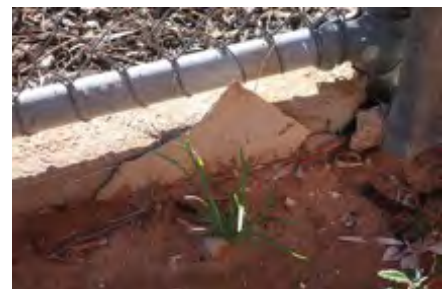
Area 2**Hall: left side of building. The Debris - Broken (Debris) has Asbestos Containing Material (ACM) present.****RISK ASSESSMENT**

Type of Asbestos or Hazardous Material	No sample taken - Visual ID	Condition	POOR	Likelihood of Damage	H (High) - almost certain
		Activity	Moderate		
		Sealed	No	Friability	Exposed Fibres
		Labelled	No	Exposure Risk	High - Short term exposure risk
		Quantity

Priority	IMMEDIATE	Label Required	Yes	Re- Audit Date	11 Feb 2022
Action	Restrict access and target for imminent removal				
Recommendation	Debris on Surface - The Debris requires immediate cleanup and disposal with specialised equipment and with licensed removalist to safely remove the asbestos debris.				
Legislative Requirements Victorian Regulation 2007	ACM debris visible. Recommend cleanup by licensed Asbestos Removalist. Warning labels should be affixed. Avoid mechanical damage and abrasion. Remove if refurbishment, structural alteration or demolition is to be carried out in this area. Re-inspect every 12 months or earlier if disturbed or removed in accordance with the Victorian OH&S Regulation 2017. All remedial/removal repairs require a Clearance Inspection & Certificate to be recorded by an approved and competent assessor.

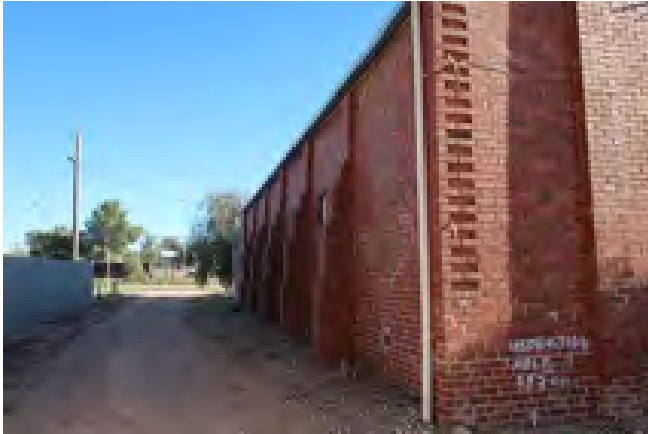
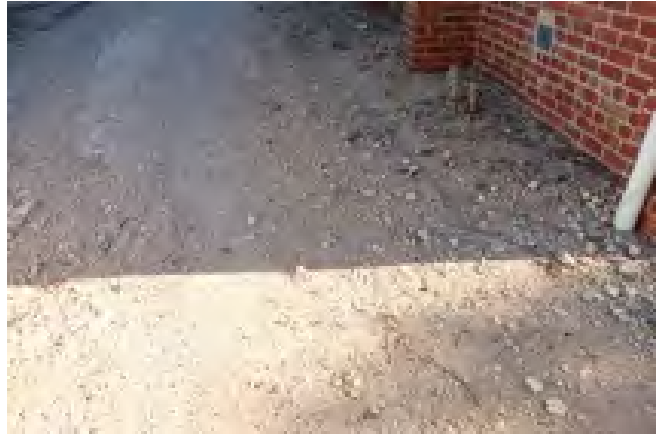
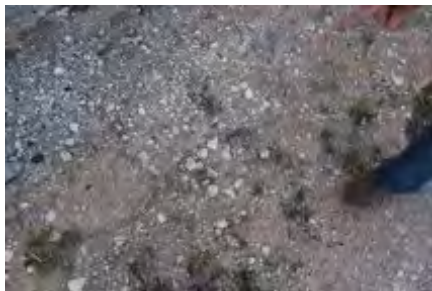
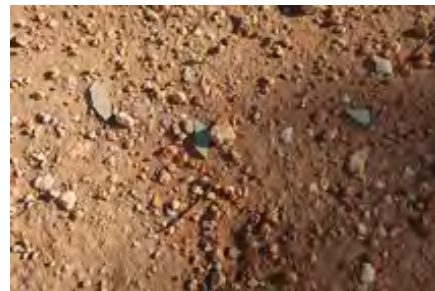
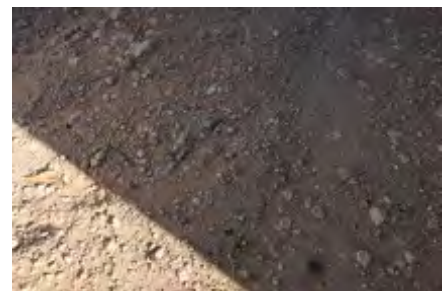
Hall: right side of building. The Debris - Broken (Debris) has Asbestos Containing Material (ACM) present.

RISK ASSESSMENT					
Type of Asbestos or Hazardous Material	Chrysotile	Condition	POOR	Likelihood of Damage	H (High) - almost certain
	Amosite	Activity	Moderate		
	Sample taken 62121-001	Sealed	No	Friability	Exposed Fibres
		Labelled	No	Exposure Risk	High - Short term exposure risk
		Quantity

RISK CONTROL					
Priority	IMMEDIATE	Label Required	Yes	Re- Audit Date	11 Feb 2022
Action	Restrict access and target for imminent removal				
Recommendation	Debris on Surface - The Debris requires immediate cleanup and disposal with specialised equipment and with licensed removalist to safely remove the asbestos debris.				
Legislative Requirements Victorian Regulation 2007	ACM debris visible. Recommend cleanup by licensed Asbestos Removalist. Warning labels should be affixed. Avoid mechanical damage and abrasion. Remove if refurbishment, structural alteration or demolition is to be carried out in this area. Re-inspect every 12 months or earlier if disturbed or removed in accordance with the Victorian OH&S Regulation 2017. All remedial/removal repairs require a Clearance Inspection & Certificate to be recorded by an approved and competent assessor.

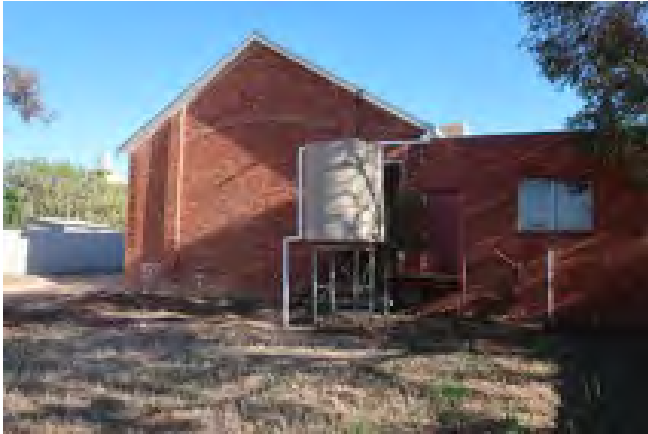
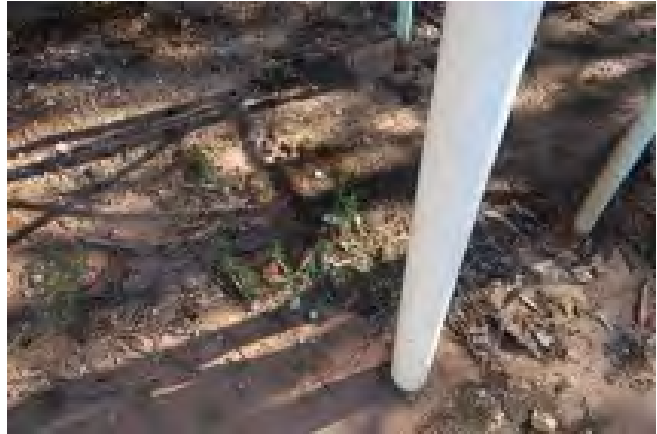
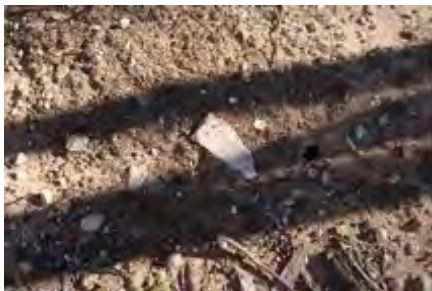
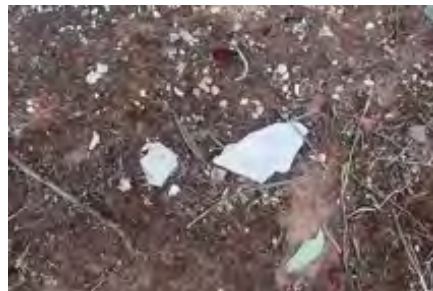
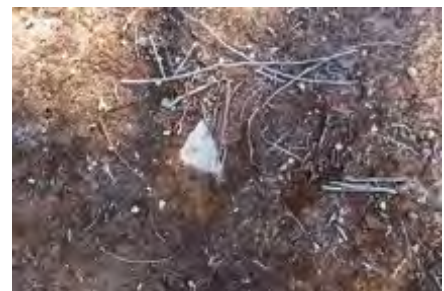
Hall: rear of building. The Debris - Broken (Debris) has Asbestos Containing Material (ACM) present.

RISK ASSESSMENT					
Type of Asbestos or Hazardous Material	Chrysotile	Condition	POOR	Likelihood of Damage	H (High) - almost certain
	Amosite	Activity	Moderate		
	Same as Sample - 62121-001	Sealed	No	Friability	Exposed Fibres
		Labelled	No	Exposure Risk	High - Short term exposure risk
		Quantity

RISK CONTROL					
Priority	IMMEDIATE	Label Required	Yes	Re- Audit Date	11 Feb 2022
Action	Restrict access and target for imminent removal				
Recommendation	Debris on Surface - The Debris requires immediate cleanup and disposal with specialised equipment and with licensed removalist to safely remove the asbestos debris.				
Legislative Requirements Victorian Regulation 2007	ACM debris visible. Recommend cleanup by licensed Asbestos Removalist. Warning labels should be affixed. Avoid mechanical damage and abrasion. Remove if refurbishment, structural alteration or demolition is to be carried out in this area. Re-inspect every 12 months or earlier if disturbed or removed in accordance with the Victorian OH&S Regulation 2017. All remedial/removal repairs require a Clearance Inspection & Certificate to be recorded by an approved and competent assessor.

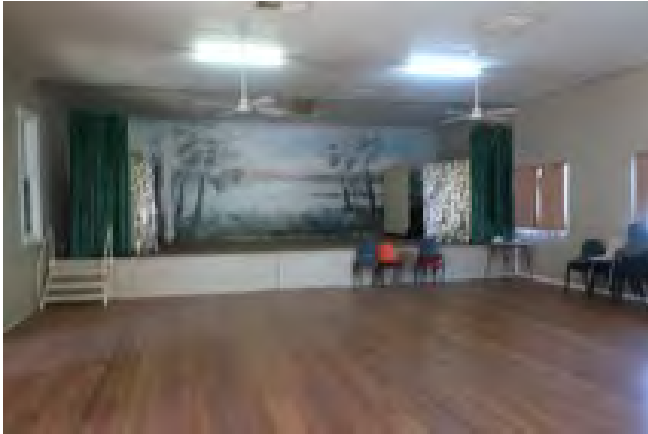
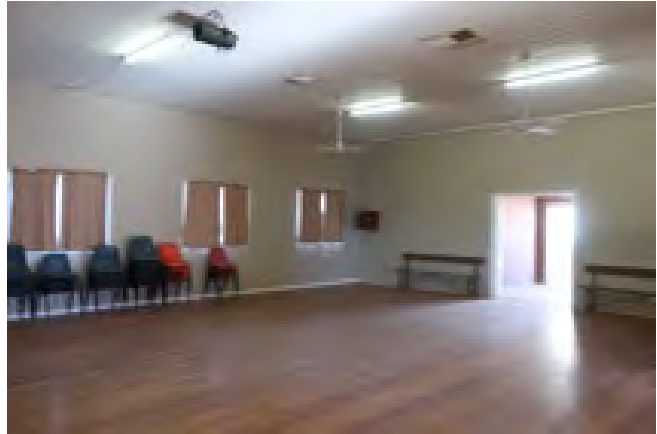
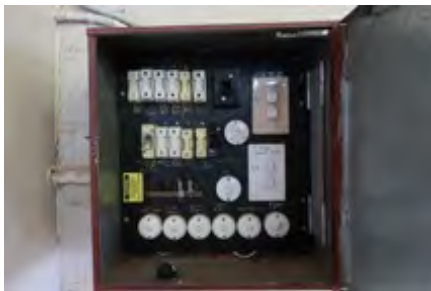
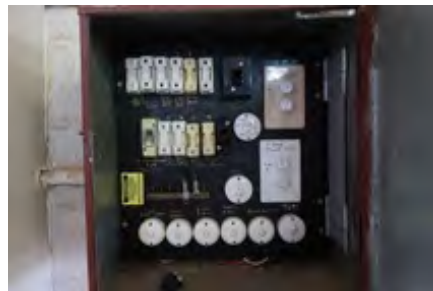
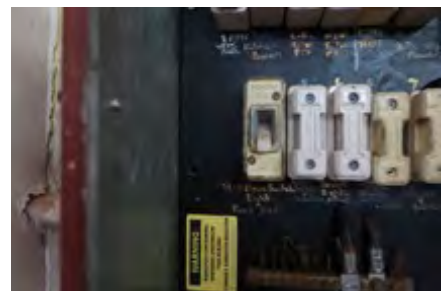
Hall 3. The A: Electrical board; B: Ceramic Fuses (A: Zelemite; B: Cloth Inserts) has Asbestos Containing Material (ACM) present.

RISK ASSESSMENT					
Type of Asbestos or Hazardous Material	No sample taken - Visual ID	Condition	AVERAGE	Likelihood of Damage	L (Low) – possible
		Activity	Moderate		
		Sealed	Yes	Friability	Exposed Fibres
		Labelled	Y	Exposure Risk	Medium - Moderate risk
		Quantity

RISK CONTROL					
Priority	HIGH	Label Required	Yes	Re- Audit Date	11 Feb 2022
Action	Remedial repairs required - seal raw material / edges				
Recommendation	Penetration Holes - The exposed edges require approved sealant. It is further recommended the gaps be filled with sealant. Do not remove the fuses without asbestos controls - test for cloth inserts				
Legislative Requirements Victorian Regulation 2007	Damaged ACM visible in area. Requires IMMEDIATE ATTENTION. WARNING labels should be affixed. Avoid mechanical damage and abrasion. Remove if refurbishment, structural alteration or demolition is to be carried out in this area. Re-inspect every 12 months or earlier if disturbed or removed in accordance with the Victorian OH&S Regulation 2017. All remedial/removal repairs require a Clearance Inspection & Certificate to be recorded by an approved and competent assessor.
