**Global
Asbestos
Audits**

Asbestos Report

YARRIAMBIACK SHIRE COUNCIL

PROPERTY ADDRESS:
LB8 AERODROME
4936 HENTY HIGHWAY
WARRACKNABEAL VIC 3393

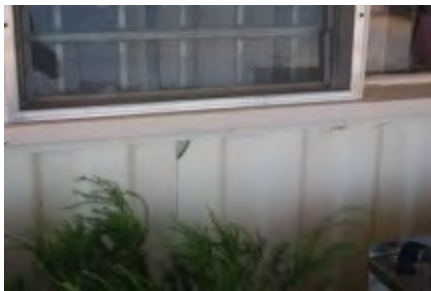
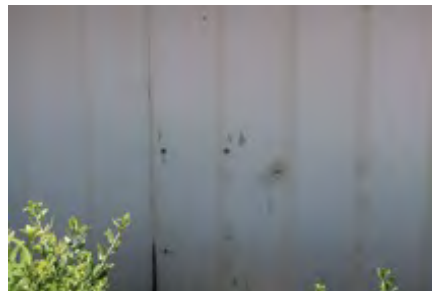
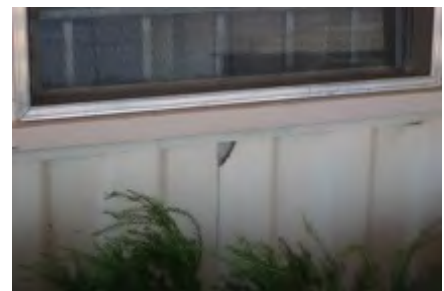
Type of Asbestos or Hazardous Material	No sample taken - Visual ID	Condition	AVERAGE	Likelihood of Damage	L (Low) – possible	
		Activity	Moderate			
		Sealed	Yes	Friability		Exposed Fibres
		Labelled	Y	Exposure Risk		Medium - Moderate risk
		Quantity

Broken sections

Broken sections - The damaged area requires immediate remedial repairs. It is recommended the asbestos sheeting be replaced (preferred) or edges sealed with approved sealant and then the area be concealed by laminating (sheeting).

Priority	HIGH	Label Required	Yes	Re- Audit Date	16 Feb 2022
Action	Remedial repairs required - seal exposed edges or replace or laminate over damaged material				
Recommendation	Broken sections - The damaged area requires immediate remedial repairs. It is recommended the asbestos sheeting be replaced (preferred) or edges sealed with approved sealant and then the area be concealed by laminating (sheeting).				
Legislative Requirements Victorian Regulation 2007	Damaged ACM visible in area. Requires IMMEDIATE ATTENTION. WARNING labels should be affixed. Avoid mechanical damage and abrasion. Remove if refurbishment, structural alteration or demolition is to be carried out in this area. Re-inspect every 12 months or earlier if disturbed or removed in accordance with the Victorian OH&S Regulation 2017. All remedial/removal repairs require a Clearance Inspection & Certificate to be recorded by an approved and competent assessor.

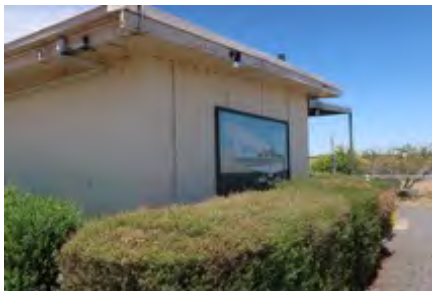
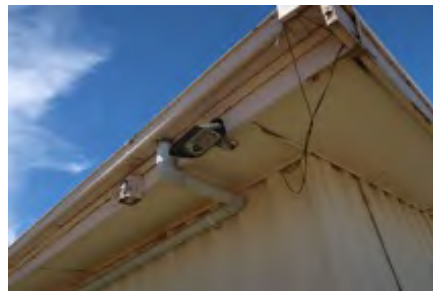
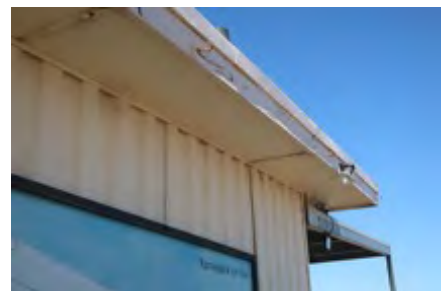
W' Beal Aero Club LB8 Aerodrome: entire perimeter of building. The Soffit (F C Sheeting) has Asbestos Containing Material (ACM) present.

RISK ASSESSMENT					
Type of Asbestos or Hazardous Material	No sample taken - Visual ID	Condition	GOOD	Likelihood of Damage	L (Low) – possible
		Activity	Moderate		
		Sealed	Yes	Friability	Bonded (non-friable)
		Labelled	No	Exposure Risk	Low - Negligible or low risk
		Quantity

Maintain paint or sealant

Priority	MEDIUM	Label Required	Yes	Re- Audit Date	16 Feb 2022
Action	No remedial action required, unless disturbed				
Recommendation	Maintain paint or sealant to ACM surfaces. Particular attention should be given to side edges, ensure paint/sealant covers ALL exposed ACM surfaces.				
Legislative Requirements Victorian Regulation 2007	Warning labels should be affixed. Avoid mechanical damage and abrasion. Remove if refurbishment, structural alteration or demolition is to be carried out in this area. Re-inspect every 12 months or earlier if disturbed or removed in accordance with the Victorian OH&S Regulation 2017. All remedial/removal repairs require a Clearance Inspection & Certificate to be recorded by an approved and competent assessor.

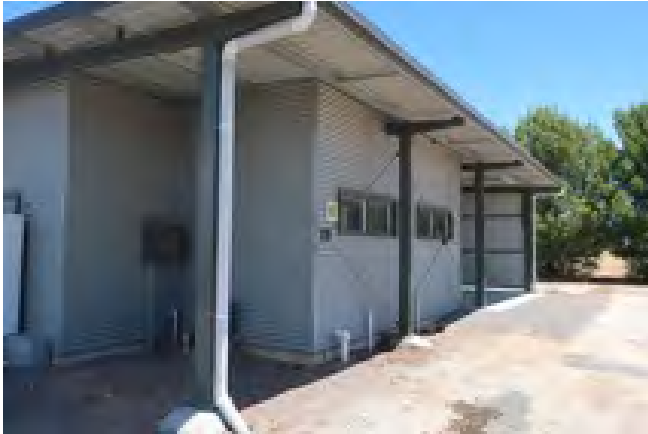
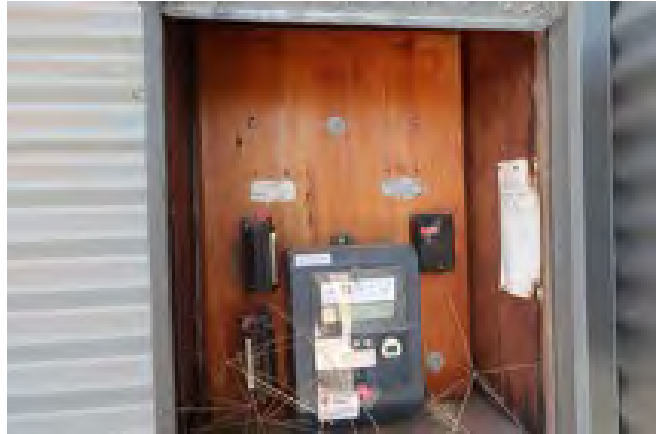
Area 3

Transfer lounge: rear of building. The Sheeting behind electrical board (F C Sheet) has Asbestos Containing Material (ACM) present.

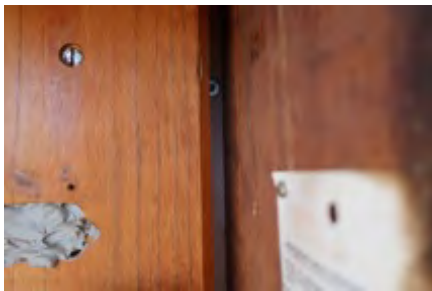
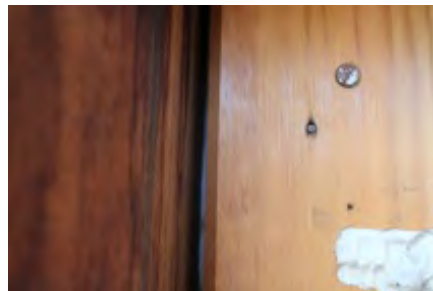
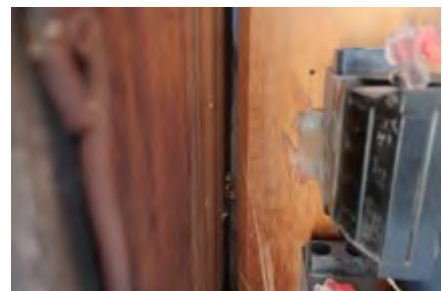
RISK ASSESSMENT					
Type of Asbestos or Hazardous Material	No sample taken - Visual ID	Condition	AVERAGE	Likelihood of Damage	L (Low) – possible
		Activity	Moderate		
		Sealed	No	Friability	Bonded (non-friable)
		Labelled	No	Exposure Risk	Medium - Moderate risk
		Quantity

Raw Material

Raw material sheeting - The area requires immediate remedial repairs. It is recommended the asbestos material be sealed with an approved membrane.

RISK CONTROL					
Priority	HIGH	Label Required	Yes	Re- Audit Date	16 Feb 2022
Action	Remedial repairs required - seal raw material / edges				
Recommendation	Raw material sheeting - The area requires immediate remedial repairs. It is recommended the asbestos material be sealed with an approved membrane.				
Legislative Requirements Victorian Regulation 2007	Damaged ACM visible in area. Requires IMMEDIATE ATTENTION. WARNING labels should be affixed. Avoid mechanical damage and abrasion. Remove if refurbishment, structural alteration or demolition is to be carried out in this area. Re-inspect every 12 months or earlier if disturbed or removed in accordance with the Victorian OH&S Regulation 2017. All remedial/removal repairs require a Clearance Inspection & Certificate to be recorded by an approved and competent assessor.
