Asbestos Report

YARRIAMBIACK SHIRE COUNCIL

PROPERTY ADDRESS:
LR47 CARAVAN PARK
2A LYLE STREET
WARRACKNABEAL VIC 3393

INSPECTION DATE: 16 FEBRUARY 2021
REFERENCE NUMBER: 62126

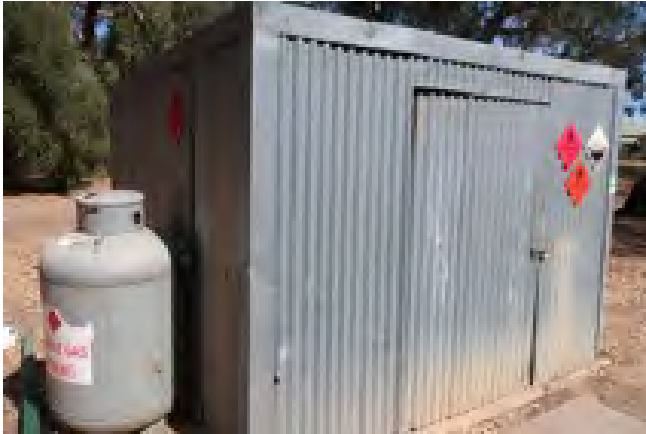
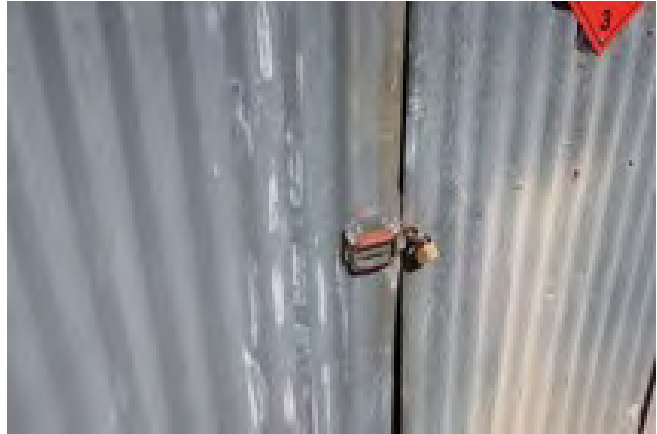
Area 5

Shed: . Until the area is inspected, it should be managed as if it Asbestos Containing Material (ACM) is present.

RISK ASSESSMENT					
Type of Asbestos or Hazardous Material	No sample taken - No Access	Condition		Likelihood of Damage	
		Activity			
		Sealed		Friability	
		Labelled	No	Exposure Risk	
		Quantity

RISK CONTROL					
Priority	HIGH	Label Required	Yes	Re- Audit Date	16 Feb 2022
Action					
Recommendation					
Legislative Requirements Victorian Regulation 2007	Unable to Gain Access. Assume asbestos in area and provide monitoring if work undertaken in these areas. If access is made available, contact Global Asbestos Audits for re-inspection

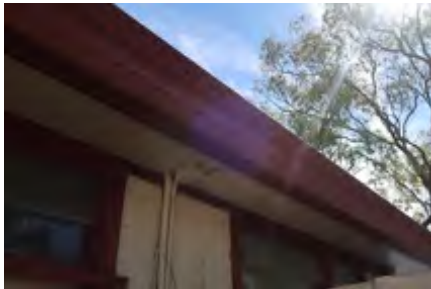
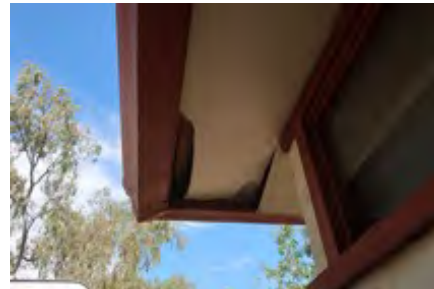
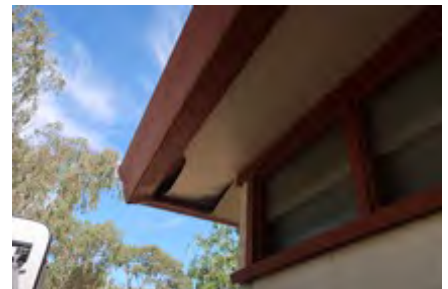
Area 1**Ensuites 1-4: entire perimeter of building. The Soffit (F C Sheeting) has Asbestos Containing Material (ACM) present.****RISK ASSESSMENT**

Type of Asbestos or Hazardous Material	Chrysotile	Condition	AVERAGE	Likelihood of Damage	L (Low) – possible
	Same as Sample - 62126 -005	Activity	Moderate		
		Sealed	Yes	Friability	Exposed Fibres
		Labelled	Y	Exposure Risk	Medium - Moderate risk
		Quantity

Broken sections

Priority	HIGH	Label Required	Yes	Re- Audit Date	16 Feb 2022
Action	Remedial repairs required - seal exposed edges or replace or laminate over damaged material				
Recommendation	Broken sections - The damaged area requires immediate remedial repairs. It is recommended the asbestos sheeting be replaced (preferred) or edges sealed with approved sealant and then the area be concealed by laminating (sheeting).				
Legislative Requirements Victorian Regulation 2007	<p>Damaged ACM visible in area. Requires IMMEDIATE ATTENTION. WARNING labels should be affixed. Avoid mechanical damage and abrasion. Remove if refurbishment, structural alteration or demolition is to be carried out in this area. Re-inspect every 12 months or earlier if disturbed or removed in accordance with the Victorian OH&S Regulation 2017.</p> <p>All remedial/removal repairs require a Clearance Inspection & Certificate to be recorded by an approved and competent assessor.</p>

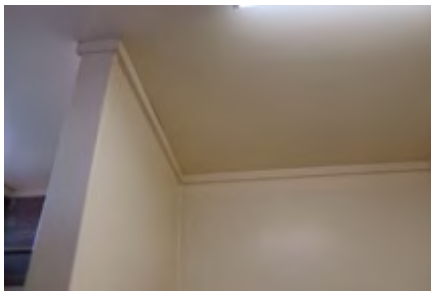
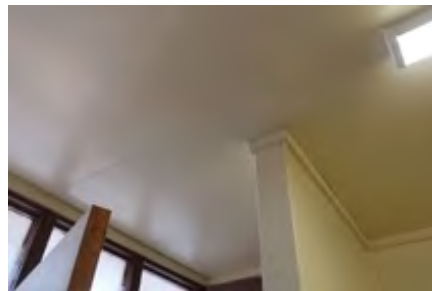
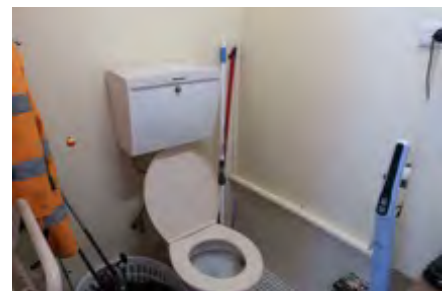
Area 7**Ensuites 1-4: Ensuite 3 1. The Walls and Ceiling (F C Sheeting) has Asbestos Containing Material (ACM) present.****RISK ASSESSMENT**

Type of Asbestos or Hazardous Material	Chrysotile	Condition	GOOD	Likelihood of Damage	L (Low) – possible
	Same as Sample - 62126-006	Activity	Moderate		
		Sealed	Yes	Friability	Bonded (non-friable)
		Labelled	Y	Exposure Risk	Low - Negligible or low risk
		Quantity

Maintain paint or sealant

Priority	MEDIUM	Label Required	Yes	Re- Audit Date	16 Feb 2022
Action	No remedial action required, unless disturbed				
Recommendation	Maintain paint or sealant to ACM surfaces. Particular attention should be given to side edges, ensure paint/sealant covers ALL exposed ACM surfaces.				
Legislative Requirements Victorian Regulation 2007	Warning labels should be affixed. Avoid mechanical damage and abrasion. Remove if refurbishment, structural alteration or demolition is to be carried out in this area. Re-inspect every 12 months or earlier if disturbed or removed in accordance with the Victorian OH&S Regulation 2017. All remedial/removal repairs require a Clearance Inspection & Certificate to be recorded by an approved and competent assessor.

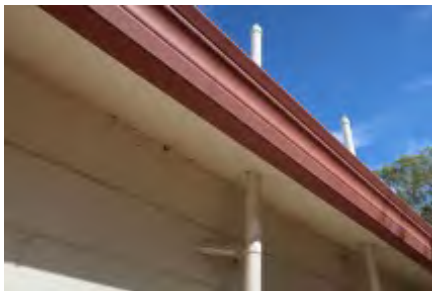
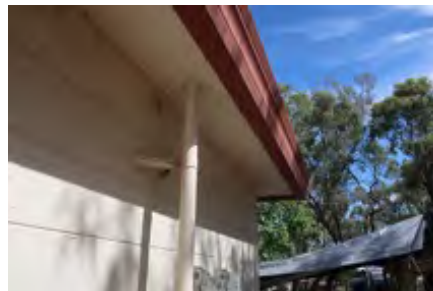
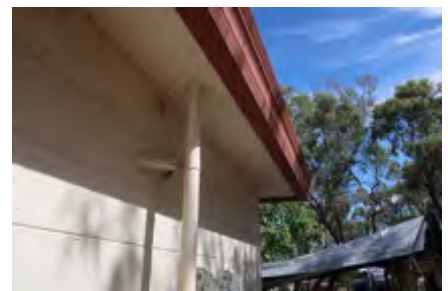
Ensuites 5-8: entire perimeter of building. The Soffit (F C Sheeting) has Asbestos Containing Material (ACM) present.

RISK ASSESSMENT					
Type of Asbestos or Hazardous Material	Chrysotile	Condition	GOOD	Likelihood of Damage	L (Low) – possible
	Same as Sample - 62126 -005	Activity	Moderate		
		Sealed	Yes	Friability	Bonded (non-friable)
		Labelled	Y	Exposure Risk	Low - Negligible or low risk
		Quantity

Maintain paint or sealant

Priority	MEDIUM	Label Required	Yes	Re- Audit Date	16 Feb 2022
Action	No remedial action required, unless disturbed				
Recommendation	Maintain paint or sealant to ACM surfaces. Particular attention should be given to side edges, ensure paint/sealant covers ALL exposed ACM surfaces.				
Legislative Requirements Victorian Regulation 2007	Warning labels should be affixed. Avoid mechanical damage and abrasion. Remove if refurbishment, structural alteration or demolition is to be carried out in this area. Re-inspect every 12 months or earlier if disturbed or removed in accordance with the Victorian OH&S Regulation 2017. All remedial/removal repairs require a Clearance Inspection & Certificate to be recorded by an approved and competent assessor.

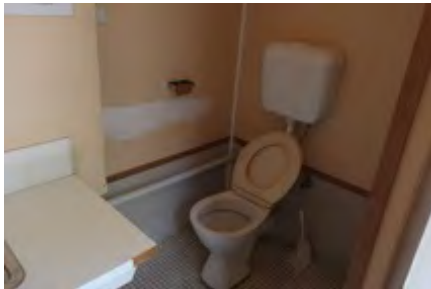
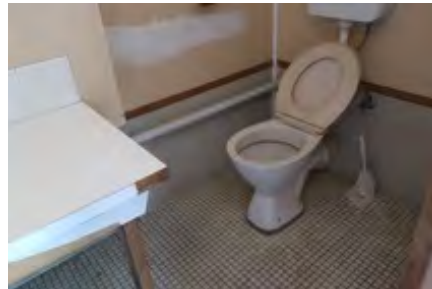
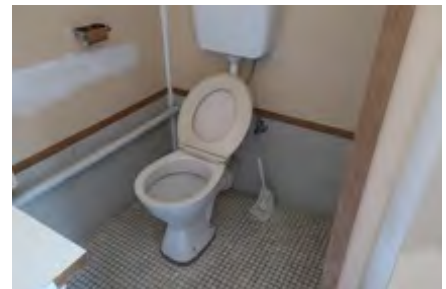
Area 3**Ensuites 5-8: Ensuite 8 1. The Walls and Ceiling (F C Sheeting) has Asbestos Containing Material (ACM) present.****RISK ASSESSMENT**

Type of Asbestos or Hazardous Material	Chrysotile	Condition	AVERAGE	Likelihood of Damage	L (Low) – possible
	Sample taken 62126-006	Activity	Moderate		
		Sealed	No	Friability	Bonded (non-friable)
		Labelled	Y	Exposure Risk	Medium - Moderate risk
		Quantity

Raw Material

Priority	HIGH	Label Required	Yes	Re- Audit Date	16 Feb 2022
Action	Remedial repairs required - seal raw material / edges				
Recommendation	Raw material sheeting - The area requires immediate remedial repairs. It is recommended the asbestos material be sealed with an approved membrane.				
Legislative Requirements Victorian Regulation 2007	<p>Damaged ACM visible in area. Requires IMMEDIATE ATTENTION. WARNING labels should be affixed. Avoid mechanical damage and abrasion. Remove if refurbishment, structural alteration or demolition is to be carried out in this area. Re-inspect every 12 months or earlier if disturbed or removed in accordance with the Victorian OH&S Regulation 2017.</p> <p>All remedial/removal repairs require a Clearance Inspection & Certificate to be recorded by an approved and competent assessor.</p>

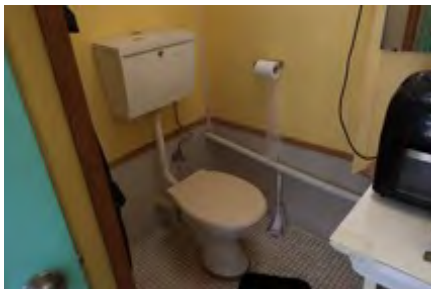
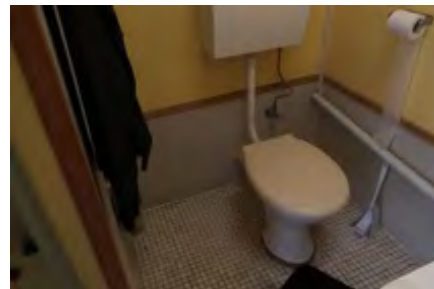
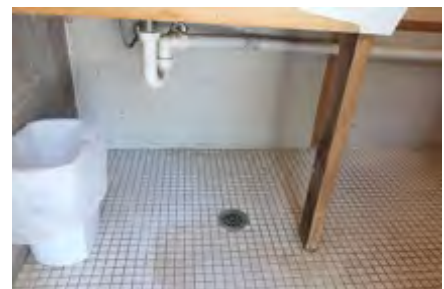
Ensuites 5-8: Ensuite 7 2. The Walls and Ceiling (F C Sheeting) has Asbestos Containing Material (ACM) present.

RISK ASSESSMENT					
Type of Asbestos or Hazardous Material	Chrysotile	Condition	AVERAGE	Likelihood of Damage	L (Low) – possible
	Same as Sample - 62126-006	Activity	Moderate		
		Sealed	No	Friability	Bonded (non-friable)
		Labelled	Y	Exposure Risk	Medium - Moderate risk
		Quantity

Raw Material

RISK CONTROL					
Priority	HIGH	Label Required	Yes	Re- Audit Date	16 Feb 2022
Action	Remedial repairs required - seal raw material / edges				
Recommendation	Raw material sheeting - The area requires immediate remedial repairs. It is recommended the asbestos material be sealed with an approved membrane.				
Legislative Requirements Victorian Regulation 2007	Damaged ACM visible in area. Requires IMMEDIATE ATTENTION. WARNING labels should be affixed. Avoid mechanical damage and abrasion. Remove if refurbishment, structural alteration or demolition is to be carried out in this area. Re-inspect every 12 months or earlier if disturbed or removed in accordance with the Victorian OH&S Regulation 2017. All remedial/removal repairs require a Clearance Inspection & Certificate to be recorded by an approved and competent assessor.

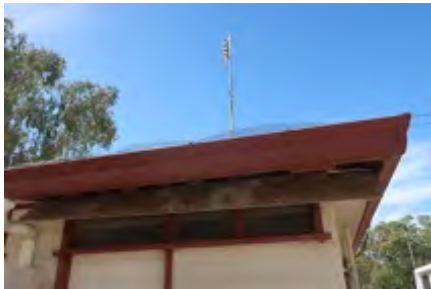
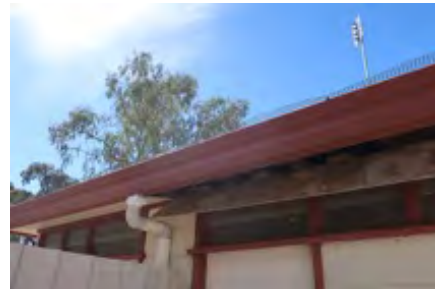
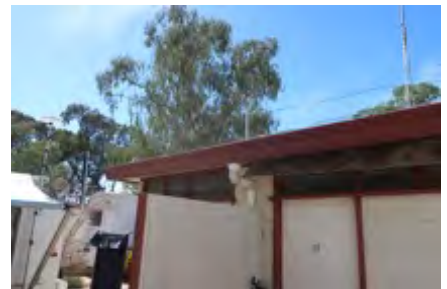
Area 4**Ensuites 9-12: entire perimeter of building. The Soffit (F C Sheeting) has Asbestos Containing Material (ACM) present.****RISK ASSESSMENT**

Type of Asbestos or Hazardous Material	Chrysotile	Condition	POOR	Likelihood of Damage	L (Low) – possible
	Sample taken 62126-005	Activity	Moderate		
		Sealed	Yes	Friability	Exposed Fibres
		Labelled	Y	Exposure Risk	Medium - Moderate risk
		Quantity

Loose sheeting

Priority	HIGH	Label Required	Yes	Re- Audit Date	16 Feb 2022
Action	Remedial repairs required - seal exposed edges or replace or laminate over damaged material				
Recommendation	Damaged material - The damaged area requires immediate remedial repairs. It is recommended the asbestos sheeting be replaced.				
Legislative Requirements Victorian Regulation 2007	Damaged ACM visible in area. Requires IMMEDIATE ATTENTION. WARNING labels should be affixed. Avoid mechanical damage and abrasion. Remove if refurbishment, structural alteration or demolition is to be carried out in this area. Re-inspect every 12 months or earlier if disturbed or removed in accordance with the Victorian OH&S Regulation 2017. All remedial/removal repairs require a Clearance Inspection & Certificate to be recorded by an approved and competent assessor.
