Asbestos Report

YARRIAMBIACK SHIRE COUNCIL

PROPERTY ADDRESS:
LB15 HISTORICAL CENTRE
81 SCOTT STREET
WARRACKNABEAL VIC 3393

INSPECTION DATE: 16 FEBRUARY 2021
REFERENCE NUMBER: 62128

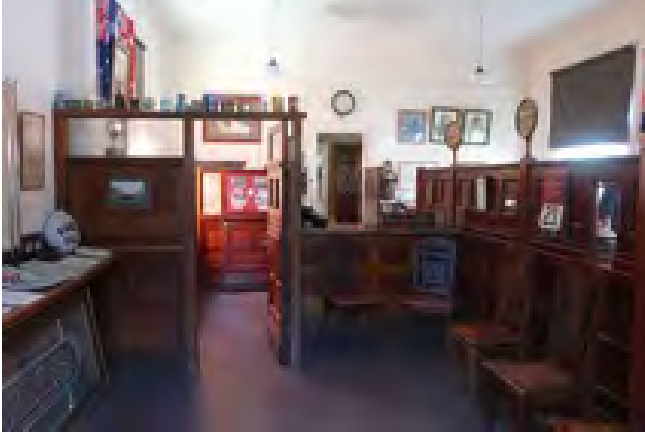
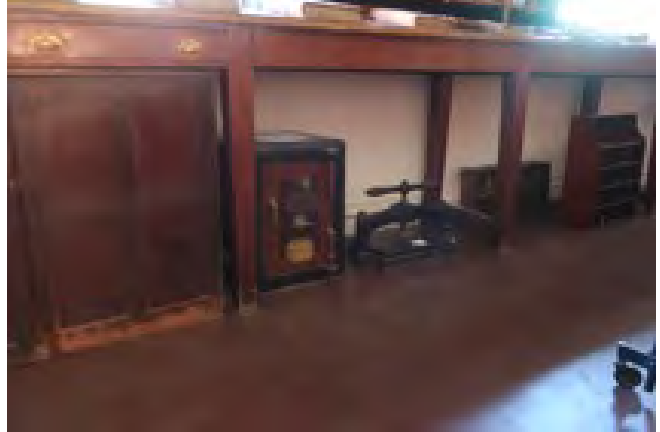
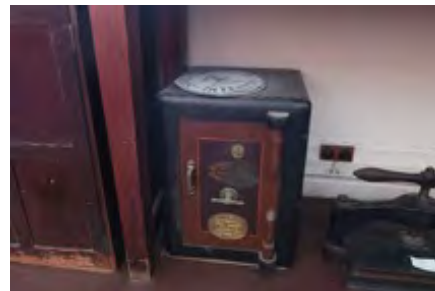
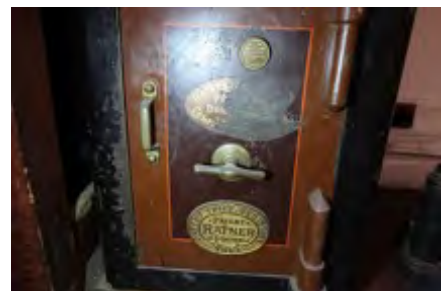
Area 5**LB15 Historical Centre: Ground Floor Banking room 1. The Safe (Walls & Doors) (Fire Retardant core) has Asbestos Containing Material (ACM) present.****RISK ASSESSMENT**

Type of Asbestos or Hazardous Material	No sample taken - Visual ID	Condition	GOOD	Likelihood of Damage	L (Low) – possible
		Activity	Moderate		
		Sealed	Yes	Friability	Bonded (non-friable)
		Labelled	Y	Exposure Risk	Low - Negligible or low risk
		Quantity

Maintain seals

Priority	MEDIUM	Label Required	Yes	Re- Audit Date	16 Feb 2022
Action	No remedial action required, unless disturbed				
Recommendation	Maintain paint or sealant to ACM surfaces. Particular attention should be given to side edges, ensure paint/sealant covers ALL exposed ACM surfaces.				
Legislative Requirements Victorian Regulation 2007	Warning labels should be affixed. Avoid mechanical damage and abrasion. Remove if refurbishment, structural alteration or demolition is to be carried out in this area. Re-inspect every 12 months or earlier if disturbed or removed in accordance with the Victorian OH&S Regulation 2017. All remedial/removal repairs require a Clearance Inspection & Certificate to be recorded by an approved and competent assessor.

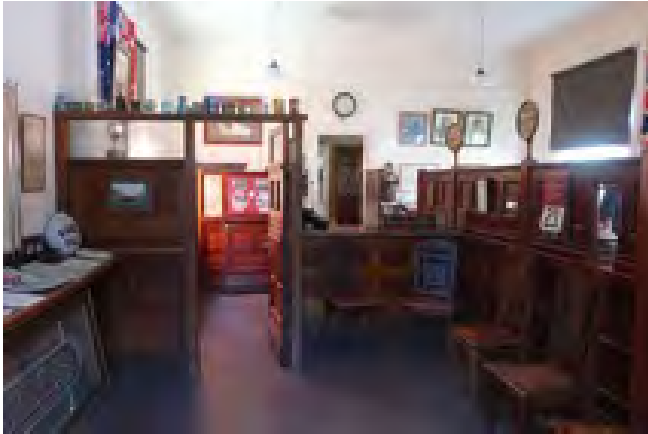
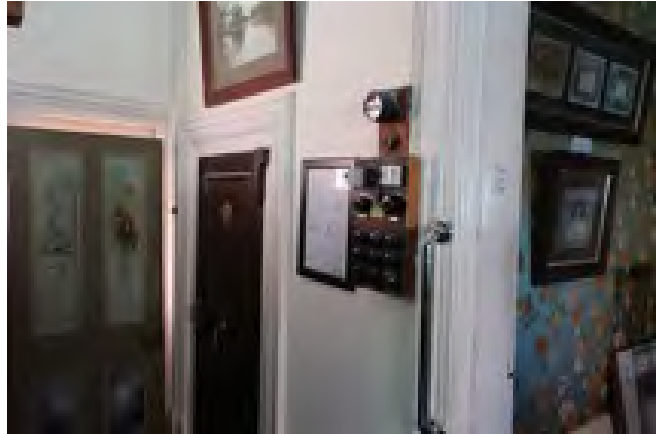
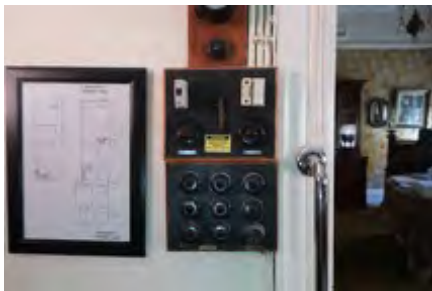
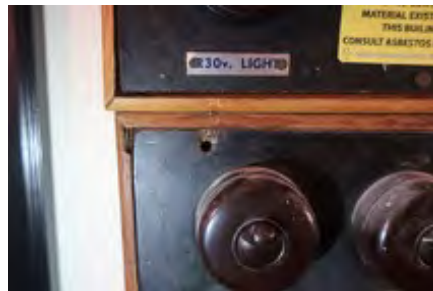
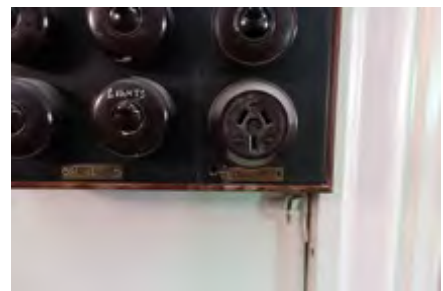
LB15 Historical Centre: Ground Floor Banking room 1. The Electrical board x2 (Backing Board (Zelemite)) has Asbestos Containing Material (ACM) present.

RISK ASSESSMENT					
Type of Asbestos or Hazardous Material	Chrysotile	Condition	AVERAGE	Likelihood of Damage	L (Low) – possible
	Sample taken 62128-001	Activity	Moderate	Friability	Exposed Fibres
		Sealed	Yes	Exposure Risk	Medium - Moderate risk
		Labelled	Y		
		Quantity

Penetration Holes

Penetration Holes - The exposed edges require approved sealant. It is further recommended the gaps be filled with sealant.

Priority	HIGH	Label Required	Yes	Re- Audit Date	16 Feb 2022
Action	Remedial repairs required - seal raw material / edges				
Recommendation	Penetration Holes - The exposed edges require approved sealant. It is further recommended the gaps be filled with sealant.				
Legislative Requirements Victorian Regulation 2007	Damaged ACM visible in area. Requires IMMEDIATE ATTENTION. WARNING labels should be affixed. Avoid mechanical damage and abrasion. Remove if refurbishment, structural alteration or demolition is to be carried out in this area. Re-inspect every 12 months or earlier if disturbed or removed in accordance with the Victorian OH&S Regulation 2017. All remedial/removal repairs require a Clearance Inspection & Certificate to be recorded by an approved and competent assessor.

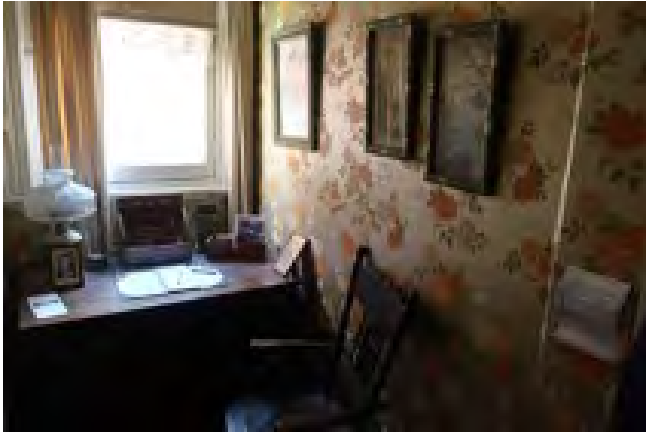
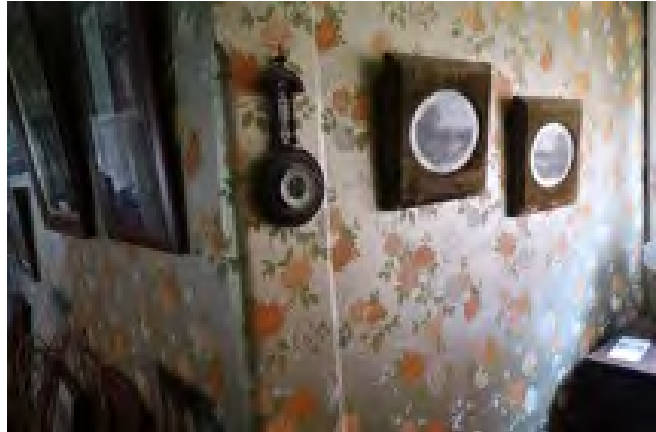
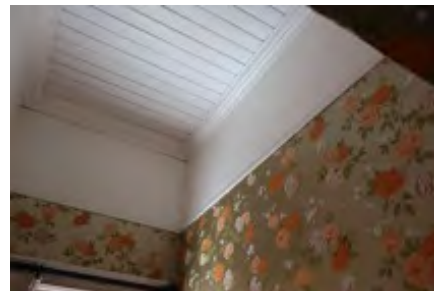
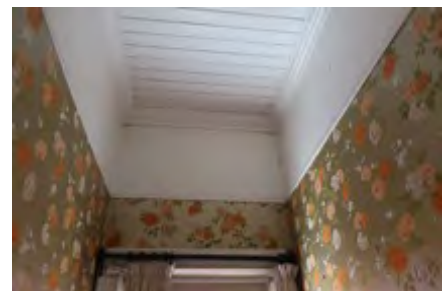
Type of Asbestos or Hazardous Material	No sample taken - Visual ID	Condition	GOOD	Likelihood of Damage	L (Low) – possible
		Activity	Moderate		
		Sealed	Yes	Friability	Bonded (non-friable)
		Labelled	Y	Exposure Risk	Low - Negligible or low risk
		Quantity

Maintain paint or sealant

Priority	MEDIUM	Label Required	Yes	Re- Audit Date	16 Feb 2022
Action	No remedial action required, unless disturbed				
Recommendation	Maintain paint or sealant to ACM surfaces. Particular attention should be given to side edges, ensure paint/sealant covers ALL exposed ACM surfaces.				
Legislative Requirements Victorian Regulation 2007	Warning labels should be affixed. Avoid mechanical damage and abrasion. Remove if refurbishment, structural alteration or demolition is to be carried out in this area. Re-inspect every 12 months or earlier if disturbed or removed in accordance with the Victorian OH&S Regulation 2017. All remedial/removal repairs require a Clearance Inspection & Certificate to be recorded by an approved and competent assessor.

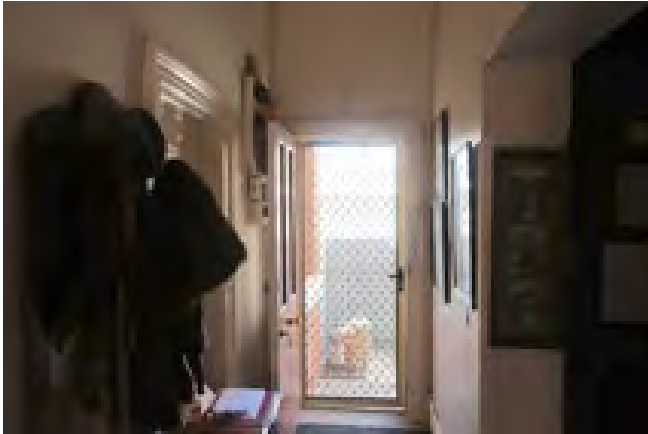
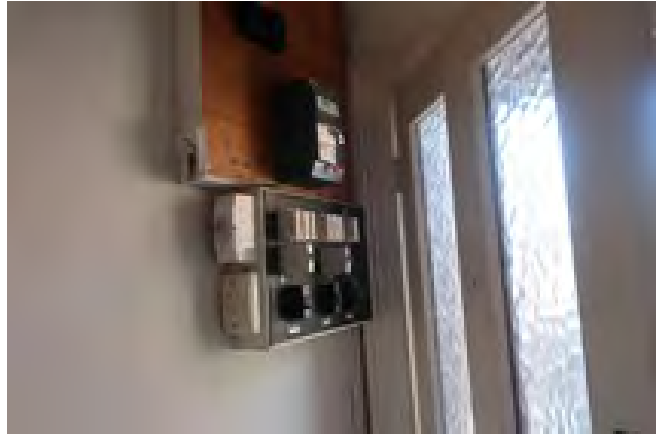
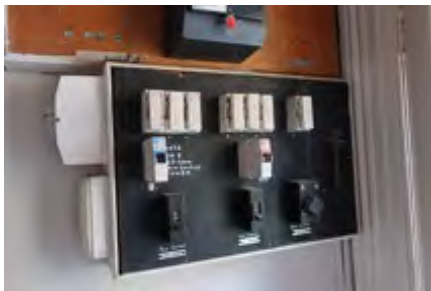
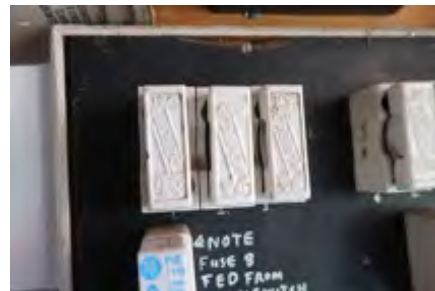
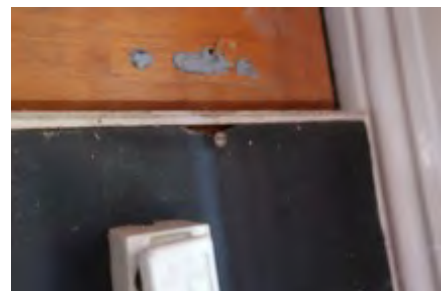
LB15 Historical Centre: Ground Floor Side entry hallway 6. The Electrical board (Backing Board (Zelemite)) has Asbestos Containing Material (ACM) present.

RISK ASSESSMENT					
Type of Asbestos or Hazardous Material	Chrysotile	Condition	AVERAGE	Likelihood of Damage	L (Low) – possible
	Same as Sample - 62128 -001	Activity	Moderate		
		Sealed	Yes	Friability	Exposed Fibres
		Labelled	Y	Exposure Risk	Medium - Moderate risk
		Quantity

Broken sections

Broken sections - The damaged area requires immediate remedial repairs. It is recommended the asbestos sheeting be replaced (preferred) or edges sealed with approved sealant and then the area be concealed by laminating (sheeting).

RISK CONTROL					
Priority	HIGH	Label Required	Yes	Re- Audit Date	16 Feb 2022
Action	Remedial repairs required - seal exposed edges or replace or laminate over damaged material				
Recommendation	Broken sections - The damaged area requires immediate remedial repairs. It is recommended the asbestos sheeting be replaced (preferred) or edges sealed with approved sealant and then the area be concealed by laminating (sheeting).				
Legislative Requirements Victorian Regulation 2007	Damaged ACM visible in area. Requires IMMEDIATE ATTENTION. WARNING labels should be affixed. Avoid mechanical damage and abrasion. Remove if refurbishment, structural alteration or demolition is to be carried out in this area. Re-inspect every 12 months or earlier if disturbed or removed in accordance with the Victorian OH&S Regulation 2017. All remedial/removal repairs require a Clearance Inspection & Certificate to be recorded by an approved and competent assessor.

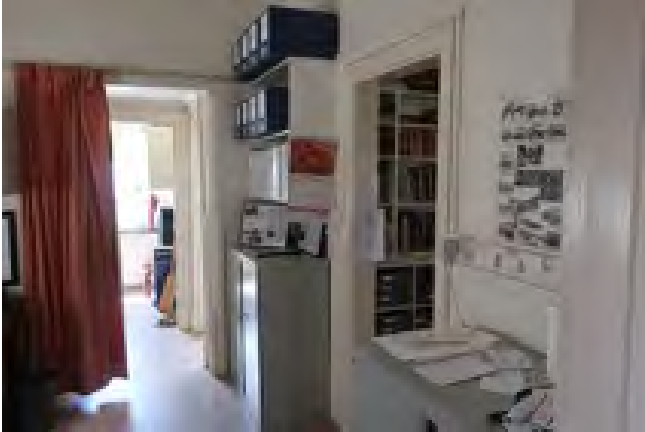
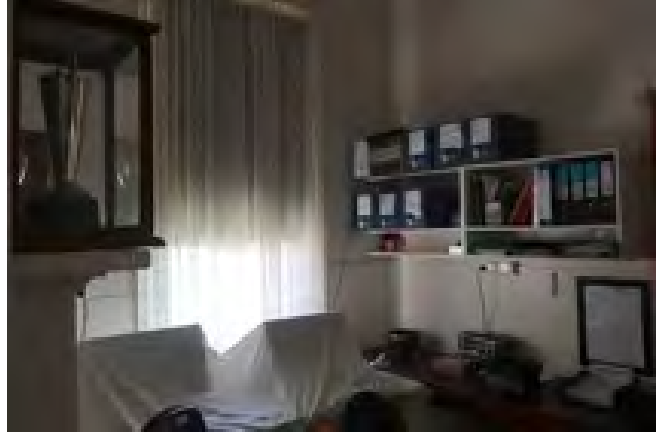
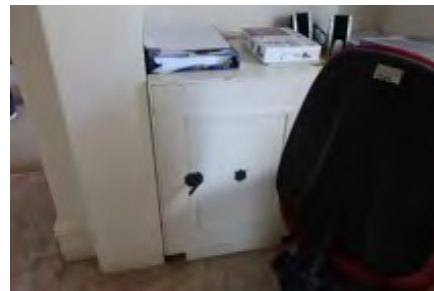
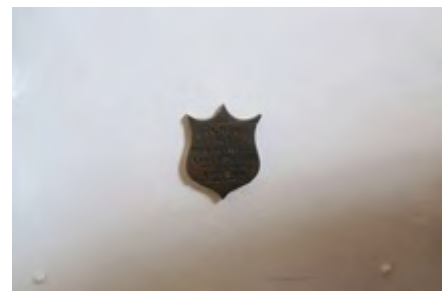
Area 7**LB15 Historical Centre: Ground Floor Office 8. The Safe (Walls & Doors) (Fire Retardant core) has Asbestos Containing Material (ACM) present.****RISK ASSESSMENT**

Type of Asbestos or Hazardous Material	No sample taken - Visual ID	Condition	GOOD	Likelihood of Damage	L (Low) – possible
		Activity	Moderate		
		Sealed	Yes	Friability	Bonded (non-friable)
		Labelled	Y	Exposure Risk	Low - Negligible or low risk
		Quantity

Maintain seals

Priority	MEDIUM	Label Required	Yes	Re- Audit Date	16 Feb 2022
Action	No remedial action required, unless disturbed				
Recommendation	Maintain paint or sealant to ACM surfaces. Particular attention should be given to side edges, ensure paint/sealant covers ALL exposed ACM surfaces.				
Legislative Requirements Victorian Regulation 2007	Warning labels should be affixed. Avoid mechanical damage and abrasion. Remove if refurbishment, structural alteration or demolition is to be carried out in this area. Re-inspect every 12 months or earlier if disturbed or removed in accordance with the Victorian OH&S Regulation 2017. All remedial/removal repairs require a Clearance Inspection & Certificate to be recorded by an approved and competent assessor.

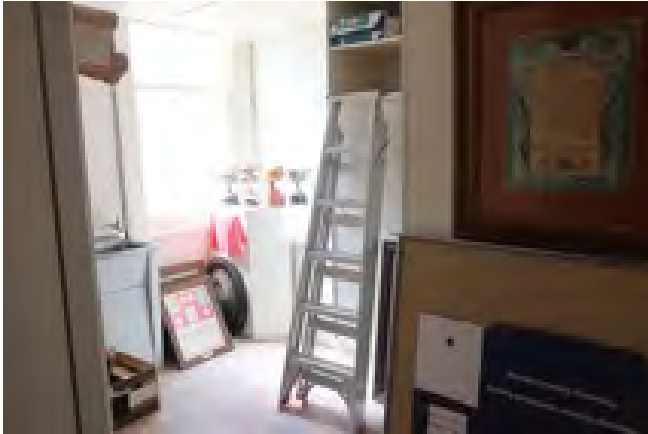
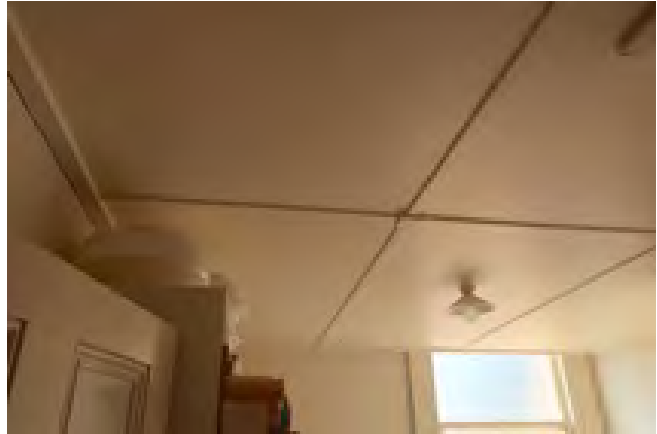
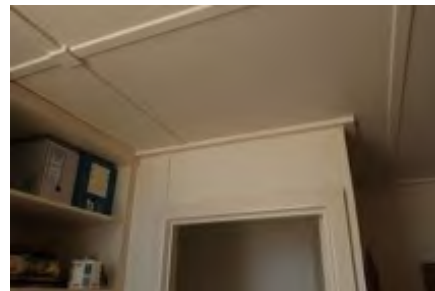
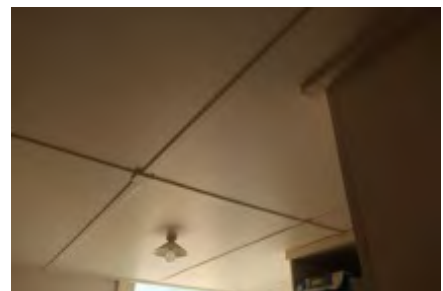
LB15 Historical Centre: Ground Floor Old laundry/ storage 12. The Ceiling (F C Sheeting) has Asbestos Containing Material (ACM) present.

RISK ASSESSMENT					
Type of Asbestos or Hazardous Material	No sample taken - Visual ID	Condition	GOOD	Likelihood of Damage	L (Low) – possible
		Activity	Moderate		
		Sealed	Yes	Friability	Bonded (non-friable)
		Labelled	Y	Exposure Risk	Low - Negligible or low risk
		Quantity

Maintain paint or sealant

RISK CONTROL					
Priority	MEDIUM	Label Required	Yes	Re- Audit Date	16 Feb 2022
Action	No remedial action required, unless disturbed				
Recommendation	Maintain paint or sealant to ACM surfaces. Particular attention should be given to side edges, ensure paint/sealant covers ALL exposed ACM surfaces.				
Legislative Requirements Victorian Regulation 2007	Warning labels should be affixed. Avoid mechanical damage and abrasion. Remove if refurbishment, structural alteration or demolition is to be carried out in this area. Re-inspect every 12 months or earlier if disturbed or removed in accordance with the Victorian OH&S Regulation 2017. All remedial/removal repairs require a Clearance Inspection & Certificate to be recorded by an approved and competent assessor.

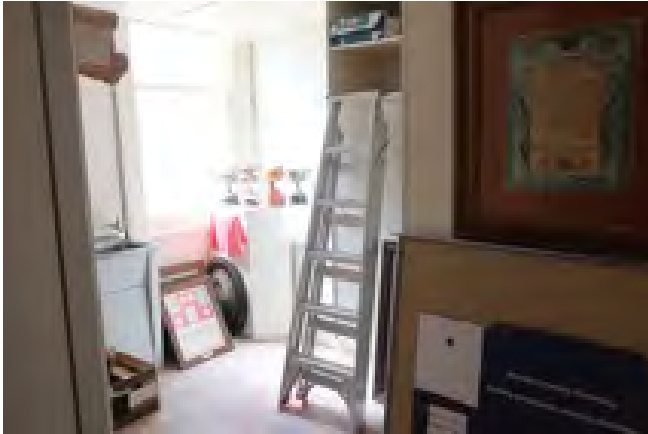
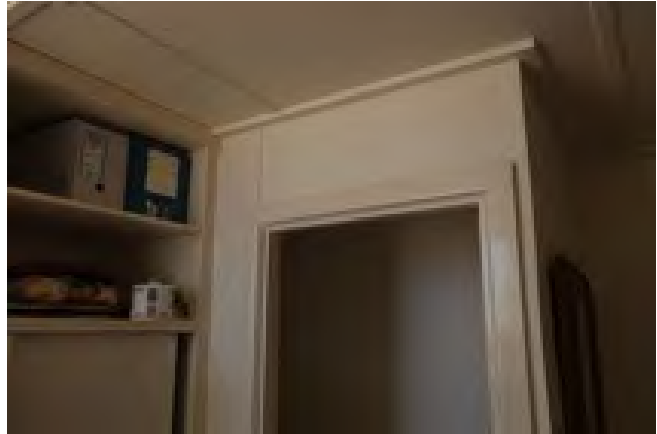
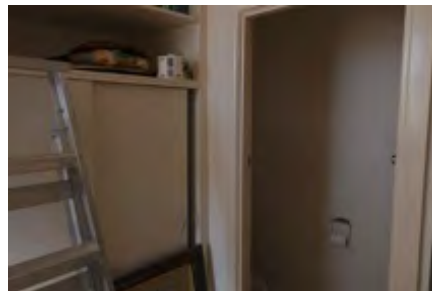
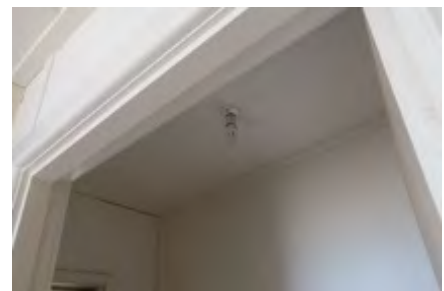
LB15 Historical Centre: Ground Floor Old laundry/ storage 12. The Toilet door surround (F C Sheeting) has Asbestos Containing Material (ACM) present.

RISK ASSESSMENT					
Type of Asbestos or Hazardous Material	No sample taken - Visual ID	Condition	GOOD	Likelihood of Damage	L (Low) – possible
		Activity	Moderate		
		Sealed	Yes	Friability	Bonded (non-friable)
		Labelled	Y	Exposure Risk	Low - Negligible or low risk
		Quantity

Maintain paint or sealant

RISK CONTROL					
Priority	MEDIUM	Label Required	Yes	Re- Audit Date	16 Feb 2022
Action	No remedial action required, unless disturbed				
Recommendation	Maintain paint or sealant to ACM surfaces. Particular attention should be given to side edges, ensure paint/sealant covers ALL exposed ACM surfaces.				
Legislative Requirements Victorian Regulation 2007	Warning labels should be affixed. Avoid mechanical damage and abrasion. Remove if refurbishment, structural alteration or demolition is to be carried out in this area. Re-inspect every 12 months or earlier if disturbed or removed in accordance with the Victorian OH&S Regulation 2017. All remedial/removal repairs require a Clearance Inspection & Certificate to be recorded by an approved and competent assessor.

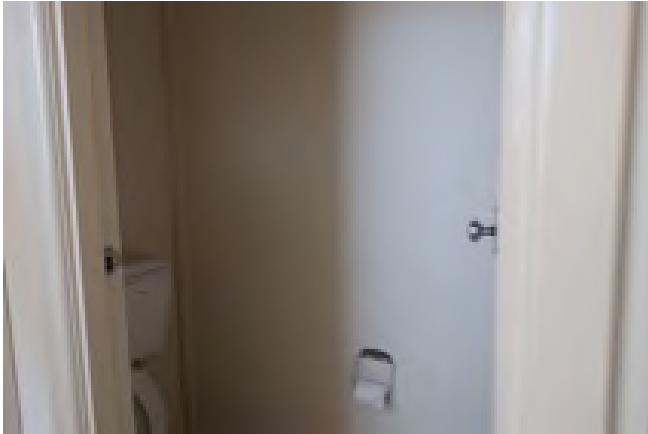
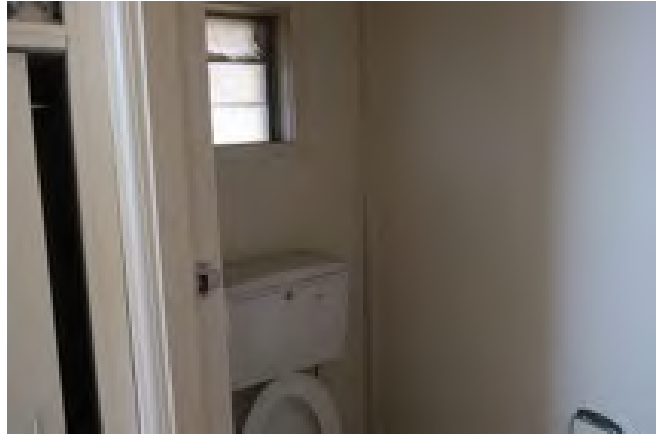
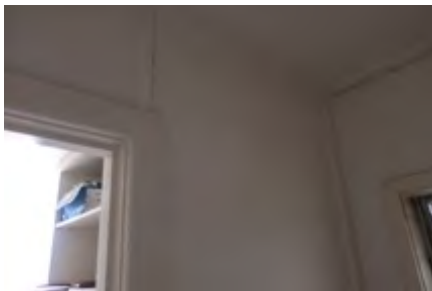
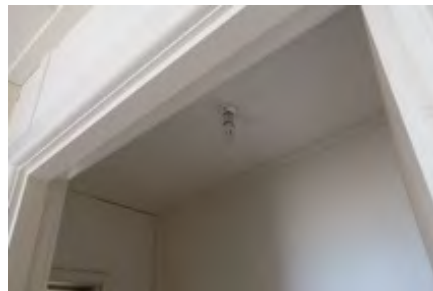
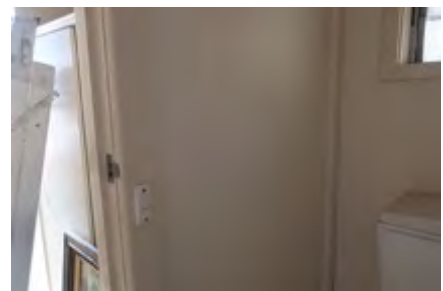
LB15 Historical Centre: Ground Floor Toilet 12.1. The Walls and Ceiling (F C Sheeting) has Asbestos Containing Material (ACM) present.

RISK ASSESSMENT					
Type of Asbestos or Hazardous Material	No sample taken - Visual ID	Condition	GOOD	Likelihood of Damage	L (Low) – possible
		Activity	Moderate		
		Sealed	Yes	Friability	Bonded (non-friable)
		Labelled	Y	Exposure Risk	Low - Negligible or low risk
		Quantity

Maintain paint or sealant

Priority	MEDIUM	Label Required	Yes	Re- Audit Date	16 Feb 2022
Action	No remedial action required, unless disturbed				
Recommendation	Maintain paint or sealant to ACM surfaces. Particular attention should be given to side edges, ensure paint/sealant covers ALL exposed ACM surfaces.				
Legislative Requirements Victorian Regulation 2007	Warning labels should be affixed. Avoid mechanical damage and abrasion. Remove if refurbishment, structural alteration or demolition is to be carried out in this area. Re-inspect every 12 months or earlier if disturbed or removed in accordance with the Victorian OH&S Regulation 2017. All remedial/removal repairs require a Clearance Inspection & Certificate to be recorded by an approved and competent assessor.

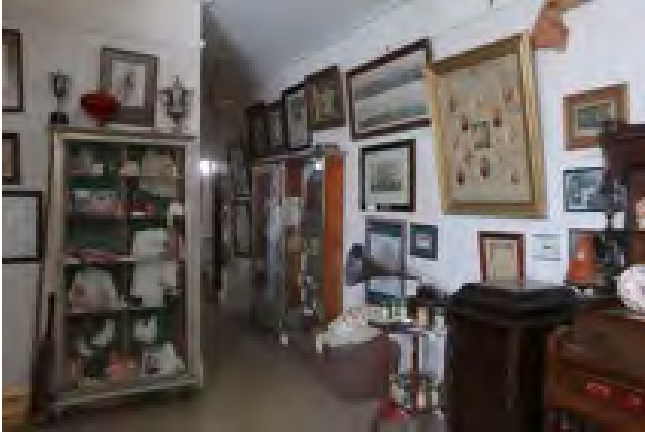
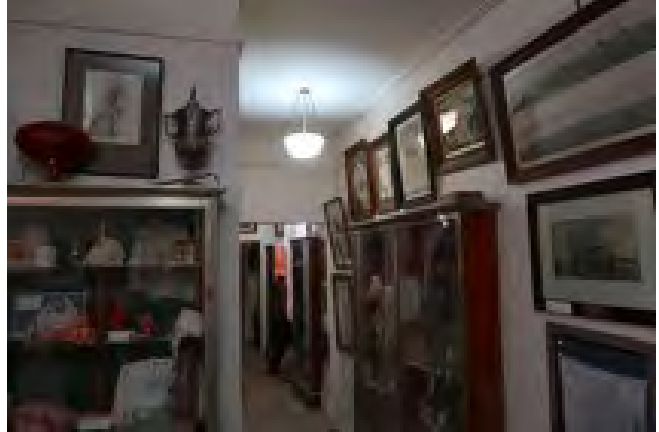
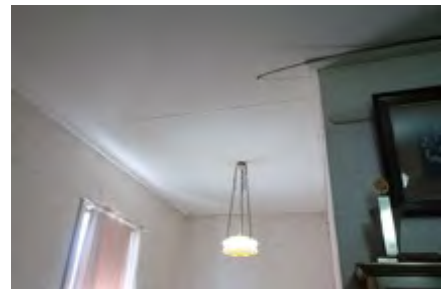
Area 13**LB15 Historical Centre: Level 1 Landing & Hallway. The Ceiling (F C Sheeting) has Asbestos Containing Material (ACM) present.****RISK ASSESSMENT**

Type of Asbestos or Hazardous Material	Chrysotile	Condition	GOOD	Likelihood of Damage	L (Low) – possible
	Sample taken 62128-003	Activity	Moderate		
		Sealed	Yes	Friability	Bonded (non-friable)
		Labelled	Y	Exposure Risk	Low - Negligible or low risk
		Quantity

Maintain paint or sealant

Priority	MEDIUM	Label Required	Yes	Re- Audit Date	16 Feb 2022
Action	No remedial action required, unless disturbed				
Recommendation	Maintain paint or sealant to ACM surfaces. Particular attention should be given to side edges, ensure paint/sealant covers ALL exposed ACM surfaces.				
Legislative Requirements Victorian Regulation 2007	Warning labels should be affixed. Avoid mechanical damage and abrasion. Remove if refurbishment, structural alteration or demolition is to be carried out in this area. Re-inspect every 12 months or earlier if disturbed or removed in accordance with the Victorian OH&S Regulation 2017. All remedial/removal repairs require a Clearance Inspection & Certificate to be recorded by an approved and competent assessor.

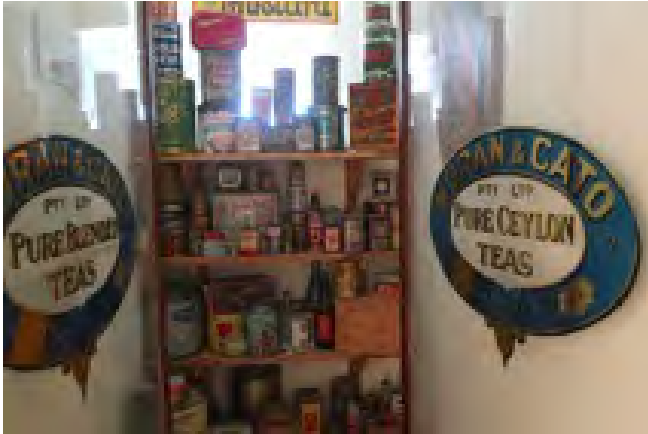
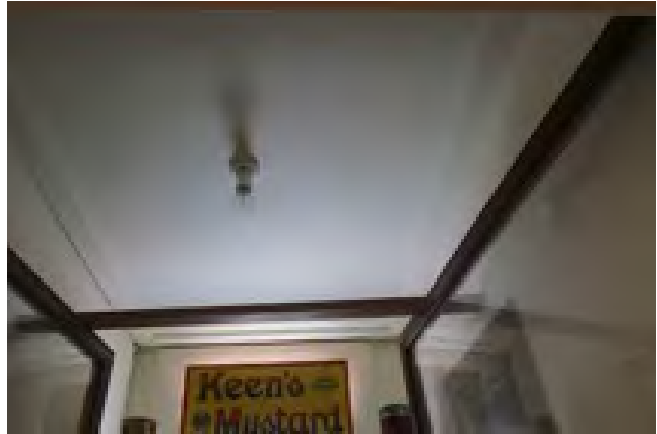
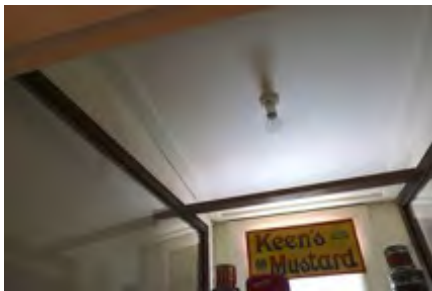
LB15 Historical Centre: Level 1 Show room 14. The Ceiling (F C Sheeting) has Asbestos Containing Material (ACM) present.

RISK ASSESSMENT					
Type of Asbestos or Hazardous Material	Chrysotile	Condition	GOOD	Likelihood of Damage	L (Low) – possible
	Same as Sample - 62128 -003	Activity	Moderate		
		Sealed	Yes	Friability	Bonded (non-friable)
		Labelled	Y	Exposure Risk	Low - Negligible or low risk
		Quantity

Maintain paint or sealant

RISK CONTROL					
Priority	MEDIUM	Label Required	Yes	Re- Audit Date	16 Feb 2022
Action	No remedial action required, unless disturbed				
Recommendation	Maintain paint or sealant to ACM surfaces. Particular attention should be given to side edges, ensure paint/sealant covers ALL exposed ACM surfaces.				
Legislative Requirements Victorian Regulation 2007	Warning labels should be affixed. Avoid mechanical damage and abrasion. Remove if refurbishment, structural alteration or demolition is to be carried out in this area. Re-inspect every 12 months or earlier if disturbed or removed in accordance with the Victorian OH&S Regulation 2017. All remedial/removal repairs require a Clearance Inspection & Certificate to be recorded by an approved and competent assessor.

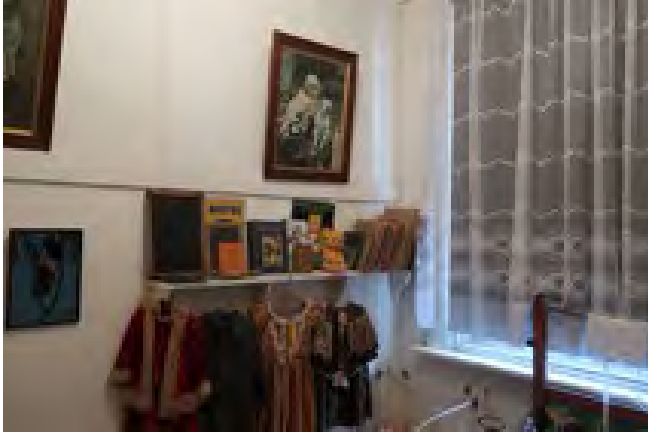
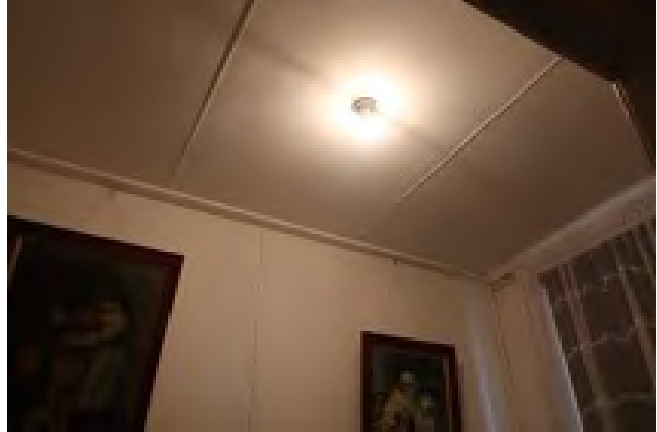
LB15 Historical Centre: Level 1 Bedroom 15. The Ceiling (F C Sheeting) has Asbestos Containing Material (ACM) present.

RISK ASSESSMENT					
Type of Asbestos or Hazardous Material	Chrysotile	Condition	GOOD	Likelihood of Damage	L (Low) – possible
	Same as Sample - 62128 -003	Activity	Moderate		
		Sealed	Yes	Friability	Bonded (non-friable)
		Labelled	Y	Exposure Risk	Low - Negligible or low risk
		Quantity

Maintain paint or sealant

RISK CONTROL					
Priority	MEDIUM	Label Required	Yes	Re- Audit Date	16 Feb 2022
Action	No remedial action required, unless disturbed				
Recommendation	Maintain paint or sealant to ACM surfaces. Particular attention should be given to side edges, ensure paint/sealant covers ALL exposed ACM surfaces.				
Legislative Requirements Victorian Regulation 2007	Warning labels should be affixed. Avoid mechanical damage and abrasion. Remove if refurbishment, structural alteration or demolition is to be carried out in this area. Re-inspect every 12 months or earlier if disturbed or removed in accordance with the Victorian OH&S Regulation 2017. All remedial/removal repairs require a Clearance Inspection & Certificate to be recorded by an approved and competent assessor.

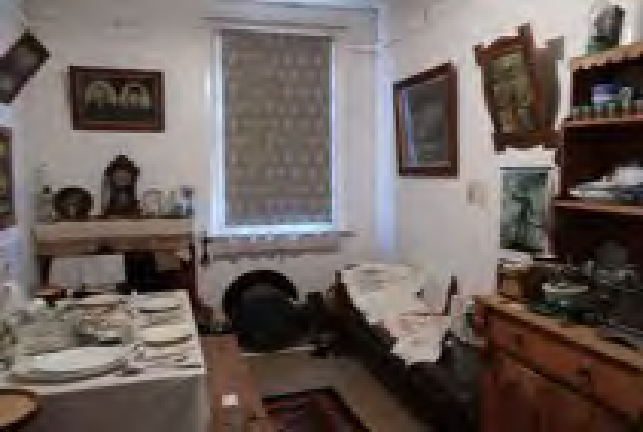
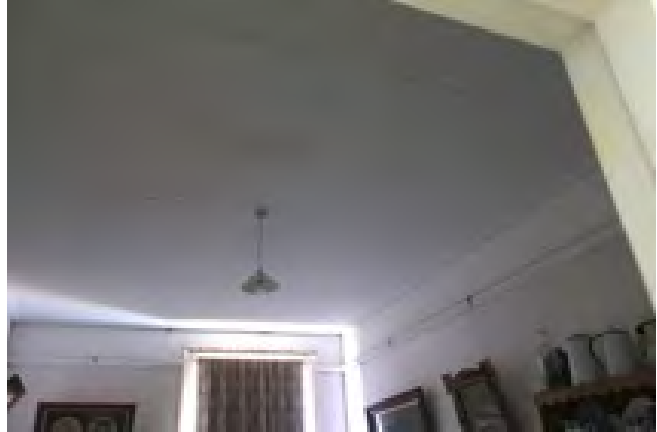
Area 14**LB15 Historical Centre: Level 1 Office 16. The Ceiling (F C Sheeting) has Asbestos Containing Material (ACM) present.****RISK ASSESSMENT**

Type of Asbestos or Hazardous Material	Chrysotile	Condition	GOOD	Likelihood of Damage	L (Low) – possible
	Same as Sample - 62128-003	Activity	Moderate		
		Sealed	Yes	Friability	Bonded (non-friable)
		Labelled	Y	Exposure Risk	Low - Negligible or low risk
		Quantity

Priority	MEDIUM	Label Required	Yes	Re- Audit Date	16 Feb 2022
Action	No remedial action required, unless disturbed				
Recommendation	No				
Legislative Requirements Victorian Regulation 2007	Warning labels should be affixed. Avoid mechanical damage and abrasion. Remove if refurbishment, structural alteration or demolition is to be carried out in this area. Re-inspect every 12 months or earlier if disturbed or removed in accordance with the Victorian OH&S Regulation 2017. All remedial/removal repairs require a Clearance Inspection & Certificate to be recorded by an approved and competent assessor.

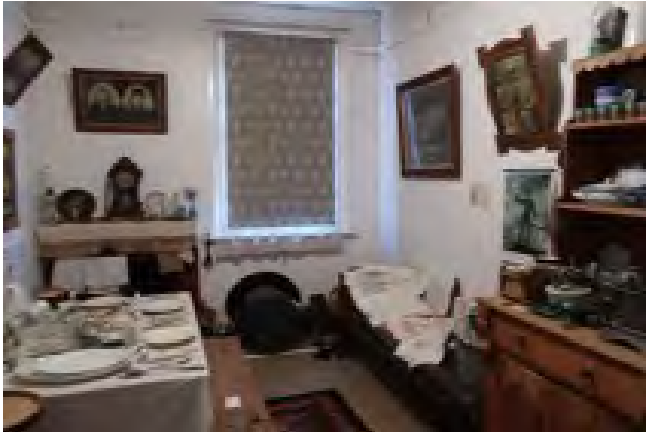
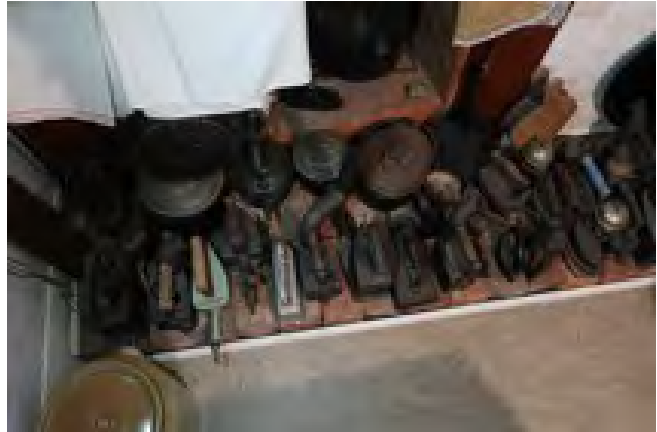
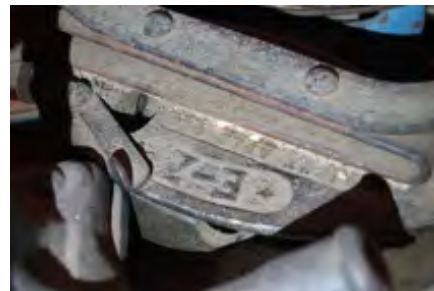
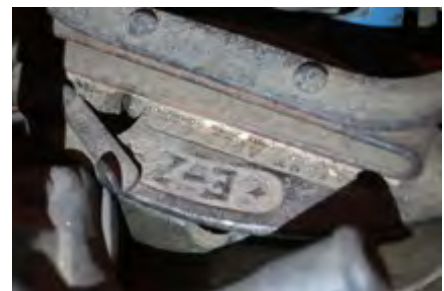
LB15 Historical Centre: Level 1 Office 16. The Iron - Gasket (Compound Material) has Asbestos Containing Material (ACM) present.

RISK ASSESSMENT					
Type of Asbestos or Hazardous Material	Chrysotile	Condition	AVERAGE	Likelihood of Damage	L (Low) – possible
	Sample taken 62128-004	Activity	Moderate	Friability	Bonded (non-friable)
		Sealed	No	Exposure Risk	Medium - Moderate risk
		Labelled	No		
		Quantity

Not in-situ

Raw material sheeting - The area requires immediate remedial repairs. It is recommended the asbestos material be removed or sealed with an approved membrane.

Priority	IMMEDIATE	Label Required	Yes	Re- Audit Date	16 Feb 2022
Action	Remedial repairs required - seal raw material / edges				
Recommendation	Raw material sheeting - The area requires immediate remedial repairs. It is recommended the asbestos material be removed or sealed with an approved membrane.				
Legislative Requirements Victorian Regulation 2007	Damaged ACM visible in area. Requires IMMEDIATE ATTENTION. WARNING labels should be affixed. Avoid mechanical damage and abrasion. Remove if refurbishment, structural alteration or demolition is to be carried out in this area. Re-inspect every 12 months or earlier if disturbed or removed in accordance with the Victorian OH&S Regulation 2017. All remedial/removal repairs require a Clearance Inspection & Certificate to be recorded by an approved and competent assessor.

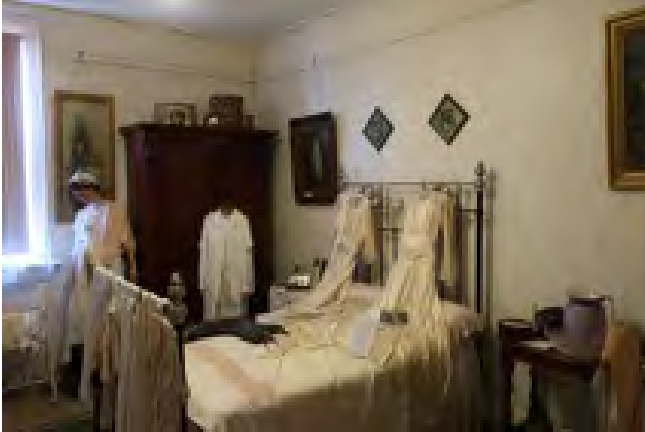
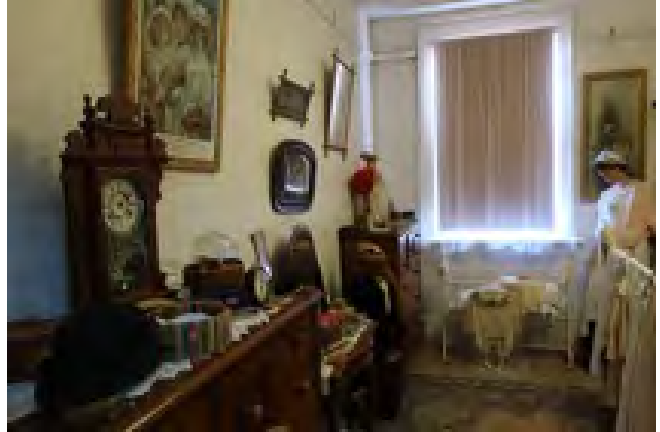
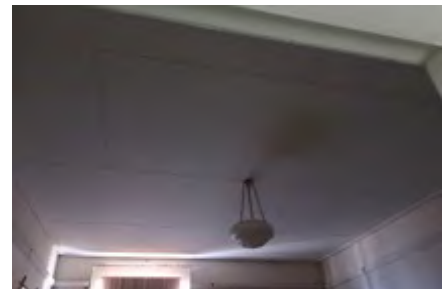
Area 12**LB15 Historical Centre: Level 1 Bedroom 17. The Ceiling (F C Sheeting) has Asbestos Containing Material (ACM) present.****RISK ASSESSMENT**

Type of Asbestos or Hazardous Material	Chrysotile	Condition	GOOD	Likelihood of Damage	L (Low) – possible
	Same as Sample - 62128-003	Activity	Moderate		
		Sealed	Yes	Friability	Bonded (non-friable)
		Labelled	Y	Exposure Risk	Low - Negligible or low risk
		Quantity

Maintain paint or sealant

Priority	MEDIUM	Label Required	Yes	Re- Audit Date	16 Feb 2022
Action	No remedial action required, unless disturbed				
Recommendation	Maintain paint or sealant to ACM surfaces. Particular attention should be given to side edges, ensure paint/sealant covers ALL exposed ACM surfaces.				
Legislative Requirements Victorian Regulation 2007	Warning labels should be affixed. Avoid mechanical damage and abrasion. Remove if refurbishment, structural alteration or demolition is to be carried out in this area. Re-inspect every 12 months or earlier if disturbed or removed in accordance with the Victorian OH&S Regulation 2017. All remedial/removal repairs require a Clearance Inspection & Certificate to be recorded by an approved and competent assessor.

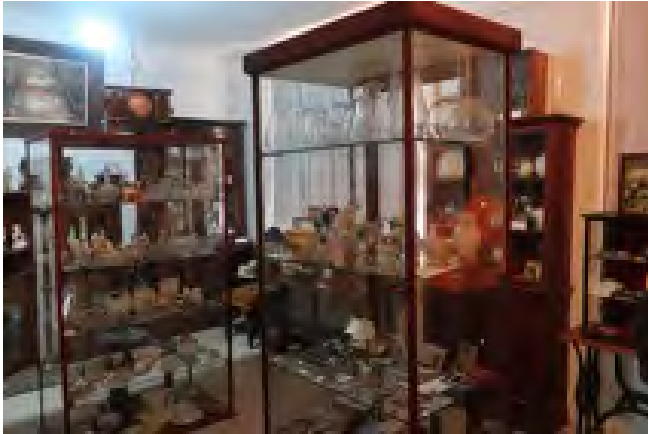
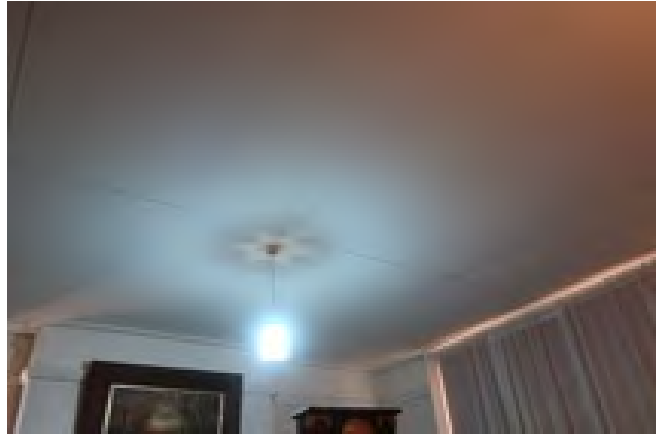
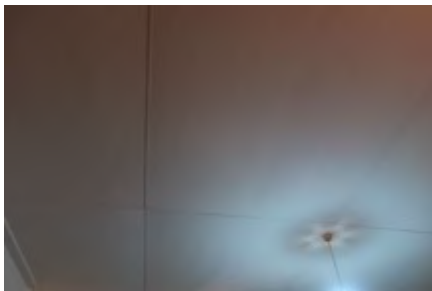
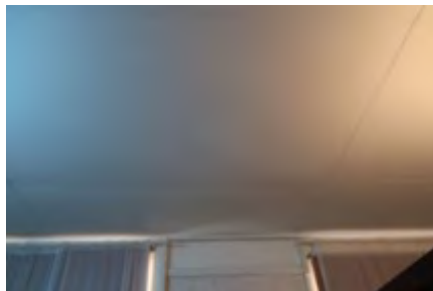
LB15 Historical Centre: Level 1 Show room 18. The Ceiling (F C Sheeting) has Asbestos Containing Material (ACM) present.

RISK ASSESSMENT					
Type of Asbestos or Hazardous Material	Chrysotile	Condition	GOOD	Likelihood of Damage	L (Low) – possible
	Same as Sample - 62128 -003	Activity	Moderate		
		Sealed	Yes	Friability	Bonded (non-friable)
		Labelled	Y	Exposure Risk	Low - Negligible or low risk
		Quantity

Maintain paint or sealant

Priority	MEDIUM	Label Required	Yes	Re- Audit Date	16 Feb 2022
Action	No remedial action required, unless disturbed				
Recommendation	Maintain paint or sealant to ACM surfaces. Particular attention should be given to side edges, ensure paint/sealant covers ALL exposed ACM surfaces.				
Legislative Requirements Victorian Regulation 2007	Warning labels should be affixed. Avoid mechanical damage and abrasion. Remove if refurbishment, structural alteration or demolition is to be carried out in this area. Re-inspect every 12 months or earlier if disturbed or removed in accordance with the Victorian OH&S Regulation 2017. All remedial/removal repairs require a Clearance Inspection & Certificate to be recorded by an approved and competent assessor.
