**Global  
Asbestos  
Audits**

# Asbestos Report

YARRIAMBIACK SHIRE COUNCIL

PROPERTY ADDRESS:  
LR14 LEISURE COMPLEX  
33 ANDERSON STREET  
WARRACKNABEAL VIC 3393

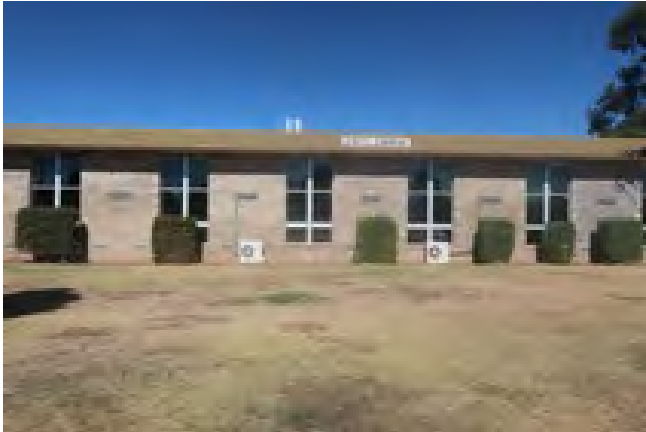
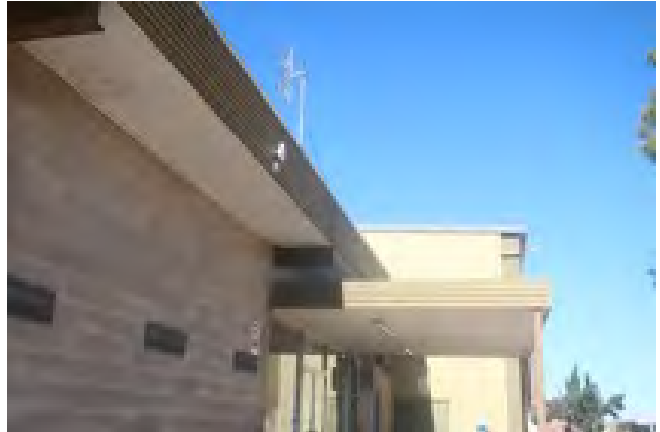
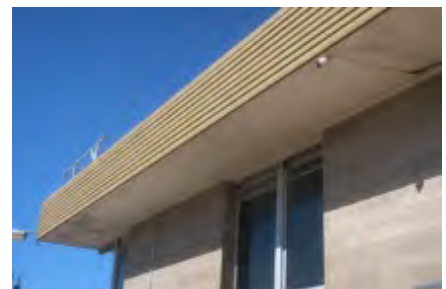
**Area 5****LR14 Leisure Complex: front, left & right side of building. The Soffit (F C Sheeting) has Asbestos Containing Material (ACM) present.****RISK ASSESSMENT**

<b>Type of Asbestos or Hazardous Material</b>	Chrysotile	<b>Condition</b>	GOOD	<b>Likelihood of Damage</b>	L (Low) – possible
	Sample taken 62130-006	<b>Activity</b>	Moderate		
		<b>Sealed</b>	Yes	<b>Friability</b>	Bonded (non-friable)
		<b>Labelled</b>	Y	<b>Exposure Risk</b>	Low - Negligible or low risk
		<b>Quantity</b>

<b>Priority</b>	MEDIUM	<b>Label Required</b>	Yes	<b>Re- Audit Date</b>	16 Feb 2022
<b>Action</b>	No remedial action required, unless disturbed				
<b>Recommendation</b>	Maintain paint or sealant to ACM surfaces. Particular attention should be given to side edges, ensure paint/sealant covers ALL exposed ACM surfaces.				
<b>Legislative Requirements Victorian Regulation 2007</b>	Warning labels should be affixed. Avoid mechanical damage and abrasion. Remove if refurbishment, structural alteration or demolition is to be carried out in this area. Re-inspect every 12 months or earlier if disturbed or removed in accordance with the Victorian OH&S Regulation 2017. <b>All remedial/removal repairs require a Clearance Inspection &amp; Certificate to be recorded by an approved and competent assessor.</b>

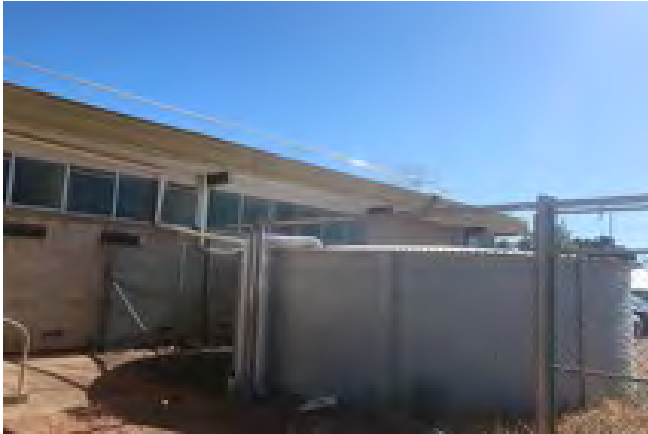
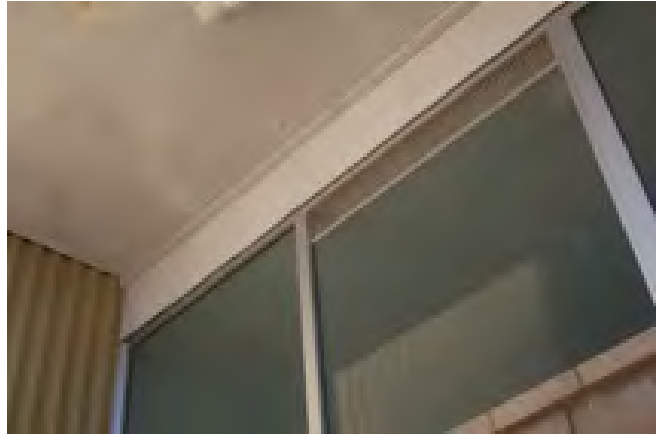
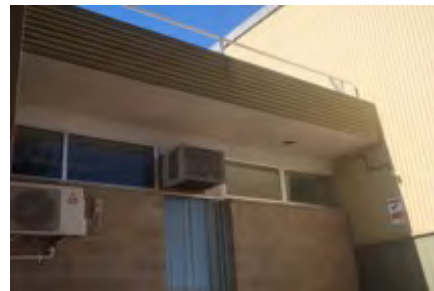
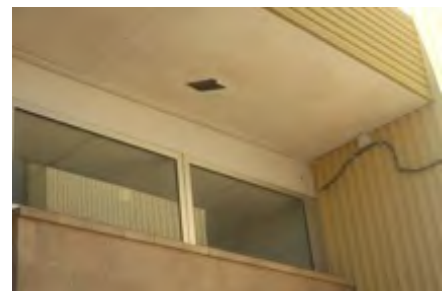
**LR14 Leisure Complex: left & right side of building. The Infill panel/s above windows (F C Sheeting) has Asbestos Containing Material (ACM) present.**

RISK ASSESSMENT					
Type of Asbestos or Hazardous Material	No sample taken - Visual ID	Condition	GOOD	Likelihood of Damage	L (Low) – possible
		Activity	Moderate		
		Sealed	Yes	Friability	Bonded (non-friable)
		Labelled	Y	Exposure Risk	Low - Negligible or low risk
		Quantity

Priority	MEDIUM	Label Required	Yes	Re- Audit Date	16 Feb 2022
Action	No remedial action required, unless disturbed				
Recommendation	Maintain paint or sealant to ACM surfaces. Particular attention should be given to side edges, ensure paint/sealant covers ALL exposed ACM surfaces.				
Legislative Requirements Victorian Regulation 2007	Warning labels should be affixed. Avoid mechanical damage and abrasion. Remove if refurbishment, structural alteration or demolition is to be carried out in this area. Re-inspect every 12 months or earlier if disturbed or removed in accordance with the Victorian OH&S Regulation 2017. <b>All remedial/removal repairs require a Clearance Inspection &amp; Certificate to be recorded by an approved and competent assessor.</b>

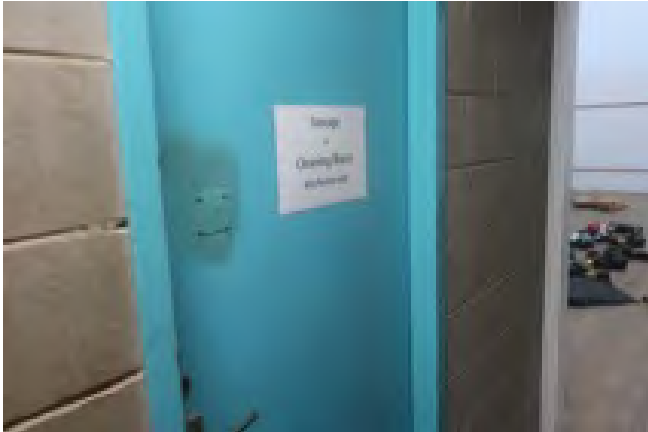
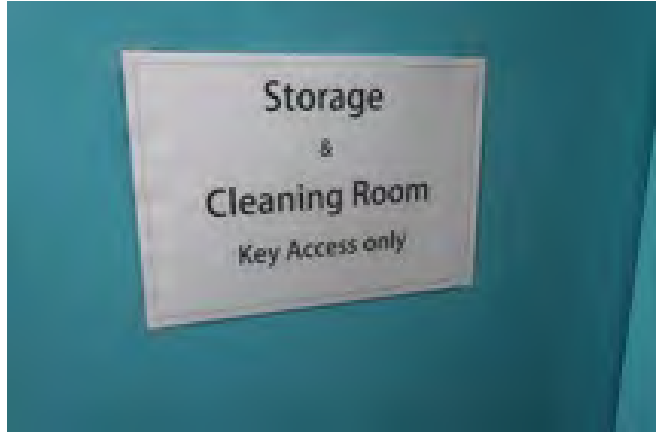
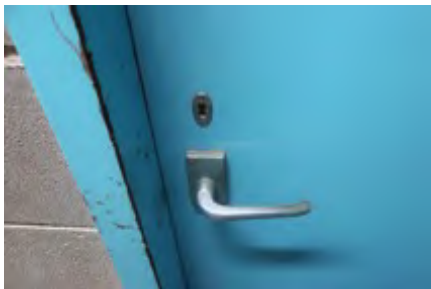
**LR14 Leisure Complex: 11.1. Until the area is inspected, it should be managed as if it Asbestos Containing Material (ACM) is present.**

RISK ASSESSMENT					
Type of Asbestos or Hazardous Material	No sample taken - No Access	Condition		Likelihood of Damage	
		Activity			
		Sealed		Friability	
		Labelled	No	Exposure Risk	
		Quantity

RISK CONTROL					
Priority	HIGH	Label Required	Yes	Re- Audit Date	16 Feb 2022
Action					
Recommendation					
Legislative Requirements Victorian Regulation 2007	Unable to Gain Access. Assume asbestos in area and provide monitoring if work undertaken in these areas. If access is made available, contact Global Asbestos Audits for re-inspection

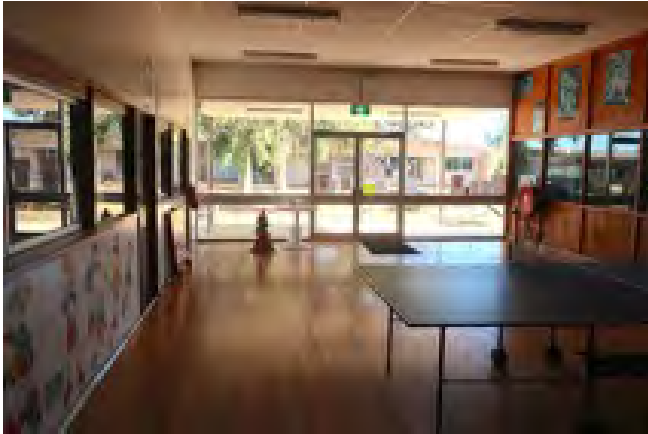
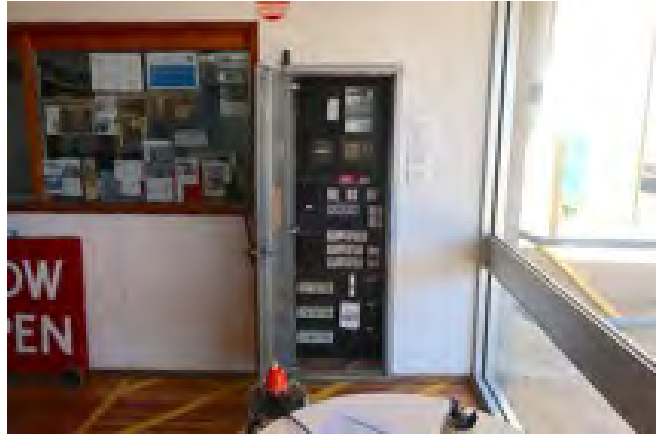
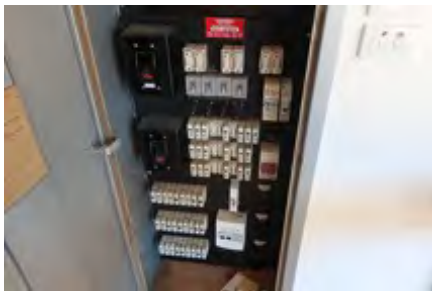
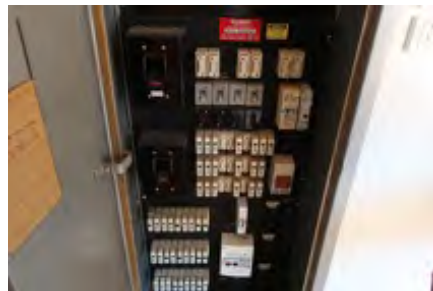
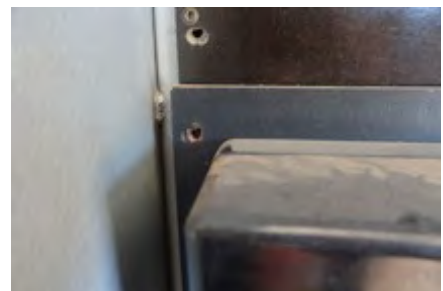
Type of Asbestos or Hazardous Material	No sample taken - Visual ID	Condition	AVERAGE	Likelihood of Damage	L (Low) – possible
		Activity	Moderate		
		Sealed	Yes	Friability	Exposed Fibres
		Labelled	Y	Exposure Risk	Medium - Moderate risk
		Quantity

Penetration Holes

Priority	HIGH	Label Required	Yes	Re- Audit Date	16 Feb 2022
Action	Remedial repairs required - seal raw material / edges				
Recommendation	Penetration Holes - The exposed edges require approved sealant. It is further recommended the gaps be filled with sealant. Do not remove fuses without asbestos controls - test when access is available.				
Legislative Requirements Victorian Regulation 2007	Damaged ACM visible in area. Requires IMMEDIATE ATTENTION. WARNING labels should be affixed. Avoid mechanical damage and abrasion. Remove if refurbishment, structural alteration or demolition is to be carried out in this area. Re-inspect every 12 months or earlier if disturbed or removed in accordance with the Victorian OH&S Regulation 2017. <b>All remedial/removal repairs require a Clearance Inspection &amp; Certificate to be recorded by an approved and competent assessor.</b>

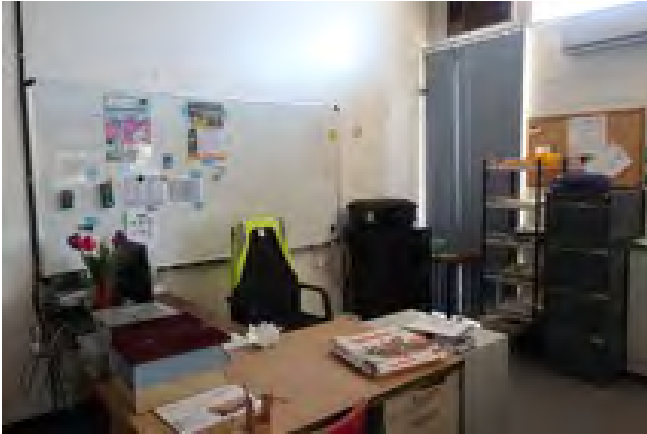
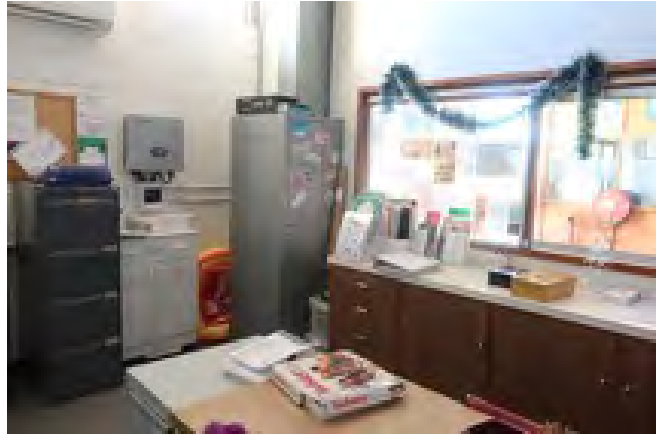
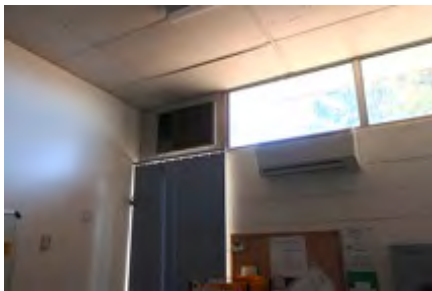
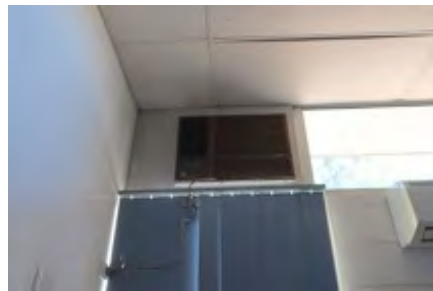
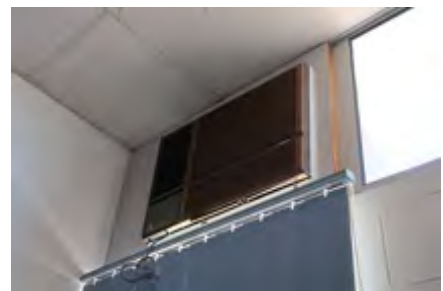
**LR14 Leisure Complex: Ground Floor Office 3. The Infill panel - air conditioning surround (F C Sheeting) has Asbestos Containing Material (ACM) present.**

RISK ASSESSMENT					
Type of Asbestos or Hazardous Material	No sample taken - Visual ID	Condition	AVERAGE	Likelihood of Damage	L (Low) – possible
		Activity	Moderate		
		Sealed	No	Friability	Bonded (non-friable)
		Labelled	Y	Exposure Risk	Medium - Moderate risk
		Quantity

Raw Material

Raw material sheeting - The area requires immediate remedial repairs. It is recommended the asbestos material be sealed with an approved membrane.

RISK CONTROL					
Priority	HIGH	Label Required	Yes	Re- Audit Date	16 Feb 2022
Action	Remedial repairs required - seal raw material / edges				
Recommendation	Raw material sheeting - The area requires immediate remedial repairs. It is recommended the asbestos material be sealed with an approved membrane.				
Legislative Requirements Victorian Regulation 2007	Damaged ACM visible in area. Requires IMMEDIATE ATTENTION. WARNING labels should be affixed. Avoid mechanical damage and abrasion. Remove if refurbishment, structural alteration or demolition is to be carried out in this area. Re-inspect every 12 months or earlier if disturbed or removed in accordance with the Victorian OH&S Regulation 2017. <b>All remedial/removal repairs require a Clearance Inspection &amp; Certificate to be recorded by an approved and competent assessor.</b>

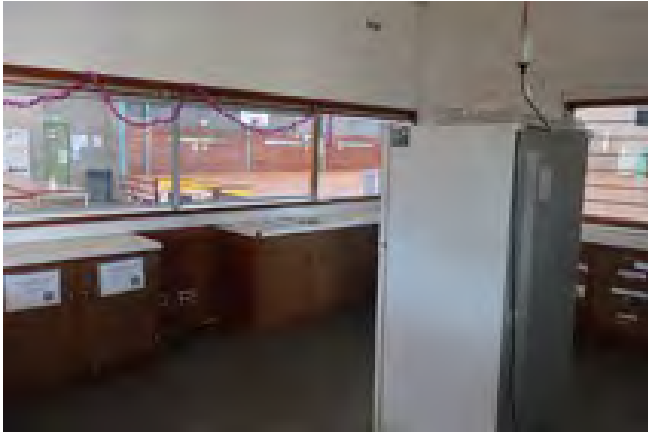
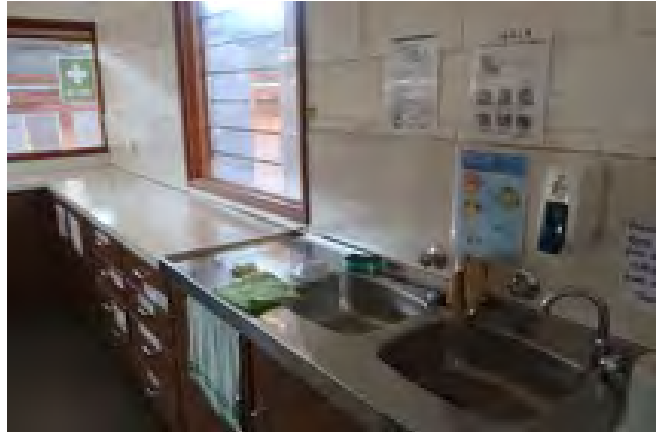
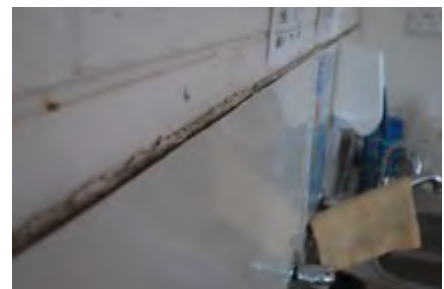
**LR14 Leisure Complex: Ground Floor Office - kitchenette 4. The Splash back (concealed) (F C Sheeting) has Asbestos Containing Material (ACM) present.**

RISK ASSESSMENT					
Type of Asbestos or Hazardous Material	Chrysotile	Condition	GOOD	Likelihood of Damage	L (Low) – possible
	Sample taken 62130-001	Activity	Moderate		
		Sealed	Yes	Friability	Bonded (non-friable)
		Labelled	Y	Exposure Risk	Low - Negligible or low risk
		Quantity

RISK CONTROL					
Priority	MEDIUM	Label Required	Yes	Re- Audit Date	16 Feb 2022
Action	No remedial action required, unless disturbed				
Recommendation	Maintain paint or sealant to ACM surfaces. Particular attention should be given to side edges, ensure paint/sealant covers ALL exposed ACM surfaces.				
Legislative Requirements Victorian Regulation 2007	Warning labels should be affixed. Avoid mechanical damage and abrasion. Remove if refurbishment, structural alteration or demolition is to be carried out in this area. Re-inspect every 12 months or earlier if disturbed or removed in accordance with the Victorian OH&S Regulation 2017. <b>All remedial/removal repairs require a Clearance Inspection &amp; Certificate to be recorded by an approved and competent assessor.</b>

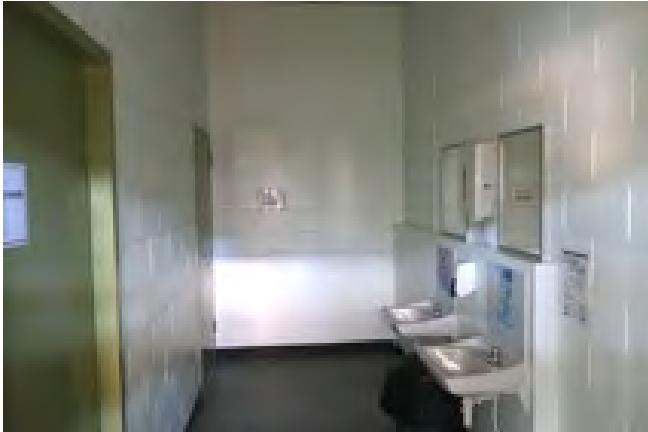
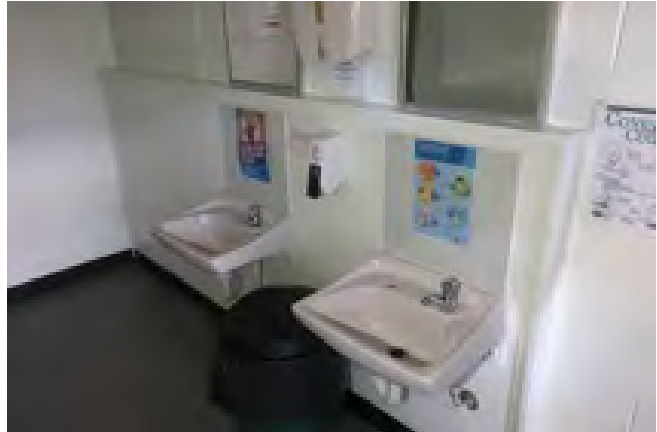
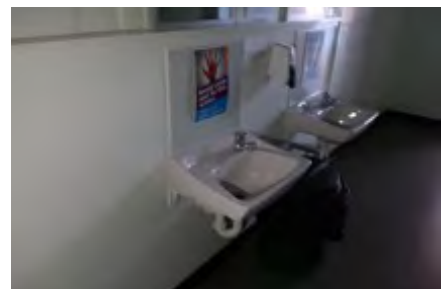
**LR14 Leisure Complex: Ground Floor Female bathroom - entry 5. The Splash back (F C Sheeting) has Asbestos Containing Material (ACM) present.**

RISK ASSESSMENT					
Type of Asbestos or Hazardous Material	No sample taken - Visual ID	Condition	GOOD	Likelihood of Damage	L (Low) – possible
		Activity	Moderate		
		Sealed	Yes	Friability	Bonded (non-friable)
		Labelled	Y	Exposure Risk	Low - Negligible or low risk
		Quantity

RISK CONTROL					
Priority	MEDIUM	Label Required	Yes	Re- Audit Date	16 Feb 2022
Action	No remedial action required, unless disturbed				
Recommendation	Maintain paint or sealant to ACM surfaces. Particular attention should be given to side edges, ensure paint/sealant covers ALL exposed ACM surfaces.				
Legislative Requirements Victorian Regulation 2007	Warning labels should be affixed. Avoid mechanical damage and abrasion. Remove if refurbishment, structural alteration or demolition is to be carried out in this area. Re-inspect every 12 months or earlier if disturbed or removed in accordance with the Victorian OH&S Regulation 2017. <b>All remedial/removal repairs require a Clearance Inspection &amp; Certificate to be recorded by an approved and competent assessor.</b>

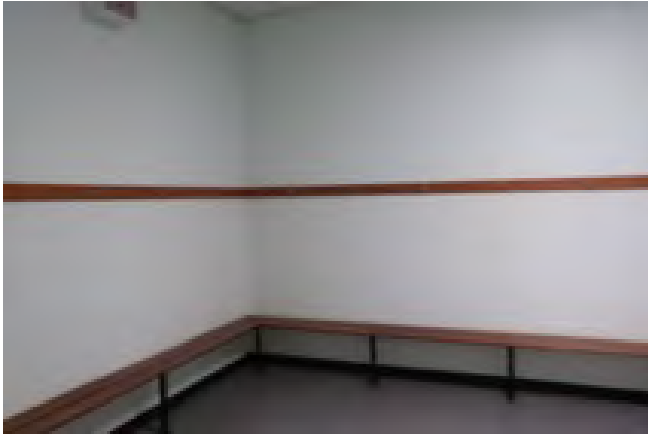
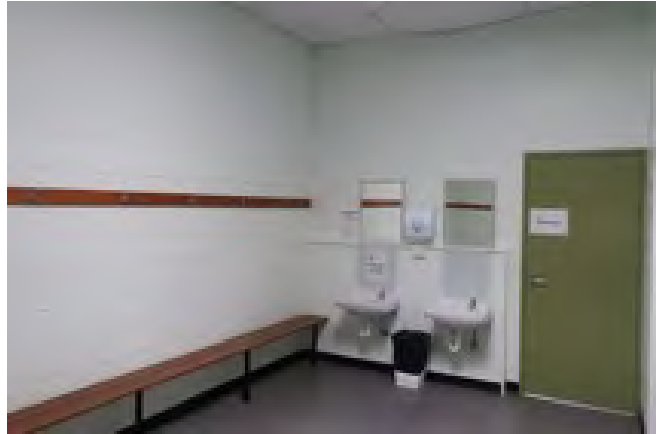
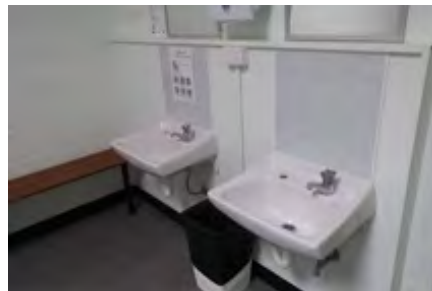
**LR14 Leisure Complex: Ground Floor Female changeroom 5.1. The Splash back (F C Sheeting) has Asbestos Containing Material (ACM) present.**

RISK ASSESSMENT					
Type of Asbestos or Hazardous Material	No sample taken - Visual ID	Condition	GOOD	Likelihood of Damage	L (Low) – possible
		Activity	Moderate		
		Sealed	Yes	Friability	Bonded (non-friable)
		Labelled	Y	Exposure Risk	Low - Negligible or low risk
		Quantity

RISK CONTROL					
Priority	MEDIUM	Label Required	Yes	Re- Audit Date	16 Feb 2022
Action	No remedial action required, unless disturbed				
Recommendation	Maintain paint or sealant to ACM surfaces. Particular attention should be given to side edges, ensure paint/sealant covers ALL exposed ACM surfaces.				
Legislative Requirements Victorian Regulation 2007	Warning labels should be affixed. Avoid mechanical damage and abrasion. Remove if refurbishment, structural alteration or demolition is to be carried out in this area. Re-inspect every 12 months or earlier if disturbed or removed in accordance with the Victorian OH&S Regulation 2017. <b>All remedial/removal repairs require a Clearance Inspection &amp; Certificate to be recorded by an approved and competent assessor.</b>

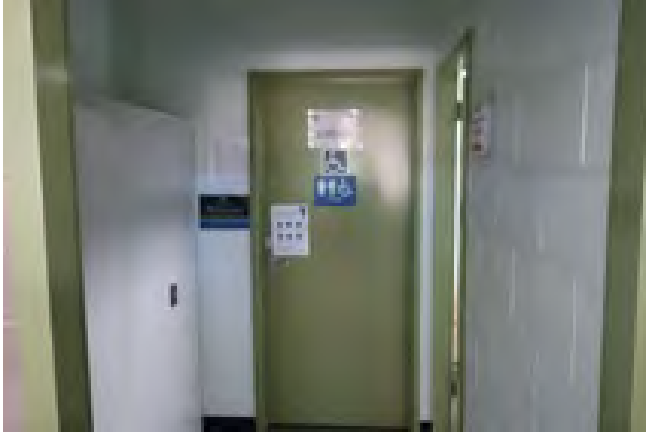
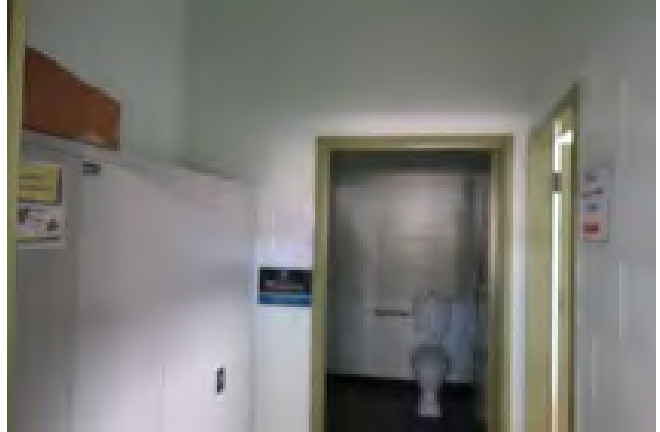
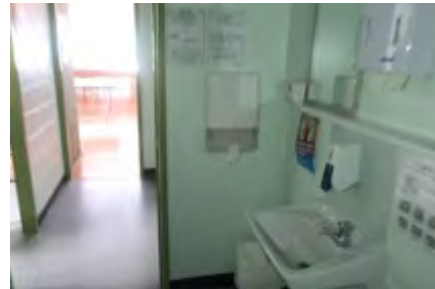
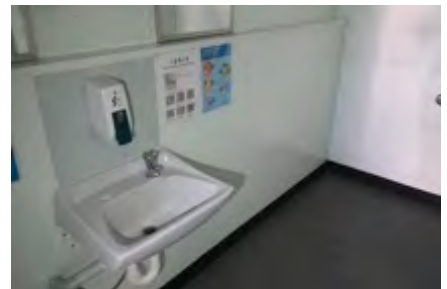
**Area 15****LR14 Leisure Complex: Ground Floor Walkway & Disabled bathroom 6 & 7. The Dividing wall (F C Sheeting) has Asbestos Containing Material (ACM) present.****RISK ASSESSMENT**

<b>Type of Asbestos or Hazardous Material</b>	No sample taken - Visual ID	<b>Condition</b>	GOOD	<b>Likelihood of Damage</b>	L (Low) – possible
		<b>Activity</b>	Moderate		
		<b>Sealed</b>	Yes	<b>Friability</b>	Bonded (non-friable)
		<b>Labelled</b>	Y	<b>Exposure Risk</b>	Low - Negligible or low risk
		<b>Quantity</b>

<b>Priority</b>	MEDIUM	<b>Label Required</b>	Yes	<b>Re- Audit Date</b>	16 Feb 2022
<b>Action</b>	No remedial action required, unless disturbed				
<b>Recommendation</b>	Maintain paint or sealant to ACM surfaces. Particular attention should be given to side edges, ensure paint/sealant covers ALL exposed ACM surfaces.				
<b>Legislative Requirements Victorian Regulation 2007</b>	Warning labels should be affixed. Avoid mechanical damage and abrasion. Remove if refurbishment, structural alteration or demolition is to be carried out in this area. Re-inspect every 12 months or earlier if disturbed or removed in accordance with the Victorian OH&S Regulation 2017. <b>All remedial/removal repairs require a Clearance Inspection &amp; Certificate to be recorded by an approved and competent assessor.</b>

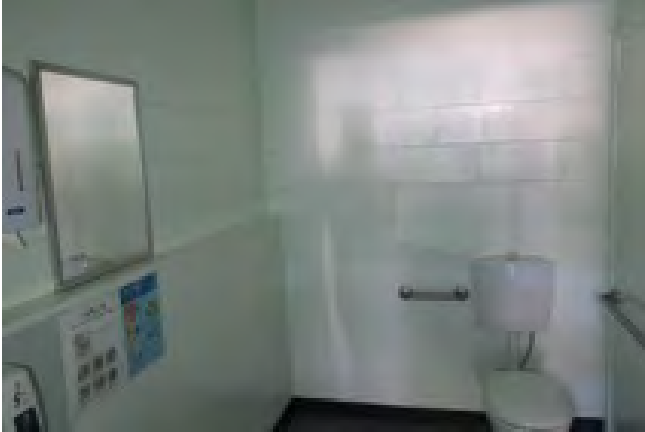
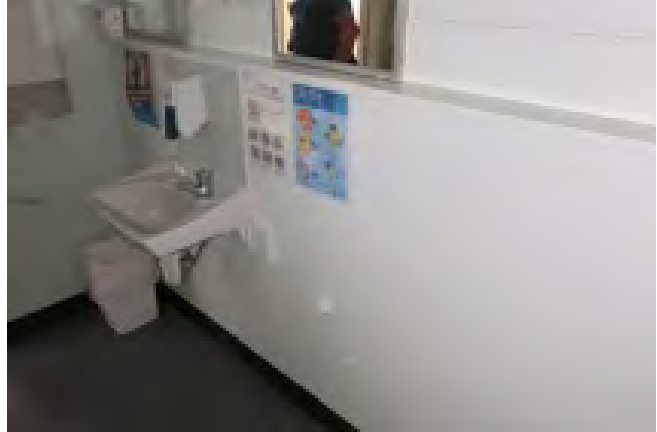
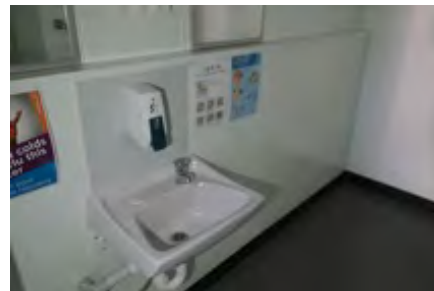
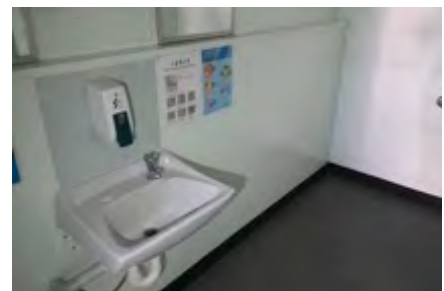
**Area 7****LR14 Leisure Complex: Ground Floor Disabled bathroom 7. The Splash back (F C Sheeting) has Asbestos Containing Material (ACM) present.****RISK ASSESSMENT**

<b>Type of Asbestos or Hazardous Material</b>	No sample taken - Visual ID	<b>Condition</b>	GOOD	<b>Likelihood of Damage</b>	L (Low) – possible
		<b>Activity</b>	Moderate		
		<b>Sealed</b>	Yes	<b>Friability</b>	Bonded (non-friable)
		<b>Labelled</b>	Y	<b>Exposure Risk</b>	Low - Negligible or low risk
		<b>Quantity</b>

<b>Priority</b>	MEDIUM	<b>Label Required</b>	Yes	<b>Re- Audit Date</b>	16 Feb 2022
<b>Action</b>	No remedial action required, unless disturbed				
<b>Recommendation</b>	Maintain paint or sealant to ACM surfaces. Particular attention should be given to side edges, ensure paint/sealant covers ALL exposed ACM surfaces.				
<b>Legislative Requirements Victorian Regulation 2007</b>	Warning labels should be affixed. Avoid mechanical damage and abrasion. Remove if refurbishment, structural alteration or demolition is to be carried out in this area. Re-inspect every 12 months or earlier if disturbed or removed in accordance with the Victorian OH&S Regulation 2017. <b>All remedial/removal repairs require a Clearance Inspection &amp; Certificate to be recorded by an approved and competent assessor.</b>

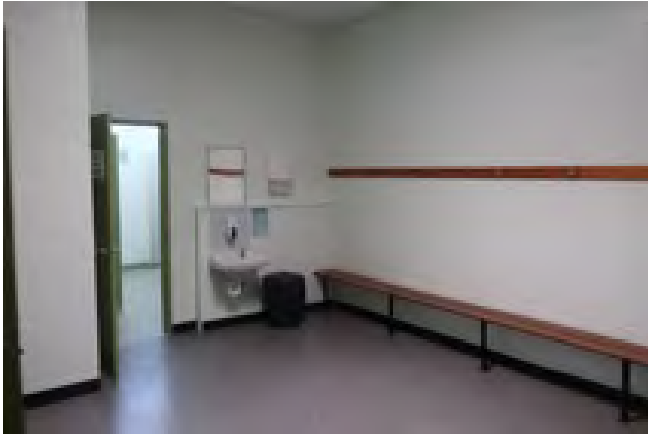
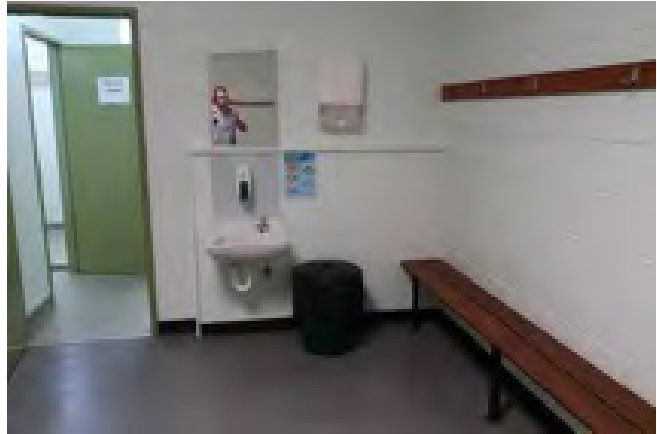
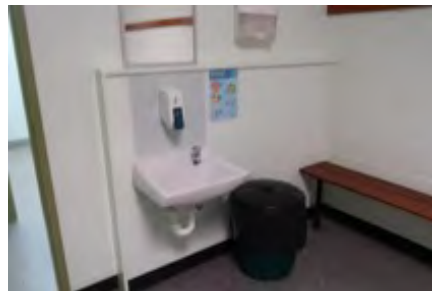
**LR14 Leisure Complex: Ground Floor Male changeroom 8. The Splash back (F C Sheeting) has Asbestos Containing Material (ACM) present.**

RISK ASSESSMENT					
Type of Asbestos or Hazardous Material	No sample taken - Visual ID	Condition	GOOD	Likelihood of Damage	L (Low) – possible
		Activity	Moderate		
		Sealed	Yes	Friability	Bonded (non-friable)
		Labelled	Y	Exposure Risk	Low - Negligible or low risk
		Quantity

RISK CONTROL					
Priority	MEDIUM	Label Required	Yes	Re- Audit Date	16 Feb 2022
Action	No remedial action required, unless disturbed				
Recommendation	Maintain paint or sealant to ACM surfaces. Particular attention should be given to side edges, ensure paint/sealant covers ALL exposed ACM surfaces.				
Legislative Requirements Victorian Regulation 2007	Warning labels should be affixed. Avoid mechanical damage and abrasion. Remove if refurbishment, structural alteration or demolition is to be carried out in this area. Re-inspect every 12 months or earlier if disturbed or removed in accordance with the Victorian OH&S Regulation 2017. <b>All remedial/removal repairs require a Clearance Inspection &amp; Certificate to be recorded by an approved and competent assessor.</b>

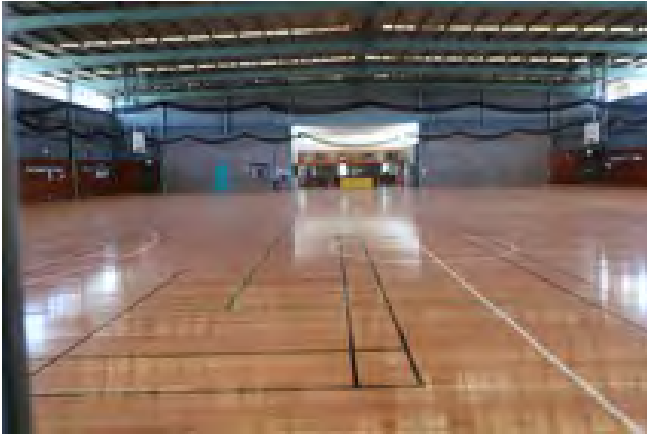
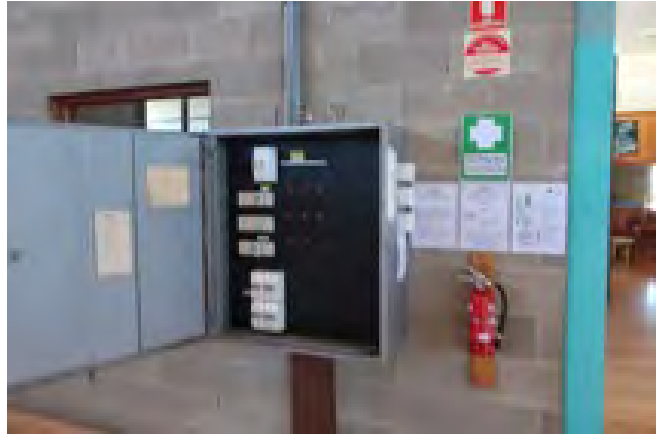
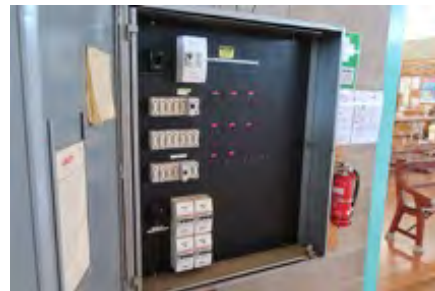
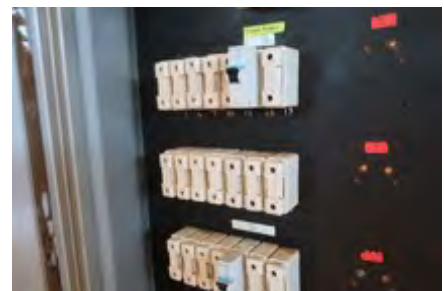
**LR14 Leisure Complex: Ground Floor Courts 10. The A: Electrical board; B: Ceramic Fuses (A: Zelemite; B: Cloth Inserts) has Asbestos Containing Material (ACM) present.**

RISK ASSESSMENT					
Type of Asbestos or Hazardous Material	Chrysotile	Condition	GOOD	Likelihood of Damage	L (Low) – possible
	Sample taken 62130-002 A: Zelemite	Activity	Moderate		
		Sealed	Yes	Friability	Bonded (non-friable)
		Labelled	Y	Exposure Risk	Low - Negligible or low risk
		Quantity

RISK CONTROL					
Priority	MEDIUM	Label Required	Yes	Re- Audit Date	16 Feb 2022
Action	No remedial action required, unless disturbed				
Recommendation	Maintain paint or sealant to ACM surfaces. Particular attention should be given to side edges, ensure paint/sealant covers ALL exposed ACM surfaces.				
Legislative Requirements Victorian Regulation 2007	Warning labels should be affixed. Avoid mechanical damage and abrasion. Remove if refurbishment, structural alteration or demolition is to be carried out in this area. Re-inspect every 12 months or earlier if disturbed or removed in accordance with the Victorian OH&S Regulation 2017. <b>All remedial/removal repairs require a Clearance Inspection &amp; Certificate to be recorded by an approved and competent assessor.</b>

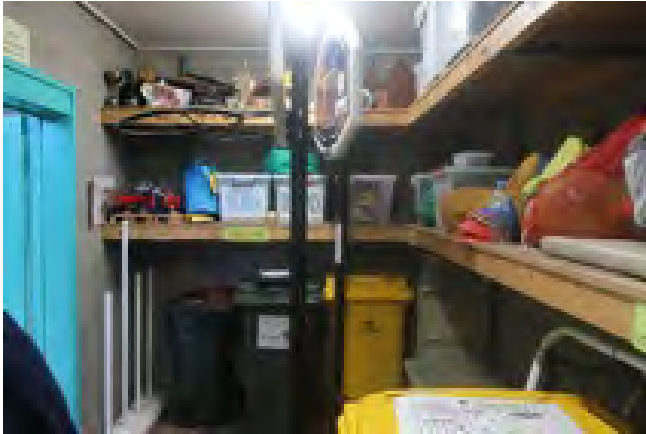
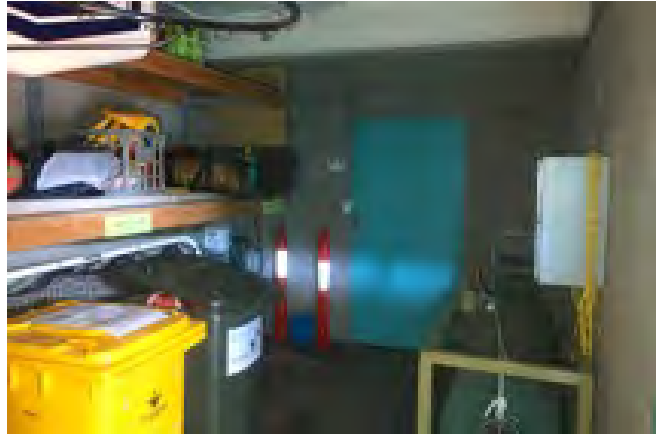
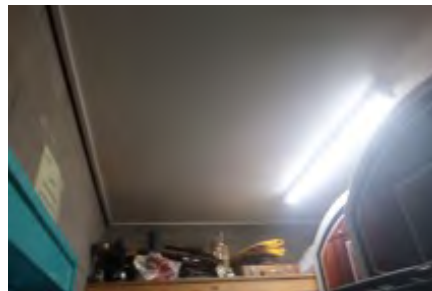
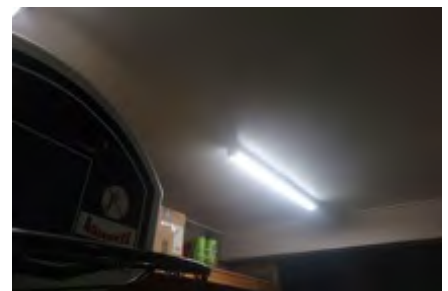
RISK ASSESSMENT					
Type of Asbestos or Hazardous Material	Chrysotile	Condition	GOOD	Likelihood of Damage	L (Low) – possible
	Sample taken 62130-003	Activity	Moderate		
		Sealed	Yes	Friability	Bonded (non-friable)
		Labelled	Y	Exposure Risk	Low - Negligible or low risk
		Quantity

RISK CONTROL					
Priority	MEDIUM	Label Required	Yes	Re- Audit Date	16 Feb 2022
Action	No remedial action required, unless disturbed				
Recommendation	Maintain paint or sealant to ACM surfaces. Particular attention should be given to side edges, ensure paint/sealant covers ALL exposed ACM surfaces.				
Legislative Requirements Victorian Regulation 2007	Warning labels should be affixed. Avoid mechanical damage and abrasion. Remove if refurbishment, structural alteration or demolition is to be carried out in this area. Re-inspect every 12 months or earlier if disturbed or removed in accordance with the Victorian OH&S Regulation 2017. <b>All remedial/removal repairs require a Clearance Inspection &amp; Certificate to be recorded by an approved and competent assessor.</b>

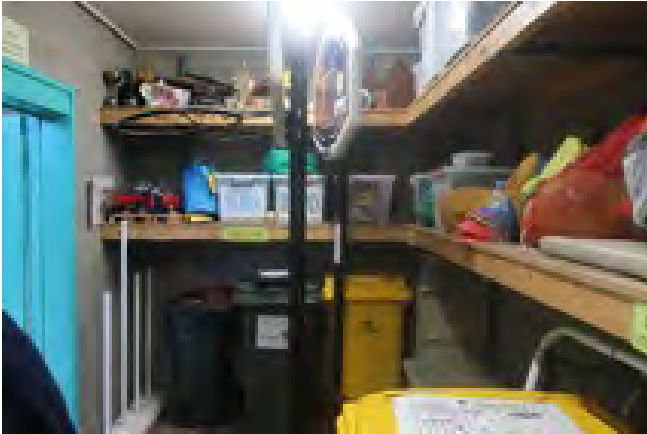
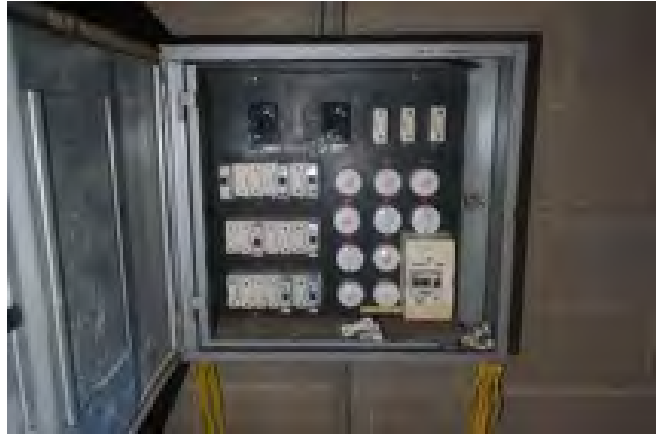
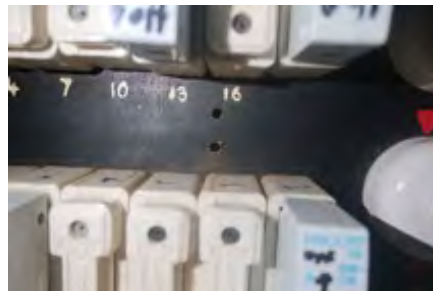
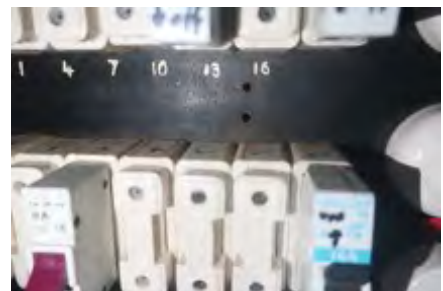
RISK ASSESSMENT					
Type of Asbestos or Hazardous Material	Chrysotile	Condition	AVERAGE	Likelihood of Damage	L (Low) – possible
	Sample taken 62130-004	Activity	Moderate		
		Sealed	Yes	Friability	Exposed Fibres
		Labelled	Y	Exposure Risk	Medium - Moderate risk
		Quantity

Penetration Holes

RISK CONTROL					
Priority	HIGH	Label Required	Yes	Re- Audit Date	16 Feb 2022
Action	Remedial repairs required - seal raw material / edges				
Recommendation	Penetration Holes - The exposed edges require approved sealant. It is further recommended the gaps be filled with sealant.				
Legislative Requirements Victorian Regulation 2007	Damaged ACM visible in area. Requires IMMEDIATE ATTENTION. WARNING labels should be affixed. Avoid mechanical damage and abrasion. Remove if refurbishment, structural alteration or demolition is to be carried out in this area. Re-inspect every 12 months or earlier if disturbed or removed in accordance with the Victorian OH&S Regulation 2017. <b>All remedial/removal repairs require a Clearance Inspection &amp; Certificate to be recorded by an approved and competent assessor.</b>

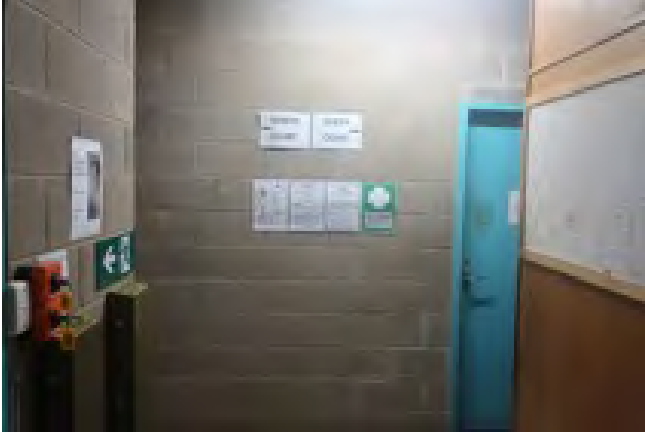
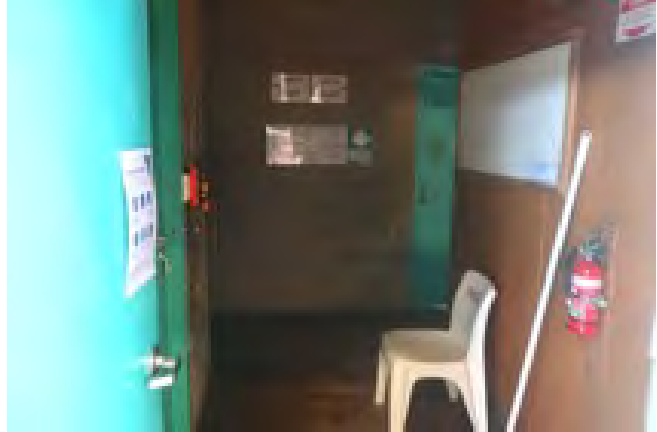
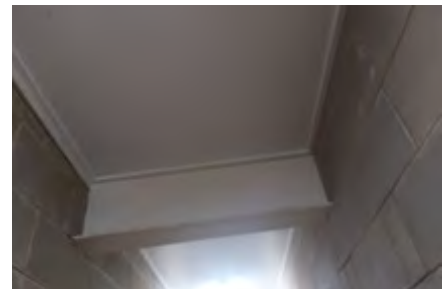
<b>Type of Asbestos or Hazardous Material</b>	Chrysotile	<b>Condition</b>	GOOD	<b>Likelihood of Damage</b>	L (Low) – possible
	Same as Sample - 62130-007	<b>Activity</b>	Moderate		
		<b>Sealed</b>	Yes	<b>Friability</b>	Bonded (non-friable)
		<b>Labelled</b>	Y	<b>Exposure Risk</b>	Low - Negligible or low risk
		<b>Quantity</b>

<b>Priority</b>	MEDIUM	<b>Label Required</b>	Yes	<b>Re- Audit Date</b>	16 Feb 2022
<b>Action</b>	No remedial action required, unless disturbed				
<b>Recommendation</b>	Maintain paint or sealant to ACM surfaces. Particular attention should be given to side edges, ensure paint/sealant covers ALL exposed ACM surfaces.				
<b>Legislative Requirements Victorian Regulation 2007</b>	Warning labels should be affixed. Avoid mechanical damage and abrasion. Remove if refurbishment, structural alteration or demolition is to be carried out in this area. Re-inspect every 12 months or earlier if disturbed or removed in accordance with the Victorian OH&S Regulation 2017. <b>All remedial/removal repairs require a Clearance Inspection &amp; Certificate to be recorded by an approved and competent assessor.</b>

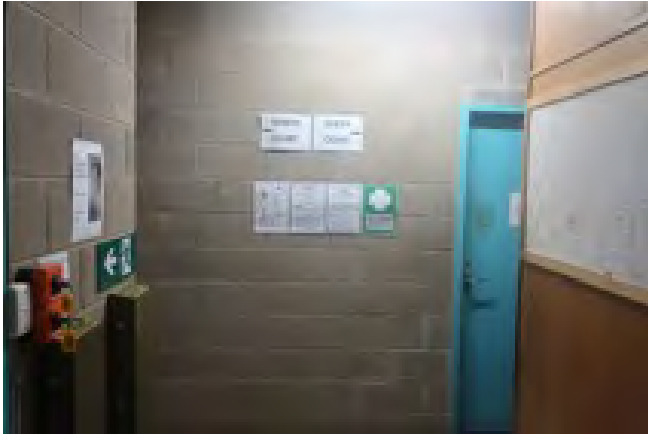
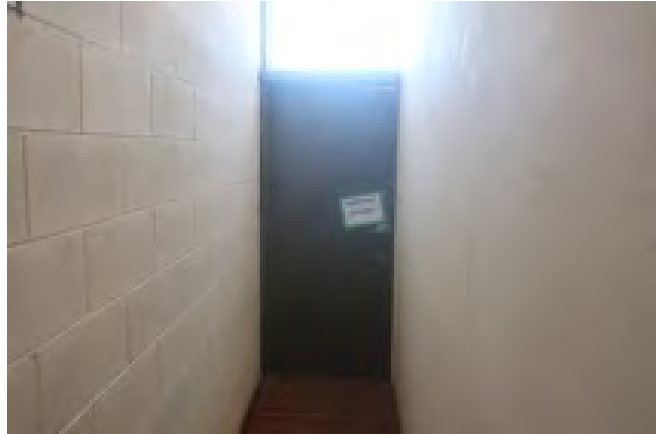
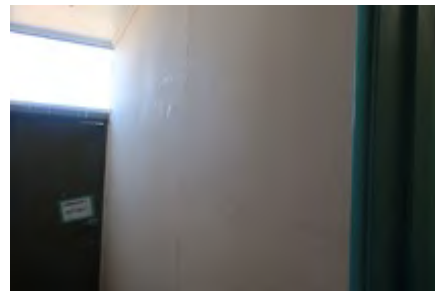
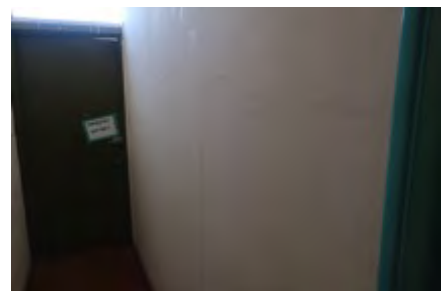
RISK ASSESSMENT					
Type of Asbestos or Hazardous Material	Chrysotile	Condition	GOOD	Likelihood of Damage	L (Low) – possible
	Sample taken 62130-007	Activity	Moderate		
		Sealed	Yes	Friability	Bonded (non-friable)
		Labelled	Y	Exposure Risk	Low - Negligible or low risk
		Quantity

RISK CONTROL					
Priority	MEDIUM	Label Required	Yes	Re- Audit Date	16 Feb 2022
Action	No remedial action required, unless disturbed				
Recommendation	Maintain paint or sealant to ACM surfaces. Particular attention should be given to side edges, ensure paint/sealant covers ALL exposed ACM surfaces.				
Legislative Requirements Victorian Regulation 2007	Warning labels should be affixed. Avoid mechanical damage and abrasion. Remove if refurbishment, structural alteration or demolition is to be carried out in this area. Re-inspect every 12 months or earlier if disturbed or removed in accordance with the Victorian OH&S Regulation 2017. <b>All remedial/removal repairs require a Clearance Inspection &amp; Certificate to be recorded by an approved and competent assessor.</b>

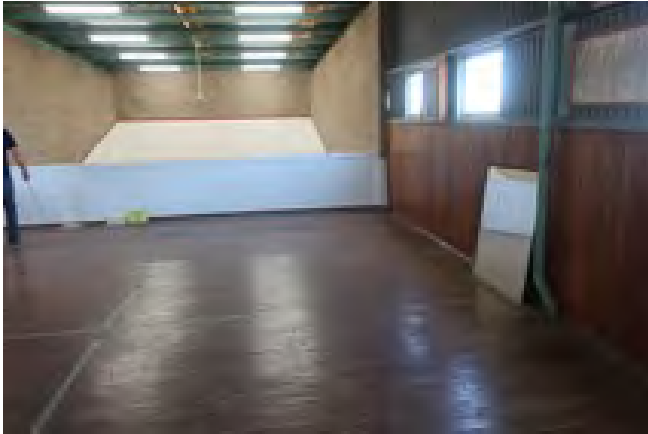
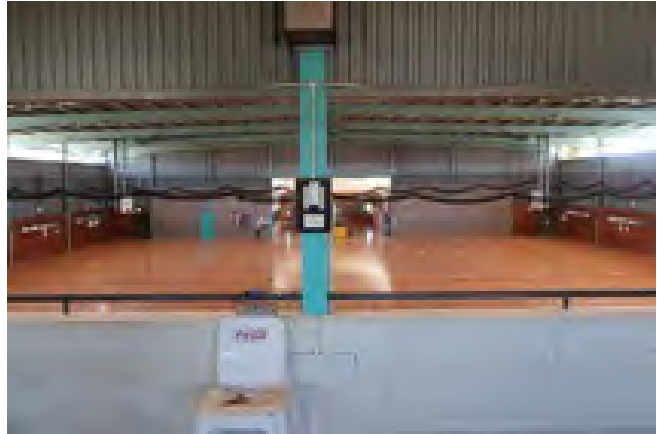
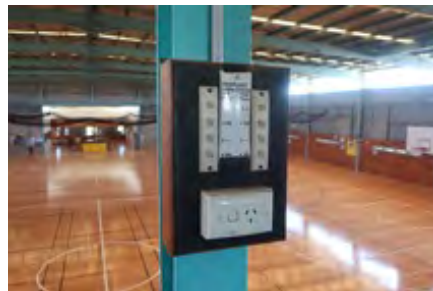
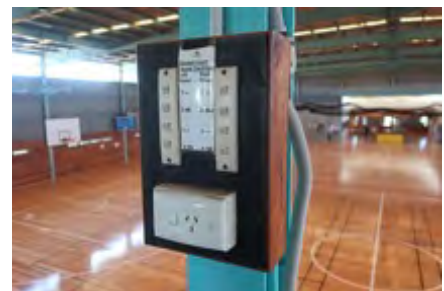
RISK ASSESSMENT					
Type of Asbestos or Hazardous Material	No sample taken - Visual ID	Condition	GOOD	Likelihood of Damage	L (Low) – possible
		Activity	Moderate		
		Sealed	Yes	Friability	Bonded (non-friable)
		Labelled	Y	Exposure Risk	Low - Negligible or low risk
		Quantity

RISK CONTROL					
Priority	MEDIUM	Label Required	Yes	Re- Audit Date	16 Feb 2022
Action	No remedial action required, unless disturbed				
Recommendation	Maintain paint or sealant to ACM surfaces. Particular attention should be given to side edges, ensure paint/sealant covers ALL exposed ACM surfaces.				
Legislative Requirements Victorian Regulation 2007	Warning labels should be affixed. Avoid mechanical damage and abrasion. Remove if refurbishment, structural alteration or demolition is to be carried out in this area. Re-inspect every 12 months or earlier if disturbed or removed in accordance with the Victorian OH&S Regulation 2017. <b>All remedial/removal repairs require a Clearance Inspection &amp; Certificate to be recorded by an approved and competent assessor.</b>
