Asbestos Report

YARRIAMBIACK SHIRE COUNCIL

PROPERTY ADDRESS:
LR15B LIBRARY
36 LYLE STREET
WARRACKNABEAL VIC 3393

INSPECTION DATE: 16 FEBRUARY 2021
REFERENCE NUMBER: 62131

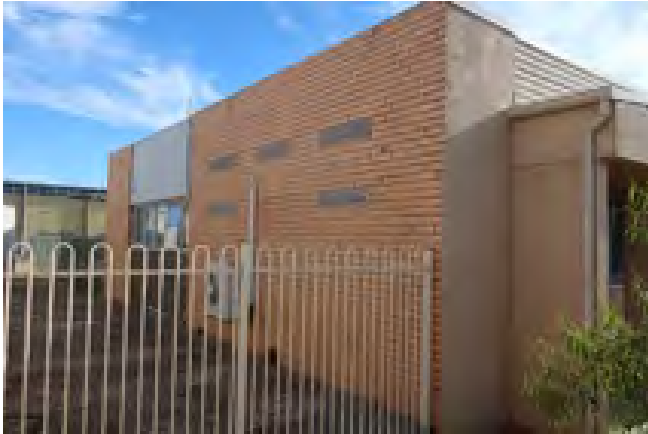
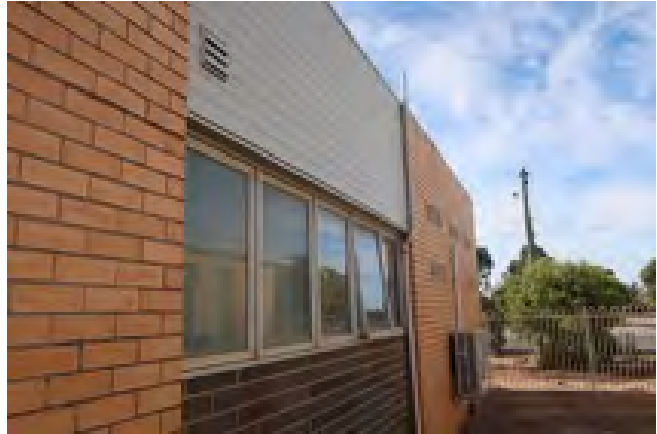
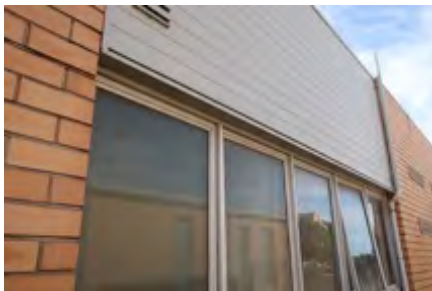
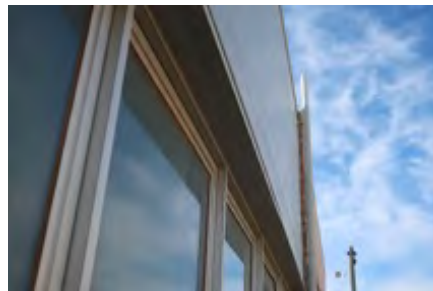
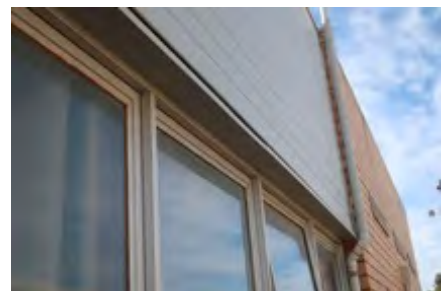
Area 3

LR15B Library: left side of building. The Soffit (F C Sheeting) has Asbestos Containing Material (ACM) present.

RISK ASSESSMENT					
Type of Asbestos or Hazardous Material	Chrysotile	Condition	GOOD	Likelihood of Damage	L (Low) – possible
	Sample taken 62131-003	Activity	Moderate		
		Sealed	Yes	Friability	Bonded (non-friable)
		Labelled	Y	Exposure Risk	Low - Negligible or low risk
		Quantity

RISK CONTROL					
Priority	MEDIUM	Label Required	Yes	Re- Audit Date	16 Feb 2022
Action	No remedial action required, unless disturbed				
Recommendation	Maintain paint or sealant to ACM surfaces. Particular attention should be given to side edges, ensure paint/sealant covers ALL exposed ACM surfaces.				
Legislative Requirements Victorian Regulation 2007	Warning labels should be affixed. Avoid mechanical damage and abrasion. Remove if refurbishment, structural alteration or demolition is to be carried out in this area. Re-inspect every 12 months or earlier if disturbed or removed in accordance with the Victorian OH&S Regulation 2017. All remedial/removal repairs require a Clearance Inspection & Certificate to be recorded by an approved and competent assessor.

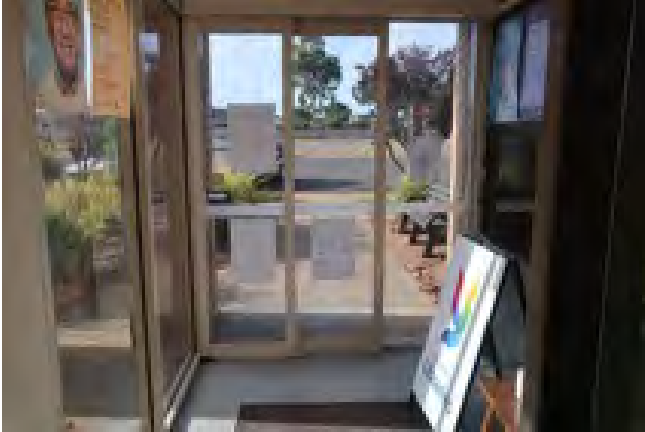
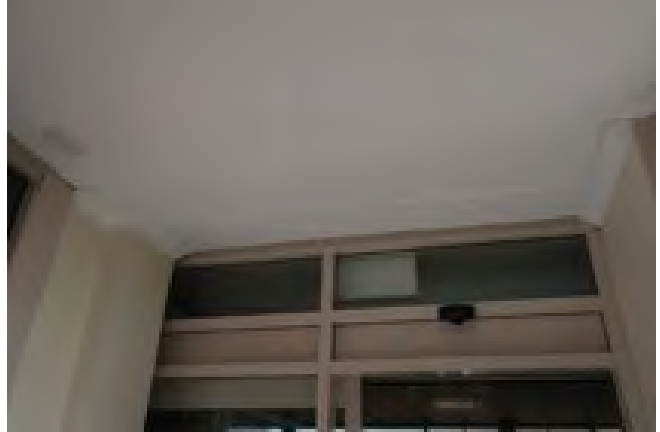
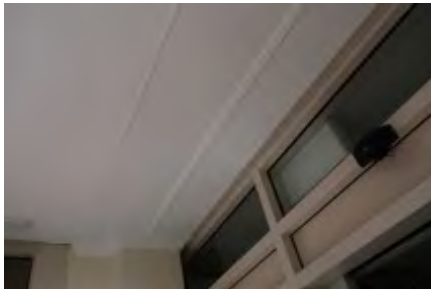
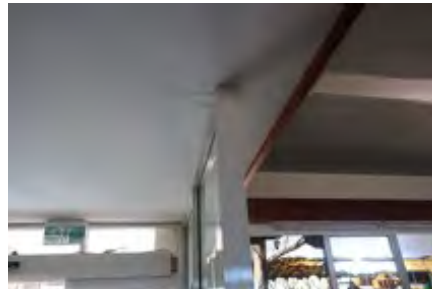
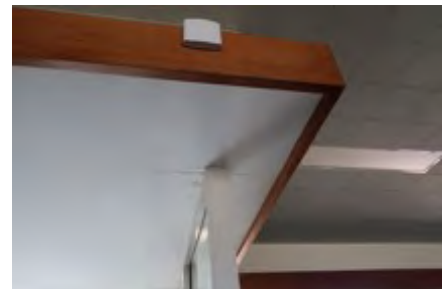
Area 2**LR15B Library: Entry 1. The Ceiling - old soffit (F C Sheeting) has Asbestos Containing Material (ACM) present.****RISK ASSESSMENT**

Type of Asbestos or Hazardous Material	Chrysotile	Condition	GOOD	Likelihood of Damage	L (Low) – possible
	Sample taken 62131-004	Activity	Moderate		
		Sealed	Yes	Friability	Bonded (non-friable)
		Labelled	Y	Exposure Risk	Low - Negligible or low risk
		Quantity

Priority	MEDIUM	Label Required	Yes	Re- Audit Date	16 Feb 2022
Action	No remedial action required, unless disturbed				
Recommendation	Maintain paint or sealant to ACM surfaces. Particular attention should be given to side edges, ensure paint/sealant covers ALL exposed ACM surfaces.				
Legislative Requirements Victorian Regulation 2007	Warning labels should be affixed. Avoid mechanical damage and abrasion. Remove if refurbishment, structural alteration or demolition is to be carried out in this area. Re-inspect every 12 months or earlier if disturbed or removed in accordance with the Victorian OH&S Regulation 2017. All remedial/removal repairs require a Clearance Inspection & Certificate to be recorded by an approved and competent assessor.

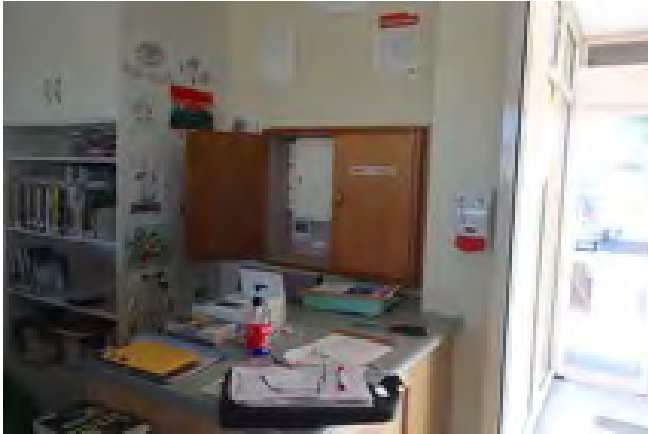
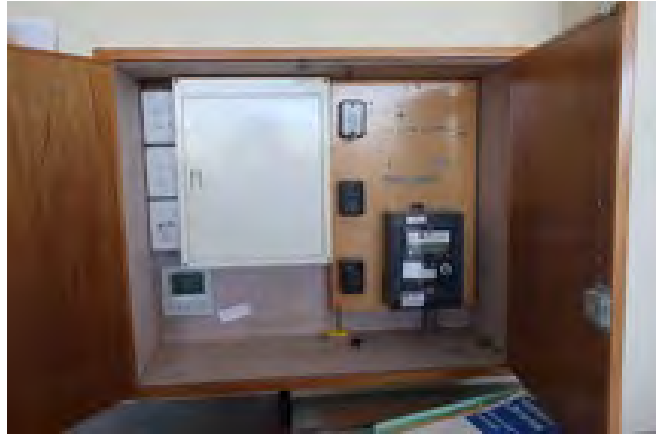
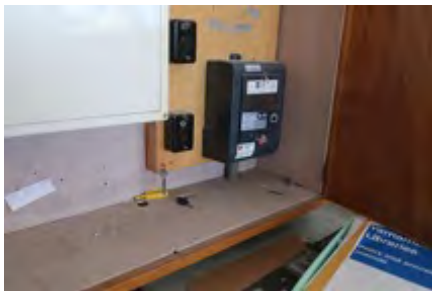
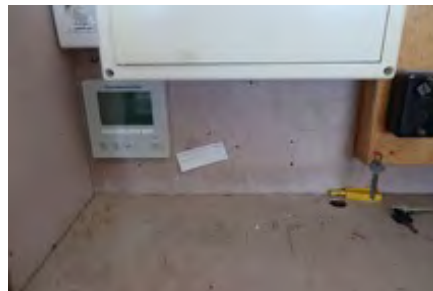
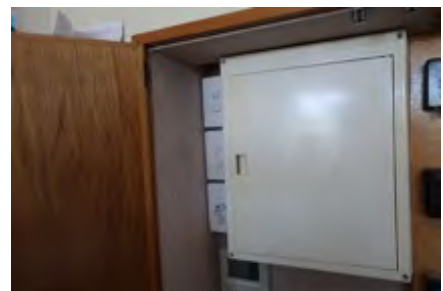
LR15B Library: Reception 3. The Electrical Cabinet (F C Sheeting) has Asbestos Containing Material (ACM) present.

RISK ASSESSMENT					
Type of Asbestos or Hazardous Material	No sample taken - Visual ID	Condition	AVERAGE	Likelihood of Damage	H (High) - almost certain
		Activity	Low	Friability	Bonded (non-friable)
		Sealed	No	Exposure Risk	Medium - Moderate risk
		Labelled	Y	Quantity

Raw material sheeting - The area requires immediate remedial repairs. It is recommended the asbestos material be sealed with an approved membrane.

RISK CONTROL					
Priority	HIGH	Label Required	Yes	Re- Audit Date	16 Feb 2022
Action	Remedial repairs required - seal raw material / edges				
Recommendation	Raw material sheeting - The area requires immediate remedial repairs. It is recommended the asbestos material be sealed with an approved membrane.				
Legislative Requirements Victorian Regulation 2007	Damaged ACM visible in area. Requires IMMEDIATE ATTENTION. WARNING labels should be affixed. Avoid mechanical damage and abrasion. Remove if refurbishment, structural alteration or demolition is to be carried out in this area. Re-inspect every 12 months or earlier if disturbed or removed in accordance with the Victorian OH&S Regulation 2017. All remedial/removal repairs require a Clearance Inspection & Certificate to be recorded by an approved and competent assessor.
