Asbestos Report

YARRIAMBIACK SHIRE COUNCIL

PROPERTY ADDRESS:
LR16 LIONS FLORA & FAUNA PARK BBQ AREA
CRAIG AVENUE
WARRACKNABEAL VIC 3393

INSPECTION DATE: 16 FEBRUARY 2021
REFERENCE NUMBER: 62132

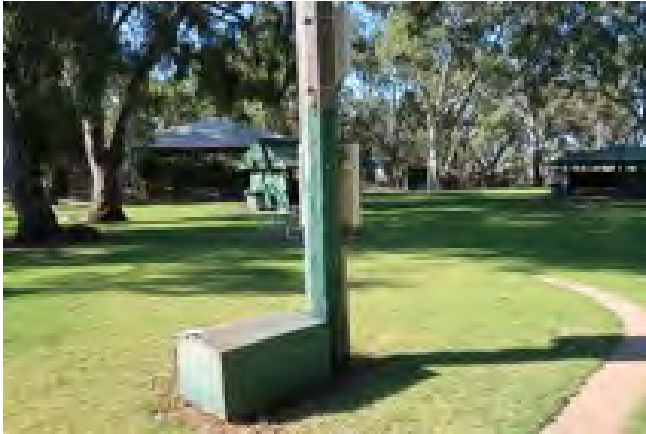
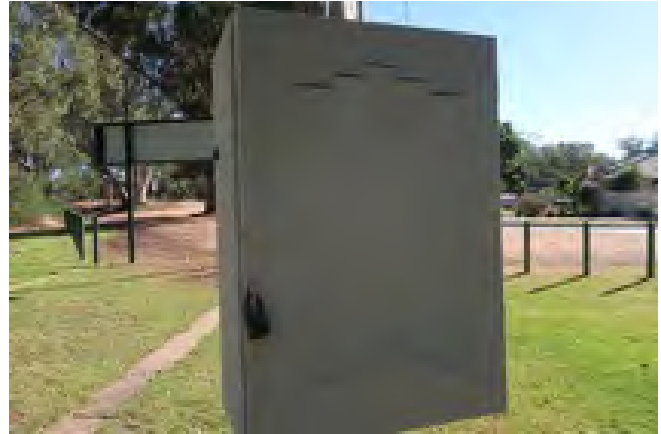
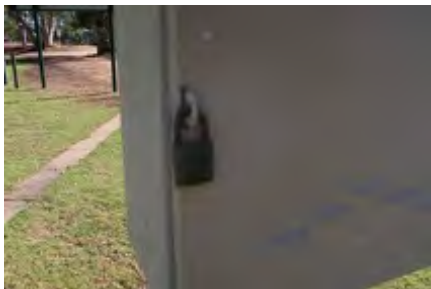
Area 1**Grounds: Until the area is inspected, it should be managed as if it Asbestos Containing Material (ACM) is present.****RISK ASSESSMENT**

Type of Asbestos or Hazardous Material	No sample taken - No Access	Condition		Likelihood of Damage	L (Low) – possible	
		Activity	Moderate			
		Sealed		Friability		
		Labelled	No	Exposure Risk		
		Quantity

Priority	HIGH	Label Required	Yes	Re- Audit Date	16 Feb 2022
Action					
Recommendation					
Legislative Requirements Victorian Regulation 2007	Unable to Gain Access. Assume asbestos in area and provide monitoring if work undertaken in these areas. If access is made available, contact Global Asbestos Audits for re-inspection

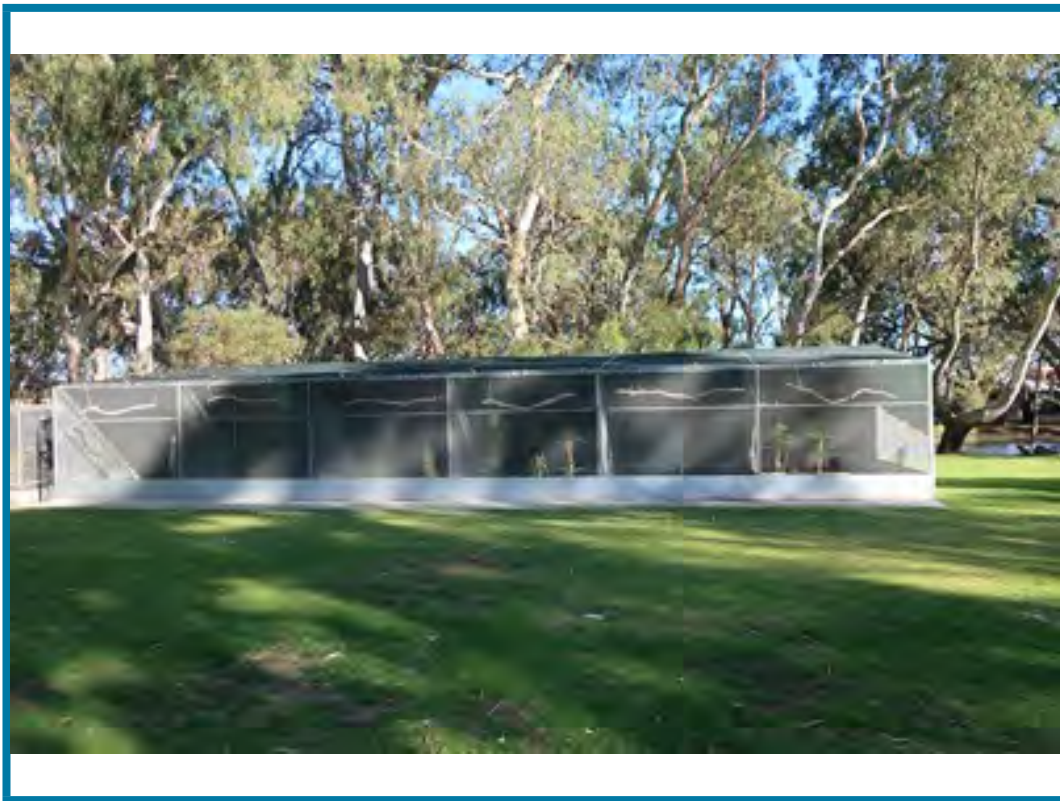
Location	Area	Component Materials	ACM Identified	Type Asbestos Assessment	ConditionPriority	Signage Required
Animal shelter 1 - Animal shelter.		No Asbestos Materials	No	No sample taken - Visual ID

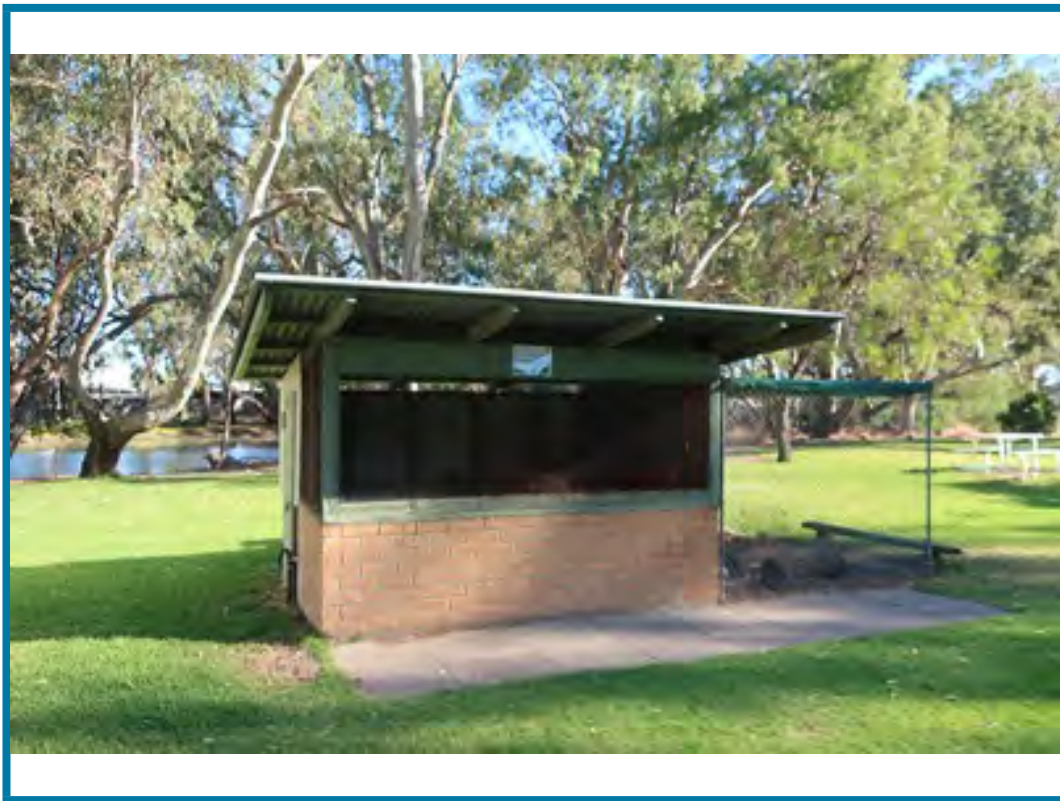
Location	Area	Component Materials	ACM Identified	Type Asbestos Assessment	ConditionPriority	Signage Required
Animal shelter 2 - front, left & rear of building.		No Asbestos Materials	No	No sample taken - Visual ID

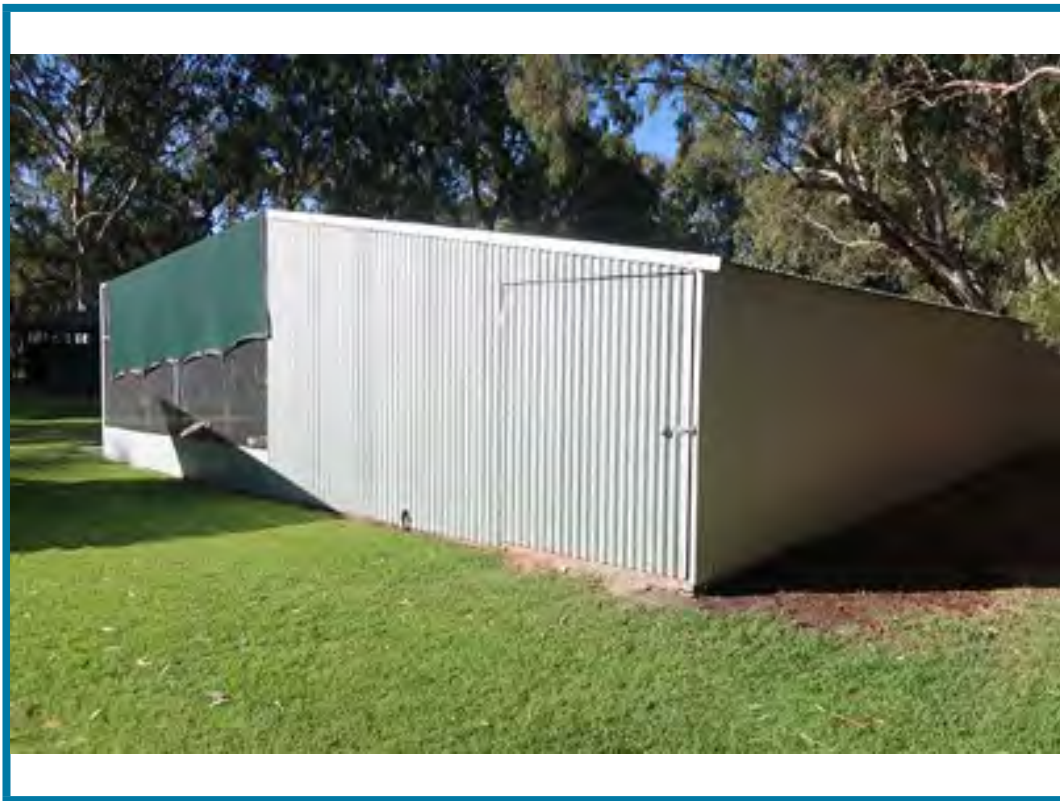
Location	Area	Component Materials	ACM Identified	Type Asbestos Assessment	ConditionPriority	Signage Required
Animal shelter 3 - entire perimeter of building.		No Asbestos Materials	No	No sample taken - Visual ID

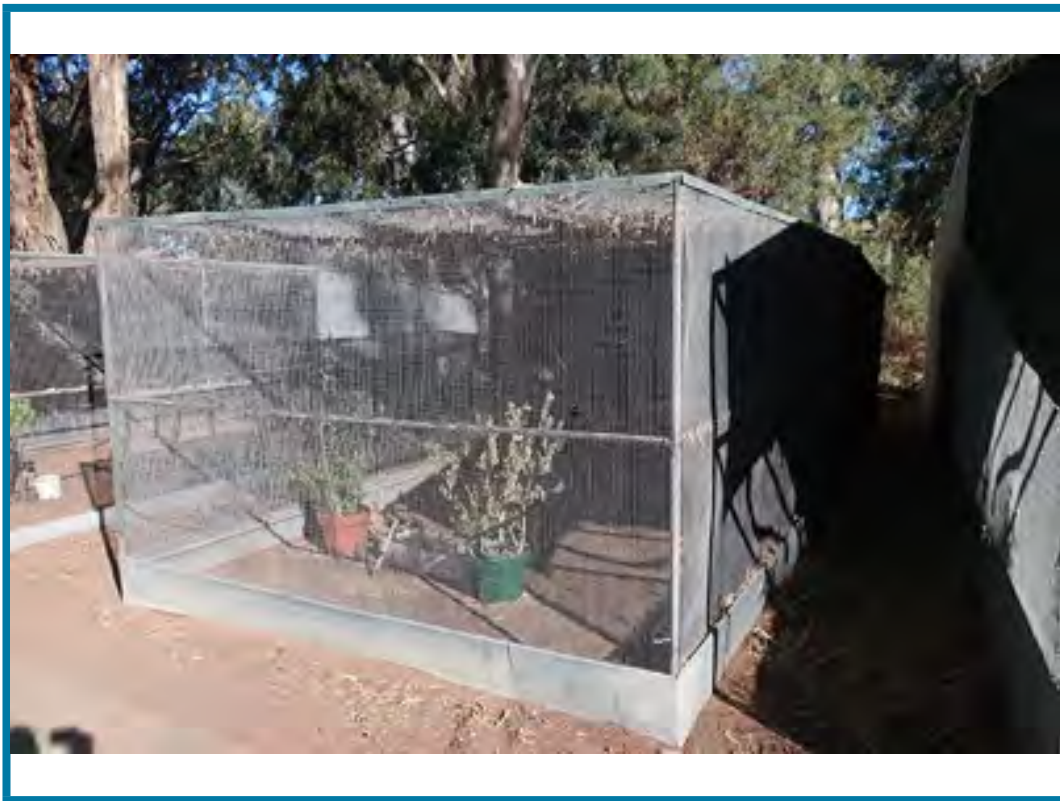
Location	Area	Component Materials	ACM Identified	Type Asbestos Assessment	Condition Priority	Signage Required
Animal shelter 4 - entire perimeter of building.		No Asbestos Materials	No	No sample taken - Visual ID

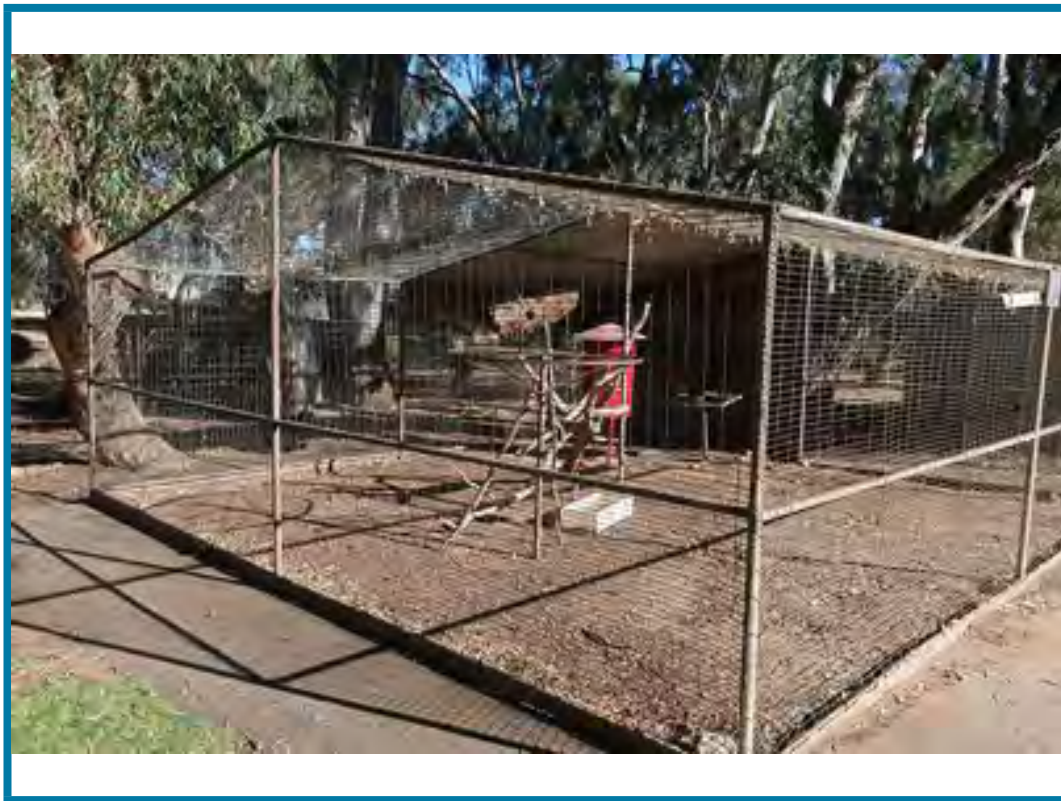
Location	Area	Component Materials	ACM Identified	Type Asbestos Assessment	ConditionPriority	Signage Required
Animal shelter 5 - entire perimeter of building.		No Asbestos Materials	No	No sample taken - Visual ID

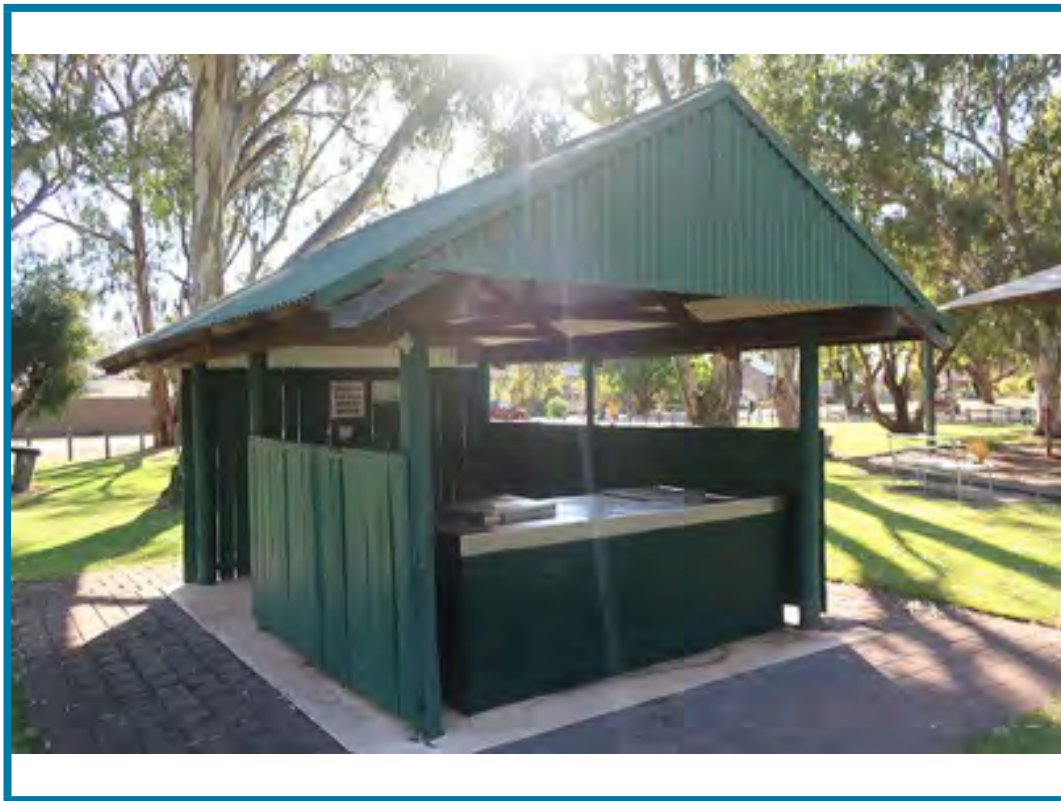
Location	Area	Component Materials	ACM Identified	Type Asbestos Assessment	ConditionPriority	Signage Required
Barbecue area LR16 Lions Flora & Fauna Park BBQ Area - entire perimeter of building.	 	No Asbestos Materials	No	No sample taken - Visual ID

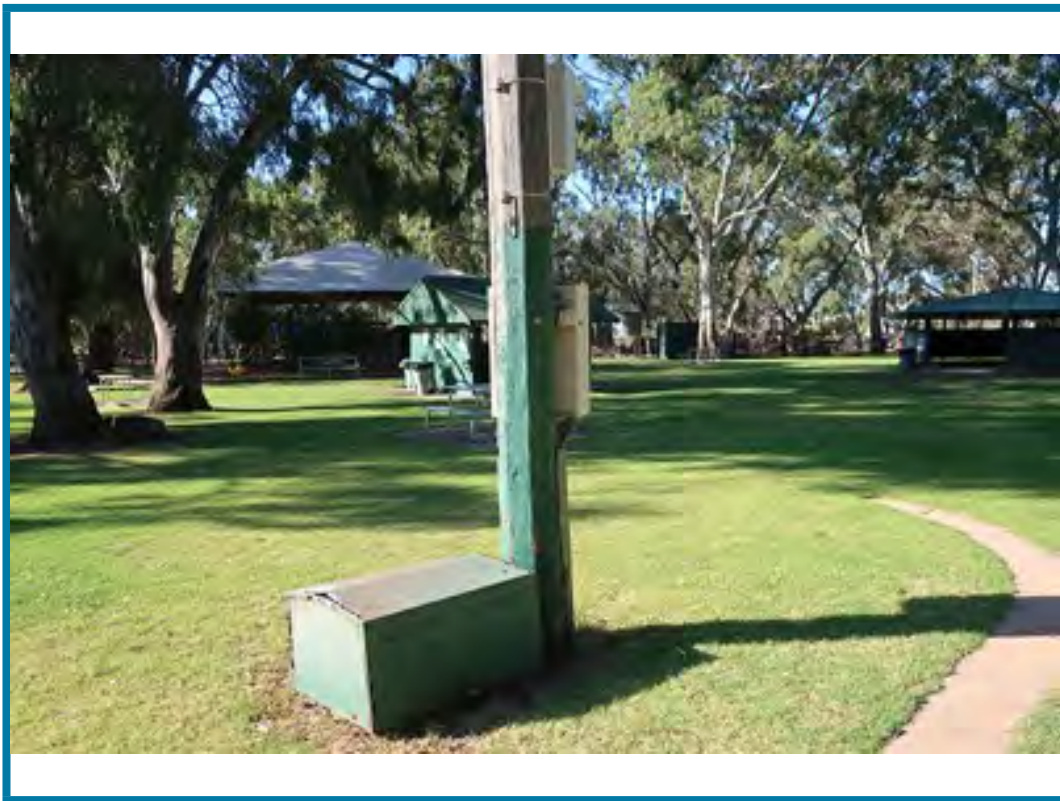
Location	Area	Component Materials	ACM Identified	Type Asbestos Assessment	Condition Priority	Signage Required
Grounds - Grounds.	Electrical board	No Asbestos Materials	Yes	No sample taken - No Access

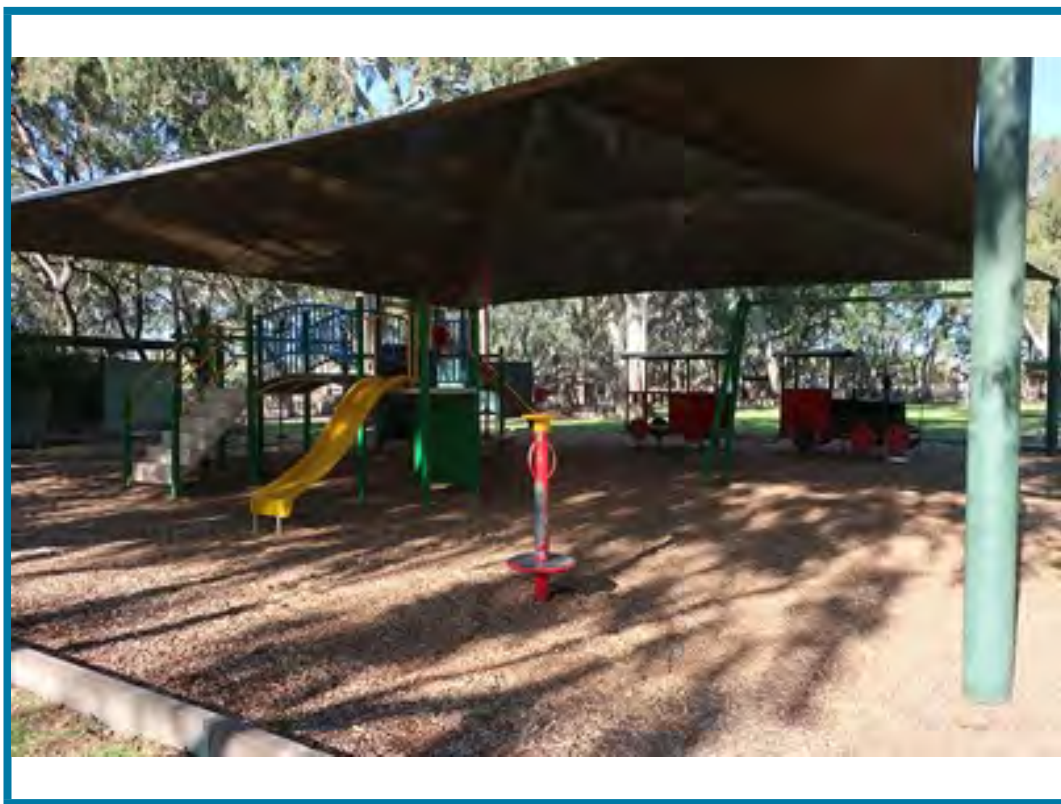
Location	Area	Component Materials	ACM Identified	Type Asbestos Assessment	ConditionPriority	Signage Required
Playground - Playground.		No Asbestos Materials	No	No sample taken - Visual ID

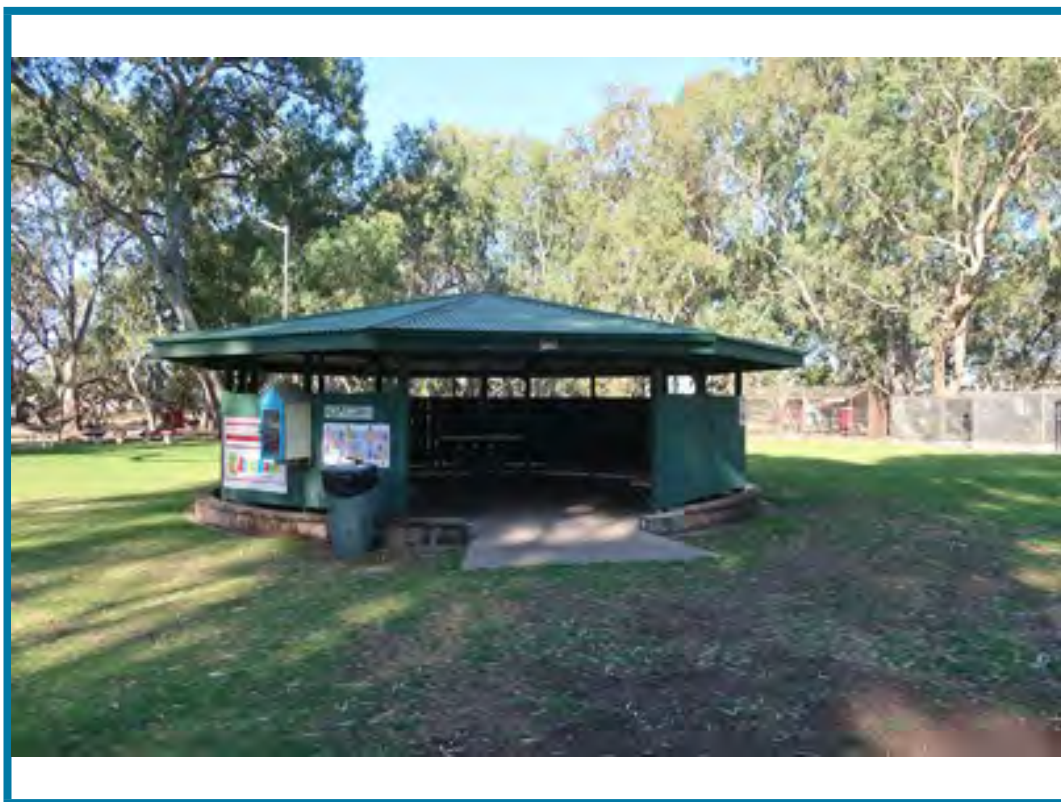
Location	Area	Component Materials	ACM Identified	Type Asbestos Assessment	ConditionPriority	Signage Required
Rotunda - entire perimeter of building.		No Asbestos Materials	No	No sample taken - Visual ID

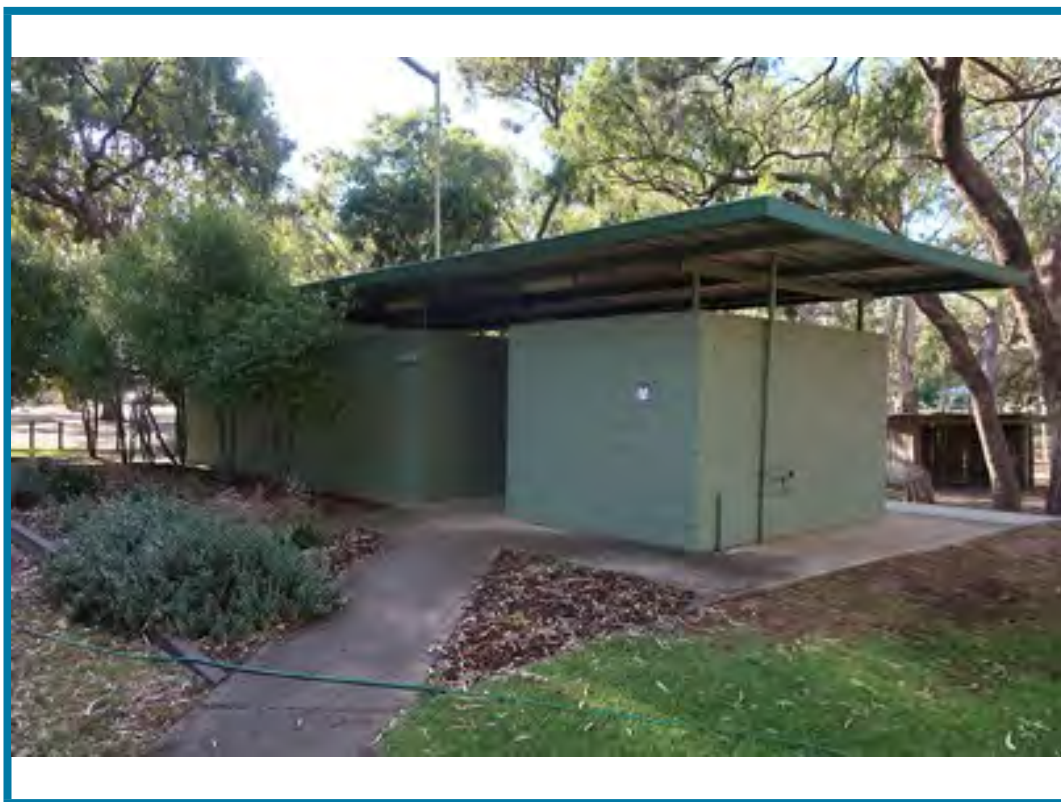
Location	Area	Component Materials	ACM Identified	Type Asbestos Assessment	ConditionPriority	Signage Required
Toilets - entire perimeter of building.		No Asbestos Materials	No	No sample taken - Visual ID
