Asbestos Report

YARRIAMBIACK SHIRE COUNCIL

PROPERTY ADDRESS:
LB6 MUSEUM WHEAT
34 HENTY HIGHWAY
WARRACKNABEAL VIC 3393

INSPECTION DATE: 16 FEBRUARY 2021
REFERENCE NUMBER: 62133

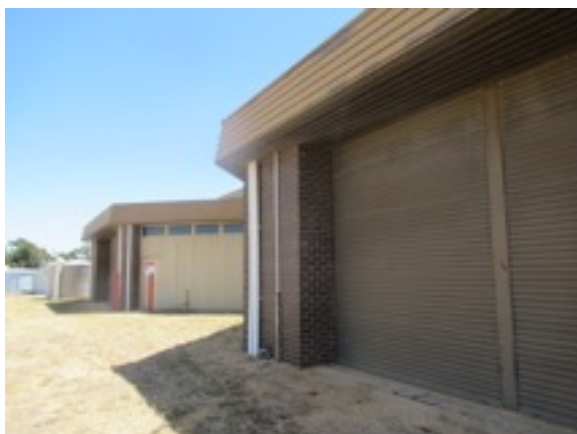
External

Area 19**Museum: right side of building. The Electrical board (F C Sheeting) has Asbestos Containing Material (ACM) present.****RISK ASSESSMENT**

Type of Asbestos or Hazardous Material	Chrysotile	Condition	AVERAGE	Likelihood of Damage	L (Low) – possible
	Sample taken 62133-007	Activity	Moderate		
		Sealed	No	Friability	Bonded (non-friable)
		Labelled	Y	Exposure Risk	Medium - Moderate risk
		Quantity

- 19 Museum: right side of building. The Electrical board (F C Sheeting) has Asbestos Containing Material (ACM) present.**
- Raw material sheeting - The area requires immediate remedial repairs. It is recommended the asbestos material be sealed with an approved membrane.

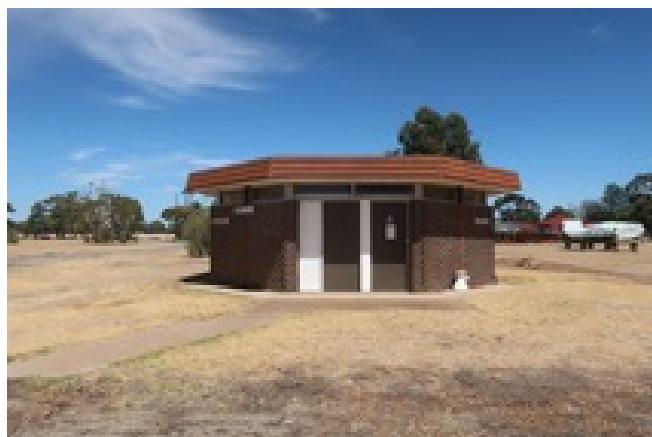
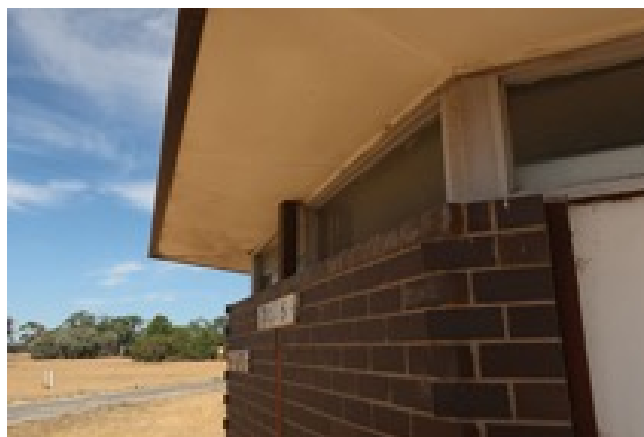
External

Area 25**Toilets: entire perimeter of building. The Soffit (F C Sheeting) has Asbestos Containing Material (ACM) present.****RISK ASSESSMENT**

Type of Asbestos or Hazardous Material	No sample taken - Visual ID	Condition	GOOD	Likelihood of Damage	L (Low) – possible
		Activity	Moderate		
		Sealed	Yes	Friability	Bonded (non-friable)
		Labelled	Y	Exposure Risk	Low - Negligible or low risk
		Quantity

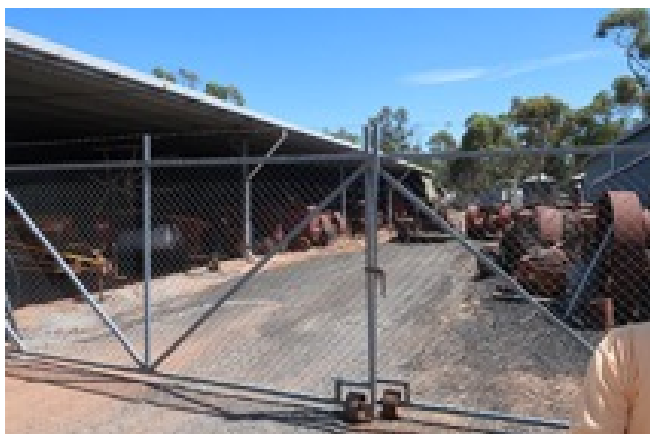
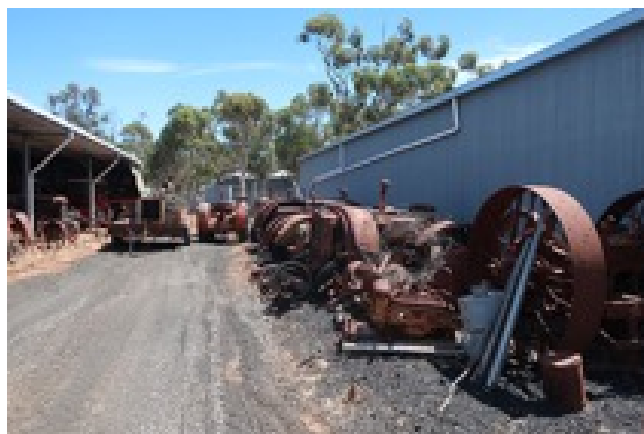
External

Area 14

Type of Asbestos or Hazardous Material	No sample taken - Visual ID	Condition	POOR	Likelihood of Damage	M (Medium) - likely
		Activity	Moderate		
		Sealed	No	Friability	Exposed Fibres
		Labelled	Y	Exposure Risk	Medium - Moderate risk
		Quantity

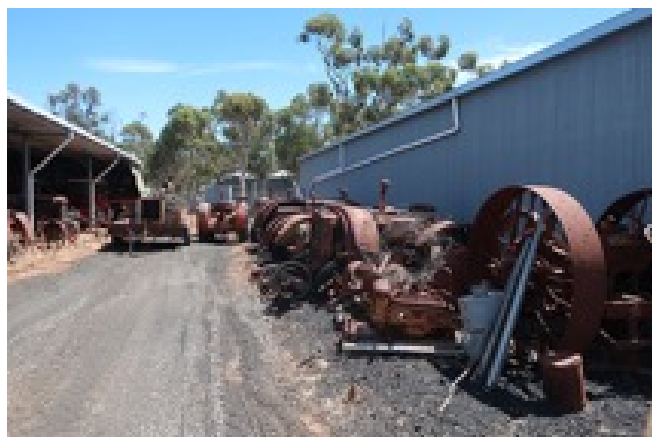
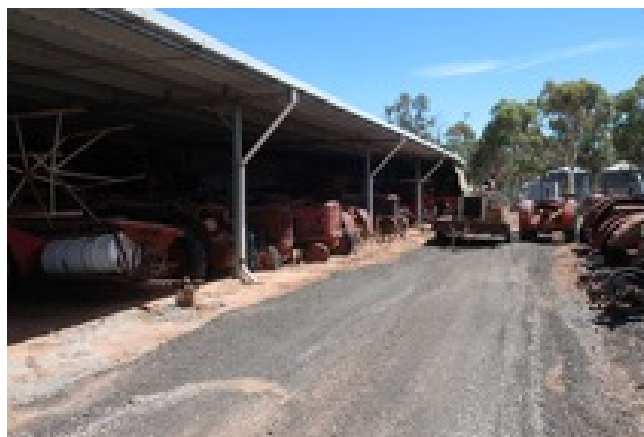
External

Area 12

Type of Asbestos or Hazardous Material	No sample taken - Visual ID	Condition	POOR	Likelihood of Damage	M (Medium) - likely
		Activity	Moderate		
		Sealed	No	Friability	Exposed Fibres
		Labelled	Y	Exposure Risk	Medium - Moderate risk
		Quantity

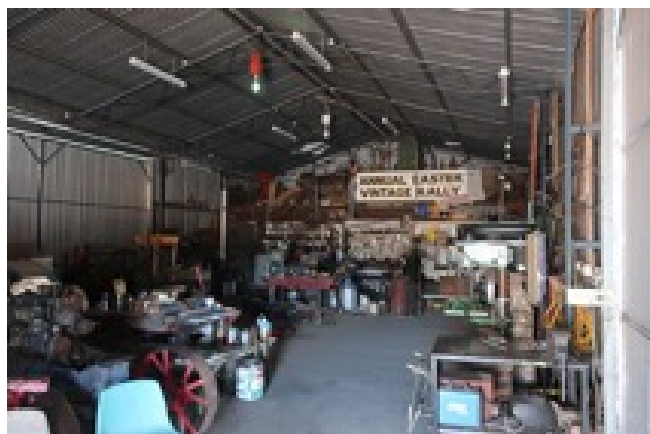
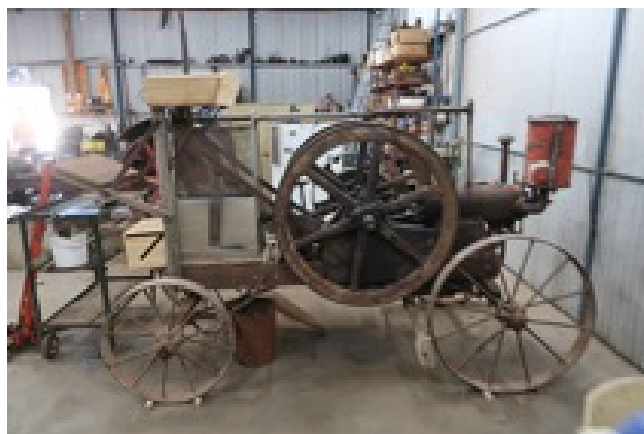
Room

Area 23

Type of Asbestos or Hazardous Material	No sample taken - Visual ID	Condition	POOR	Likelihood of Damage	M (Medium) - likely
		Activity	Moderate		
		Sealed	No	Friability	Exposed Fibres
		Labelled	Y	Exposure Risk	Medium - Moderate risk
		Quantity

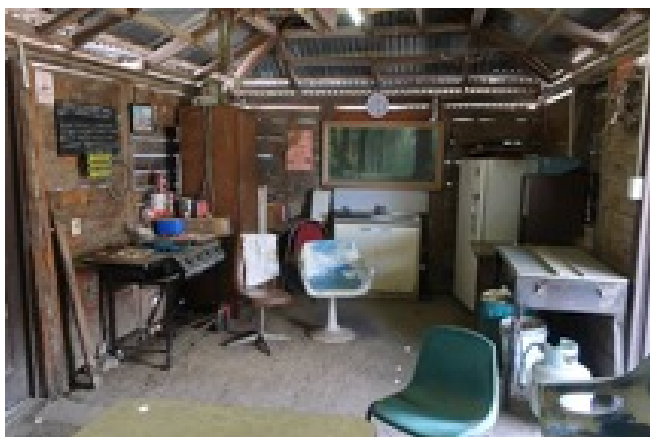
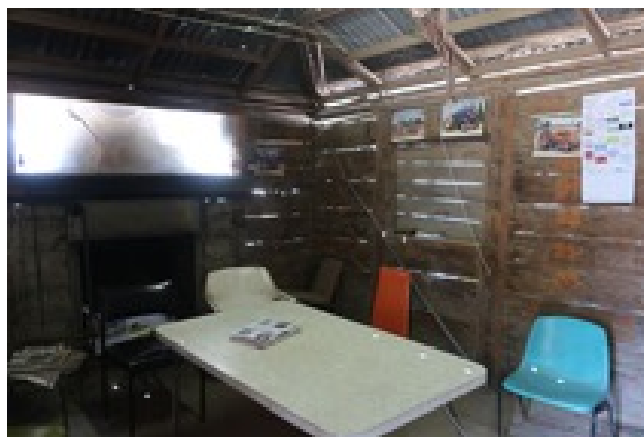
Room

Area 4**Staff building: Staff room 1. The Fire place - back panel (F C Sheet) has Asbestos Containing Material (ACM) present.****RISK ASSESSMENT**

Type of Asbestos or Hazardous Material	No sample taken - Visual ID	Condition	POOR	Likelihood of Damage	H (High) - almost certain
		Activity	High		
		Sealed	No	Friability	Exposed Fibres
		Labelled	Y	Exposure Risk	High - Short term exposure risk
		Quantity

- 4 Staff building: Staff room 1. The Fire place - back panel (F C Sheet) has Asbestos Containing Material (ACM) present.**
- Material is breaking down from use - Unbonded surface - The area requires immediate remedial repairs. It is recommended the asbestos sheeting be replaced (preferred) or the material be sealed with an approved membrane.

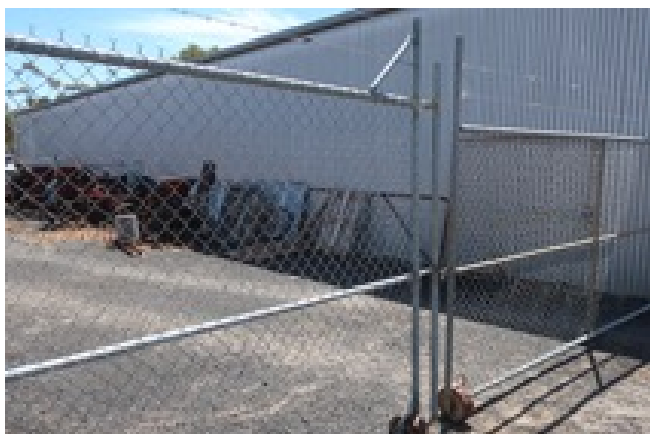
External

Area 5**Tractor storage shed: left side of building. The Tractors & Machinery (Various - Gaskets, Brake pads, Insulating Materials) has Asbestos Containing Material (ACM) present.****RISK ASSESSMENT**

Type of Asbestos or Hazardous Material	No sample taken - Visual ID	Condition	POOR	Likelihood of Damage	M (Medium) - likely
		Activity	Moderate		
		Sealed	No	Friability	Exposed Fibres
		Labelled	Y	Exposure Risk	High - Short term exposure risk
		Quantity

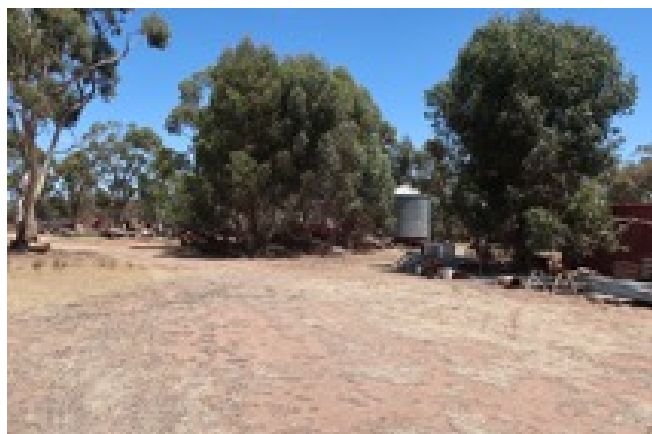
External

Area 13**Grounds: . The Tractors & Machinery (Various - Gaskets, Brake pads, Insulating Materials) has Asbestos Containing Material (ACM) present.****RISK ASSESSMENT**

Type of Asbestos or Hazardous Material	No sample taken - Visual ID	Condition	POOR	Likelihood of Damage	M (Medium) - likely
		Activity	Moderate		
		Sealed	No	Friability	Exposed Fibres
		Labelled	No	Exposure Risk	High - Short term exposure risk
		Quantity
