# Asbestos Report

YARRIAMBIACK SHIRE COUNCIL

PROPERTY ADDRESS:  
LB51 RESIDENCE  
51 GARDINER STREET  
WARRACKNABEAL VIC 3393

INSPECTION DATE: 16 FEBRUARY 2021  
REFERENCE NUMBER: 62136

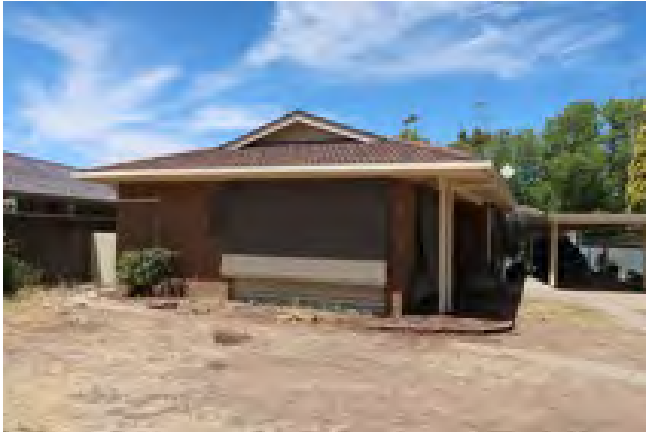
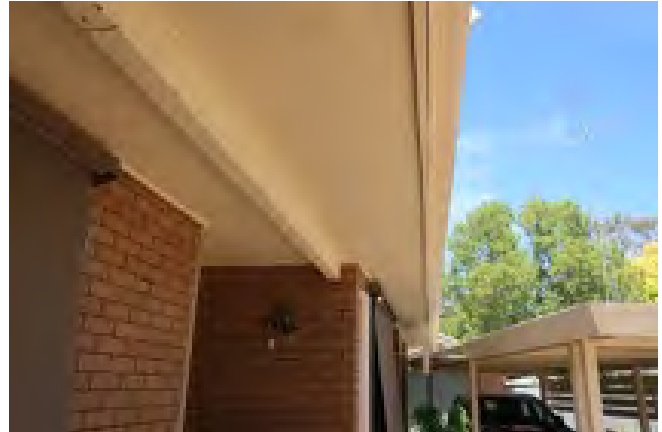
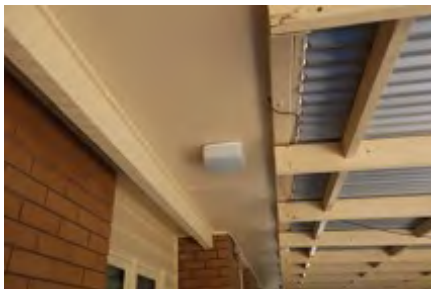
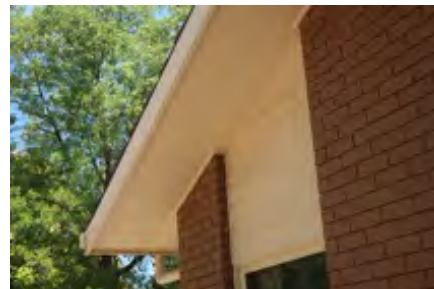
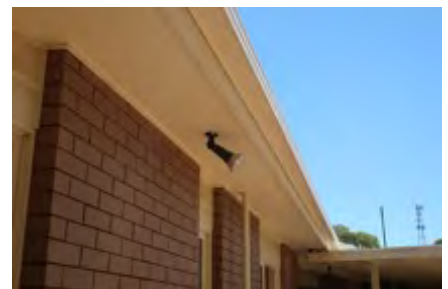
**Area 3*****Dwelling LB51 Residence: entire perimeter of building. The Soffit (F C Sheeting) has Asbestos Containing Material (ACM) present.*****RISK ASSESSMENT**

<b>Type of Asbestos or Hazardous Material</b>	Chrysotile	<b>Condition</b>	GOOD	<b>Likelihood of Damage</b>	L (Low) – possible
	Sample taken 62136-001	<b>Activity</b>	Moderate		
		<b>Sealed</b>	Yes	<b>Friability</b>	Bonded (non-friable)
		<b>Labelled</b>	Y	<b>Exposure Risk</b>	Low - Negligible or low risk
		<b>Quantity</b>

<b>Priority</b>	MEDIUM	<b>Label Required</b>	Yes	<b>Re- Audit Date</b>	16 Feb 2022
<b>Action</b>	No remedial action required, unless disturbed				
<b>Recommendation</b>	Maintain paint or sealant to ACM surfaces. Particular attention should be given to side edges, ensure paint/sealant covers ALL exposed ACM surfaces.				
<b>Legislative Requirements Victorian Regulation 2007</b>	Warning labels should be affixed. Avoid mechanical damage and abrasion. Remove if refurbishment, structural alteration or demolition is to be carried out in this area. Re-inspect every 12 months or earlier if disturbed or removed in accordance with the Victorian OH&S Regulation 2017. <b>All remedial/removal repairs require a Clearance Inspection &amp; Certificate to be recorded by an approved and competent assessor.</b>

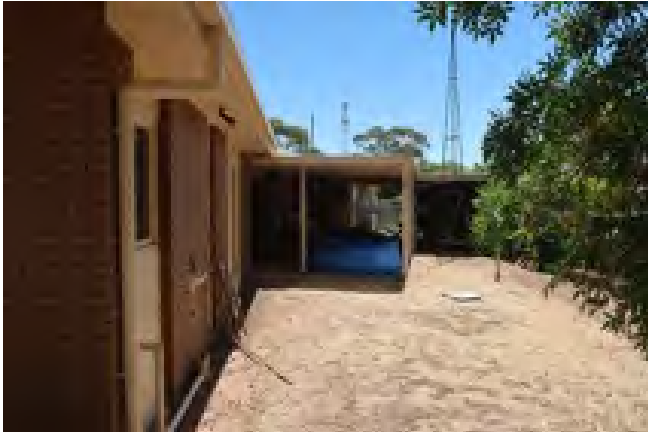
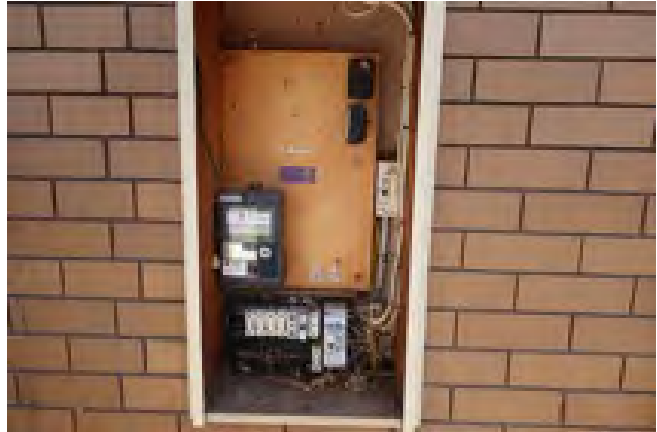
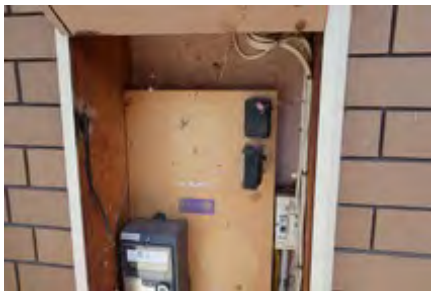
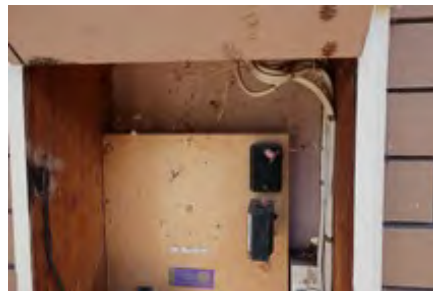
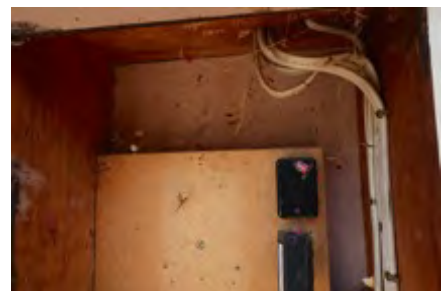
**Dwelling LB51 Residence: left side of building. The Sheeting behind electrical board (F C Sheet) has Asbestos Containing Material (ACM) present.**

RISK ASSESSMENT					
Type of Asbestos or Hazardous Material	No sample taken - Visual ID	Condition	AVERAGE	Likelihood of Damage	L (Low) – possible
		Activity	Moderate		
		Sealed	No	Friability	Bonded (non-friable)
		Labelled	Y	Exposure Risk	Medium - Moderate risk
		Quantity

Raw Material

Raw material sheeting - The area requires immediate remedial repairs. It is recommended the asbestos material be sealed with an approved membrane.

RISK CONTROL					
Priority	HIGH	Label Required	Yes	Re- Audit Date	16 Feb 2022
Action	Remedial repairs required - seal raw material / edges				
Recommendation	Raw material sheeting - The area requires immediate remedial repairs. It is recommended the asbestos material be sealed with an approved membrane.				
Legislative Requirements Victorian Regulation 2007	Damaged ACM visible in area. Requires IMMEDIATE ATTENTION. WARNING labels should be affixed. Avoid mechanical damage and abrasion. Remove if refurbishment, structural alteration or demolition is to be carried out in this area. Re-inspect every 12 months or earlier if disturbed or removed in accordance with the Victorian OH&S Regulation 2017. <b>All remedial/removal repairs require a Clearance Inspection &amp; Certificate to be recorded by an approved and competent assessor.</b>

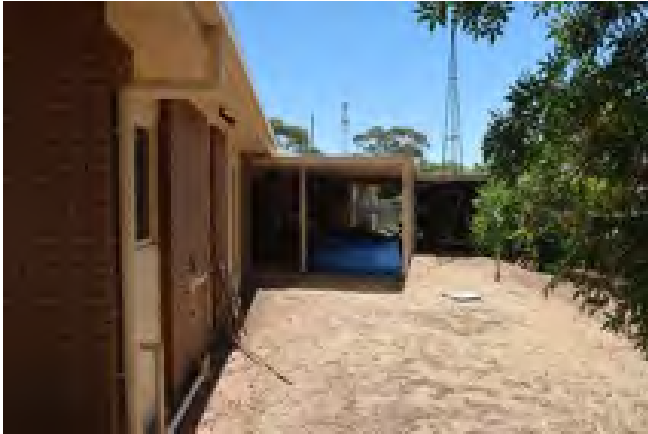
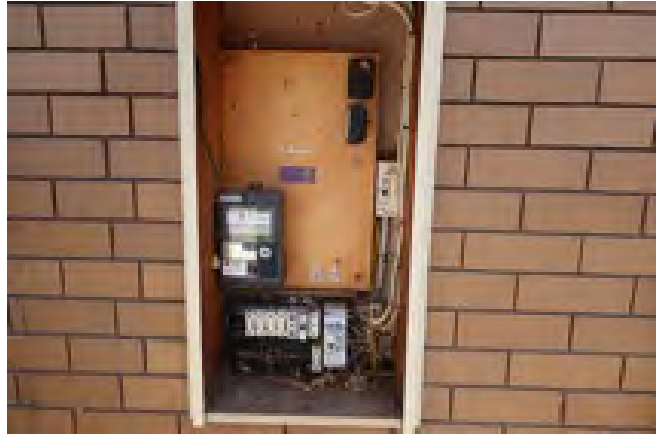
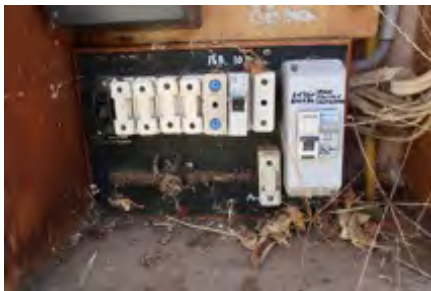
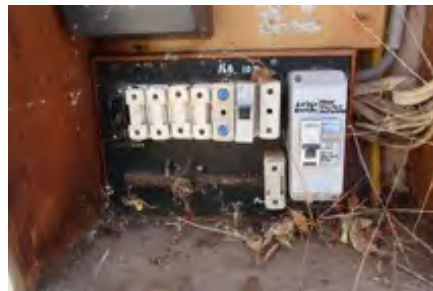
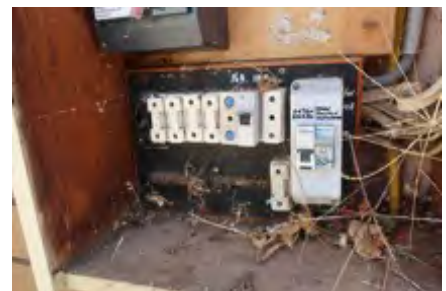
**Dwelling LB51 Residence: left side of building. The A: Electrical board; B: Ceramic Fuses (A: Zelemite; B: Fuse Cloth Inserts) has Asbestos Containing Material (ACM) present.**

RISK ASSESSMENT					
Type of Asbestos or Hazardous Material	No sample taken - Visual ID	Condition	GOOD	Likelihood of Damage	L (Low) – possible
		Activity	Moderate		
		Sealed	Yes	Friability	Bonded (non-friable)
		Labelled	Y	Exposure Risk	Low - Negligible or low risk
		Quantity

Priority	MEDIUM	Label Required	Yes	Re- Audit Date	16 Feb 2022
Action	No remedial action required, unless disturbed				
Recommendation	Maintain paint or sealant to ACM surfaces. Particular attention should be given to side edges, ensure paint/sealant covers ALL exposed ACM surfaces. Do not remove fuses without asbestos controls - test for cloth				
Legislative Requirements Victorian Regulation 2007	Warning labels should be affixed. Avoid mechanical damage and abrasion. Remove if refurbishment, structural alteration or demolition is to be carried out in this area. Re-inspect every 12 months or earlier if disturbed or removed in accordance with the Victorian OH&S Regulation 2017. <b>All remedial/removal repairs require a Clearance Inspection &amp; Certificate to be recorded by an approved and competent assessor.</b>

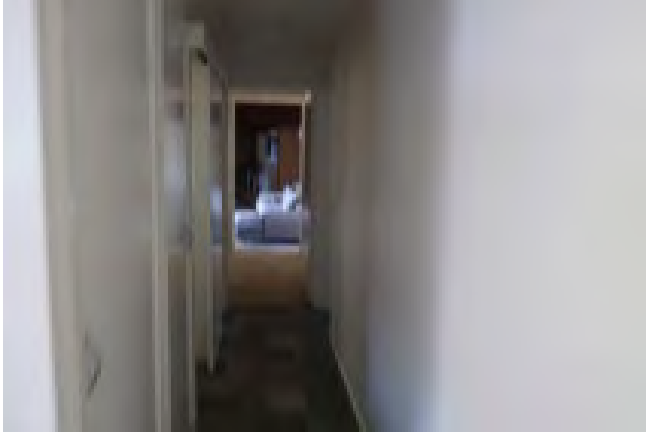
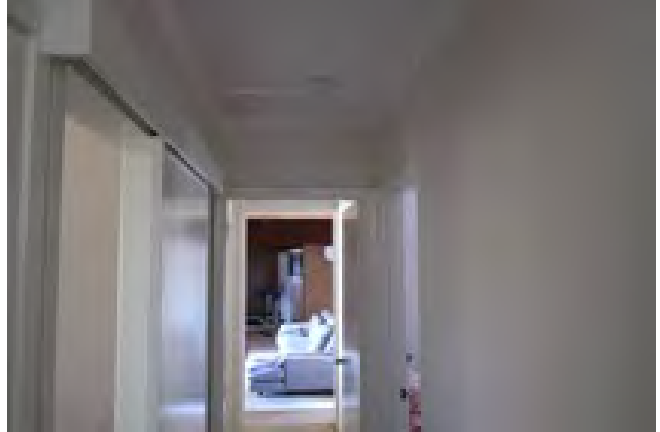
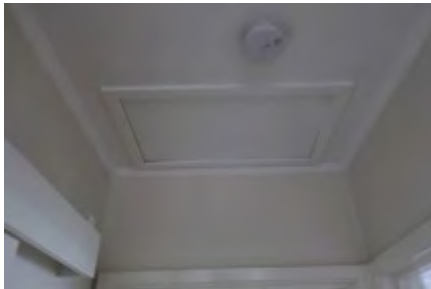
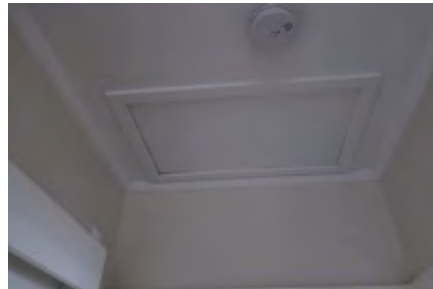
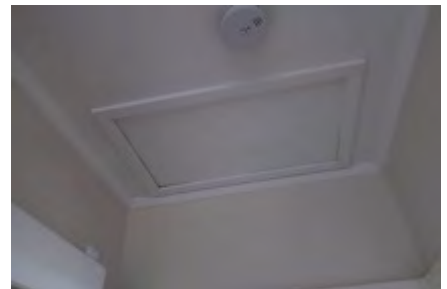
**Area 1****Dwelling LB51 Residence: Hallway 5. The Access panel (F C Sheet) has Asbestos Containing Material (ACM) present.****RISK ASSESSMENT**

<b>Type of Asbestos or Hazardous Material</b>	Chrysotile	<b>Condition</b>	GOOD	<b>Likelihood of Damage</b>	H (High) - Most likely
	Same as Sample - 62136-001	<b>Activity</b>	Moderate		
		<b>Sealed</b>	Yes	<b>Friability</b>	Exposed Fibres
		<b>Labelled</b>	No	<b>Exposure Risk</b>	Medium - Moderate risk
		<b>Quantity</b>

Not in-situ

Replace access panel - remove and clean edges under asbestos controls

<b>Priority</b>	IMMEDIATE	<b>Label Required</b>	Yes	<b>Re- Audit Date</b>	16 Feb 2022
<b>Action</b>	Remove ACM				
<b>Recommendation</b>	Replace access panel - remove and clean edges under asbestos controls				
<b>Legislative Requirements Victorian Regulation 2007</b>	<p>The ACM identified is removable therefore not in-situ.          Requires replacement.          Re-inspect every 12 months or earlier if disturbed or removed in accordance with the Victorian OH&amp;S Regulation 2017.  <b>All remedial/removal repairs require a Clearance Inspection &amp; Certificate to be recorded by an approved and competent assessor.</b></p>

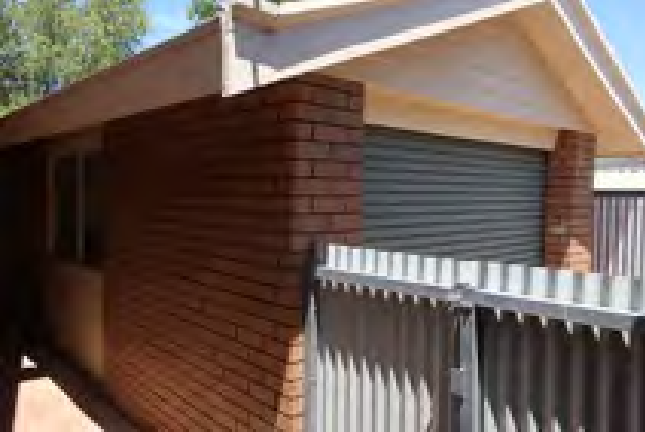
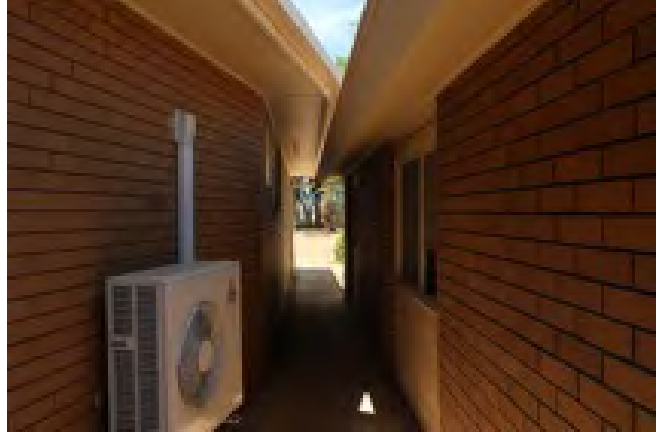
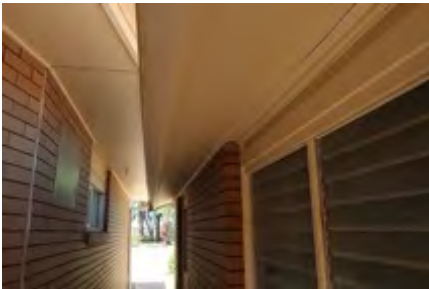
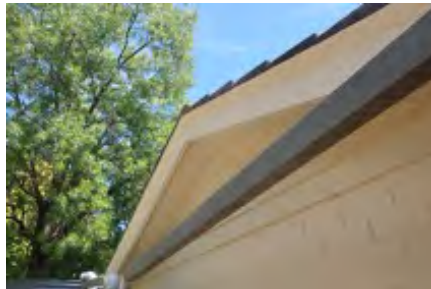
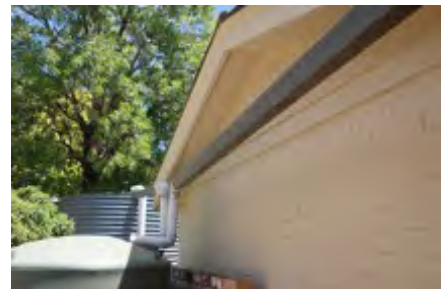
**Area 5****Garage: entire perimeter of building. The Soffit (F C Sheeting) has Asbestos Containing Material (ACM) present.****RISK ASSESSMENT**

<b>Type of Asbestos or Hazardous Material</b>	Chrysotile	<b>Condition</b>	GOOD	<b>Likelihood of Damage</b>	L (Low) – possible
	Same as Sample - 62136 -001	<b>Activity</b>	Moderate		
		<b>Sealed</b>	Yes	<b>Friability</b>	Bonded (non-friable)
		<b>Labelled</b>	Y	<b>Exposure Risk</b>	Low - Negligible or low risk
		<b>Quantity</b>

<b>Priority</b>	MEDIUM	<b>Label Required</b>	Yes	<b>Re- Audit Date</b>	16 Feb 2022
<b>Action</b>	No remedial action required, unless disturbed				
<b>Recommendation</b>	Maintain paint or sealant to ACM surfaces. Particular attention should be given to side edges, ensure paint/sealant covers ALL exposed ACM surfaces.				
<b>Legislative Requirements Victorian Regulation 2007</b>	Warning labels should be affixed. Avoid mechanical damage and abrasion. Remove if refurbishment, structural alteration or demolition is to be carried out in this area. Re-inspect every 12 months or earlier if disturbed or removed in accordance with the Victorian OH&S Regulation 2017. <b>All remedial/removal repairs require a Clearance Inspection &amp; Certificate to be recorded by an approved and competent assessor.</b>

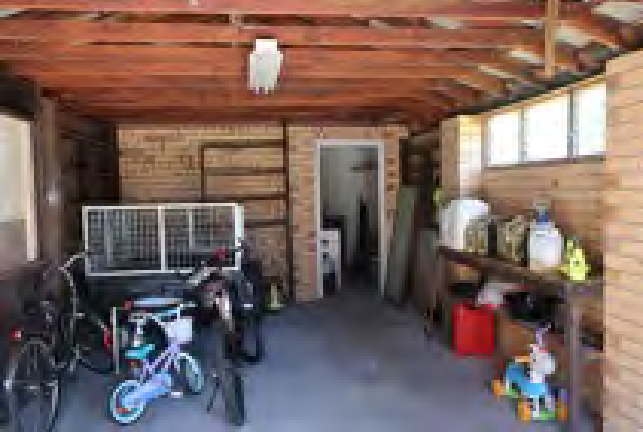
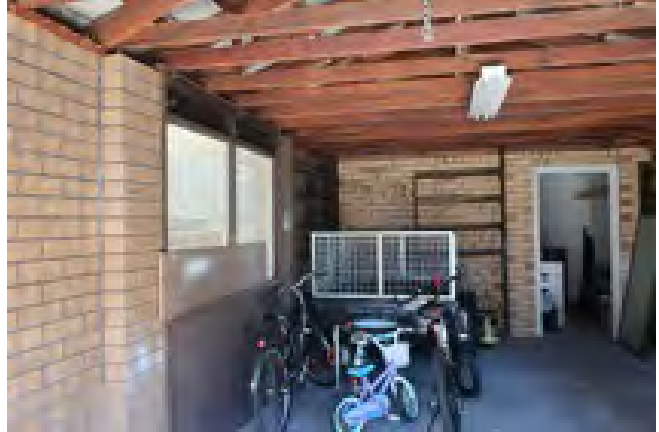
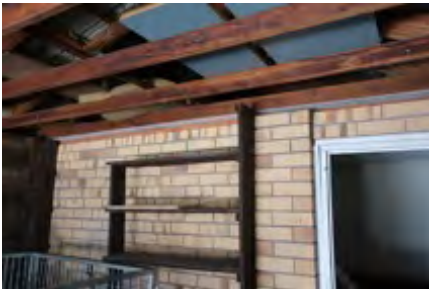
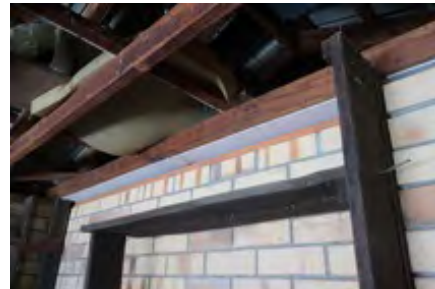
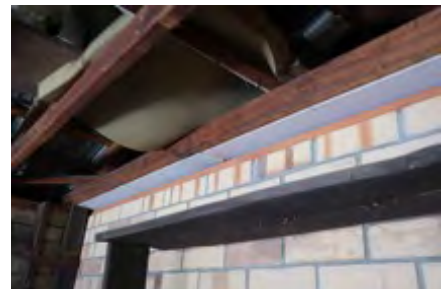
**Area 6****Garage: Garage 1. The Ceiling panels (F C Sheeting) has Asbestos Containing Material (ACM) present.****RISK ASSESSMENT**

<b>Type of Asbestos or Hazardous Material</b>	Chrysotile	<b>Condition</b>	GOOD	<b>Likelihood of Damage</b>	L (Low) – possible
	Same as Sample - 62136 -001	<b>Activity</b>	Moderate		
		<b>Sealed</b>	Yes	<b>Friability</b>	Bonded (non-friable)
		<b>Labelled</b>	Y	<b>Exposure Risk</b>	Low - Negligible or low risk
		<b>Quantity</b>

<b>Priority</b>	MEDIUM	<b>Label Required</b>	Yes	<b>Re- Audit Date</b>	16 Feb 2022
<b>Action</b>	No remedial action required, unless disturbed				
<b>Recommendation</b>	Maintain paint or sealant to ACM surfaces. Particular attention should be given to side edges, ensure paint/sealant covers ALL exposed ACM surfaces.				
<b>Legislative Requirements Victorian Regulation 2007</b>	Warning labels should be affixed. Avoid mechanical damage and abrasion. Remove if refurbishment, structural alteration or demolition is to be carried out in this area. Re-inspect every 12 months or earlier if disturbed or removed in accordance with the Victorian OH&S Regulation 2017. <b>All remedial/removal repairs require a Clearance Inspection &amp; Certificate to be recorded by an approved and competent assessor.</b>

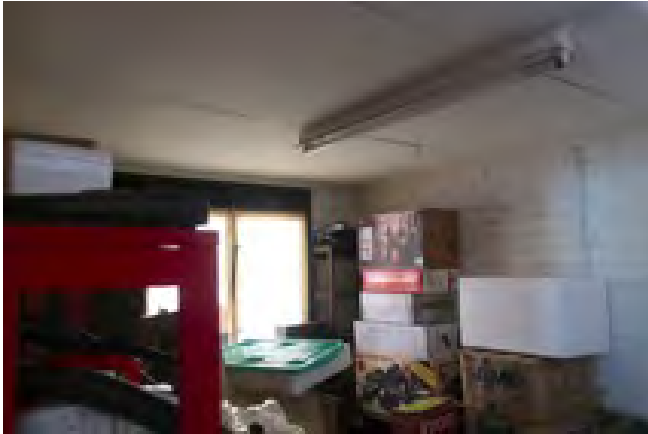
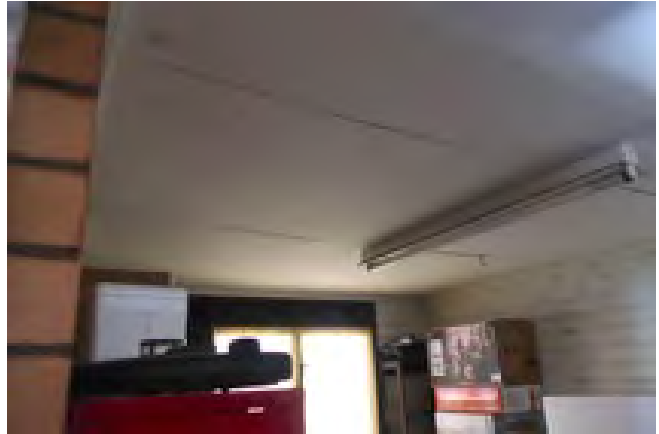
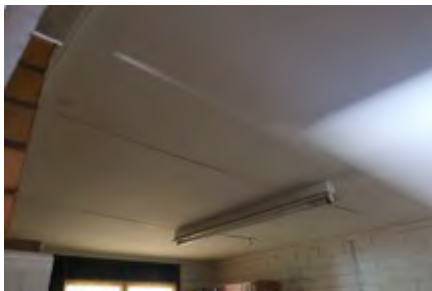
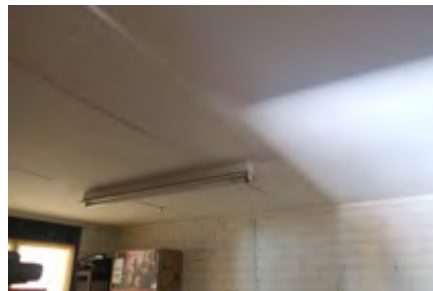
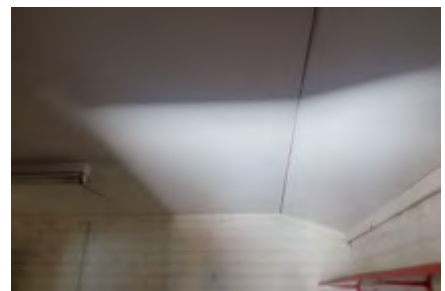
**Garage: Storage 2. The Ceiling (F C Sheeting) has Asbestos Containing Material (ACM) present.**

RISK ASSESSMENT					
Type of Asbestos or Hazardous Material	Chrysotile	Condition	GOOD	Likelihood of Damage	L (Low) – possible
	Same as Sample - 62136 -001	Activity	Moderate		
		Sealed	Yes	Friability	Bonded (non-friable)
		Labelled	Y	Exposure Risk	Low - Negligible or low risk
		Quantity

RISK CONTROL					
Priority	MEDIUM	Label Required	Yes	Re- Audit Date	16 Feb 2022
Action	No remedial action required, unless disturbed				
Recommendation	Maintain paint or sealant to ACM surfaces. Particular attention should be given to side edges, ensure paint/sealant covers ALL exposed ACM surfaces.				
Legislative Requirements Victorian Regulation 2007	Warning labels should be affixed. Avoid mechanical damage and abrasion. Remove if refurbishment, structural alteration or demolition is to be carried out in this area. Re-inspect every 12 months or earlier if disturbed or removed in accordance with the Victorian OH&S Regulation 2017. <b>All remedial/removal repairs require a Clearance Inspection &amp; Certificate to be recorded by an approved and competent assessor.</b>
