Asbestos Report

YARRIAMBIACK SHIRE COUNCIL

**PROPERTY ADDRESS:
LR15D SENIOR CITIZENS
26 JAMOUNEAU STREET
WARRACKNABEAL VIC 3393**

**INSPECTION DATE: 16 FEBRUARY 2021
REFERENCE NUMBER: 62138**

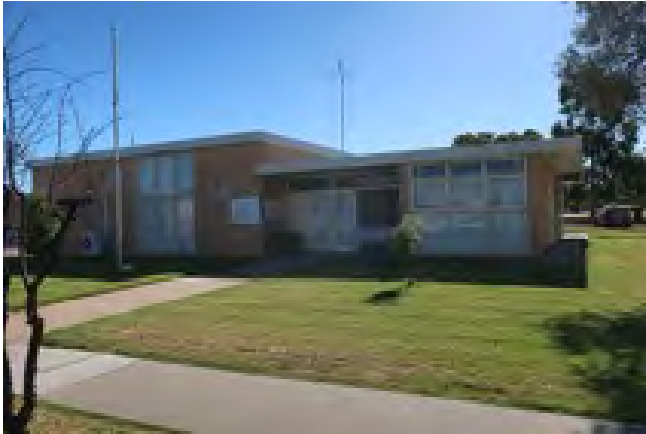
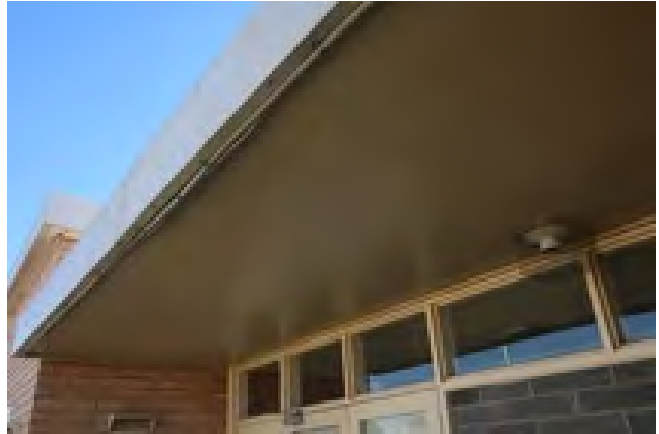
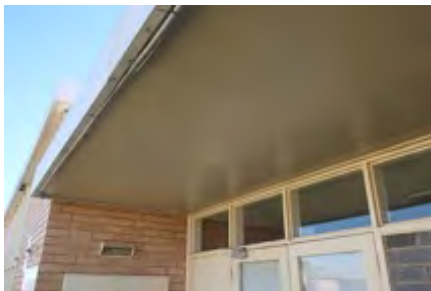
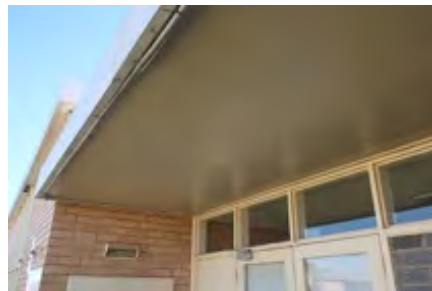
Area 2

LR15D Senior Citizens: front of building. The Awning - ceiling/ soffit (F C Sheeting) has Asbestos Containing Material (ACM) present.

RISK ASSESSMENT					
Type of Asbestos or Hazardous Material	No sample taken - Visual ID	Condition	GOOD	Likelihood of Damage	L (Low) – possible
		Activity	Moderate		
		Sealed	Yes	Friability	Bonded (non-friable)
		Labelled	Y	Exposure Risk	Low - Negligible or low risk
		Quantity

RISK CONTROL					
Priority	MEDIUM	Label Required	Yes	Re- Audit Date	16 Feb 2022
Action	No remedial action required, unless disturbed				
Recommendation	Maintain paint or sealant to ACM surfaces. Particular attention should be given to side edges, ensure paint/sealant covers ALL exposed ACM surfaces.				
Legislative Requirements Victorian Regulation 2007	Warning labels should be affixed. Avoid mechanical damage and abrasion. Remove if refurbishment, structural alteration or demolition is to be carried out in this area. Re-inspect every 12 months or earlier if disturbed or removed in accordance with the Victorian OH&S Regulation 2017. All remedial/removal repairs require a Clearance Inspection & Certificate to be recorded by an approved and competent assessor.

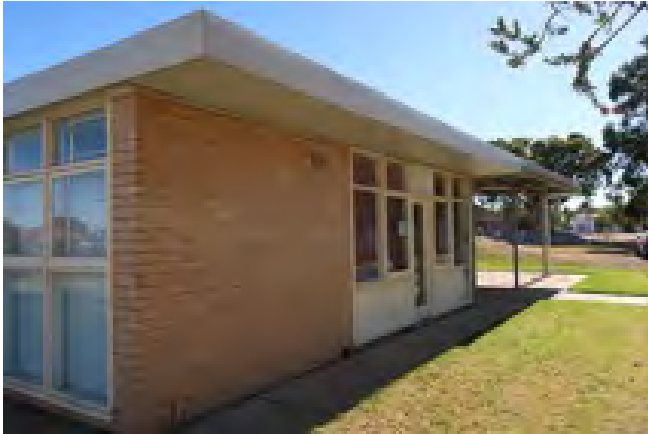
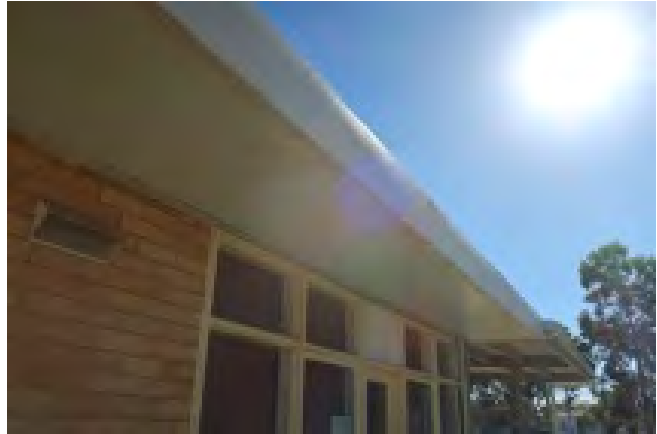
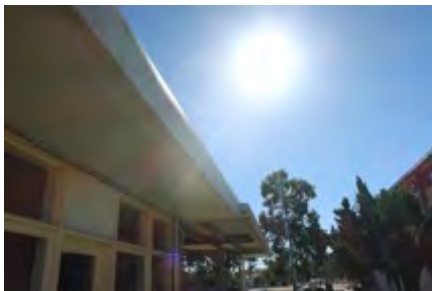
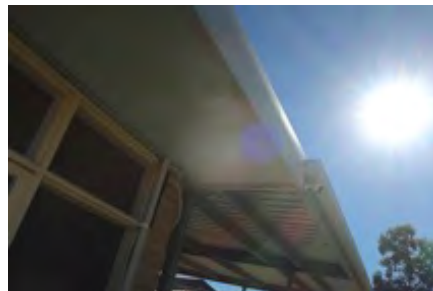
LR15D Senior Citizens: right side of building. The Awning - ceiling/ soffit (F C Sheeting) has Asbestos Containing Material (ACM) present.

RISK ASSESSMENT					
Type of Asbestos or Hazardous Material	No sample taken - Visual ID	Condition	GOOD	Likelihood of Damage	L (Low) – possible
		Activity	Moderate		
		Sealed	Yes	Friability	Bonded (non-friable)
		Labelled	Y	Exposure Risk	Low - Negligible or low risk
		Quantity

RISK CONTROL					
Priority	MEDIUM	Label Required	Yes	Re- Audit Date	16 Feb 2022
Action	No remedial action required, unless disturbed				
Recommendation	Maintain paint or sealant to ACM surfaces. Particular attention should be given to side edges, ensure paint/sealant covers ALL exposed ACM surfaces.				
Legislative Requirements Victorian Regulation 2007	Warning labels should be affixed. Avoid mechanical damage and abrasion. Remove if refurbishment, structural alteration or demolition is to be carried out in this area. Re-inspect every 12 months or earlier if disturbed or removed in accordance with the Victorian OH&S Regulation 2017. All remedial/removal repairs require a Clearance Inspection & Certificate to be recorded by an approved and competent assessor.

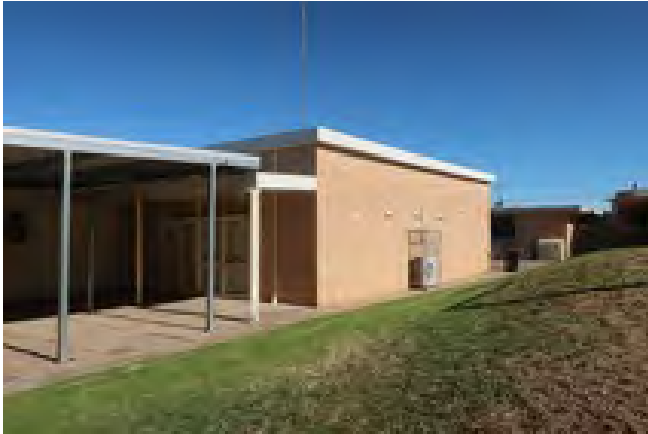
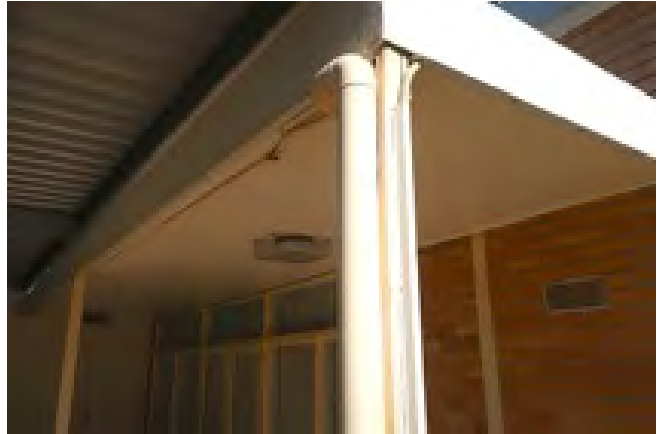
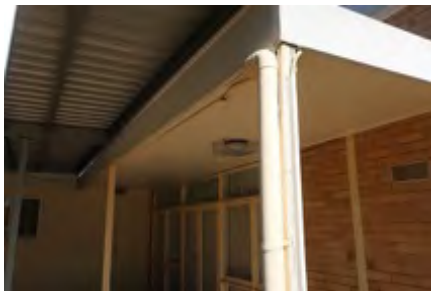
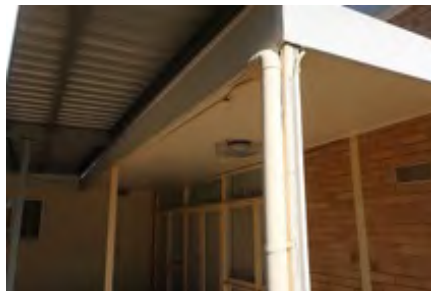
Type of Asbestos or Hazardous Material	No sample taken - Visual ID	Condition	GOOD	Likelihood of Damage	L (Low) – possible
		Activity	Moderate		
		Sealed	Yes	Friability	Bonded (non-friable)
		Labelled	Y	Exposure Risk	Low - Negligible or low risk
		Quantity

Priority	MEDIUM	Label Required	Yes	Re- Audit Date	16 Feb 2022
Action	No remedial action required, unless disturbed				
Recommendation	Maintain paint or sealant to ACM surfaces. Particular attention should be given to side edges, ensure paint/sealant covers ALL exposed ACM surfaces.				
Legislative Requirements Victorian Regulation 2007	Warning labels should be affixed. Avoid mechanical damage and abrasion. Remove if refurbishment, structural alteration or demolition is to be carried out in this area. Re-inspect every 12 months or earlier if disturbed or removed in accordance with the Victorian OH&S Regulation 2017. All remedial/removal repairs require a Clearance Inspection & Certificate to be recorded by an approved and competent assessor.

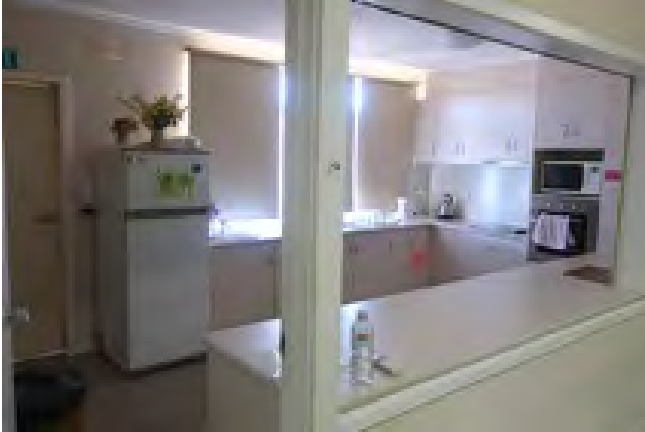
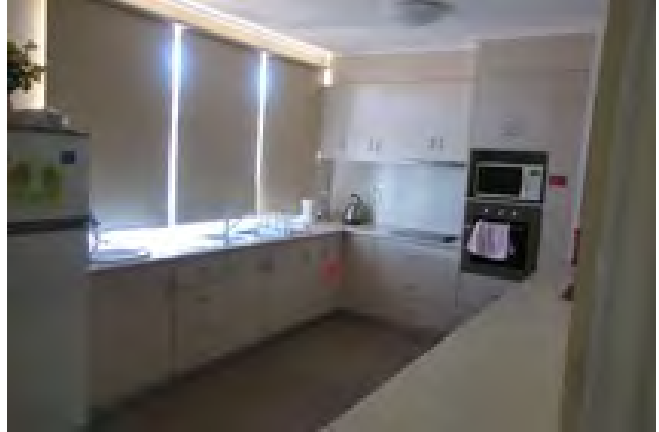
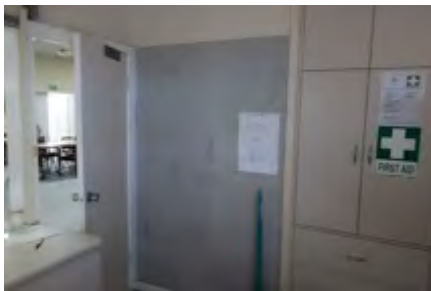
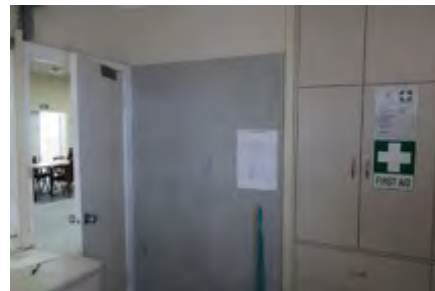
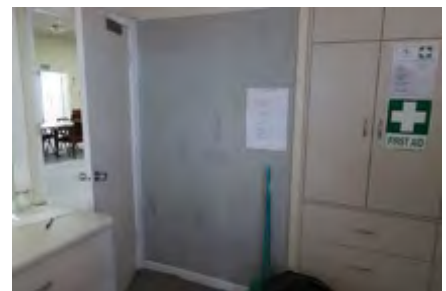
Area 3**LR15D Senior Citizens: Kitchen 4. The Wall (Vinyl Tiles) has Asbestos Containing Material (ACM) present.****RISK ASSESSMENT**

Type of Asbestos or Hazardous Material	Chrysotile	Condition	GOOD	Likelihood of Damage	L (Low) – possible
	Sample taken 62138-003	Activity	Moderate		
		Sealed	Yes	Friability	Bonded (non-friable)
		Labelled	Y	Exposure Risk	Low - Negligible or low risk
		Quantity

Priority	MEDIUM	Label Required	Yes	Re- Audit Date	16 Feb 2022
Action	No remedial action required, unless disturbed				
Recommendation	Maintain paint or sealant to ACM surfaces. Particular attention should be given to side edges, ensure paint/sealant covers ALL exposed ACM surfaces.				
Legislative Requirements Victorian Regulation 2007	Warning labels should be affixed. Avoid mechanical damage and abrasion. Remove if refurbishment, structural alteration or demolition is to be carried out in this area. Re-inspect every 12 months or earlier if disturbed or removed in accordance with the Victorian OH&S Regulation 2017. All remedial/removal repairs require a Clearance Inspection & Certificate to be recorded by an approved and competent assessor.

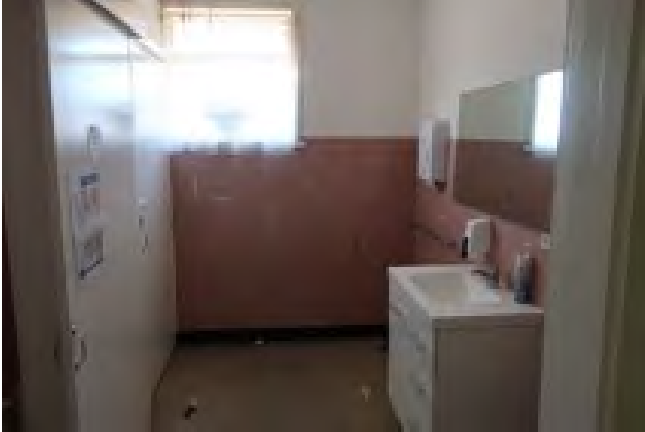
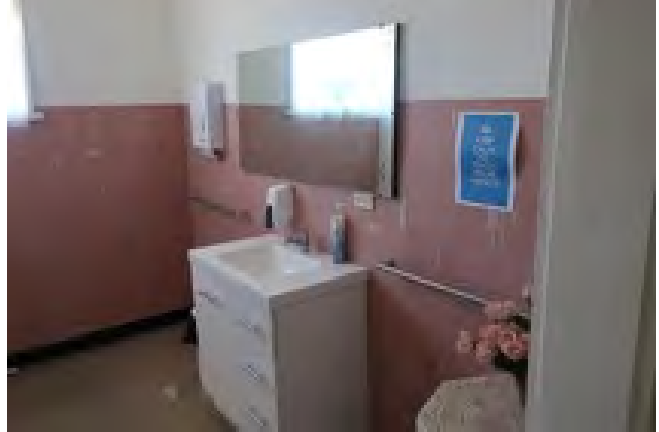
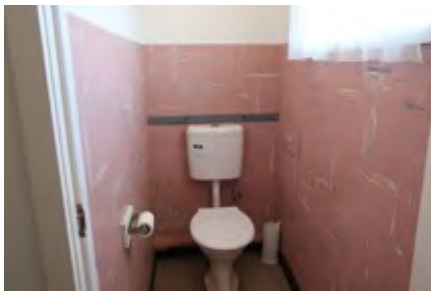
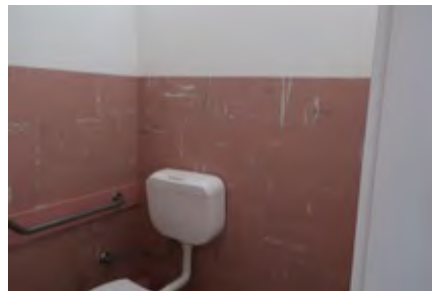
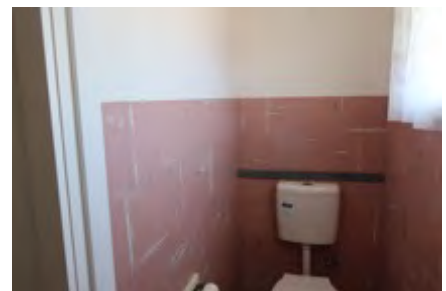
Area 1**LR15D Senior Citizens: Female bathroom 6. The Walls (Vinyl Tiles) has Asbestos Containing Material (ACM) present.****RISK ASSESSMENT**

Type of Asbestos or Hazardous Material	Chrysotile	Condition	GOOD	Likelihood of Damage	L (Low) – possible
	Sample taken 62138-004	Activity	Moderate		
		Sealed	Yes	Friability	Bonded (non-friable)
		Labelled	Y	Exposure Risk	Low - Negligible or low risk
		Quantity

Priority	MEDIUM	Label Required	Yes	Re- Audit Date	16 Feb 2022
Action	No remedial action required, unless disturbed				
Recommendation	Maintain paint or sealant to ACM surfaces. Particular attention should be given to side edges, ensure paint/sealant covers ALL exposed ACM surfaces.				
Legislative Requirements Victorian Regulation 2007	Warning labels should be affixed. Avoid mechanical damage and abrasion. Remove if refurbishment, structural alteration or demolition is to be carried out in this area. Re-inspect every 12 months or earlier if disturbed or removed in accordance with the Victorian OH&S Regulation 2017. All remedial/removal repairs require a Clearance Inspection & Certificate to be recorded by an approved and competent assessor.

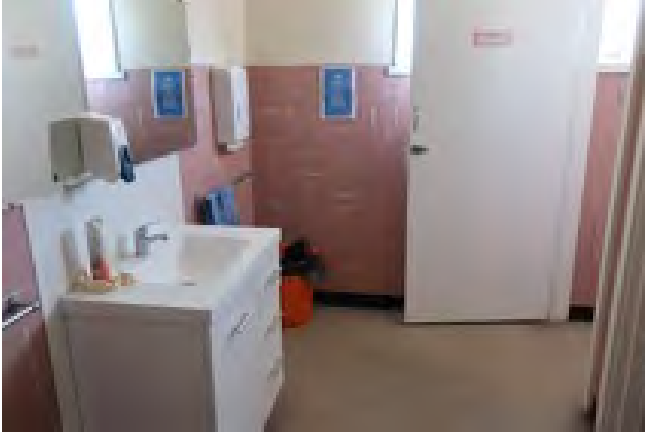
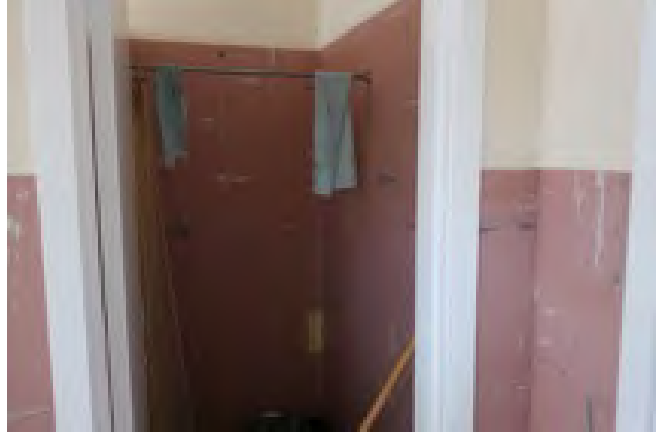
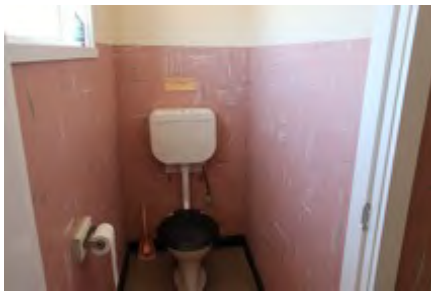
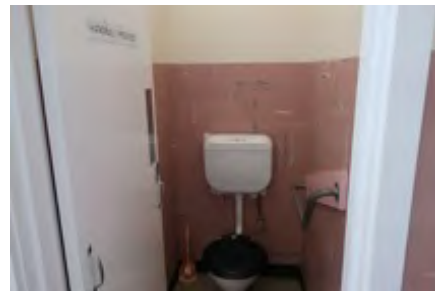
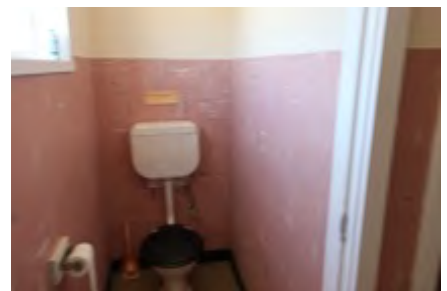
Area 4**LR15D Senior Citizens: Male bathroom 7. The Walls (Vinyl Tiles) has Asbestos Containing Material (ACM) present.****RISK ASSESSMENT**

Type of Asbestos or Hazardous Material	Chrysotile	Condition	GOOD	Likelihood of Damage	L (Low) – possible
	Same as Sample - 62138-004	Activity	Moderate		
		Sealed	Yes	Friability	Bonded (non-friable)
		Labelled	Y	Exposure Risk	Low - Negligible or low risk
		Quantity

Priority	MEDIUM	Label Required	Yes	Re- Audit Date	16 Feb 2022
Action	No remedial action required, unless disturbed				
Recommendation	Maintain paint or sealant to ACM surfaces. Particular attention should be given to side edges, ensure paint/sealant covers ALL exposed ACM surfaces.				
Legislative Requirements Victorian Regulation 2007	Warning labels should be affixed. Avoid mechanical damage and abrasion. Remove if refurbishment, structural alteration or demolition is to be carried out in this area. Re-inspect every 12 months or earlier if disturbed or removed in accordance with the Victorian OH&S Regulation 2017. All remedial/removal repairs require a Clearance Inspection & Certificate to be recorded by an approved and competent assessor.
