Asbestos Report

YARRIAMBIACK SHIRE COUNCIL

PROPERTY ADDRESS:
LB101 SHIRE DEPOT
1 PYERS STREET
WARRACKNABEAL VIC 3393

INSPECTION DATE: 16 FEBRUARY 2021
REFERENCE NUMBER: 62139

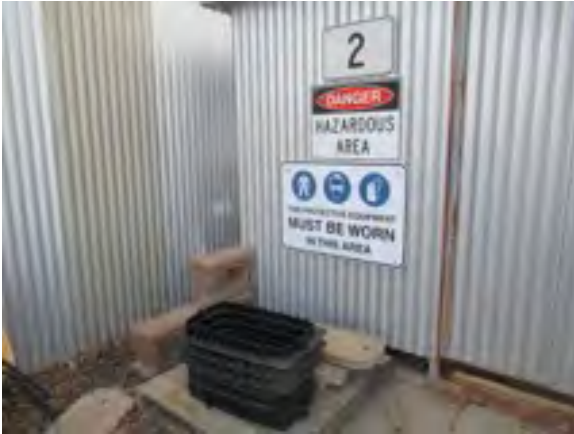
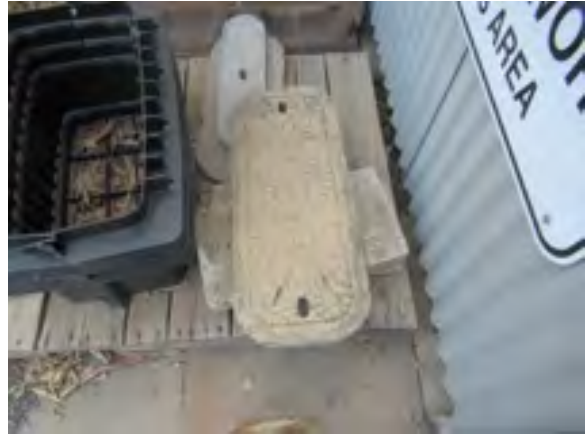
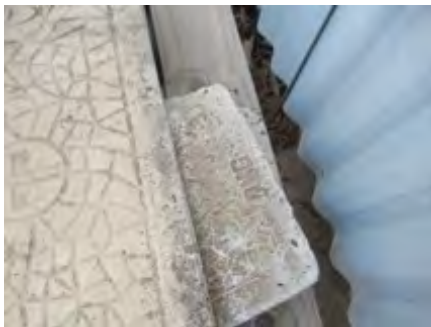
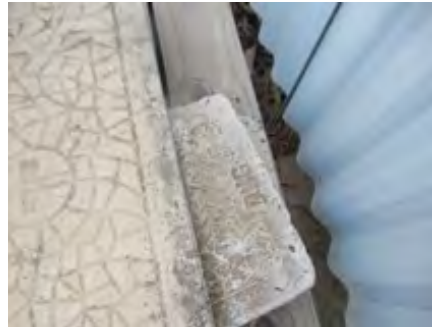
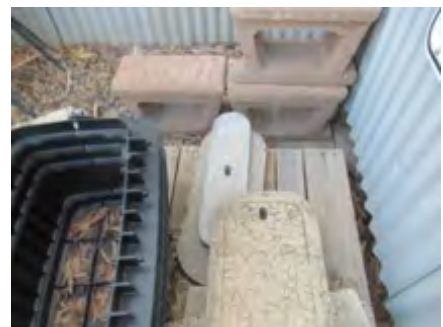
Area 1

Type of Asbestos or Hazardous Material	No sample taken - Visual ID	Condition	AVERAGE	Likelihood of Damage	High
		Activity	Moderate		
		Sealed	No	Friability	Exposed Fibres
		Labelled	No	Exposure Risk	Medium - Moderate risk
		Quantity

Priority	HIGH	Label Required	Yes	Re- Audit Date	16 Feb 2022
Action	Remedial repairs required - seal raw material / edges				
Recommendation	The Pit lids may come from asbestos pits, therefore the edges/sides will be contaminated with asbestos fibres and then can cause cross contamination and possible exposure - put in place a clean & remediate lids at the time of removal using asbestos controls. Remediate lids stored on site.				
Legislative Requirements Victorian Regulation 2007	ACM debris visible. Recommend cleanup by licensed Asbestos Removalist. Warning labels should be affixed. Avoid mechanical damage and abrasion. Re-inspect every 12 months or earlier if disturbed or removed in accordance with the Victorian OH&S Regulation 2017. All remedial/removal repairs require a Clearance Inspection & Certificate to be recorded by an approved and competent assessor.

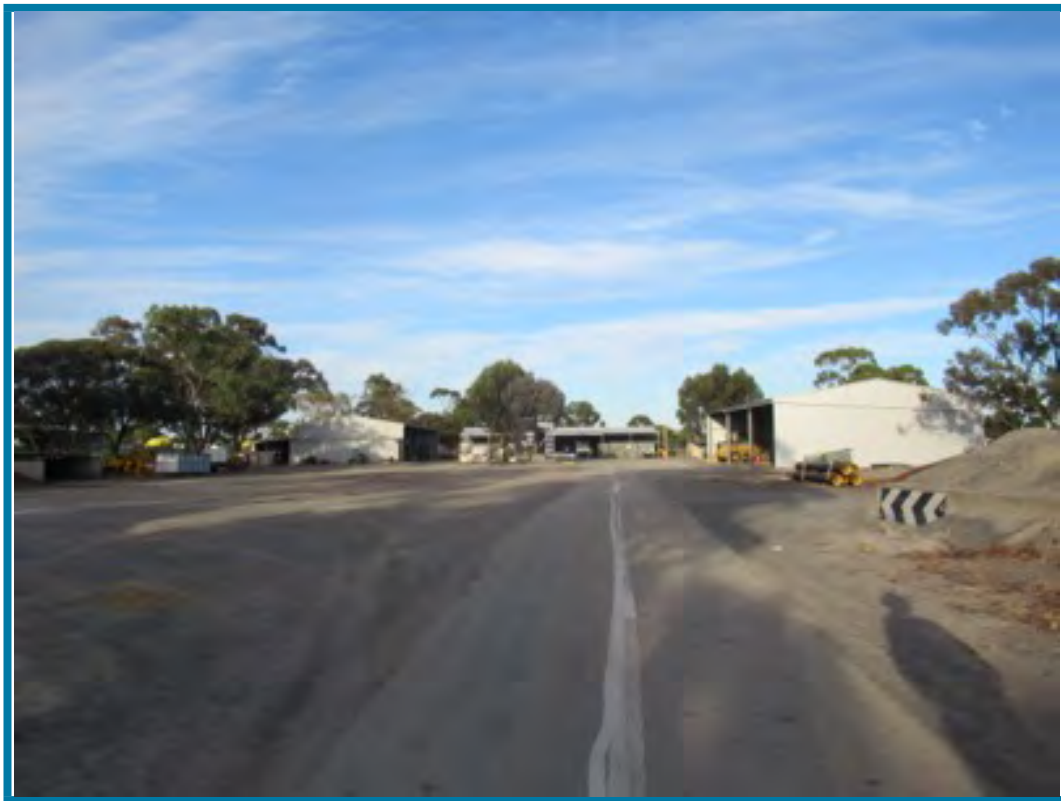
Location	Area	Component Materials	ACM Identified	Type Asbestos Assessment	ConditionPriority	Signage Required
Grounds - Grounds.		No Asbestos Materials	No	No sample taken - Visual ID

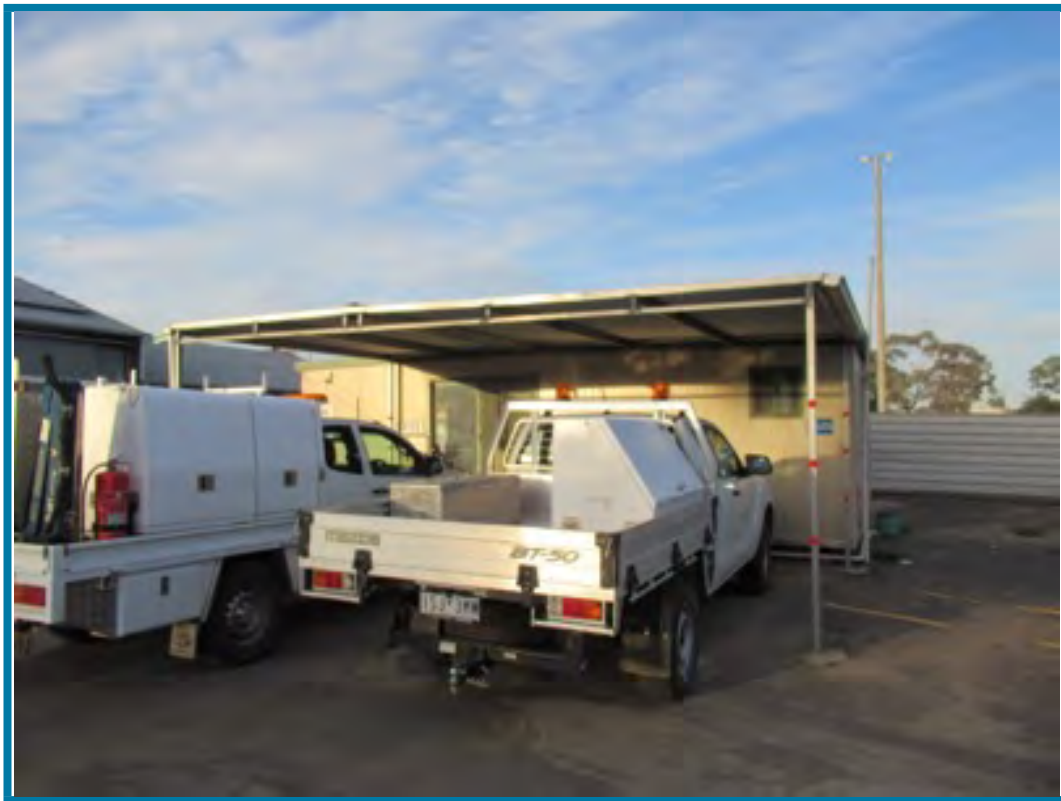
Location	Area	Component Materials	ACM Identified	Type Asbestos Assessment	ConditionPriority	Signage Required
Office - entire perimeter of building.		No Asbestos Materials	No	No sample taken - Visual ID

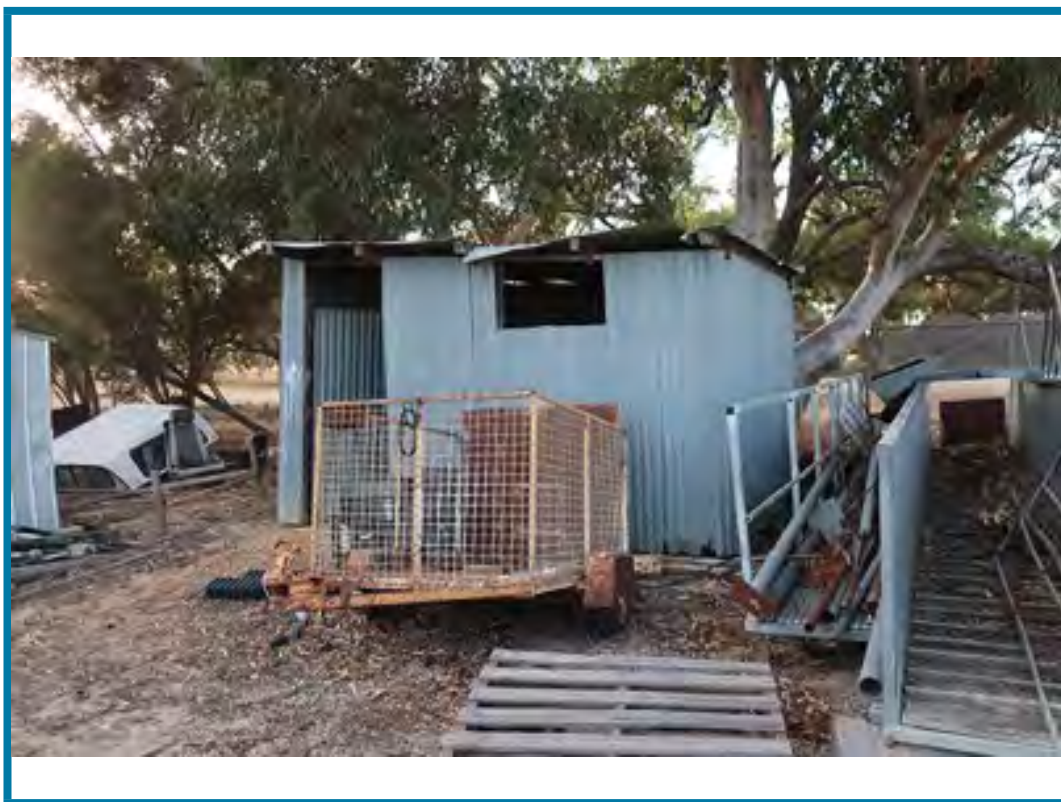
Location	Area	Component Materials	ACM Identified	Type Asbestos Assessment	ConditionPriority	Signage Required
Shed - entire perimeter of building.		No Asbestos Materials	No	No sample taken - Visual ID

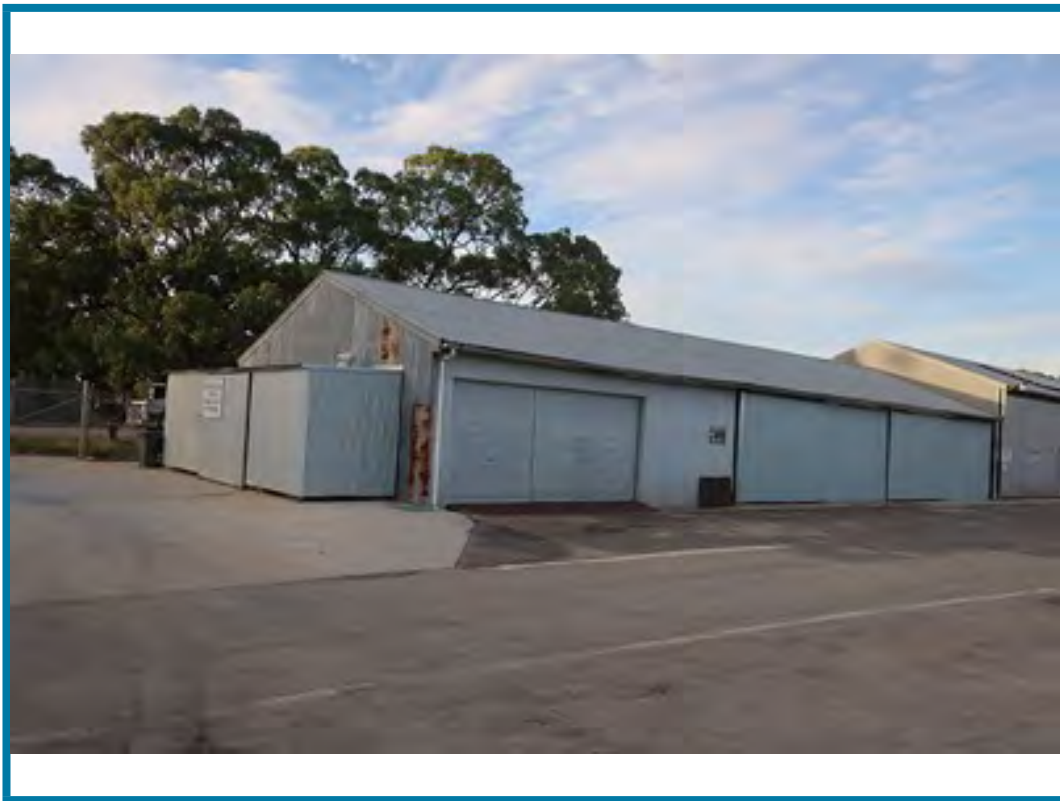
Location	Area	Component Materials	ACM Identified	Type Asbestos Assessment	ConditionPriority	Signage Required
Shed 1 LB101 Shire Depot - entire perimeter of building.		No Asbestos Materials	No	No sample taken - Visual ID

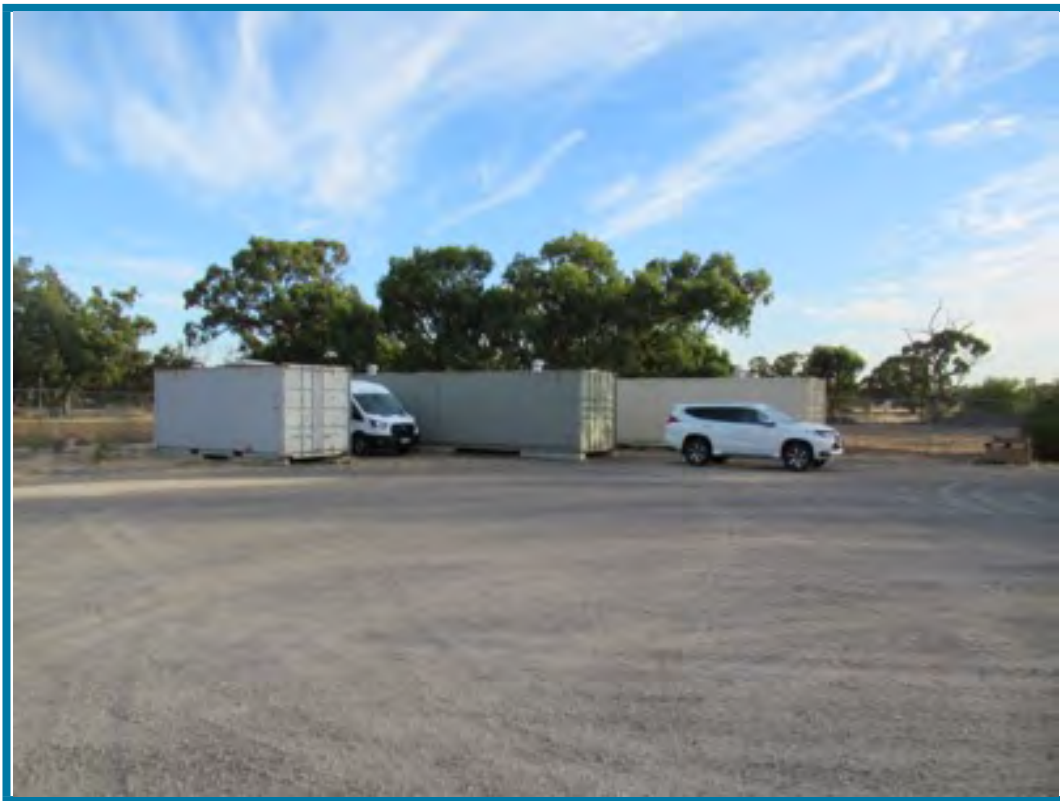
Location	Area	Component Materials	ACM Identified	Type Asbestos Assessment	ConditionPriority	Signage Required
Shipping containers x3 - entire perimeter of building.	 	No Asbestos Materials	No	No sample taken - Visual ID
