Asbestos Report

YARRIAMBIACK SHIRE COUNCIL

PROPERTY ADDRESS:
LR15C TECH OFFICE
28 JAMOUNEAU STREET
WARRACKNABEAL VIC 3393

INSPECTION DATE: 16 FEBRUARY 2021
REFERENCE NUMBER: 62143

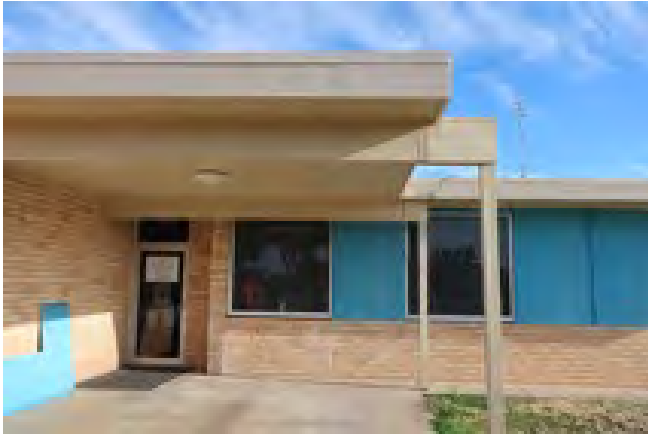
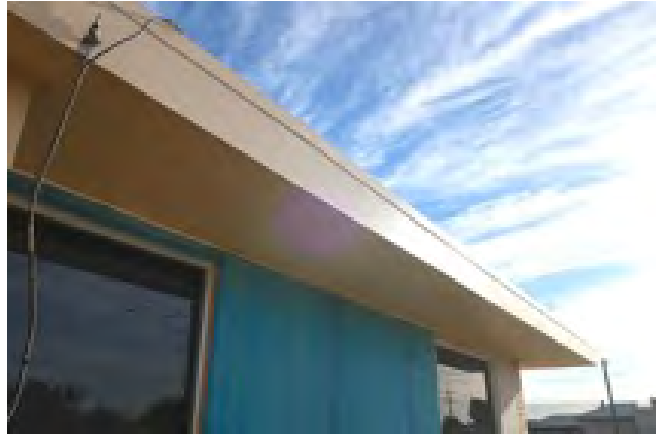
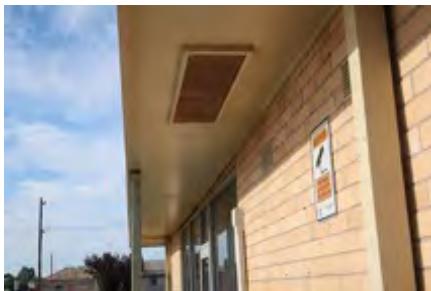
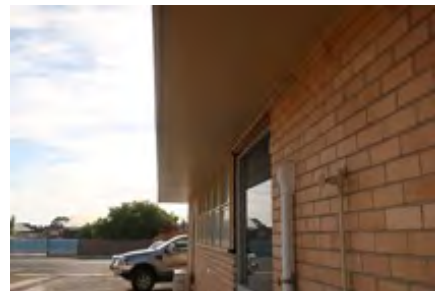
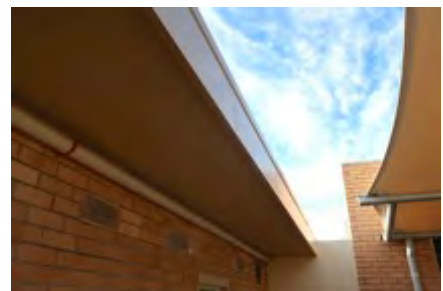
Area 2

| RISK ASSESSMENT | | | | | |
|--|--|---|---|---|---|
| Type of Asbestos or Hazardous Material | Chrysotile Amosite Crocidolite Sample taken 62143-001 | Condition | GOOD | Likelihood of Damage | L (Low) – possible |
| | | Labelled | Y | Exposure Risk | Low - Negligible or low risk |

| RISK CONTROL | | | | | |
|--|--|---|---|---|---|
| Recommendation | Maintain paint or sealant to ACM surfaces. Particular attention should be given to side edges, ensure paint/sealant covers ALL exposed ACM surfaces. | | | | |

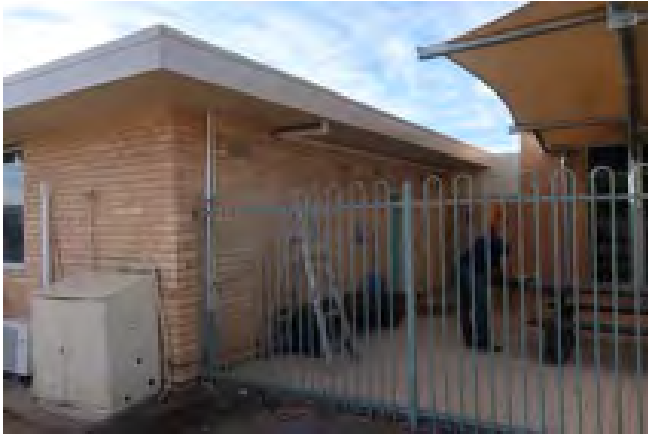
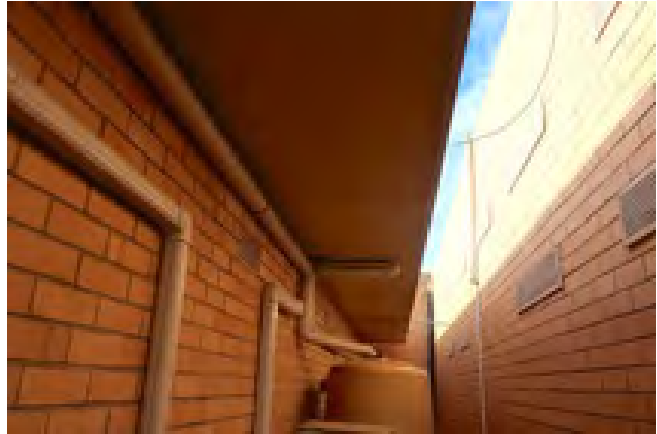
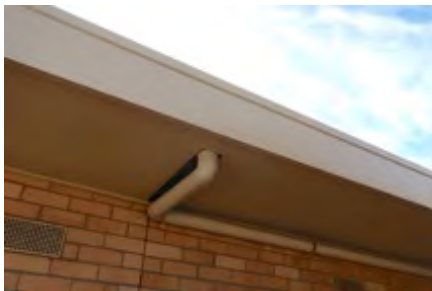
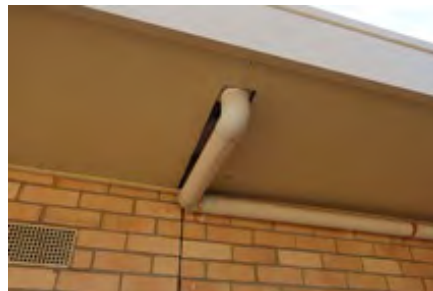
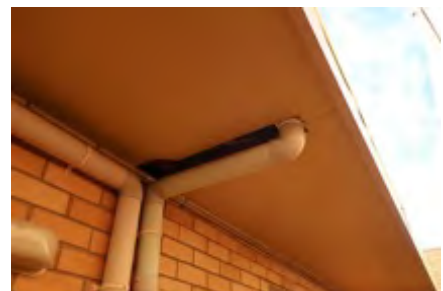
| RISK ASSESSMENT | | | | | |
|--|---|---|---|---|---|
| Type of Asbestos or Hazardous Material | Chrysotile | Condition | AVERAGE | Likelihood of Damage | L (Low) – possible |
| | Sample taken 62143-002 | Labelled | Y | Exposure Risk | Medium - Moderate risk |

Penetration Holes

| RISK CONTROL | | | | | |
|--|---|---|---|---|---|
| Legislative Requirements Victorian Regulation 2007 | Damaged ACM visible in area. Requires IMMEDIATE ATTENTION. WARNING labels should be affixed. Avoid mechanical damage and abrasion. Remove if refurbishment, structural alteration or demolition is to be carried out in this area. Re-inspect every 12 months or earlier if disturbed or removed in accordance with the Victorian OH&S Regulation 2017. All remedial/removal repairs require a Clearance Inspection & Certificate to be recorded by an approved and competent assessor. | | | | |

| RISK CONTROL | | | | | |
|--|---|---|---|---|---|
| Action | Remedial repairs required - seal raw material / edges | | | | |
| Recommendation | Penetration Holes - The exposed edges require approved sealant. It is further recommended the gaps be filled with sealant. | | | | |

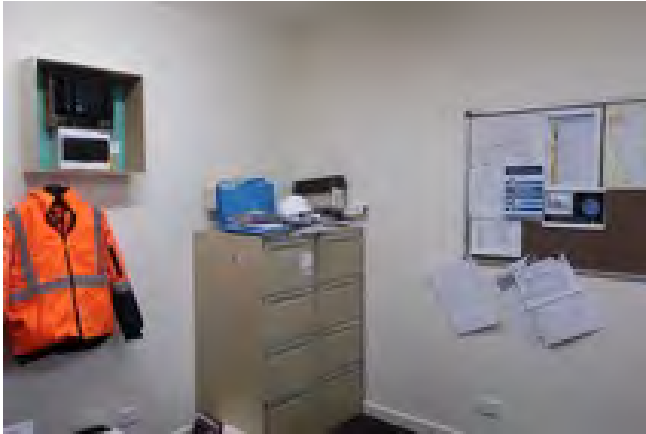
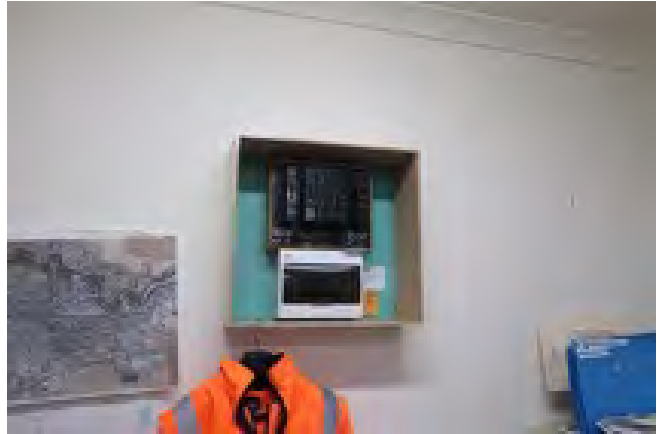
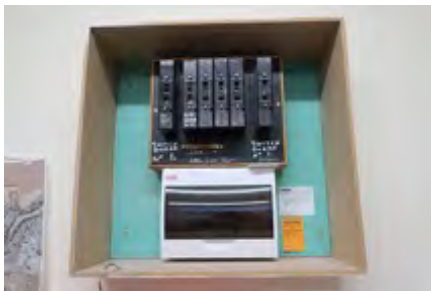
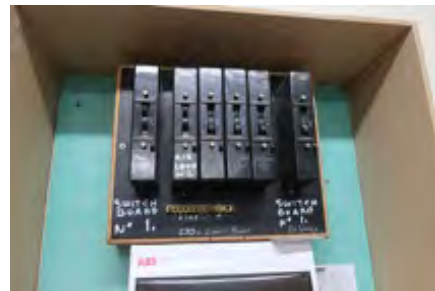
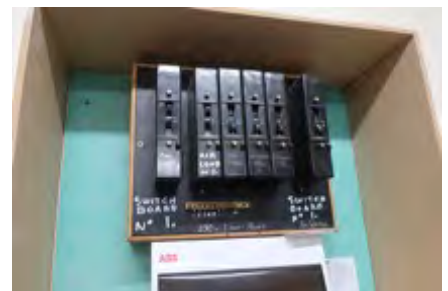
| RISK ASSESSMENT | | | | | |
|--|---|---|---|---|---|
| Type of Asbestos or Hazardous Material | No sample taken - Visual ID | Condition | GOOD | Likelihood of Damage | L (Low) – possible |
| | | Labelled | Y | Exposure Risk | Low - Negligible or low risk |

| RISK CONTROL | | | | | |
|--|--|---|---|---|---|
| Recommendation | Maintain paint or sealant to ACM surfaces. Particular attention should be given to side edges, ensure paint/sealant covers ALL exposed ACM surfaces. | | | | |

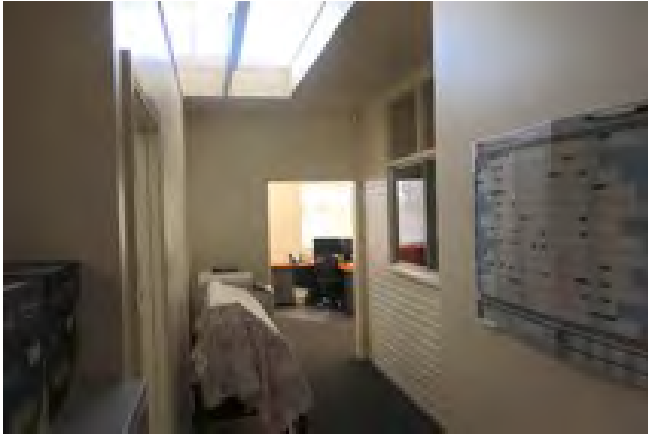
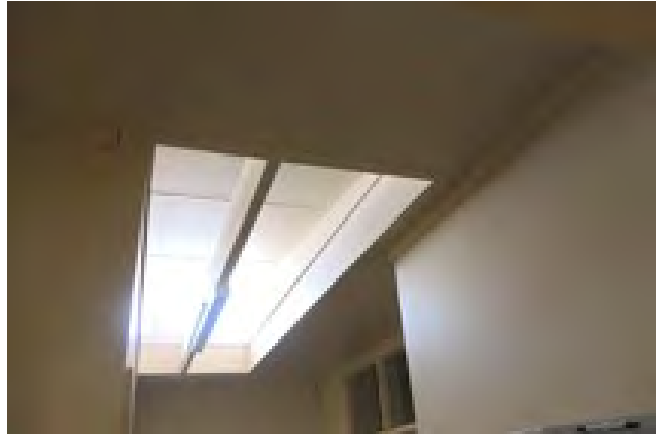
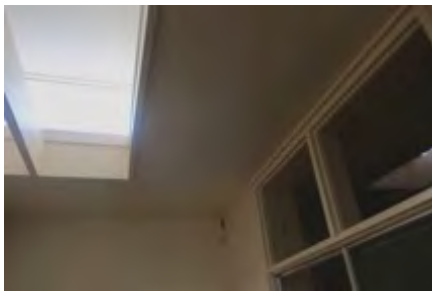
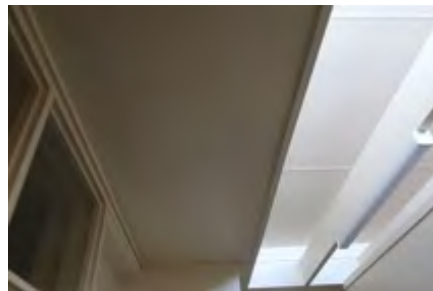
| RISK ASSESSMENT | | | | | |
|--|---|---|---|---|---|
| Type of Asbestos or Hazardous Material | Chrysotile Crocidolite | Condition | GOOD | Likelihood of Damage | L (Low) – possible |
| | | Labelled | Y | Exposure Risk | Low - Negligible or low risk |

| RISK CONTROL | | | | | |
|--|--|---|---|---|---|
| Recommendation | Maintain paint or sealant to ACM surfaces. Particular attention should be given to side edges, ensure paint/sealant covers ALL exposed ACM surfaces. | | | | |

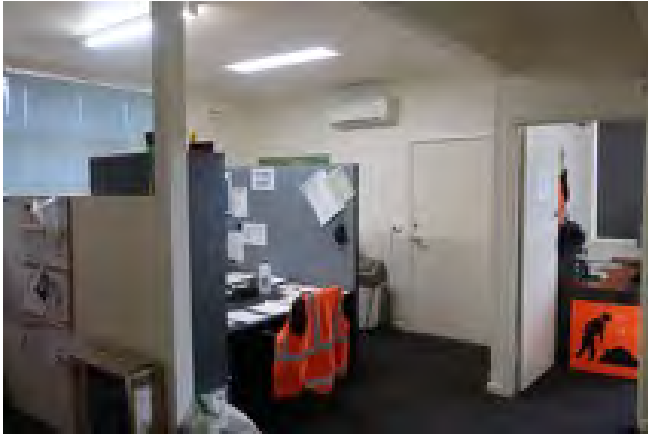
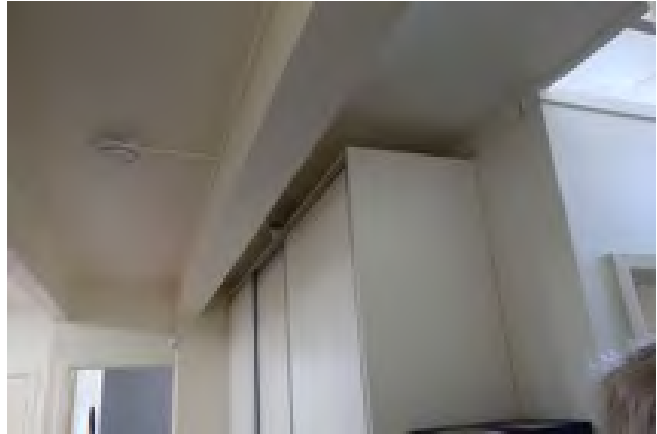
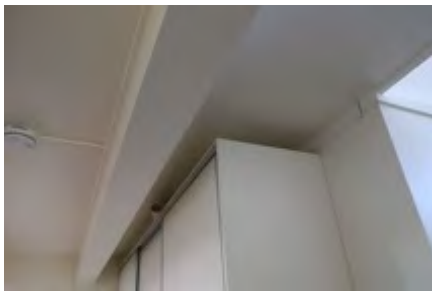
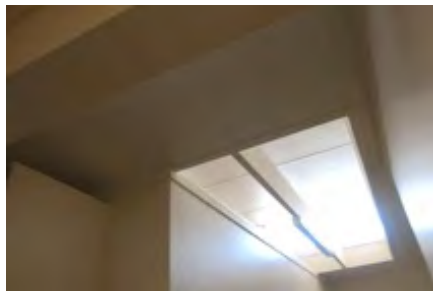
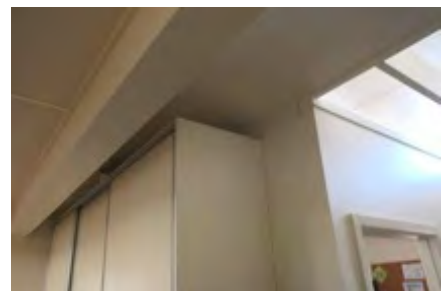
| RISK ASSESSMENT | | | | | |
|--|---|---|---|---|---|
| Type of Asbestos or Hazardous Material | Chrysotile Crocidolite Sample taken 62143-004 | Condition | GOOD | Likelihood of Damage | L (Low) – possible |
| | | Labelled | Y | Exposure Risk | Low - Negligible or low risk |

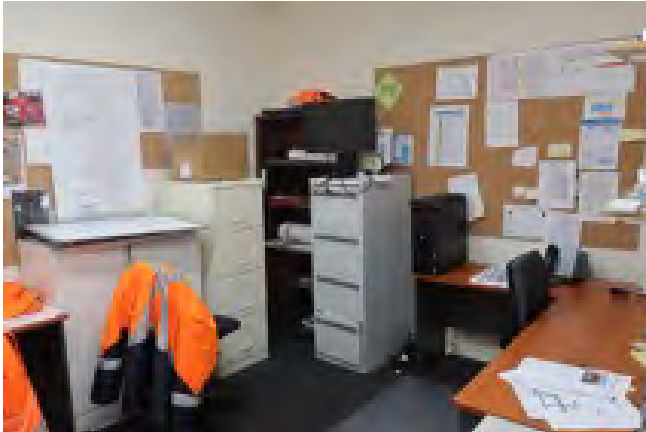
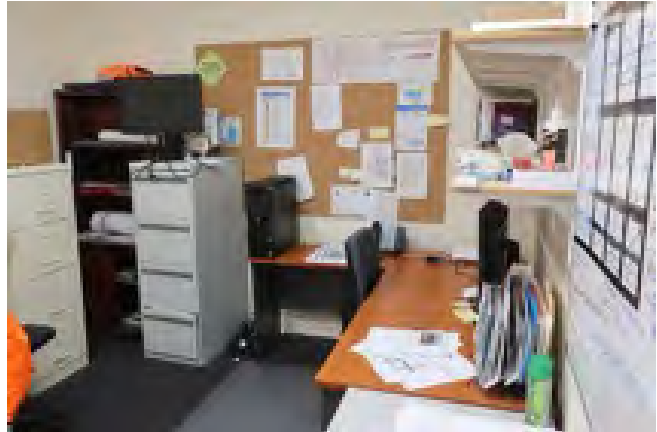
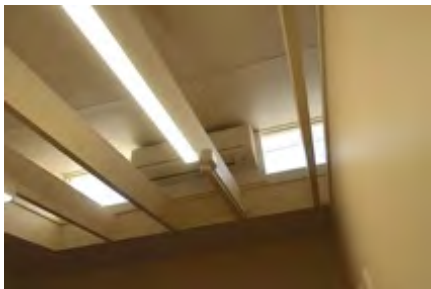
| RISK ASSESSMENT | | | | | |
|--|--|---|---|---|---|
| Type of Asbestos or Hazardous Material | Chrysotile Crocidolite Same as Sample - 62143 -004 | Condition | GOOD | Likelihood of Damage | L (Low) – possible |
| | | Labelled | Y | Exposure Risk | Low - Negligible or low risk |

| RISK CONTROL | | | | | |
|--|--|---|---|---|---|
| Recommendation | Maintain paint or sealant to ACM surfaces. Particular attention should be given to side edges, ensure paint/sealant covers ALL exposed ACM surfaces. | | | | |

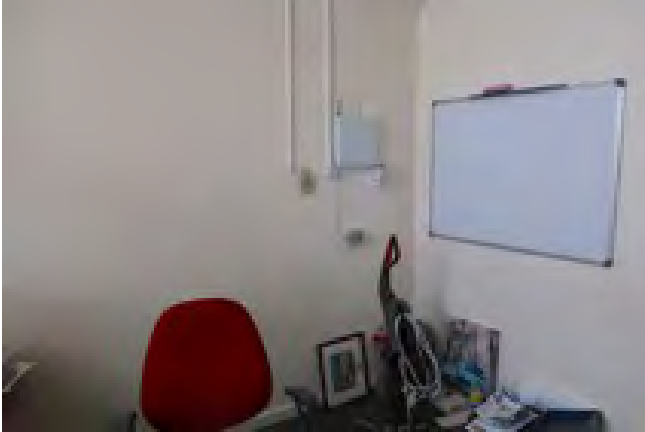
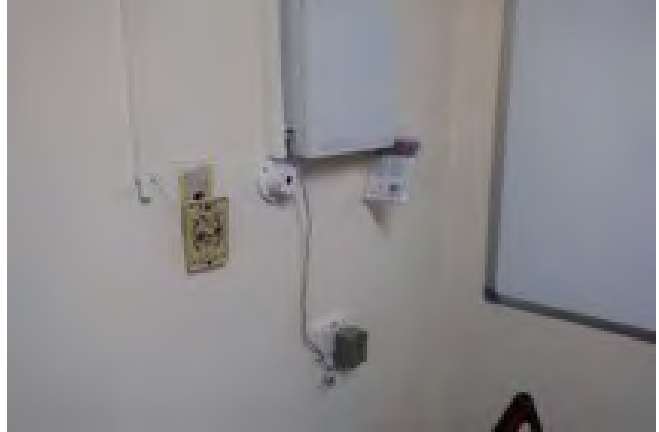
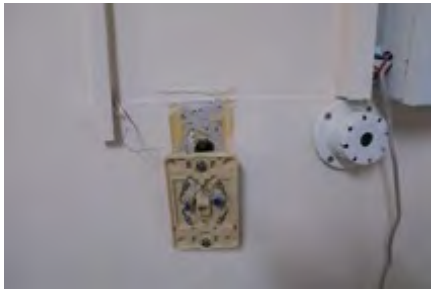
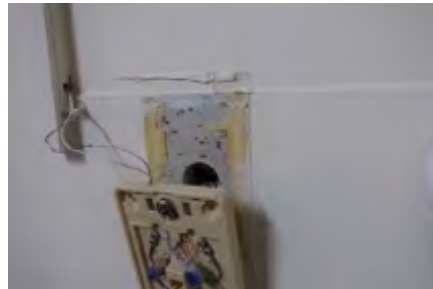
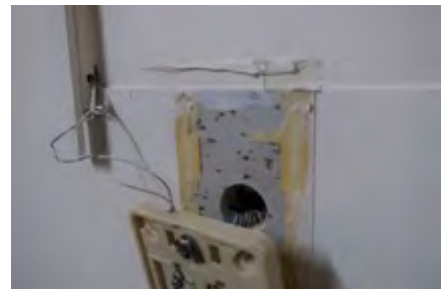
| Type of Asbestos or Hazardous Material | Chrysotile | Condition | GOOD | Likelihood of Damage | L (Low) – possible |
| | | Labelled | Y | Exposure Risk | Low - Negligible or low risk |

| Recommendation | Maintain paint or sealant to ACM surfaces. Particular attention should be given to side edges, ensure paint/sealant covers ALL exposed ACM surfaces. | | | | |

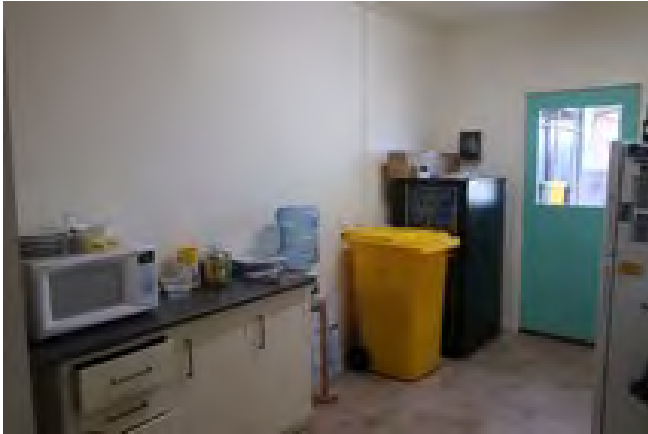
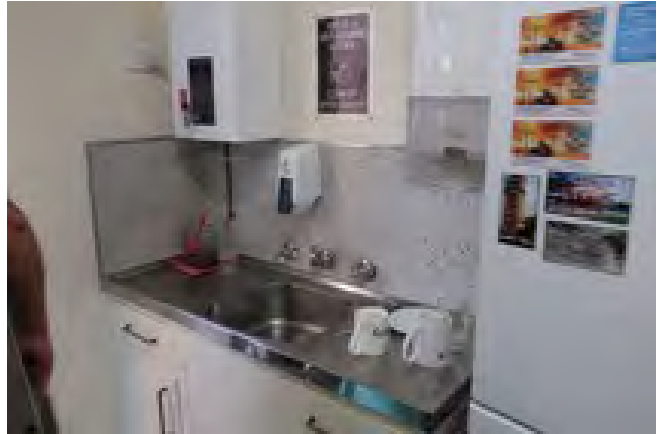
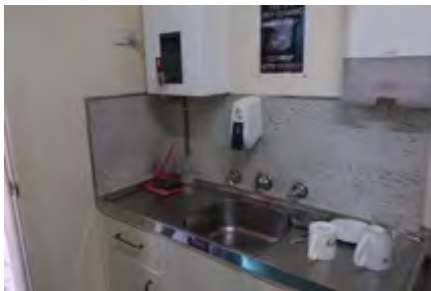
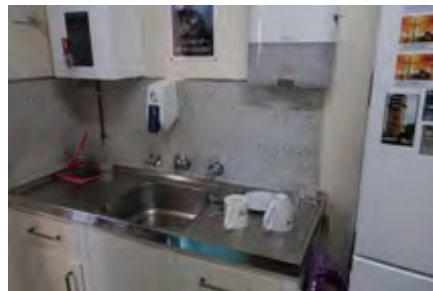
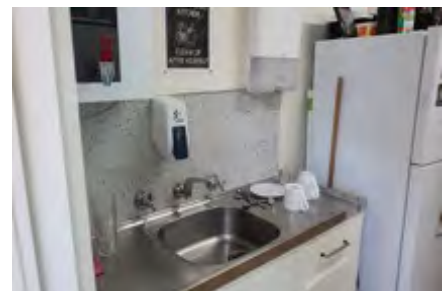
| RISK ASSESSMENT | | | | | |
|--|---|---|---|---|---|
| Type of Asbestos or Hazardous Material | Chrysotile | Condition | GOOD | Likelihood of Damage | L (Low) – possible |

| Recommendation | Maintain paint or sealant to ACM surfaces. Particular attention should be given to side edges, ensure paint/sealant covers ALL exposed ACM surfaces. | | | | |

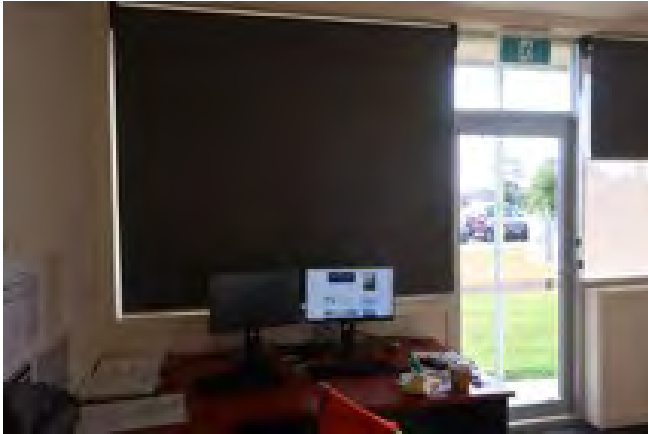
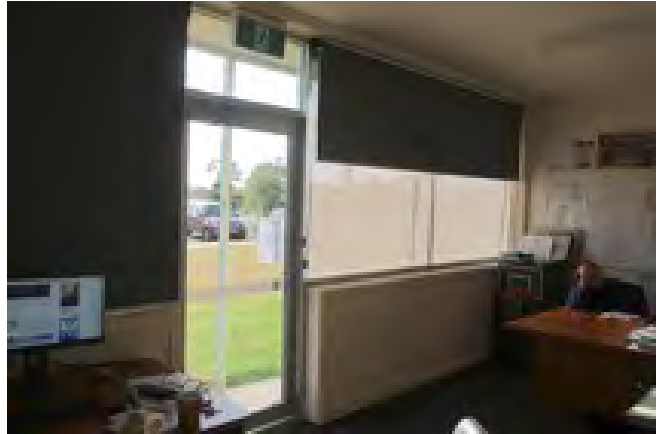
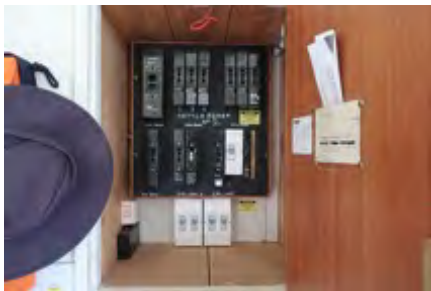
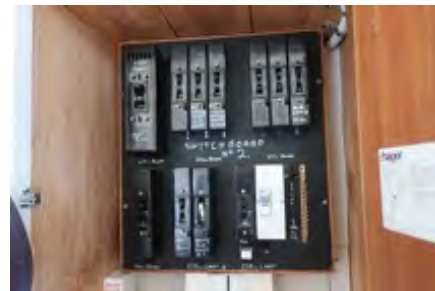
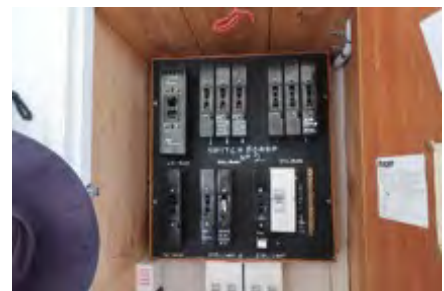
| RISK ASSESSMENT | | | | | |
|--|---|---|---|---|---|
| Type of Asbestos or Hazardous Material | No sample taken - Visual ID | Condition | GOOD | Likelihood of Damage | L (Low) – possible |
| | | Labelled | Y | Exposure Risk | Low - Negligible or low risk |

| RISK CONTROL | | | | | |
|--|--|---|---|---|---|
| Recommendation | Maintain paint or sealant to ACM surfaces. Particular attention should be given to side edges, ensure paint/sealant covers ALL exposed ACM surfaces. | | | | |

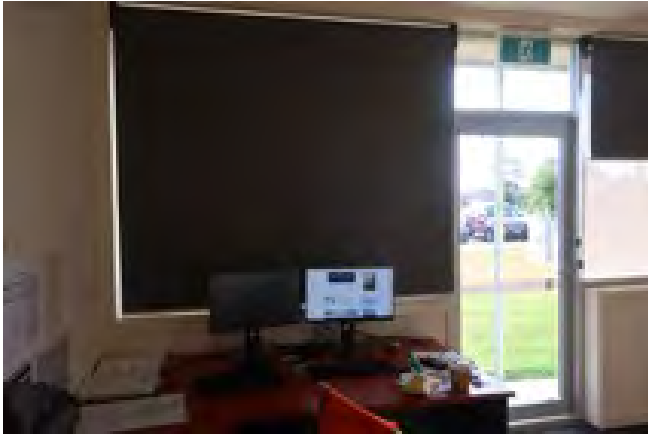
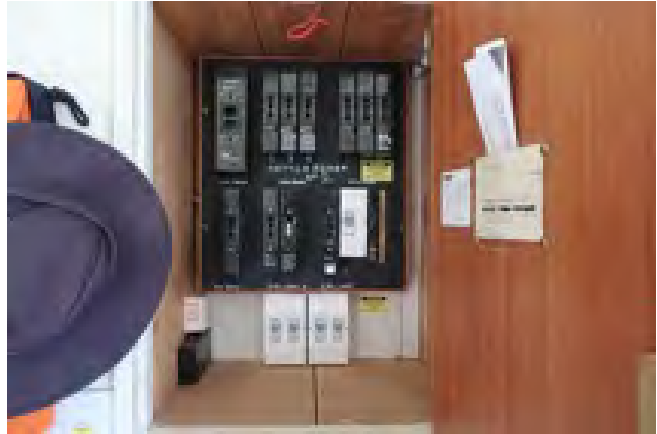
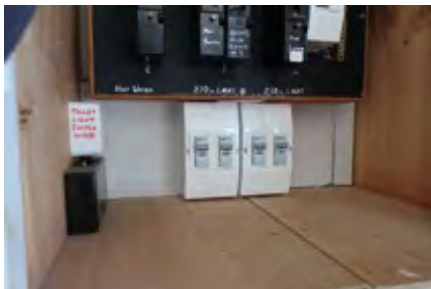
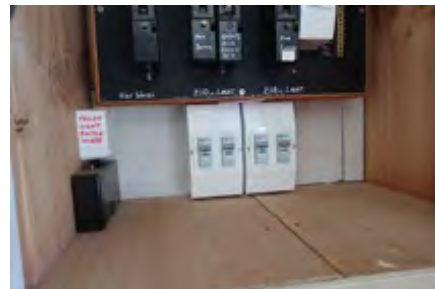
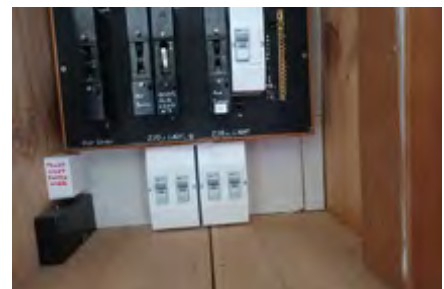
| RISK ASSESSMENT | | | | | |
|--|---|---|---|---|---|
| Type of Asbestos or Hazardous Material | No sample taken - Visual ID | Condition | GOOD | Likelihood of Damage | L (Low) – possible |
| | | Labelled | Y | Exposure Risk | Low - Negligible or low risk |

| RISK CONTROL | | | | | |
|--|--|---|---|---|---|
| Recommendation | Maintain paint or sealant to ACM surfaces. Particular attention should be given to side edges, ensure paint/sealant covers ALL exposed ACM surfaces. | | | | |
