# Asbestos Report

YARRIAMBIACK SHIRE COUNCIL

PROPERTY ADDRESS:  
LB17 TIP WARRACKNABEAL  
108 TIP ROAD  
WARRACKNABEAL VIC 3393

INSPECTION DATE: 16 FEBRUARY 2021  
REFERENCE NUMBER: 62144

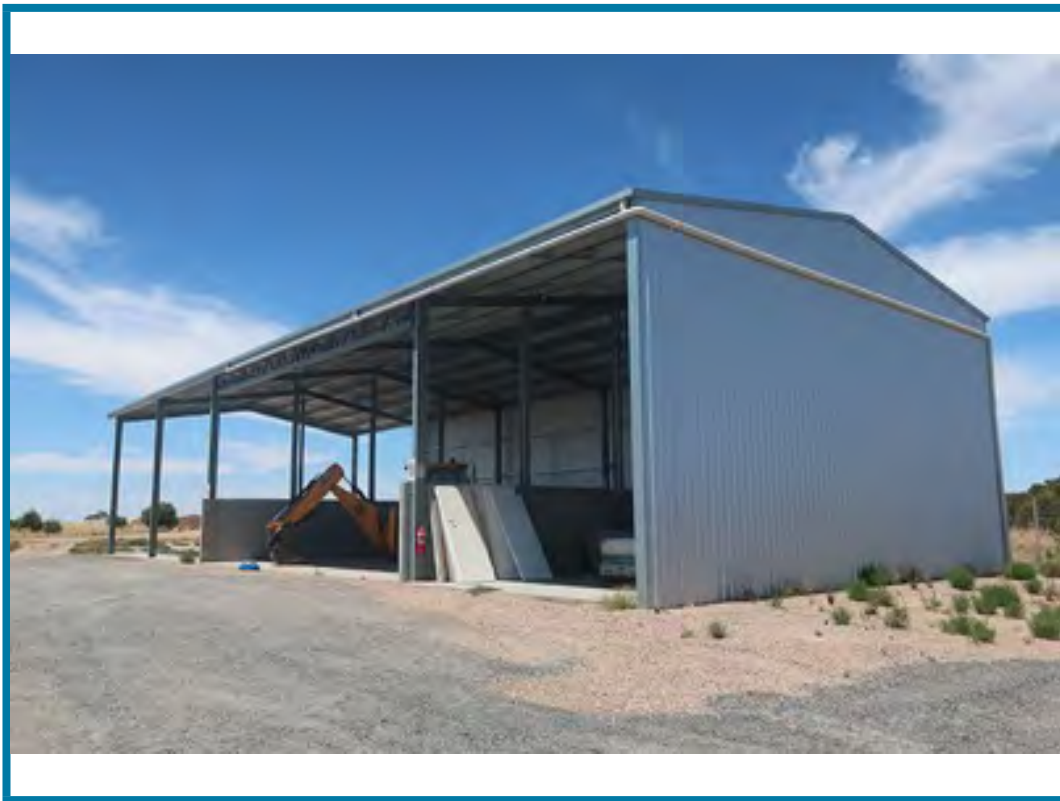
# Machinery shed

Location	Area	Component Materials	ACM Identified	Type Asbestos Assessment	ConditionPriority	Signage Required
Machinery shed - entire perimeter of building.		No Asbestos Materials	No	No sample taken - Visual ID

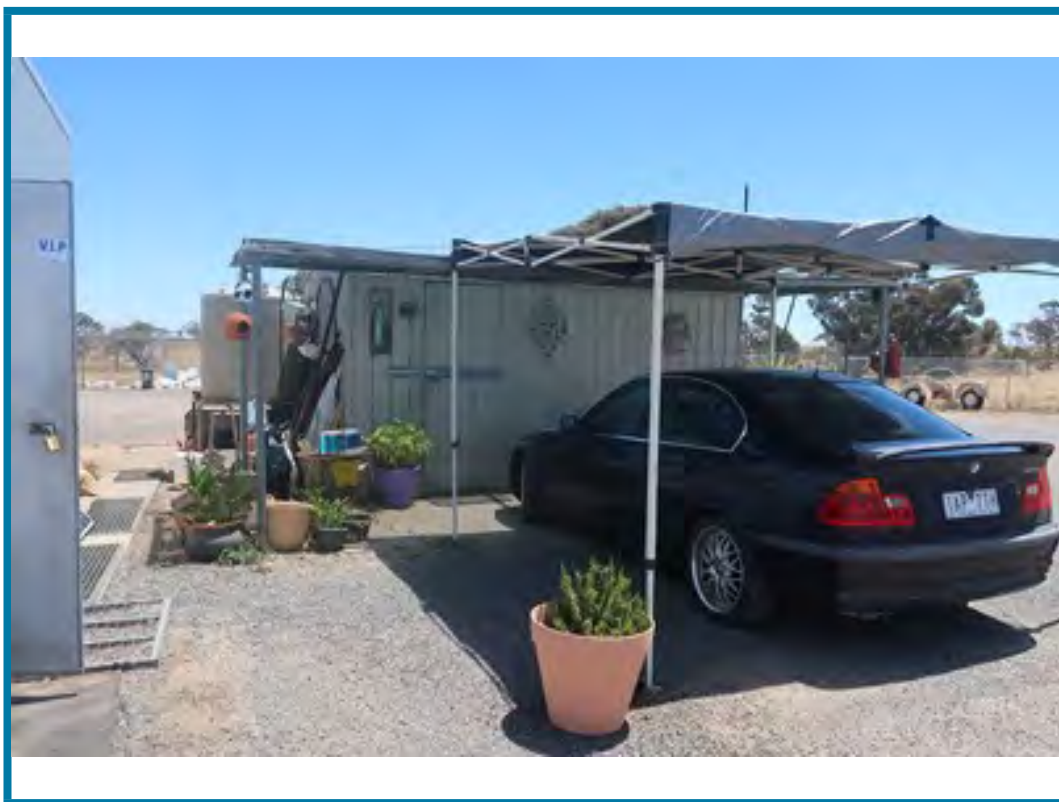
# Main Shed

Location	Area	Component Materials	ACM Identified	Type Asbestos Assessment	ConditionPriority	Signage Required
Main Shed - entire perimeter of building.		No Asbestos Materials	No	No sample taken - Visual ID

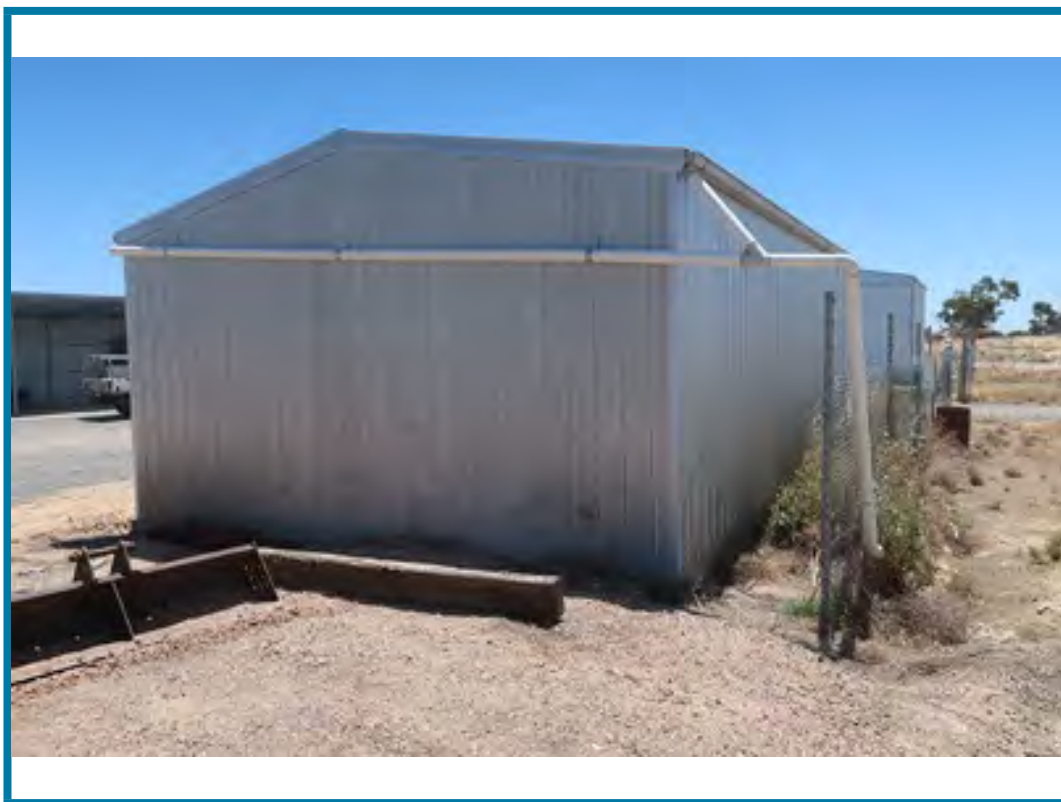
# Second chance shed

Location	Area	Component Materials	ACM Identified	Type Asbestos Assessment	Condition Priority	Signage Required
Second chance shed - entire perimeter of building.		No Asbestos Materials	No	No sample taken - Visual ID

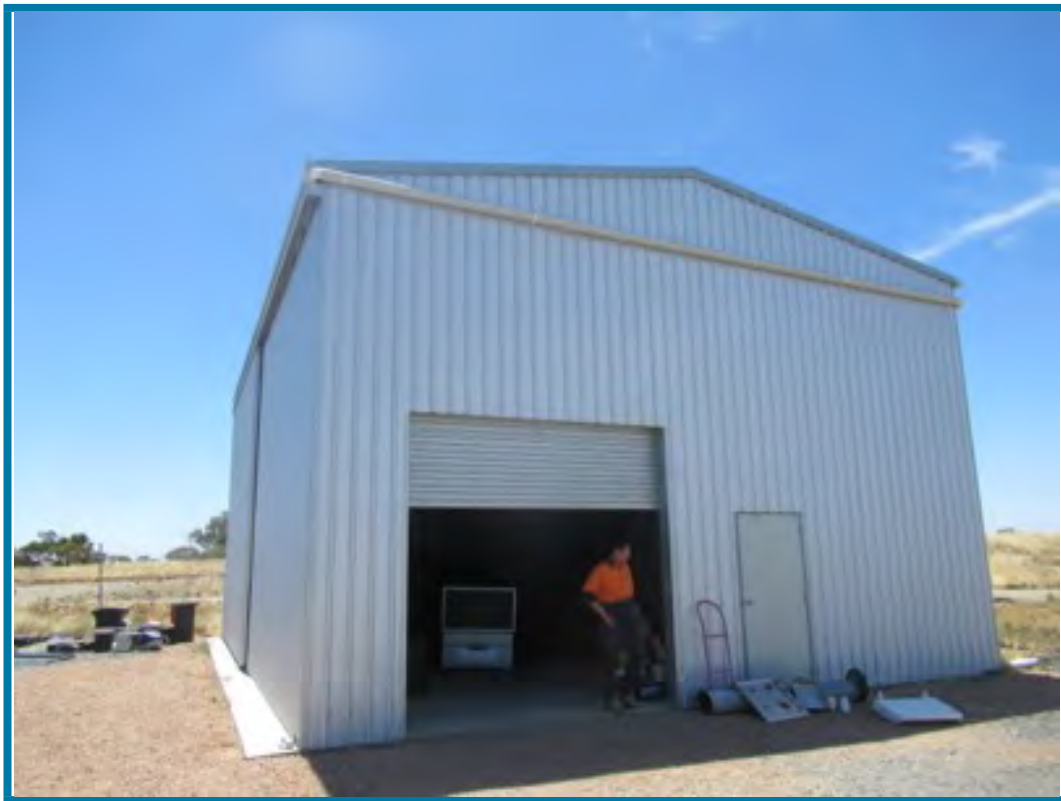
# Shed

Location	Area	Component Materials	ACM Identified	Type Asbestos Assessment	ConditionPriority	Signage Required
Shed - entire perimeter of building.		No Asbestos Materials	No	No sample taken - Visual ID

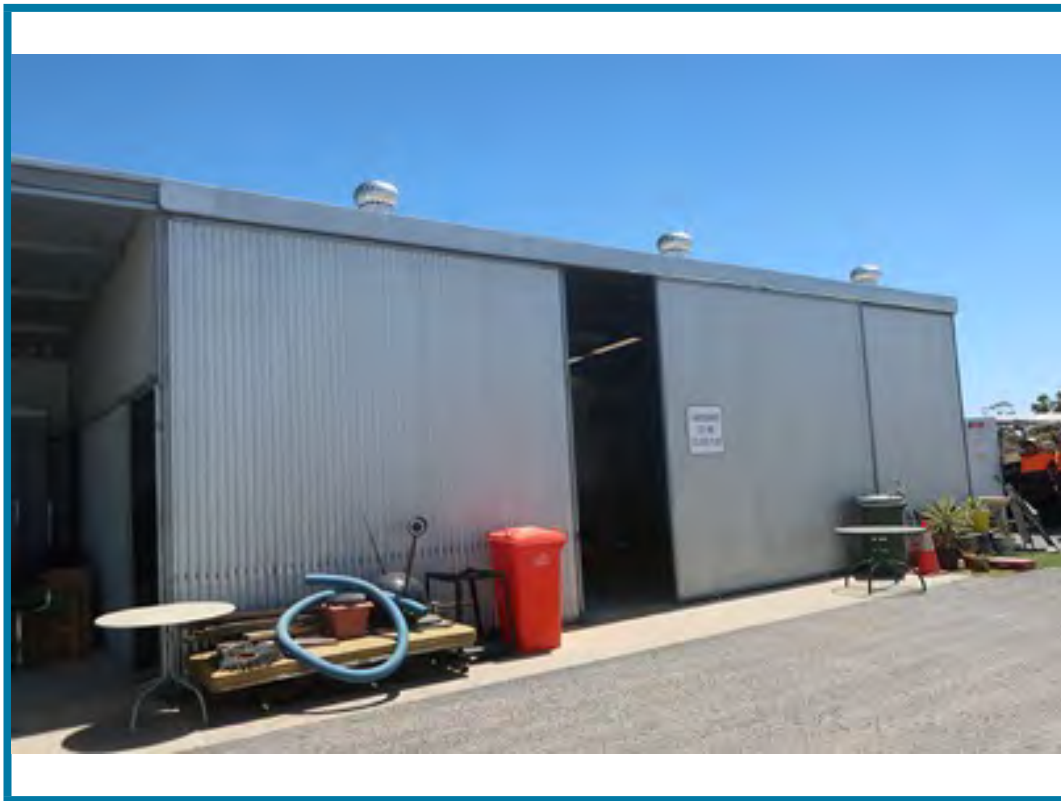
# Workshop

Location	Area	Component Materials	ACM Identified	Type Asbestos Assessment	ConditionPriority	Signage Required
Workshop - entire perimeter of building.		No Asbestos Materials	No	No sample taken - Visual ID
