Asbestos Report

YARRIAMBIACK SHIRE COUNCIL

PROPERTY ADDRESS:
LB22 PRIMARY SCHOOL
2808 WARRACKNABEAL-WILKUR ROAD
WILKUR SOUTH VIC 3393

INSPECTION DATE: 11 FEBRUARY 2021
REFERENCE NUMBER: 62147

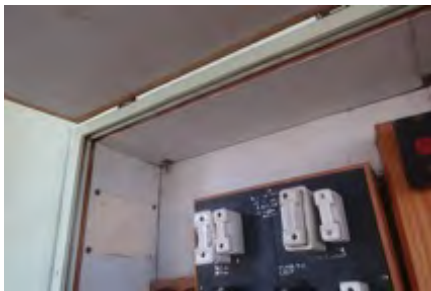
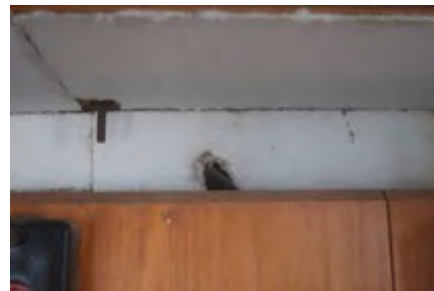
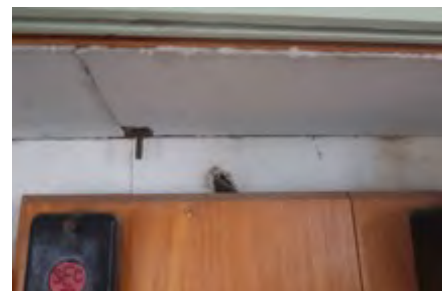
Hall 2. The Electrical Cabinet - lining (Millboard) has Asbestos Containing Material (ACM) present.

RISK ASSESSMENT					
Type of Asbestos or Hazardous Material	No sample taken - Visual ID	Condition	AVERAGE	Likelihood of Damage	L (Low) – possible
		Activity	Moderate		
		Sealed	No	Friability	Friable
		Labelled	Y	Exposure Risk	Medium - Moderate risk
		Quantity

Raw Material

RISK CONTROL					
Priority	HIGH	Label Required	Yes	Re- Audit Date	11 Feb 2022
Action	Remedial repairs required - seal raw material / edges				
Recommendation	Raw material sheeting - The area requires immediate remedial repairs. It is recommended the asbestos material be sealed with an approved membrane.				
Legislative Requirements Victorian Regulation 2007	Damaged ACM visible in area. Requires IMMEDIATE ATTENTION. WARNING labels should be affixed. Avoid mechanical damage and abrasion. Remove if refurbishment, structural alteration or demolition is to be carried out in this area. Re-inspect every 12 months or earlier if disturbed or removed in accordance with the Victorian OH&S Regulation 2017. All remedial/removal repairs require a Clearance Inspection & Certificate to be recorded by an approved and competent assessor.

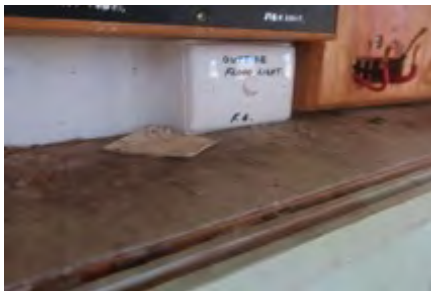
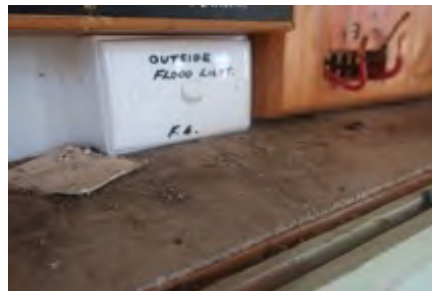
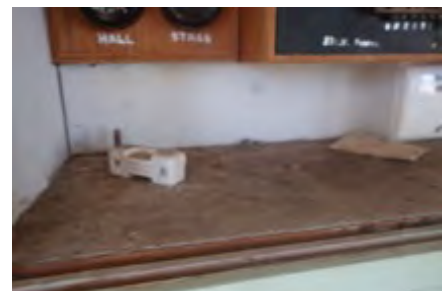
Hall 2. The Electrical Cabinet (Debris) has Asbestos Containing Material (ACM) present.

RISK ASSESSMENT					
Type of Asbestos or Hazardous Material	No sample taken - Visual ID	Condition	POOR	Likelihood of Damage	H (High) - almost certain
		Activity	Low	Friability	Exposed Fibres
		Sealed	No	Exposure Risk	High - Short term exposure risk
		Labelled	Y	Quantity

Debris on Surface

RISK CONTROL					
Priority	IMMEDIATE	Label Required	Yes	Re- Audit Date	11 Feb 2022
Action	Restrict access and target for imminent removal				
Recommendation	Debris on Surface - The Debris requires immediate cleanup and disposal with specialised equipment and with licensed removalist to safely remove the asbestos debris.				
Legislative Requirements Victorian Regulation 2007	ACM debris visible. Recommend cleanup by licensed Asbestos Removalist. Warning labels should be affixed. Avoid mechanical damage and abrasion. Remove if refurbishment, structural alteration or demolition is to be carried out in this area. Re-inspect every 12 months or earlier if disturbed or removed in accordance with the Victorian OH&S Regulation 2017. All remedial/removal repairs require a Clearance Inspection & Certificate to be recorded by an approved and competent assessor.

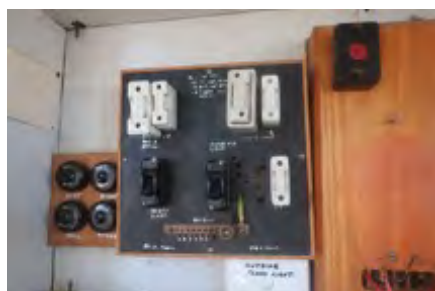
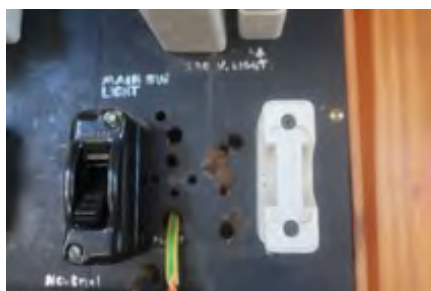
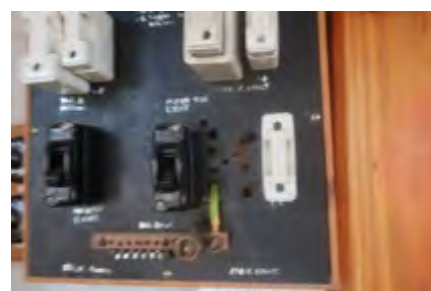
Hall 2. The A: Electrical board; B: Ceramic Fuses (A: Zelemite; B: Cloth Inserts) has Asbestos Containing Material (ACM) present.

RISK ASSESSMENT						
Type of Asbestos or Hazardous Material	No sample taken - Visual ID	Condition	AVERAGE	Likelihood of Damage	L (Low) – possible	
		Activity	Moderate			
		Sealed	Yes	Friability		Exposed Fibres
		Labelled	Y	Exposure Risk		Medium - Moderate risk
		Quantity

Penetration Holes

Priority	HIGH	Label Required	Yes	Re- Audit Date	11 Feb 2022
Action	Remedial repairs required - seal raw material / edges				
Recommendation	Penetration Holes - The exposed edges require approved sealant. It is further recommended the gaps be filled with sealant. Do not remove the fuses without asbestos controls - test for cloth inserts				
Legislative Requirements Victorian Regulation 2007	Damaged ACM visible in area. Requires IMMEDIATE ATTENTION. WARNING labels should be affixed. Avoid mechanical damage and abrasion. Remove if refurbishment, structural alteration or demolition is to be carried out in this area. Re-inspect every 12 months or earlier if disturbed or removed in accordance with the Victorian OH&S Regulation 2017. All remedial/removal repairs require a Clearance Inspection & Certificate to be recorded by an approved and competent assessor.

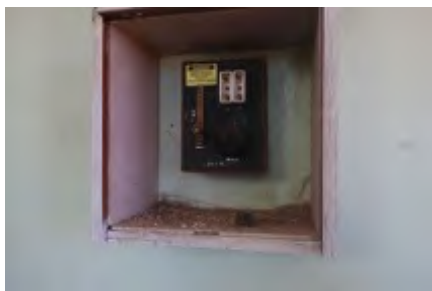
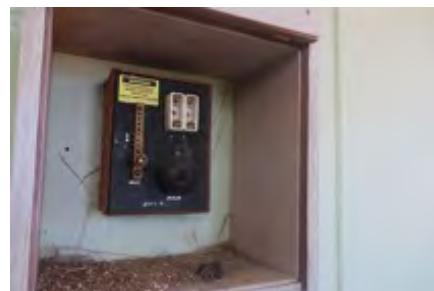
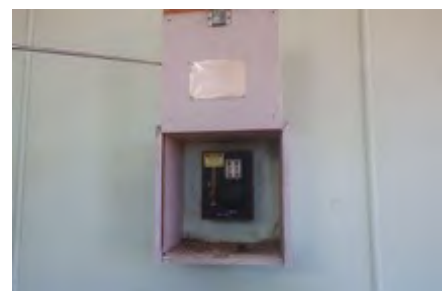
Area 6**Rear room 3. The Electrical Cabinet - lining (F C Sheeting) has Asbestos Containing Material (ACM) present.****RISK ASSESSMENT**

Type of Asbestos or Hazardous Material	No sample taken - Visual ID	Condition	AVERAGE	Likelihood of Damage	L (Low) – possible
		Activity	Moderate		
		Sealed	No	Friability	Bonded (non-friable)
		Labelled	Y	Exposure Risk	Medium - Moderate risk
		Quantity

Raw Material

Priority	HIGH	Label Required	Yes	Re- Audit Date	11 Feb 2022
Action	Remedial repairs required - seal raw material / edges				
Recommendation	Raw material sheeting - The area requires immediate remedial repairs. It is recommended the asbestos material be sealed with an approved membrane.				
Legislative Requirements Victorian Regulation 2007	<p>Damaged ACM visible in area. Requires IMMEDIATE ATTENTION. WARNING labels should be affixed. Avoid mechanical damage and abrasion. Remove if refurbishment, structural alteration or demolition is to be carried out in this area. Re-inspect every 12 months or earlier if disturbed or removed in accordance with the Victorian OH&S Regulation 2017.</p> <p>All remedial/removal repairs require a Clearance Inspection & Certificate to be recorded by an approved and competent assessor.</p>

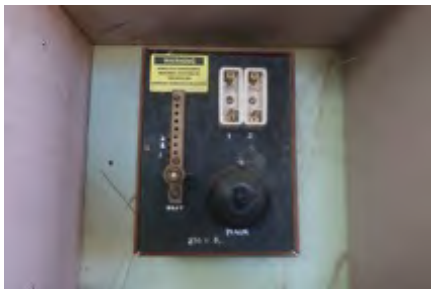
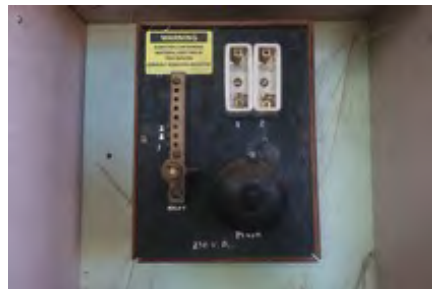
Rear room 3. The Electrical board (Backing Board (Zelemite)) has Asbestos Containing Material (ACM) present.

RISK ASSESSMENT					
Type of Asbestos or Hazardous Material	No sample taken - Visual ID	Condition	GOOD	Likelihood of Damage	L (Low) – possible
		Activity	Moderate		
		Sealed	Yes	Friability	Bonded (non-friable)
		Labelled	Y	Exposure Risk	Low - Negligible or low risk
		Quantity

RISK CONTROL					
Priority	MEDIUM	Label Required	Yes	Re- Audit Date	11 Feb 2022
Action	No remedial action required, unless disturbed				
Recommendation	Maintain paint or sealant to ACM surfaces. Particular attention should be given to side edges, ensure paint/sealant covers ALL exposed ACM surfaces.				
Legislative Requirements Victorian Regulation 2007	Warning labels should be affixed. Avoid mechanical damage and abrasion. Remove if refurbishment, structural alteration or demolition is to be carried out in this area. Re-inspect every 12 months or earlier if disturbed or removed in accordance with the Victorian OH&S Regulation 2017. All remedial/removal repairs require a Clearance Inspection & Certificate to be recorded by an approved and competent assessor.

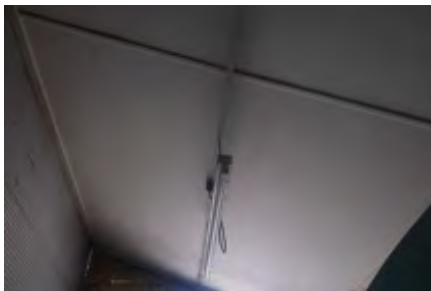
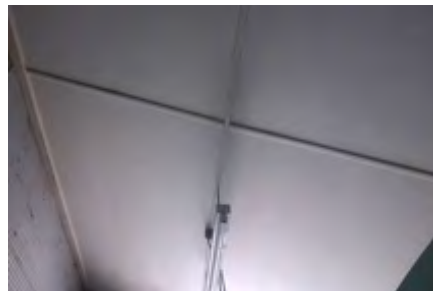
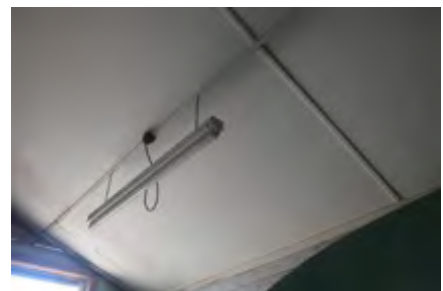
Kitchen. The Ceiling (F C Sheeting) has Asbestos Containing Material (ACM) present.

RISK ASSESSMENT					
Type of Asbestos or Hazardous Material	No sample taken - Visual ID	Condition	GOOD	Likelihood of Damage	L (Low) – possible
		Activity	Moderate		
		Sealed	Yes	Friability	Bonded (non-friable)
		Labelled	Y	Exposure Risk	Low - Negligible or low risk
		Quantity

Priority	MEDIUM	Label Required	Yes	Re- Audit Date	11 Feb 2022
Action	No remedial action required, unless disturbed				
Recommendation	Maintain paint or sealant to ACM surfaces. Particular attention should be given to side edges, ensure paint/sealant covers ALL exposed ACM surfaces.				
Legislative Requirements Victorian Regulation 2007	Warning labels should be affixed. Avoid mechanical damage and abrasion. Remove if refurbishment, structural alteration or demolition is to be carried out in this area. Re-inspect every 12 months or earlier if disturbed or removed in accordance with the Victorian OH&S Regulation 2017. All remedial/removal repairs require a Clearance Inspection & Certificate to be recorded by an approved and competent assessor.

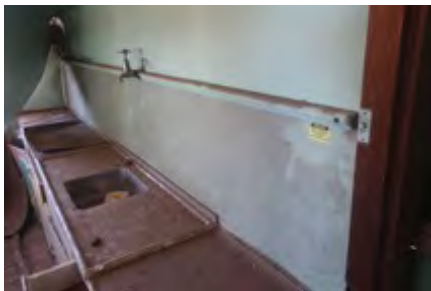
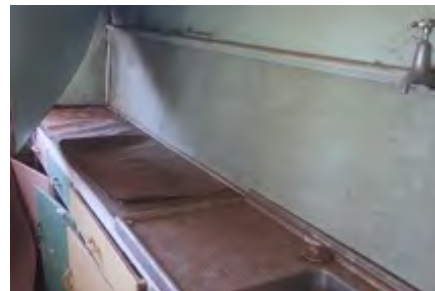
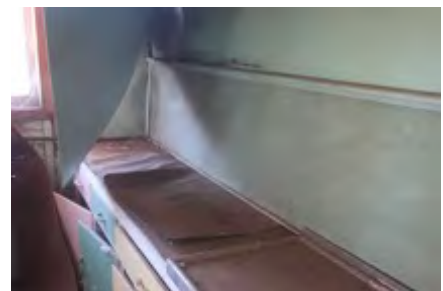
Kitchen. The Splach back (F C Sheeting) has Asbestos Containing Material (ACM) present.

RISK ASSESSMENT					
Type of Asbestos or Hazardous Material	No sample taken - Visual ID	Condition	GOOD	Likelihood of Damage	L (Low) – possible
		Activity	Moderate		
		Sealed	Yes	Friability	Bonded (non-friable)
		Labelled	Y	Exposure Risk	Low - Negligible or low risk
		Quantity

RISK CONTROL					
Priority	MEDIUM	Label Required	Yes	Re- Audit Date	11 Feb 2022
Action	No remedial action required, unless disturbed				
Recommendation	Maintain paint or sealant to ACM surfaces. Particular attention should be given to side edges, ensure paint/sealant covers ALL exposed ACM surfaces.				
Legislative Requirements Victorian Regulation 2007	Warning labels should be affixed. Avoid mechanical damage and abrasion. Remove if refurbishment, structural alteration or demolition is to be carried out in this area. Re-inspect every 12 months or earlier if disturbed or removed in accordance with the Victorian OH&S Regulation 2017. All remedial/removal repairs require a Clearance Inspection & Certificate to be recorded by an approved and competent assessor.

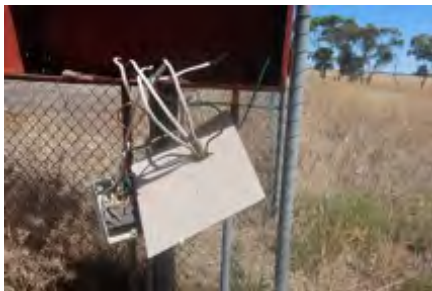
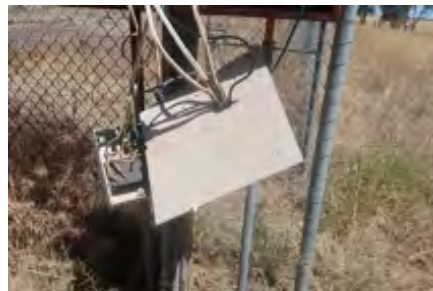
Tennis Court: External. The Electrical board (Backing Board (Zelemite)) has Asbestos Containing Material (ACM) present.

RISK ASSESSMENT					
Type of Asbestos or Hazardous Material	No sample taken - Visual ID	Condition	POOR	Likelihood of Damage	L (Low) – possible
		Activity	Moderate		
		Sealed	Yes	Friability	Exposed Fibres
		Labelled	Y	Exposure Risk	Medium - Moderate risk
		Quantity

Damaged material

Priority	IMMEDIATE	Label Required	Yes	Re- Audit Date	11 Feb 2022
Action	Remedial repairs required - seal exposed edges or replace or laminate over damaged material				
Recommendation	Damaged material - The damaged area requires immediate remedial repairs. It is recommended the asbestos sheeting be replaced.				
Legislative Requirements Victorian Regulation 2007	ACM debris visible. Recommend cleanup by licensed Asbestos Removalist. Warning labels should be affixed. Avoid mechanical damage and abrasion. Remove if refurbishment, structural alteration or demolition is to be carried out in this area. Re-inspect every 12 months or earlier if disturbed or removed in accordance with the Victorian OH&S Regulation 2017. All remedial/removal repairs require a Clearance Inspection & Certificate to be recorded by an approved and competent assessor.

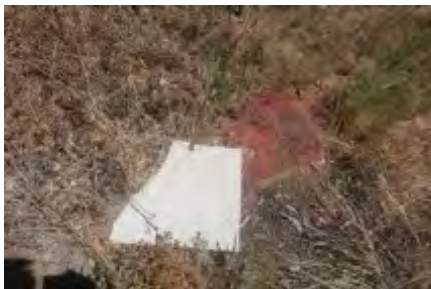
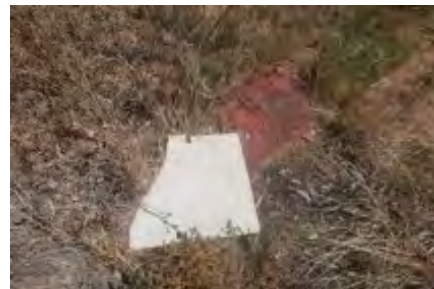
Tennis Court: External. The Debris - Broken (Debris) has Asbestos Containing Material (ACM) present.

RISK ASSESSMENT					
Type of Asbestos or Hazardous Material	No sample taken - Visual ID	Condition	POOR	Likelihood of Damage	H (High) - almost certain
		Activity	Moderate		
		Sealed	No	Friability	Exposed Fibres
		Labelled	No	Exposure Risk	High - Short term exposure risk
		Quantity

Debris on Surface

RISK CONTROL					
Priority	IMMEDIATE	Label Required	Yes	Re- Audit Date	11 Feb 2022
Action	Restrict access and target for imminent removal				
Recommendation	Debris on Surface - The Debris requires immediate cleanup and disposal with specialised equipment and with licensed removalist to safely remove the asbestos debris.				
Legislative Requirements Victorian Regulation 2007	ACM debris visible. Recommend cleanup by licensed Asbestos Removalist. Warning labels should be affixed. Avoid mechanical damage and abrasion. Remove if refurbishment, structural alteration or demolition is to be carried out in this area. Re-inspect every 12 months or earlier if disturbed or removed in accordance with the Victorian OH&S Regulation 2017. All remedial/removal repairs require a Clearance Inspection & Certificate to be recorded by an approved and competent assessor.
