Asbestos Report

YARRIAMBIACK SHIRE COUNCIL

PROPERTY ADDRESS:
LB88 BOWLING CLUB
18-20 GLOUCESTER AVENUE
WOOMELANG VIC 3485

INSPECTION DATE: 11 FEBRUARY 2021
REFERENCE NUMBER: 62148

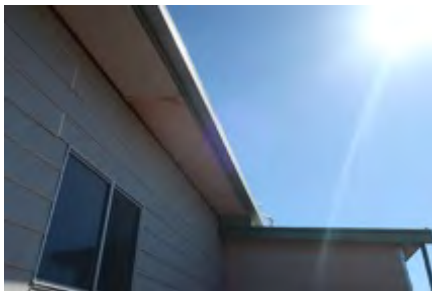
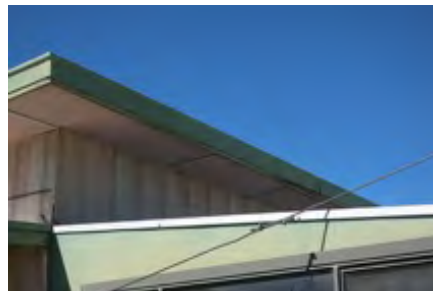
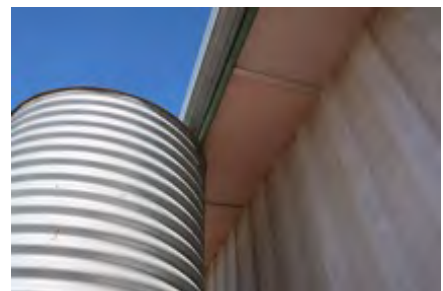
Type of Asbestos or Hazardous Material	No sample taken - Visual ID	Condition	AVERAGE	Likelihood of Damage	L (Low) – possible
		Activity	Moderate		
		Sealed	No	Friability	Bonded (non-friable)
		Labelled	Y	Exposure Risk	Medium - Moderate risk
		Quantity

Raw Material

Priority	HIGH	Label Required	Yes	Re- Audit Date	11 Feb 2022
Action	Remedial repairs required - seal raw material / edges				
Recommendation	Raw material sheeting - The area requires immediate remedial repairs. It is recommended the asbestos material be sealed with an approved membrane.				
Legislative Requirements Victorian Regulation 2007	Damaged ACM visible in area. Requires IMMEDIATE ATTENTION. WARNING labels should be affixed. Avoid mechanical damage and abrasion. Remove if refurbishment, structural alteration or demolition is to be carried out in this area. Re-inspect every 12 months or earlier if disturbed or removed in accordance with the Victorian OH&S Regulation 2017. All remedial/removal repairs require a Clearance Inspection & Certificate to be recorded by an approved and competent assessor.

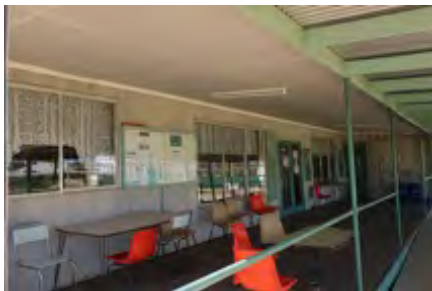
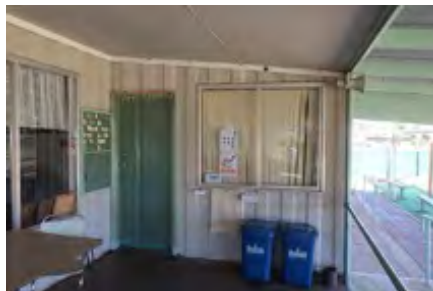
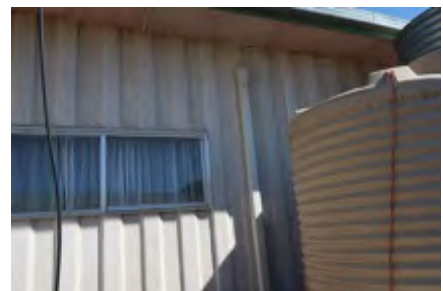
Type of Asbestos or Hazardous Material	No sample taken - Visual ID	Condition	AVERAGE	Likelihood of Damage	L (Low) – possible
		Activity	Moderate		
		Sealed	No	Friability	Bonded (non-friable)
		Labelled	Y	Exposure Risk	Medium - Moderate risk
		Quantity

Raw Material

Priority	HIGH	Label Required	Yes	Re- Audit Date	11 Feb 2022
Action	Remedial repairs required - seal raw material / edges				
Recommendation	Raw material sheeting - The area requires immediate remedial repairs. It is recommended the asbestos material be sealed with an approved membrane. Asbestos materials have been reused in the recent building extensions				
Legislative Requirements Victorian Regulation 2007	Damaged ACM visible in area. Requires IMMEDIATE ATTENTION. WARNING labels should be affixed. Avoid mechanical damage and abrasion. Remove if refurbishment, structural alteration or demolition is to be carried out in this area. Re-inspect every 12 months or earlier if disturbed or removed in accordance with the Victorian OH&S Regulation 2017. All remedial/removal repairs require a Clearance Inspection & Certificate to be recorded by an approved and competent assessor.

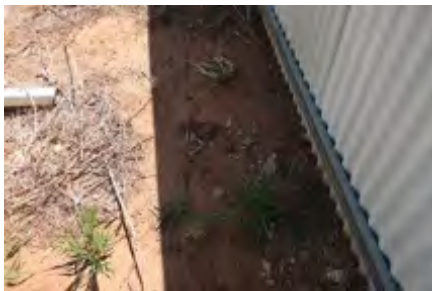
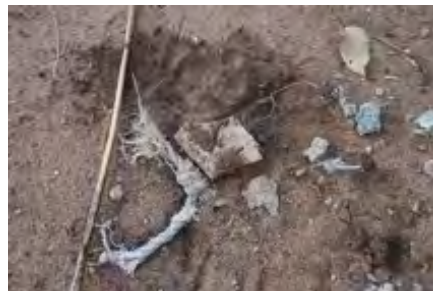
LB88 Bowling Club: rear of building. The Debris - Broken (Debris) has Asbestos Containing Material (ACM) present.

RISK ASSESSMENT					
Type of Asbestos or Hazardous Material	No sample taken - Visual ID	Condition	POOR	Likelihood of Damage	H (High) - almost certain
		Activity	Moderate		
		Sealed	No	Friability	Exposed Fibres
		Labelled	No	Exposure Risk	High - Short term exposure risk
		Quantity

Debris on Surface

RISK CONTROL					
Priority	IMMEDIATE	Label Required	Yes	Re- Audit Date	11 Feb 2022
Action	Restrict access and target for imminent removal				
Recommendation	Debris on Surface - The Debris requires immediate cleanup and disposal with specialised equipment and with licensed removalist to safely remove the asbestos debris.				
Legislative Requirements Victorian Regulation 2007	ACM debris visible. Recommend cleanup by licensed Asbestos Removalist. Warning labels should be affixed. Avoid mechanical damage and abrasion. Remove if refurbishment, structural alteration or demolition is to be carried out in this area. Re-inspect every 12 months or earlier if disturbed or removed in accordance with the Victorian OH&S Regulation 2017. All remedial/removal repairs require a Clearance Inspection & Certificate to be recorded by an approved and competent assessor.

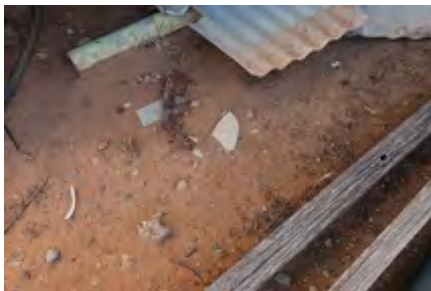
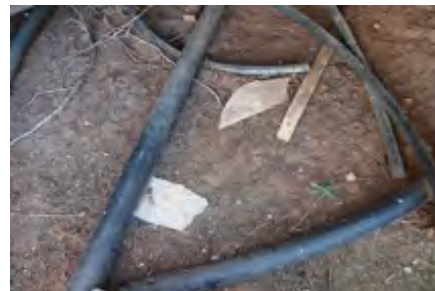
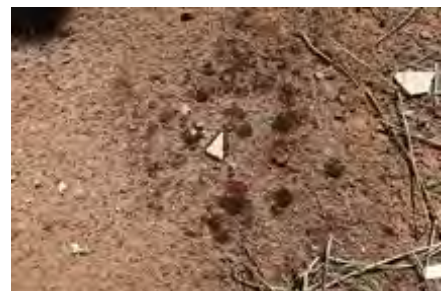
LB88 Bowling Club: left side of building. The Debris - Broken (Debris) has Asbestos Containing Material (ACM) present.

RISK ASSESSMENT					
Type of Asbestos or Hazardous Material	No sample taken - Visual ID	Condition	POOR	Likelihood of Damage	H (High) - almost certain
		Activity	Moderate		
		Sealed	No	Friability	Exposed Fibres
		Labelled	No	Exposure Risk	High - Short term exposure risk
		Quantity

Debris on Surface

RISK CONTROL					
Priority	IMMEDIATE	Label Required	Yes	Re- Audit Date	11 Feb 2022
Action	Restrict access and target for imminent removal				
Recommendation	Debris on Surface - The Debris requires immediate cleanup and disposal with specialised equipment and with licensed removalist to safely remove the asbestos debris.				
Legislative Requirements Victorian Regulation 2007	ACM debris visible. Recommend cleanup by licensed Asbestos Removalist. Warning labels should be affixed. Avoid mechanical damage and abrasion. Remove if refurbishment, structural alteration or demolition is to be carried out in this area. Re-inspect every 12 months or earlier if disturbed or removed in accordance with the Victorian OH&S Regulation 2017. All remedial/removal repairs require a Clearance Inspection & Certificate to be recorded by an approved and competent assessor.

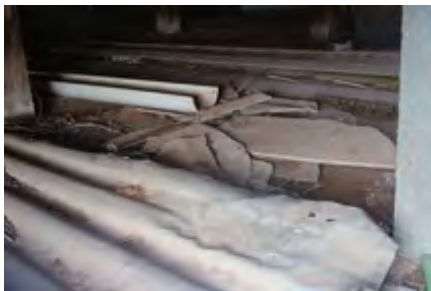
LB88 Bowling Club: Subfloor. The Debris - Broken (Debris) has Asbestos Containing Material (ACM) present.

RISK ASSESSMENT					
Type of Asbestos or Hazardous Material	Chrysotile	Condition	POOR	Likelihood of Damage	H (High) - almost certain
	Amosite	Activity	Moderate		
	Sample taken 62148-003	Sealed	No	Friability	Exposed Fibres
		Labelled	No	Exposure Risk	High - Short term exposure risk
		Quantity

Debris on Surface

RISK CONTROL					
Priority	IMMEDIATE	Label Required	Yes	Re- Audit Date	11 Feb 2022
Action	Restrict access and target for imminent removal				
Recommendation	Debris on Surface - The Debris requires immediate cleanup and disposal with specialised equipment and with licensed removalist to safely remove the asbestos debris.				
Legislative Requirements Victorian Regulation 2007	ACM debris visible. Recommend cleanup by licensed Asbestos Removalist. Warning labels should be affixed. Avoid mechanical damage and abrasion. Remove if refurbishment, structural alteration or demolition is to be carried out in this area. Re-inspect every 12 months or earlier if disturbed or removed in accordance with the Victorian OH&S Regulation 2017. All remedial/removal repairs require a Clearance Inspection & Certificate to be recorded by an approved and competent assessor.

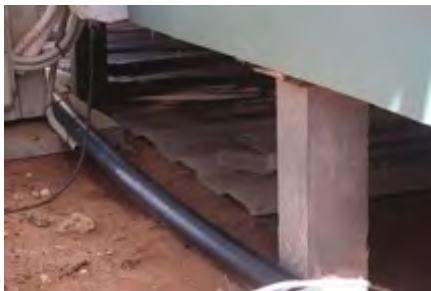
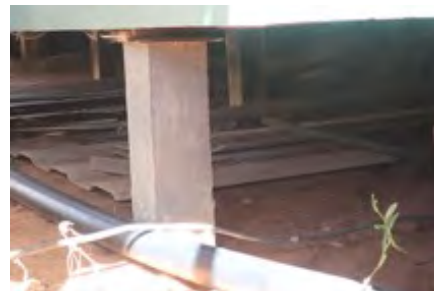
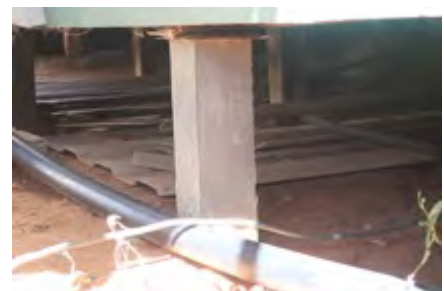
LB88 Bowling Club: Subfloor. The Stored Material (Debris) has Asbestos Containing Material (ACM) present.

RISK ASSESSMENT					
Type of Asbestos or Hazardous Material	No sample taken - Visual ID	Condition	POOR	Likelihood of Damage	L (Low) – possible
		Activity	Moderate		
		Sealed	No	Friability	Exposed Fibres
		Labelled	Y	Exposure Risk	Medium - Moderate risk
		Quantity

Stored Material

RISK CONTROL					
Priority	IMMEDIATE	Label Required	Yes	Re- Audit Date	11 Feb 2022
Action	Restrict access and target for imminent removal				
Recommendation	Stored material - cannot be used - Debris on Surface - The Debris requires immediate cleanup and disposal with specialised equipment and with licensed removalist to safely remove the asbestos debris.				
Legislative Requirements Victorian Regulation 2007	Stored material - illegal to use and store. - ACM debris visible. Recommend cleanup by licensed Asbestos Removalist. Warning labels should be affixed. Avoid mechanical damage and abrasion. Remove if refurbishment, structural alteration or demolition is to be carried out in this area. Re-inspect every 12 months or earlier if disturbed or removed in accordance with the Victorian OH&S Regulation 2017. All remedial/removal repairs require a Clearance Inspection & Certificate to be recorded by an approved and competent assessor.

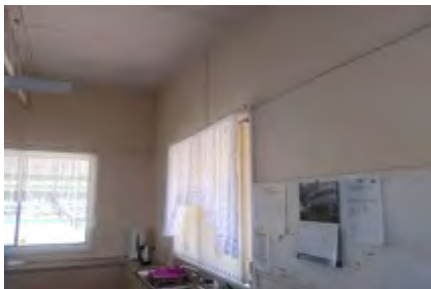
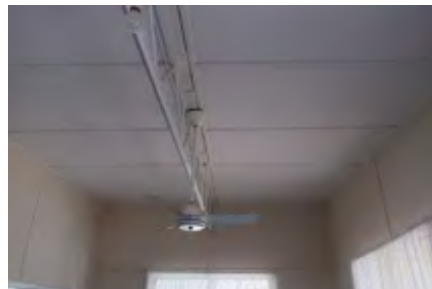
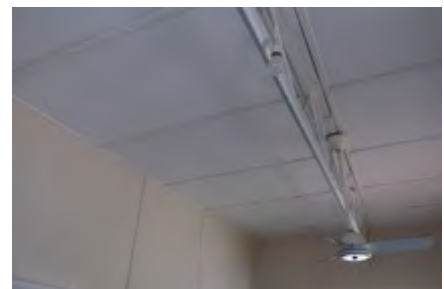
LB88 Bowling Club: Kitchen 1. The Walls and Ceiling (F C Sheeting) has Asbestos Containing Material (ACM) present.

RISK ASSESSMENT					
Type of Asbestos or Hazardous Material	No sample taken - Visual ID	Condition	GOOD	Likelihood of Damage	L (Low) – possible
		Activity	Moderate		
		Sealed	Yes	Friability	Bonded (non-friable)
		Labelled	Y	Exposure Risk	Low - Negligible or low risk
		Quantity

Maintain paint or sealant

Priority	MEDIUM	Label Required	Yes	Re- Audit Date	11 Feb 2022
Action	No remedial action required, unless disturbed				
Recommendation	Maintain paint or sealant to ACM surfaces. Particular attention should be given to side edges, ensure paint/sealant covers ALL exposed ACM surfaces.				
Legislative Requirements Victorian Regulation 2007	Warning labels should be affixed. Avoid mechanical damage and abrasion. Remove if refurbishment, structural alteration or demolition is to be carried out in this area. Re-inspect every 12 months or earlier if disturbed or removed in accordance with the Victorian OH&S Regulation 2017. All remedial/removal repairs require a Clearance Inspection & Certificate to be recorded by an approved and competent assessor.

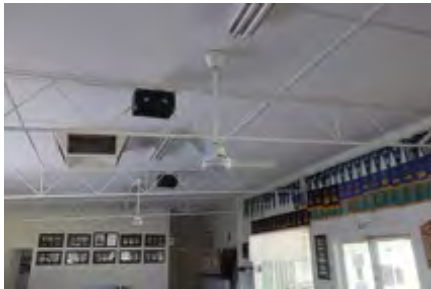
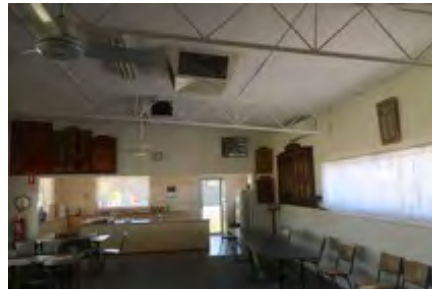
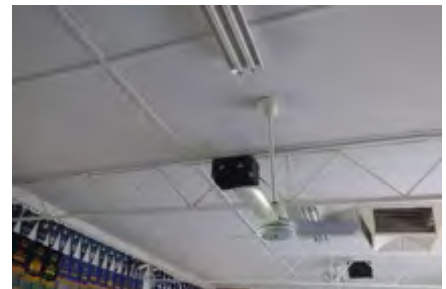
Area 9**LB88 Bowling Club: Clubroom 2. The Walls and Ceiling (F C Sheeting) has Asbestos Containing Material (ACM) present.****RISK ASSESSMENT**

Type of Asbestos or Hazardous Material	No sample taken - Visual ID	Condition	GOOD	Likelihood of Damage	L (Low) – possible
		Activity	Moderate		
		Sealed	Yes	Friability	Bonded (non-friable)
		Labelled	Y	Exposure Risk	Low - Negligible or low risk
		Quantity

Maintain paint or sealant

Priority	MEDIUM	Label Required	Yes	Re- Audit Date	11 Feb 2022
Action	No remedial action required, unless disturbed				
Recommendation	Maintain paint or sealant to ACM surfaces. Particular attention should be given to side edges, ensure paint/sealant covers ALL exposed ACM surfaces.				
Legislative Requirements Victorian Regulation 2007	Warning labels should be affixed. Avoid mechanical damage and abrasion. Remove if refurbishment, structural alteration or demolition is to be carried out in this area. Re-inspect every 12 months or earlier if disturbed or removed in accordance with the Victorian OH&S Regulation 2017. All remedial/removal repairs require a Clearance Inspection & Certificate to be recorded by an approved and competent assessor.

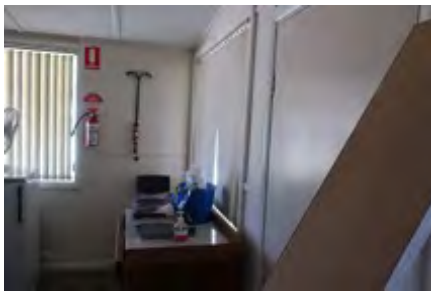
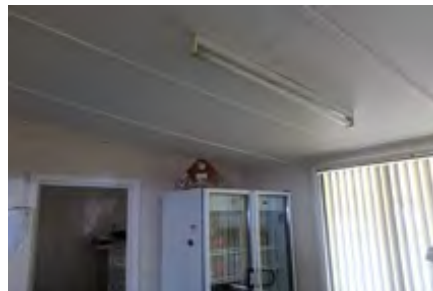
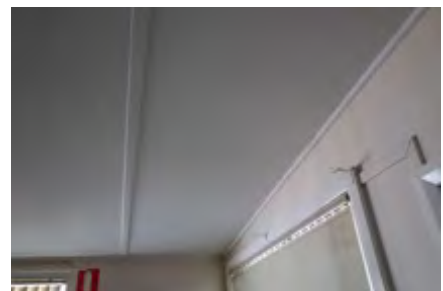
LB88 Bowling Club: Bar 7. The Walls and Ceiling (F C Sheeting) has Asbestos Containing Material (ACM) present.

RISK ASSESSMENT					
Type of Asbestos or Hazardous Material	No sample taken - Visual ID	Condition	GOOD	Likelihood of Damage	L (Low) – possible
		Activity	Moderate		
		Sealed	Yes	Friability	Bonded (non-friable)
		Labelled	Y	Exposure Risk	Low - Negligible or low risk
		Quantity

Maintain paint or sealant

Priority	MEDIUM	Label Required	Yes	Re- Audit Date	11 Feb 2022
Action	No remedial action required, unless disturbed				
Recommendation	Maintain paint or sealant to ACM surfaces. Particular attention should be given to side edges, ensure paint/sealant covers ALL exposed ACM surfaces.				
Legislative Requirements Victorian Regulation 2007	Warning labels should be affixed. Avoid mechanical damage and abrasion. Remove if refurbishment, structural alteration or demolition is to be carried out in this area. Re-inspect every 12 months or earlier if disturbed or removed in accordance with the Victorian OH&S Regulation 2017. All remedial/removal repairs require a Clearance Inspection & Certificate to be recorded by an approved and competent assessor.

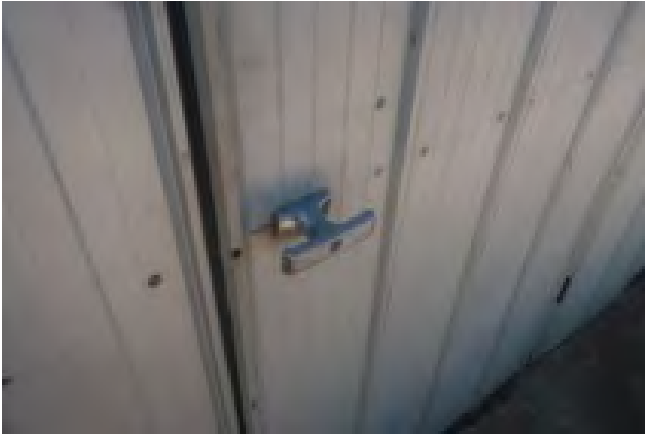
Room

Type of Asbestos or Hazardous Material	No sample taken - No Access	Condition		Likelihood of Damage	
		Activity			
		Sealed		Friability	
		Labelled	No	Exposure Risk	
		Quantity

Priority	HIGH	Label Required	Yes	Re- Audit Date	11 Feb 2022
Action					
Recommendation					
Legislative Requirements Victorian Regulation 2007	Unable to Gain Access. Assume asbestos in area and provide monitoring if work undertaken in these areas. If access is made available, contact Global Asbestos Audits for re-inspection
